Date: April 29, 2005
Refer To: ER2005-0239

SUBJECT: DP CANYON QUARTERLY INSPECTION REPORT FOR SECOND QUARTER, FY05

DP Canyon Quarterly Inspection Report for Second Quarter, Fiscal Year 2005

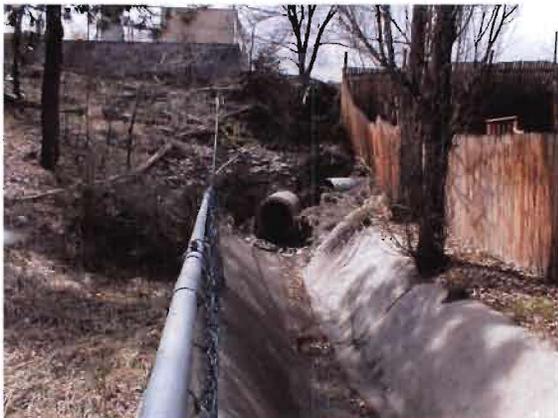
Location 1. Moderate flow from both culverts at the head of DP Canyon during the March 2005 inspection

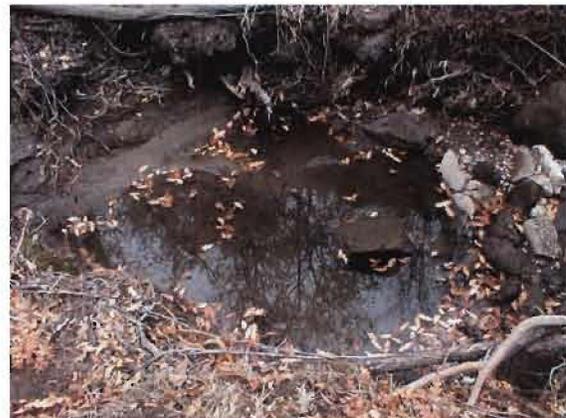
Air	Water	Soil/Sediment
Upstream Location	No petroleum hydrocarbon odor in air	No petroleum hydrocarbon sheen on standing water until sediments were disturbed	Petroleum hydrocarbon odor and sheen in disturbed sediments
Downstream Location	No petroleum hydrocarbon odor in air	No petroleum hydrocarbon sheen on standing water	Faint petroleum hydrocarbon odor in disturbed sediments

Location 2. Standing water at the upstream location during the March 2005 inspection

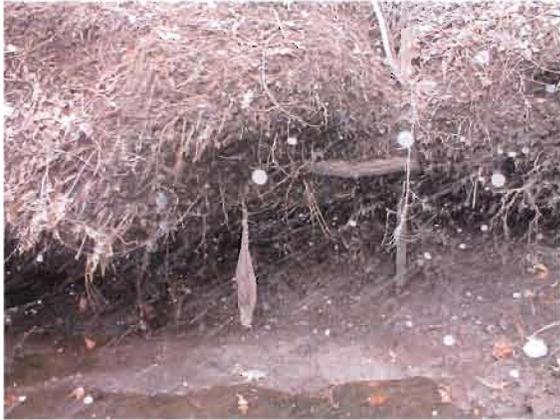
Location 3. Cut bank at the upstream location during the March 2005 inspection

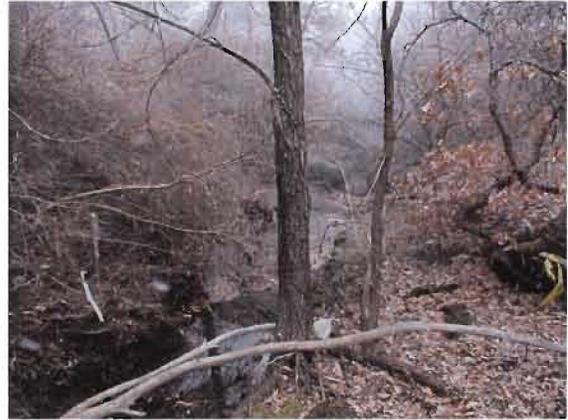
Location 4. Stream channel, looking downstream from sample location 21-11136

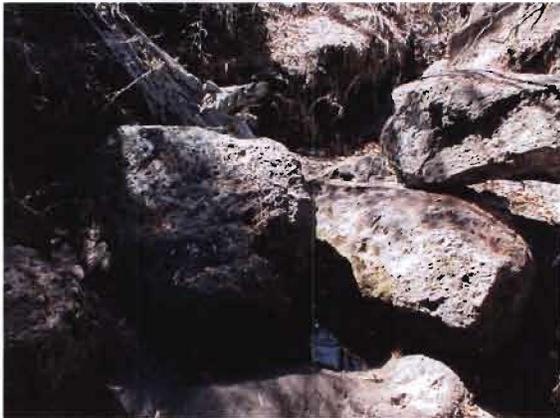
Location 5. Standing water in the drainage at the upstream location during the March 2005 inspection

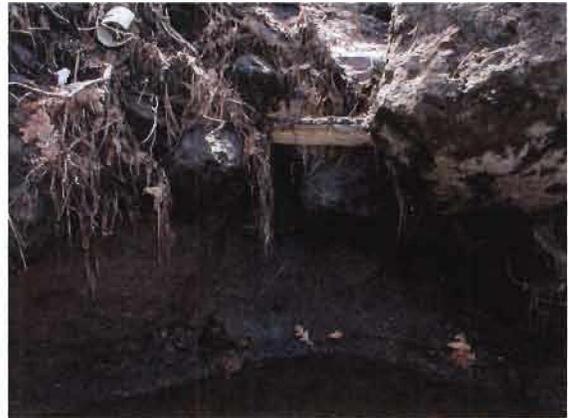
Location 6. Cut bank where faint petroleum hydrocarbon odors were noted in disturbed sediments at the down stream location during the March 2005 inspection

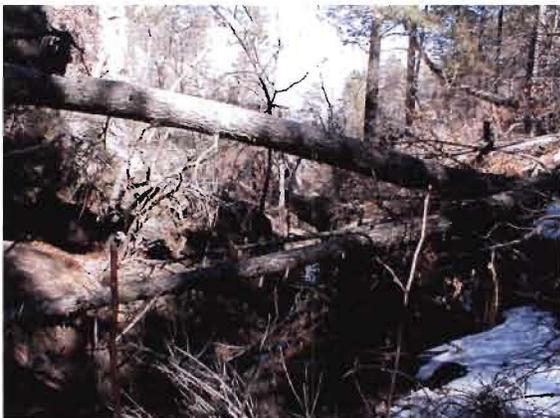
Location 7. Stream channel, looking downstream from sample location 21-11176
