Date: October 15, 2007
Refer To: EP2007-0635

Subject: Submittal of Certification of Culvert Repair behind the SM-30 Warehouse, in the Vicinity of Solid Waste Management Units 03-010(a) and 03-001(e)

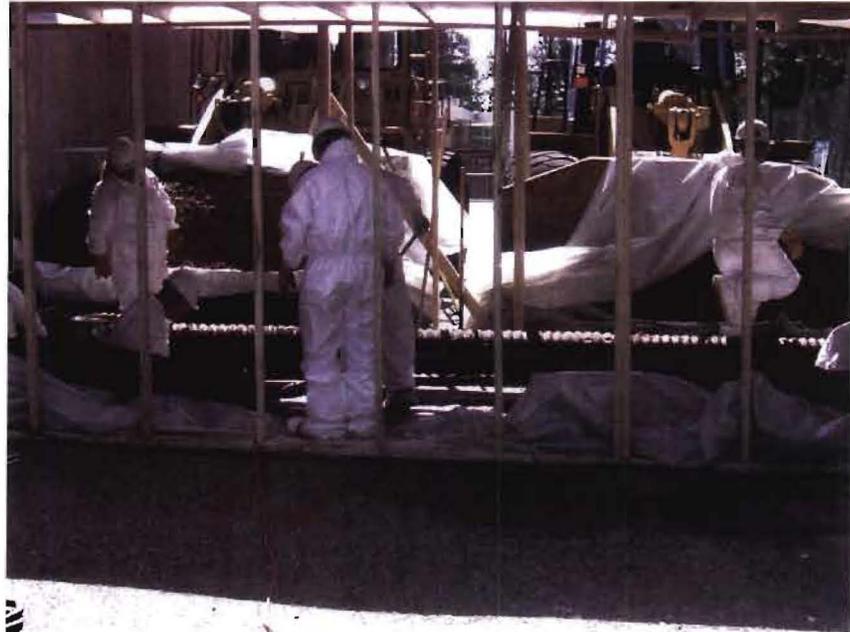
Photo 1. Removal of old culvert.

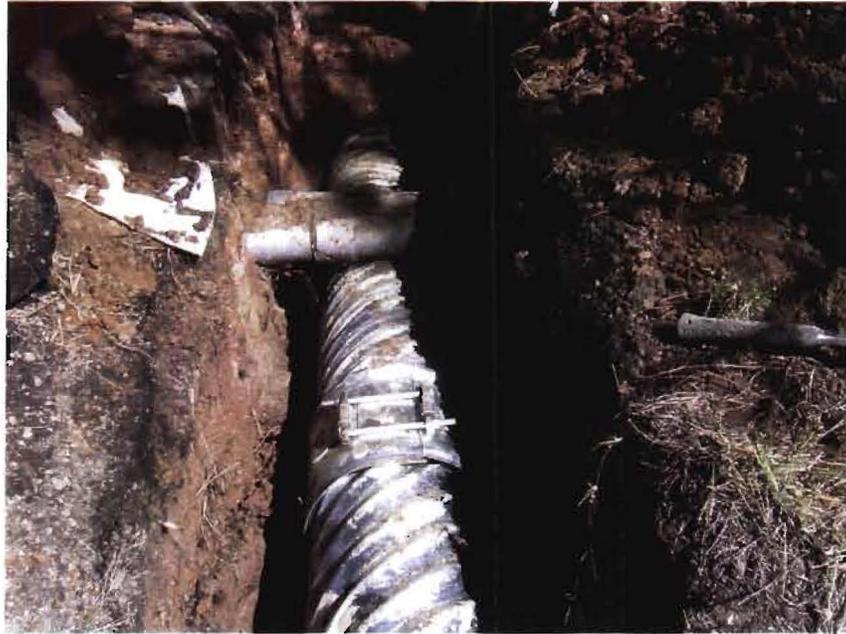
Photo 3. New CMP and existing utility line.

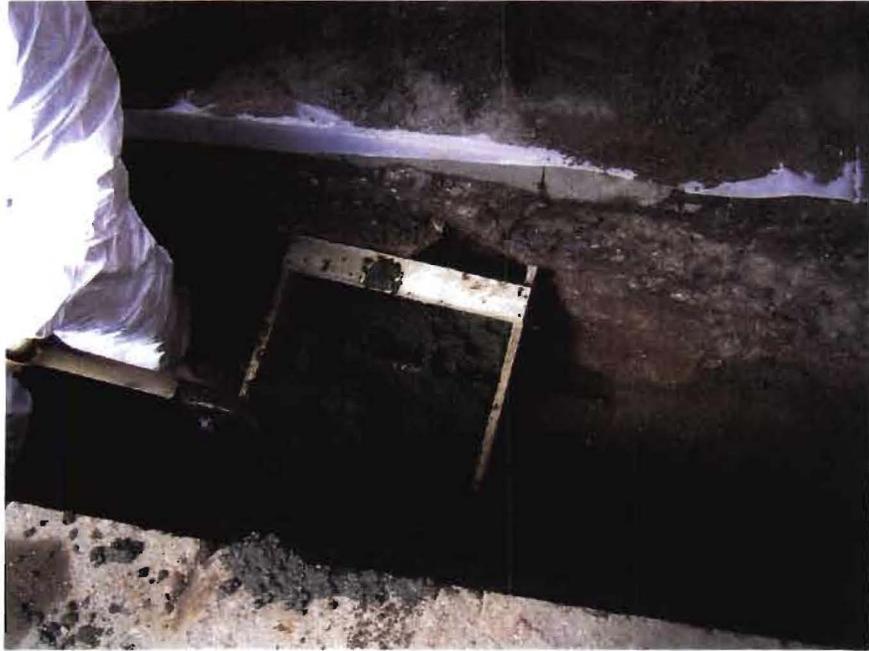
Photo 5. Encasing the coupling in concrete.
