TO: Distribution
FROM: David B. Rogers, ESH-18
SYMBOL: ESH-18/WQ&H:00-0422
SUBJECT: **MORTANDAD CANYON WELL ABANDONMENT PROJECT REPORT**

LA-UR-00-5975

**Mortandad Canyon Well Abandonment Project
Report**

November 2000

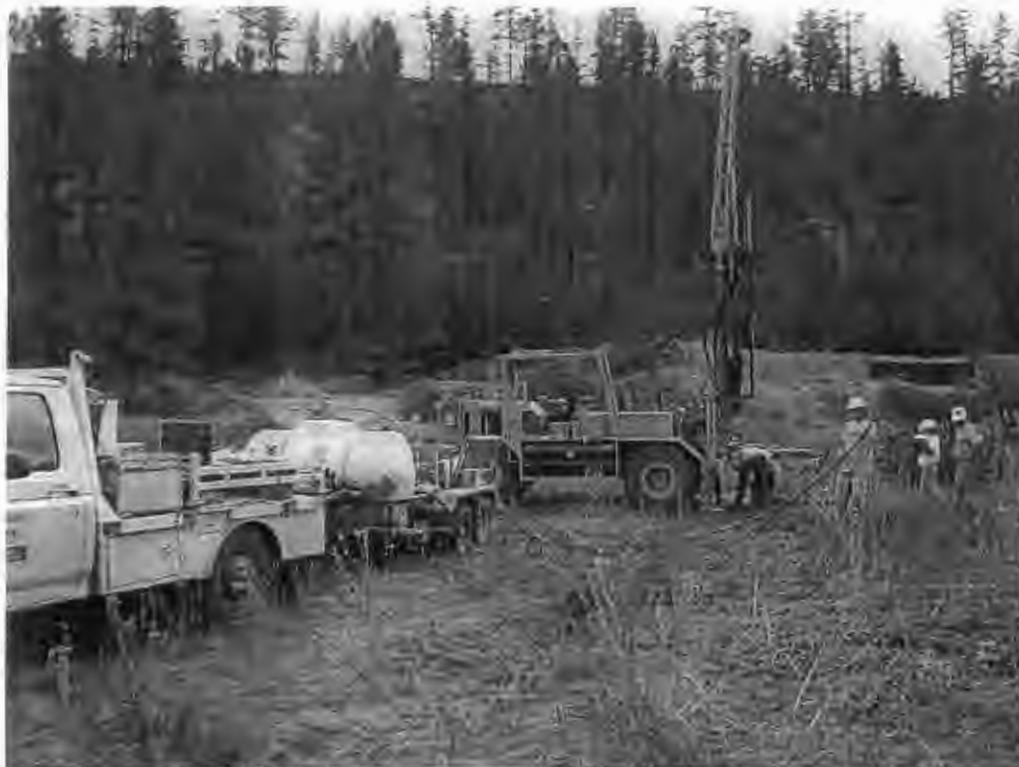
| Hole ID | Survey Date | Survey Time | Tubing Type | Surface Casing | Height of Tubing (Ft from GL) | Sounded Depth (Ft from GL)* | Water Depth (Ft from GL)* | Comments |
|---|---|---|---|---|---|---|---|---|
| MCO-7.5A | 08/25/2000 | 10:35:00 AM | 3" diameter black plastic | None | 0 | 0 | Dry | Fire damaged, tubing burned to ground level |

Photo 1 – Drill rig set up to abandon well MCO-7.5A in Mortandad Canyon.

The tubing for each well was then over-drilled with a hollow stem auger to a depth of 5 feet below ground surface. At each site an attempt was made to pull the tubing from the well. Where possible, the tubing was removed from the hole, however, depending on the age and brittleness of the tubing, the tubing often parted a few feet below the surface. At wells where the tubing parted below surface, the tubing was left in the hole. Each well was then grouted with a mixture of Type I & II Portland cement with 3% bentonite gel added. The drilling company used a trailer-mounted cement mixer to mix the cement, water, and bentonite. The grout mixture was poured into the hole using the tubing remaining in the hole and a hose that connected to the cement mixer. The entire length of the open hole to surface was grouted. The grouted wells were subsequently checked within 24 hours for any settling of the grout. If the grout had settled, extra grout was added to make the grouted holes flush with the surface.

| Hole ID | Date Abandoned | Waste Generated | Tubing (Ft) | SFC Casing (Ft) | Concrete (Ft ³) |
|---|---|--|---|---|---|
| MCO-7.5A | 09/18/2000 | 1 "t" post, tubing | 4 | 0 | 0 |

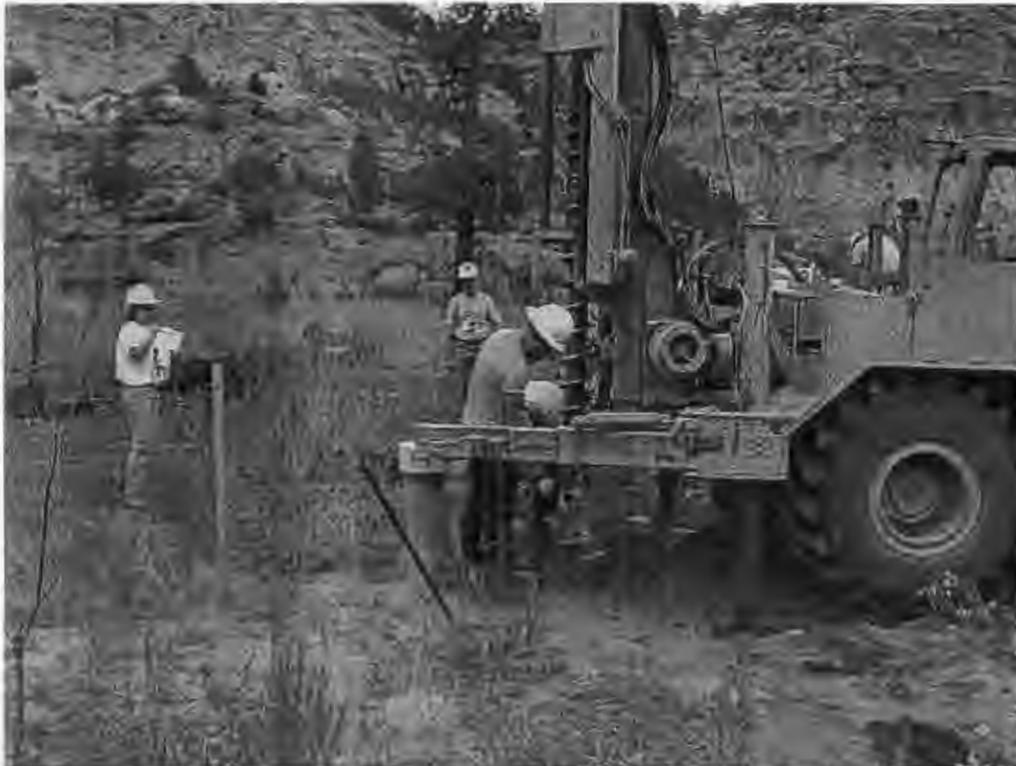
Photo 2 – Drill rig set up to abandon well MCO-7.5A in Mortandad Canyon.

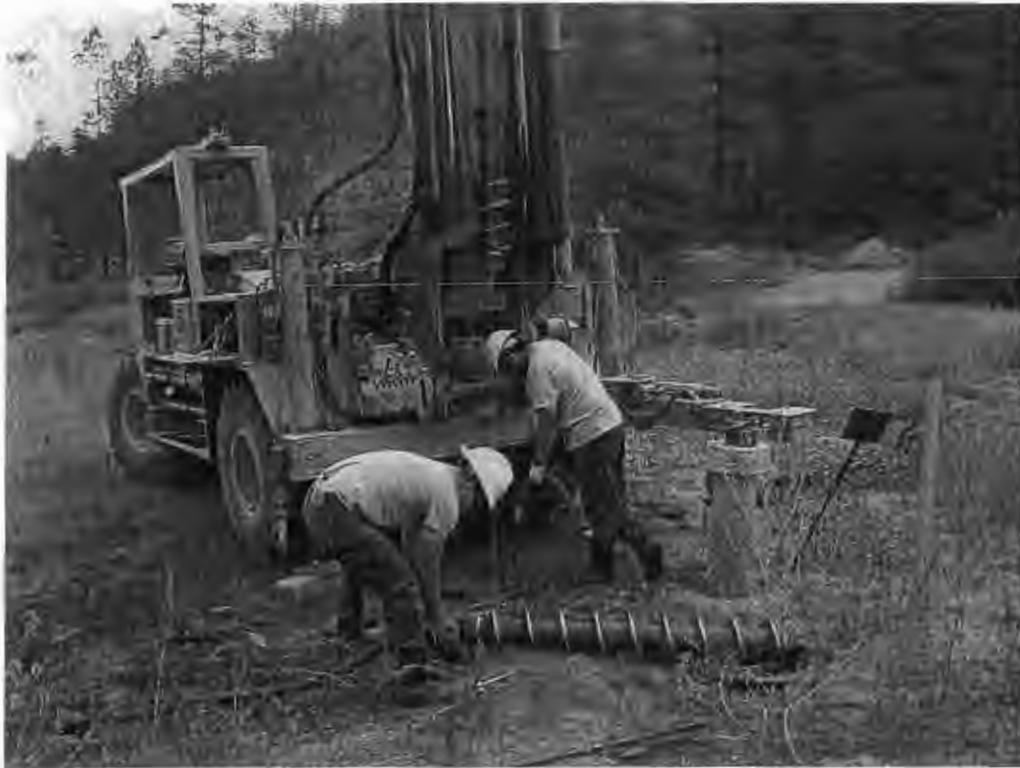
Photo 3 – Grouting up the hole after abandonment of MCO-7.5A.

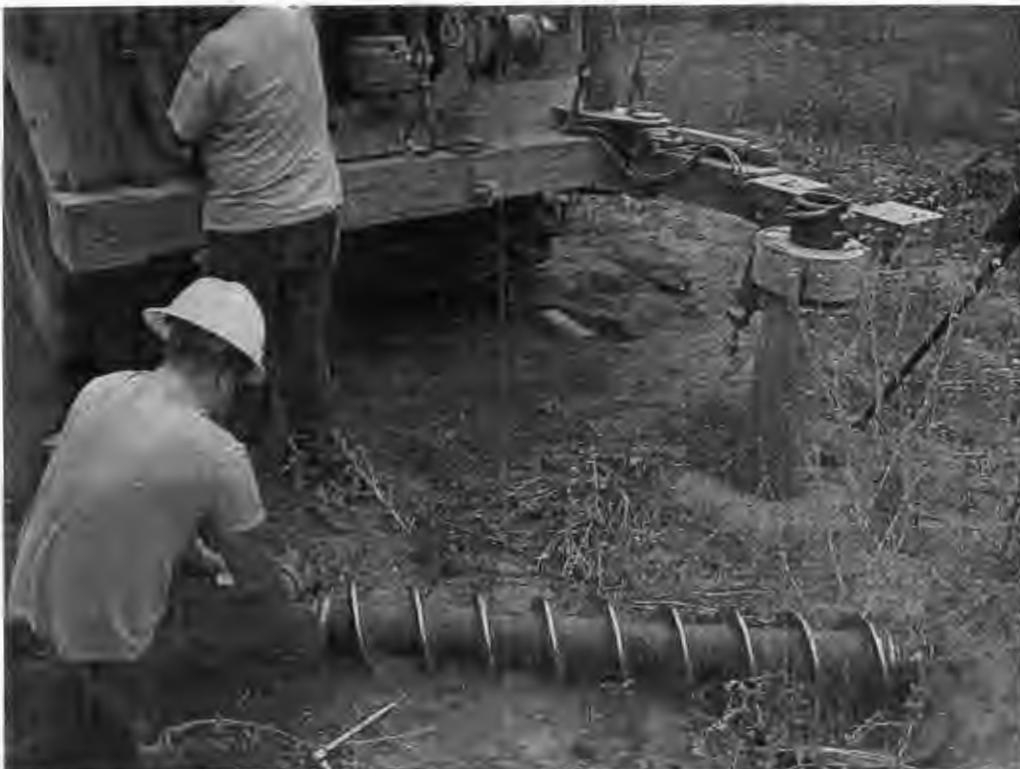
Photo 4 – Hollow stem auger used to overdrill and grouted hole at MCO-7.5A.

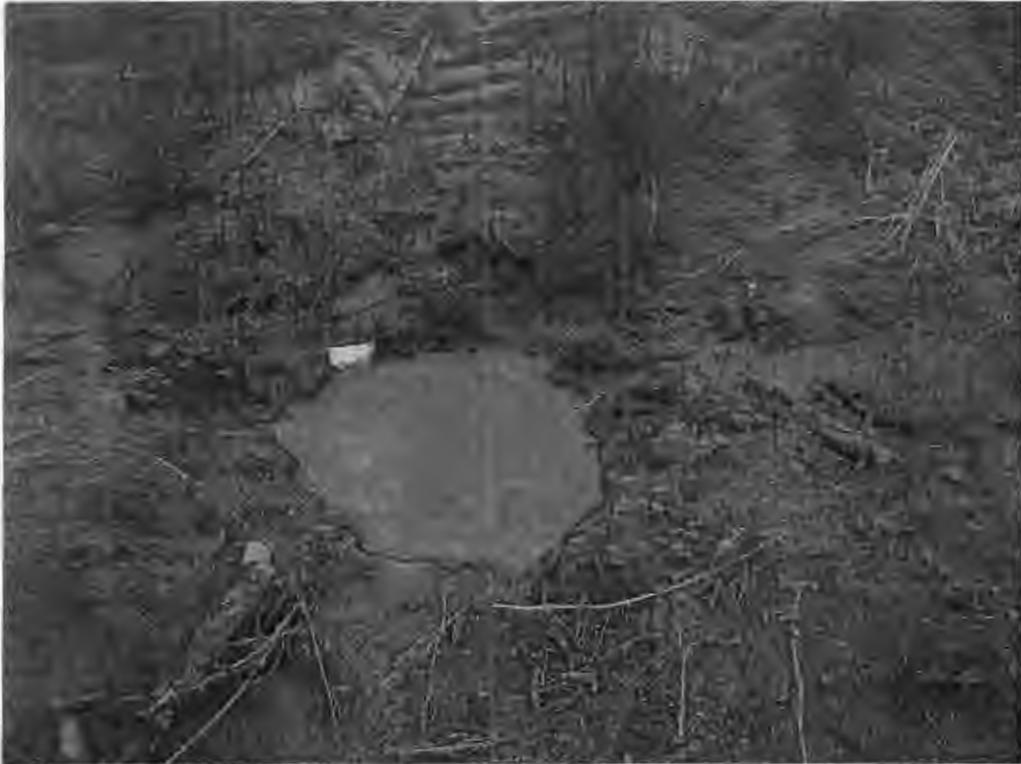
Photo 5. Abandoned moisture access tube MCM-7.5. Hole is grouted and metal ID tag placed in the grout.

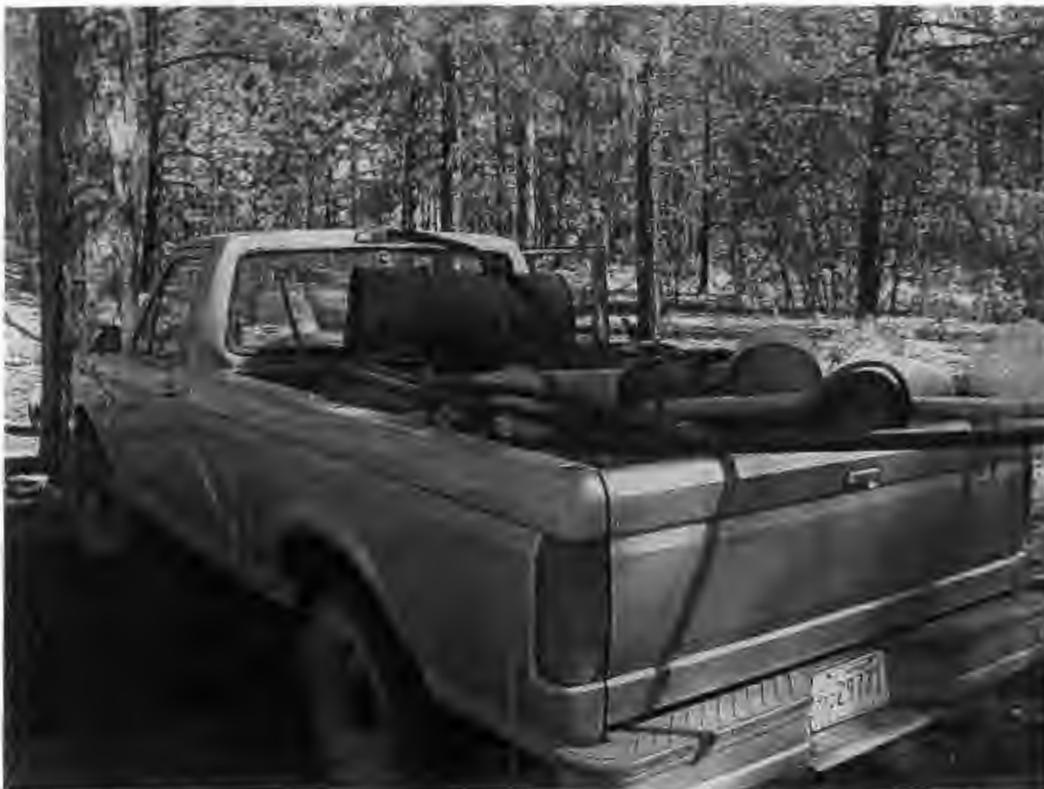
Photo 7. Waste materials collected from the well abandonment project.
