SUBJECT: INTEGRITY TESTING INSPECTION REPORT FOR TA-3-26 ABOVEGROUND STORAGE TANK (AST)

In-Service Internal Floor Inspection Report

Los Alamos National Labs
#2 Diesel Fuel
Tank SM-26

Report # R0216402

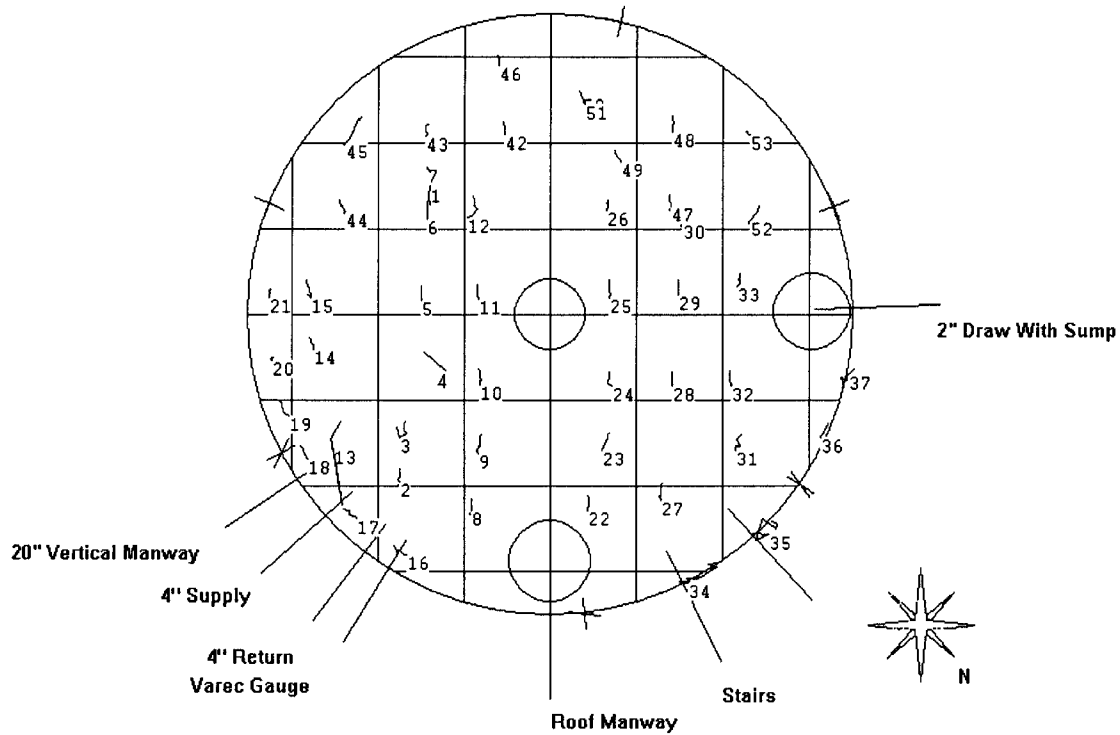
Figure 4-1

The average measured floor thickness was .252 inches. The highest measured floor thickness was .262 inches recorded during run 19. The minimum measured floor thickness was .196 inches recorded during run 18. There were 4 runs where plate thinning of 10% or more was noted during this in-service floor inspection.

Distribution of All UT Runs

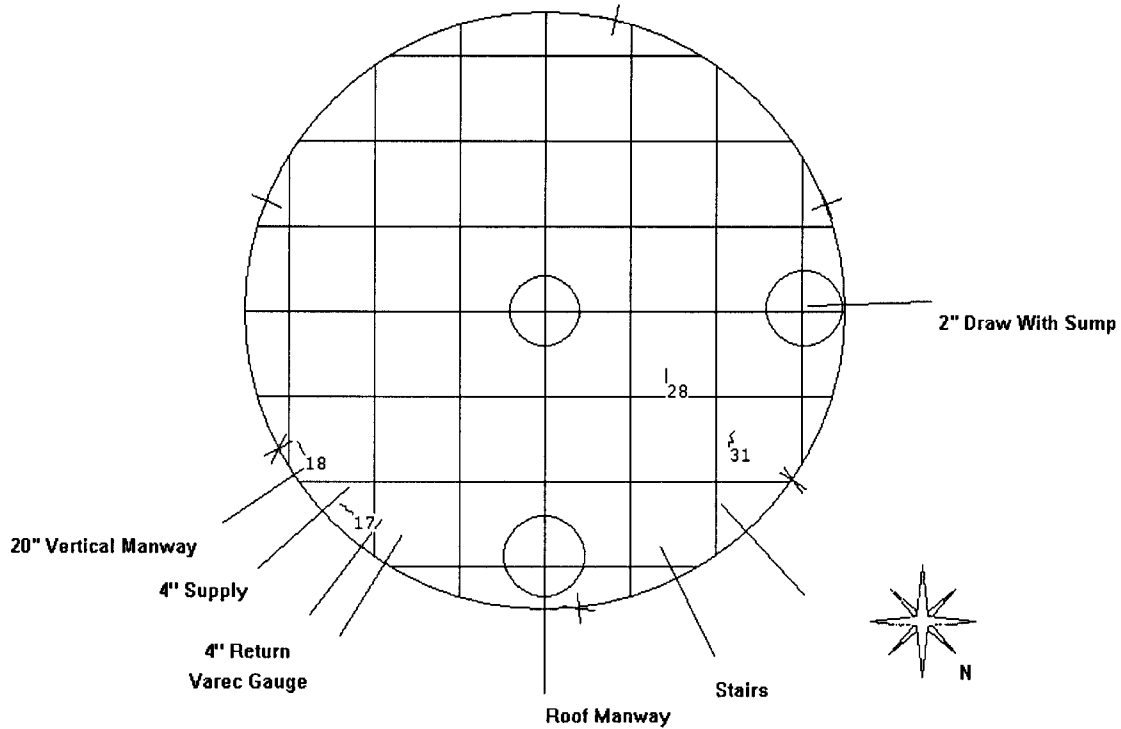
Figure 4-2

Based on the data provided from the internal inspections no tank floor integrity issues were detected. Over the fifty-three (53) years that the tank has been in service it has experienced a 0.0010-inch per year corrosion rate. Approximately 8% of the floor ultrasonic thickness runs indicated bottomsides corrosion. The most severe of the pitting areas has experienced a 21.6% metal loss.

Distribution of Plate Thinning Areas Greater than 10% of Nominal Plate Thickness
