Subject: Erosion Controls Associated with Fishladder Canyon [Solid Waste Management Unit 16-003(o)]

This letter documents stormwater management following mitigation activities on Solid Waste Management Unit (SWMU) 16-003(o)—“Fishladder Canyon.” This letter is required as part of the New Mexico Environment Department’s (NMED’s) approval with modifications for the Phase II investigation report for the TA-16-340 Complex, Revision 1, dated February 9, 2009.

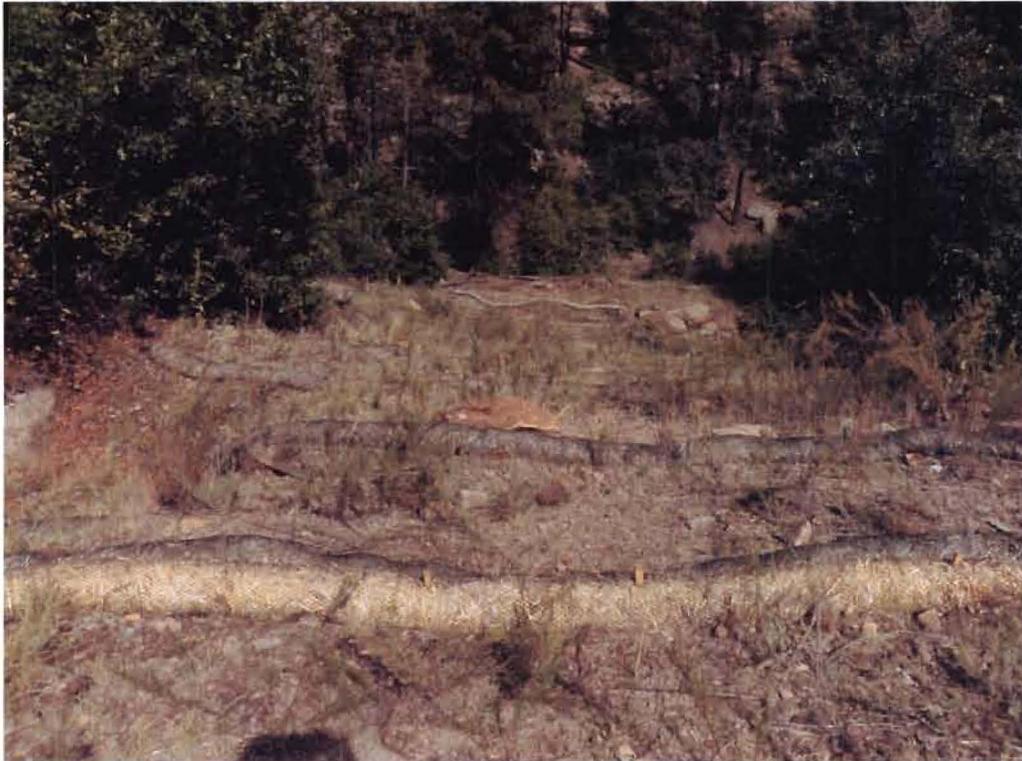
Stormwater controls were installed on the mesa top and north-facing hillslope draining into Fishladder Canyon and in the main Fishladder Canyon drainage. Controls included straw wattles on the mesa top and hillslope (see attached Figures 1 to 3) that were designed to control surface erosion and sediment transport by establishing a permanent vegetation cover. Previously existing controls in the main channel include a rock check dam and a gabion structure, which were designed to reduce flow velocities and sediment.

Figure 1 Downslope from mesa top into Fishladder Canyon

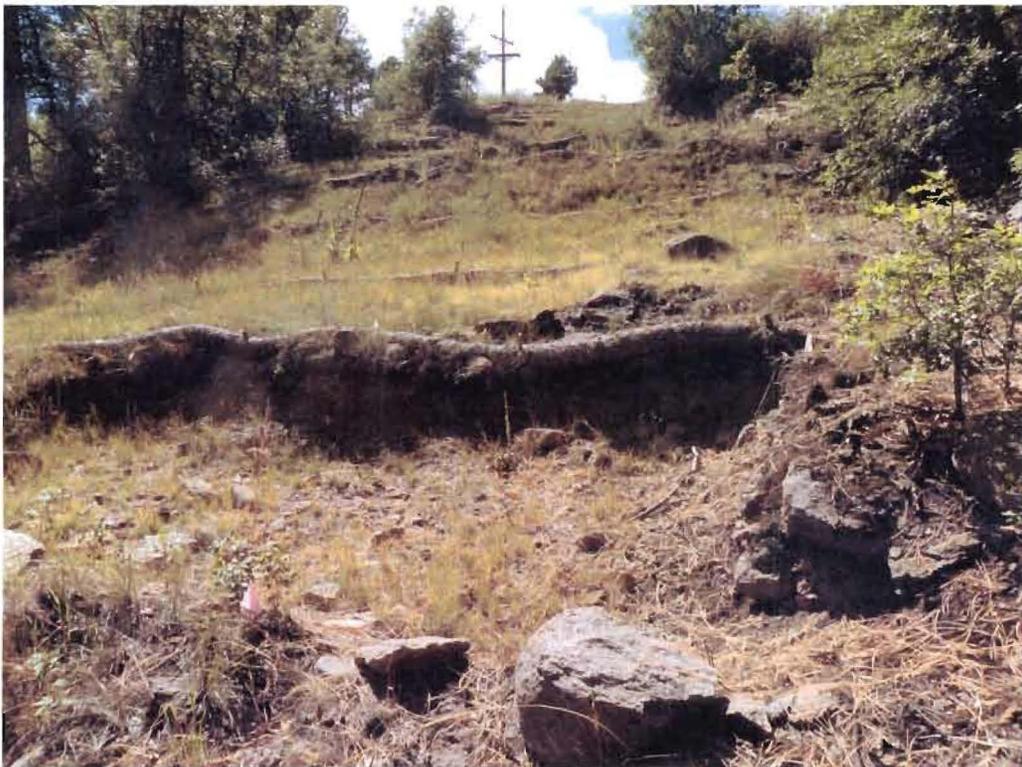
Figure 2 Upslope from bottom of Fishladder Canyon

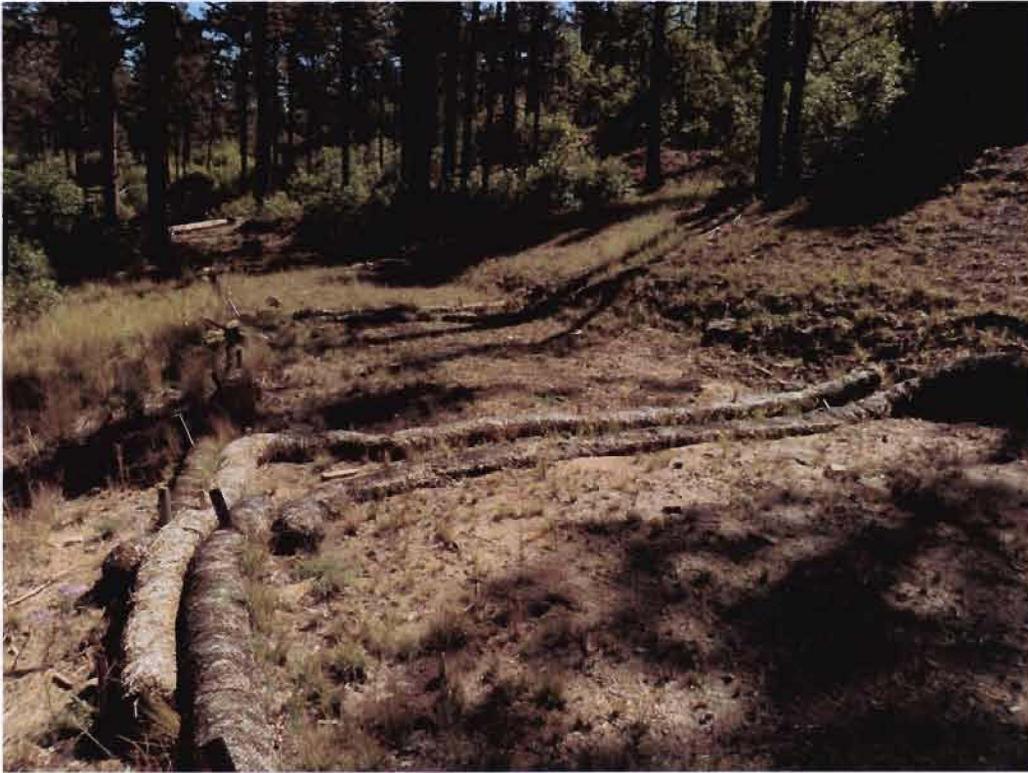
Figure 3 East down Fishladder Canyon access road
