Date: **DEC 14 2011**
 Refer To: EP2011-0407

Subject: Erosion Controls Associated with Fishladder Canyon [Solid Waste Management Unit 16-003(o)]

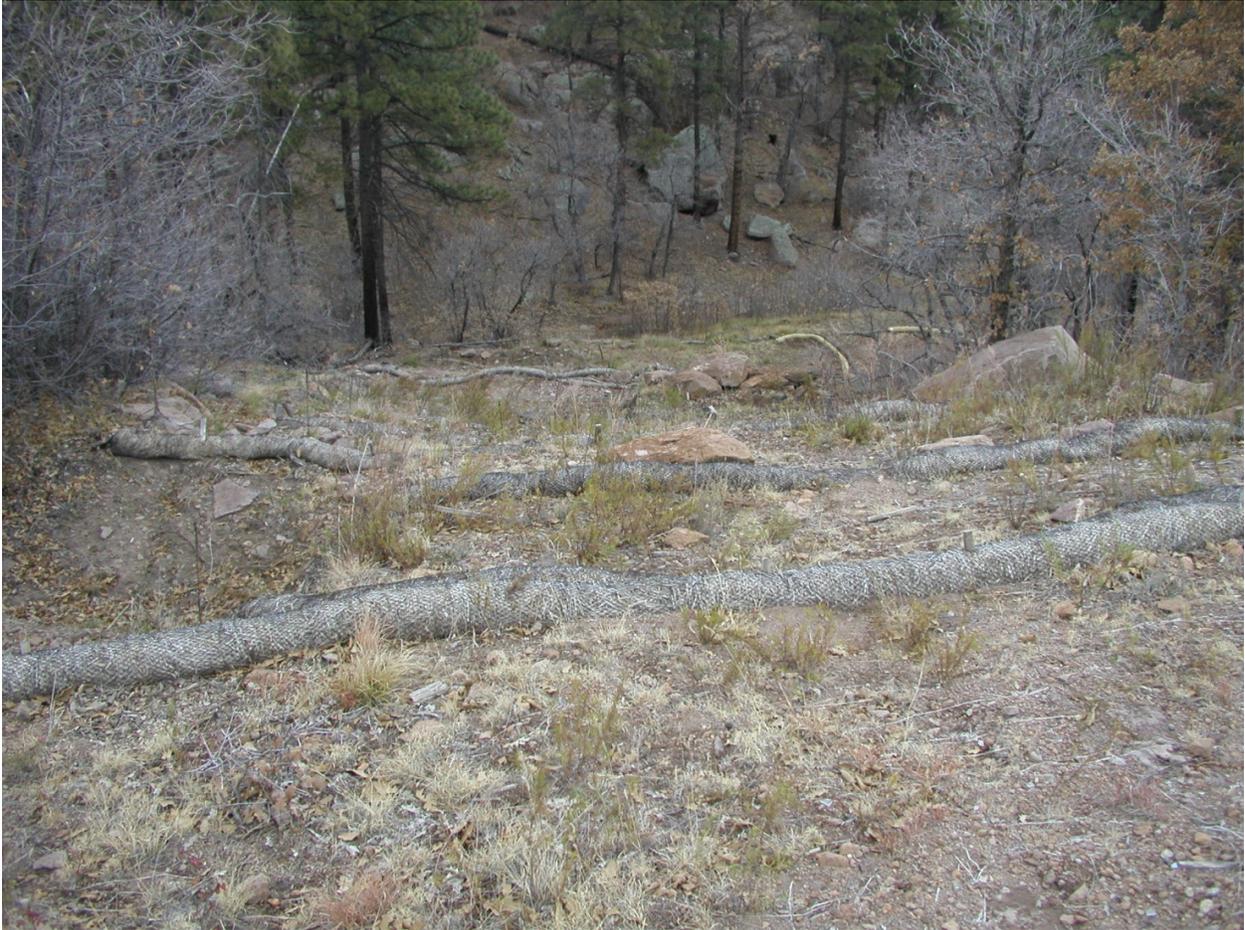
Stormwater controls were installed during Phase II investigation activities in July 2008 on the mesa top and north-facing hillslope draining into Fishladder Canyon and in the main Fishladder Canyon drainage. Controls included straw wattles on the mesa top, hillslope, and access road (see attached Figures 1 to 3) designed to control surface erosion and sediment transport by establishing a permanent vegetation cover. Controls in the main channel included a rock check dam and a gabion structure, designed to reduce flow velocities.

Figure 1 Downslope from mesa top into Fishladder Canyon

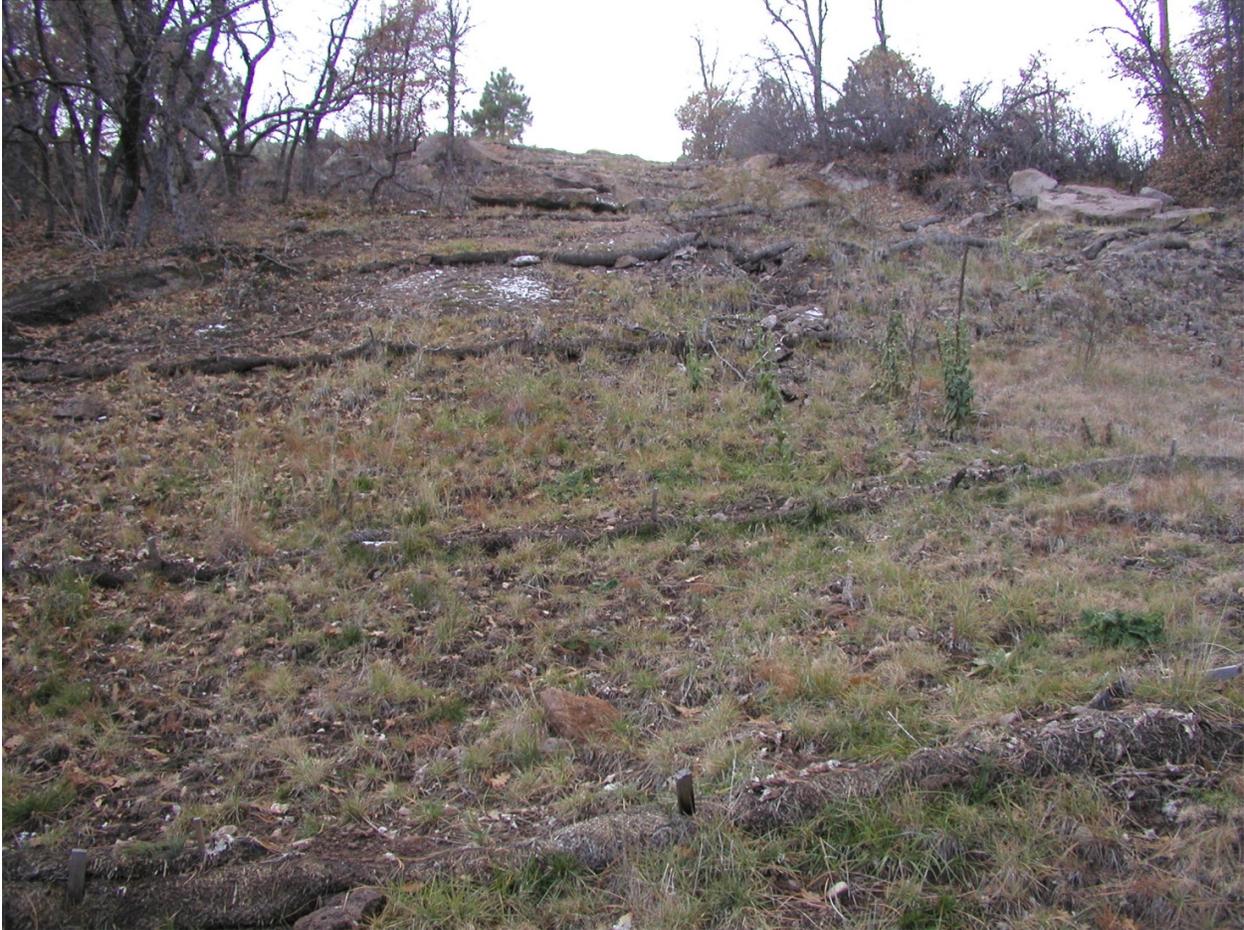
Figure 2 Upslope from bottom of Fishladder Canyon

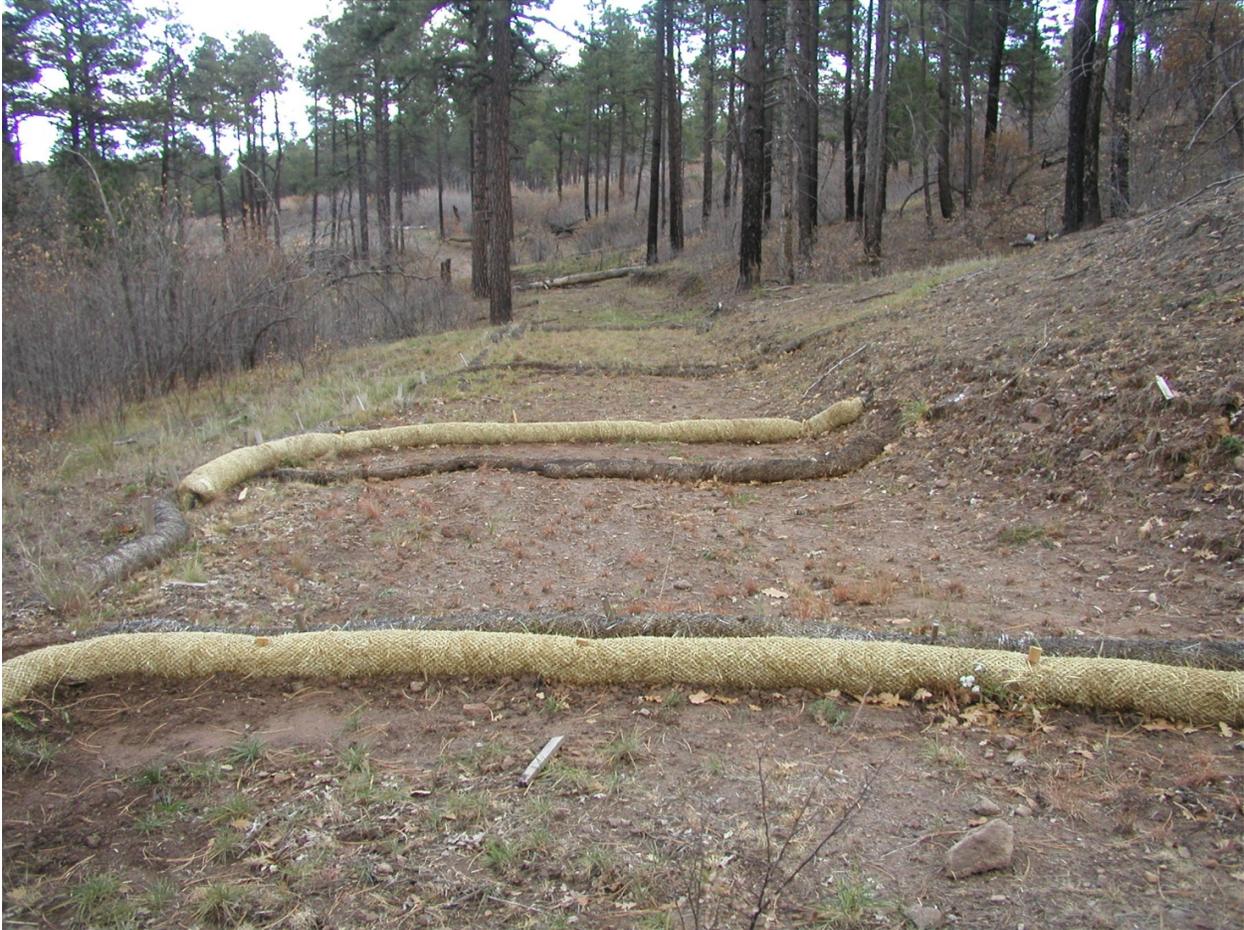
Figure 3 East down Fishladder Canyon access road
