Date: **DEC 18 2012**
 Refer To: EP2012-0290

**Subject: Submittal of the Erosion Controls Associated with Fishladder Canyon
 [Solid Waste Management Unit 16-003(o)]**

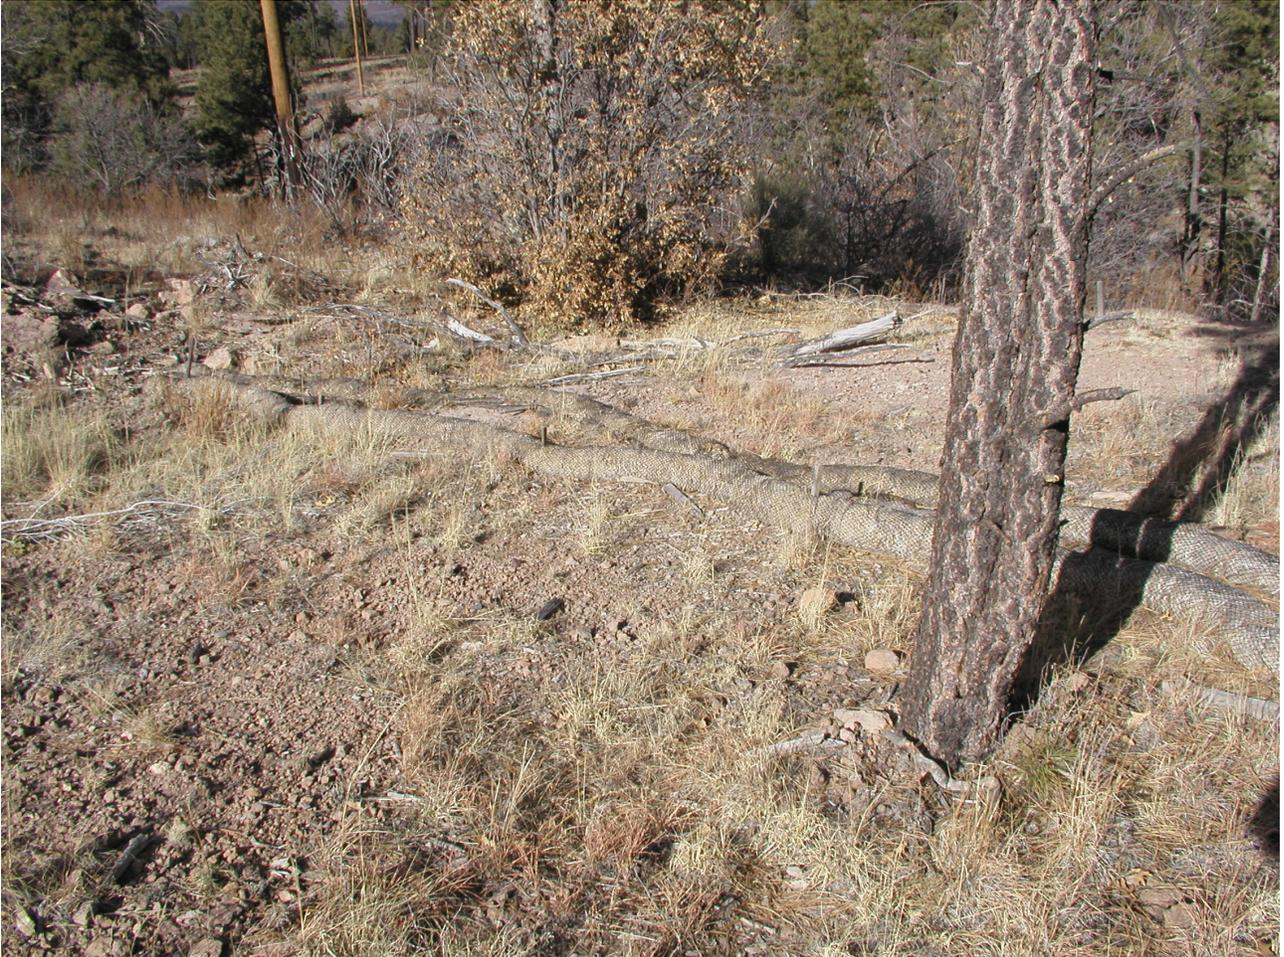
Figure 1 Wattles at the top of drainage into Fishladder Canyon (2012)

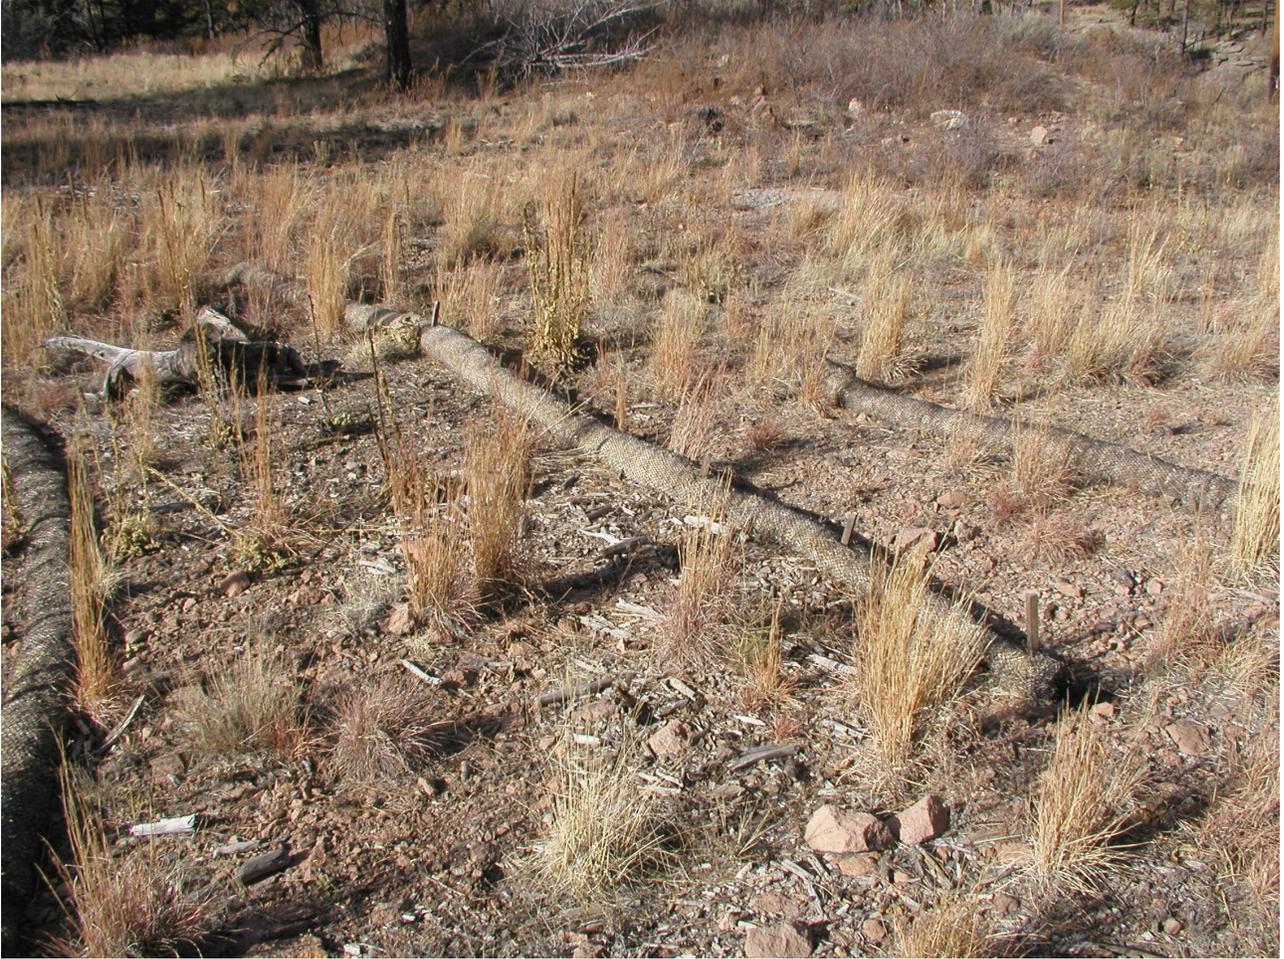
Figure 2 Wattles at the top of drainage into Fishladder Canyon (2012)

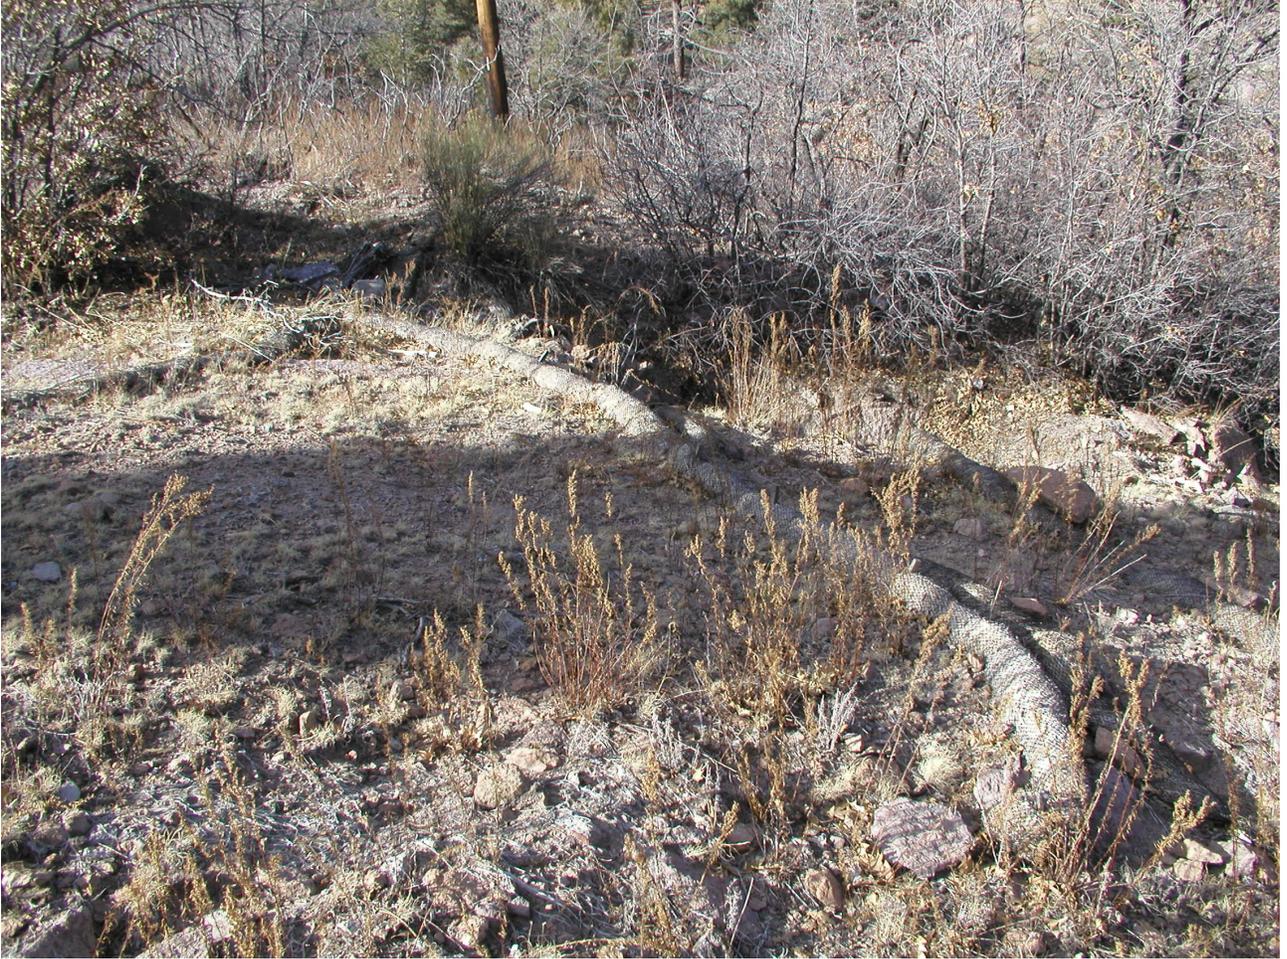
Figure 3 Wattles at the top of drainage into Fishladder Canyon (2012)

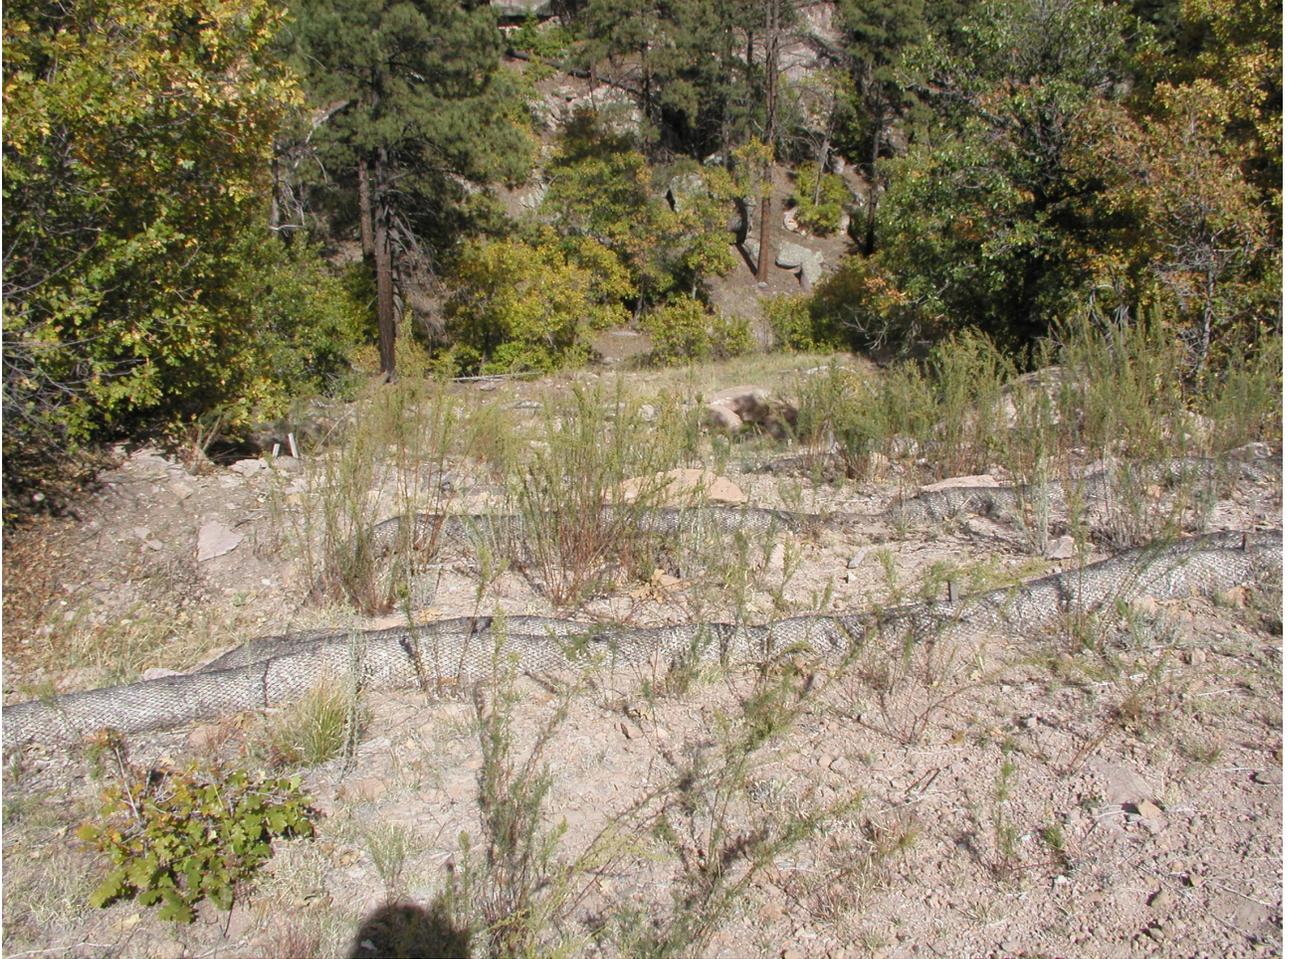
Figure 4 View looking downslope from mesa top into Fishladder Canyon (2012)

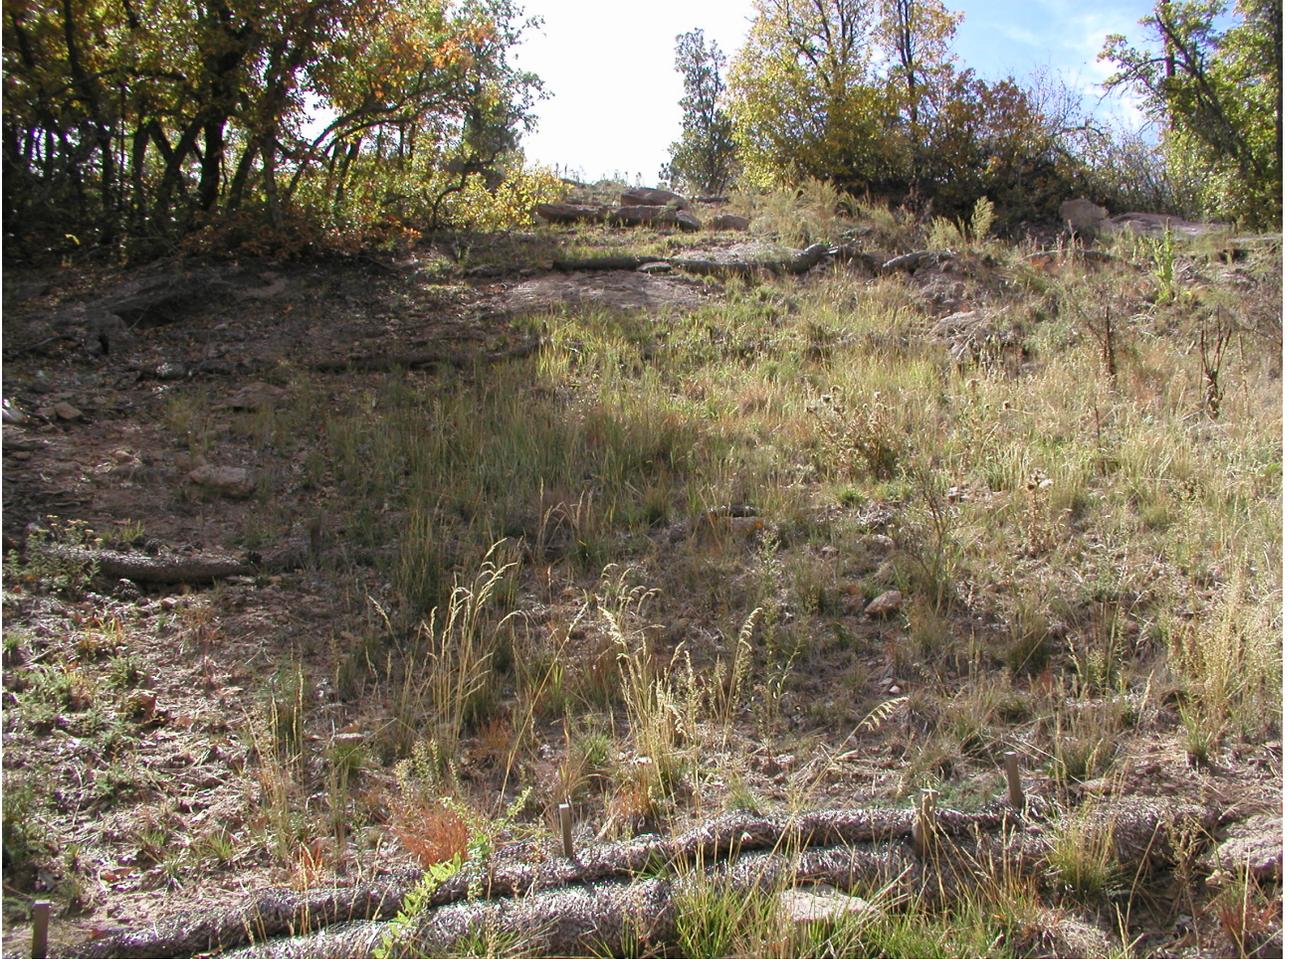
Figure 5 View looking upslope out of Fishladder Canyon (2012)

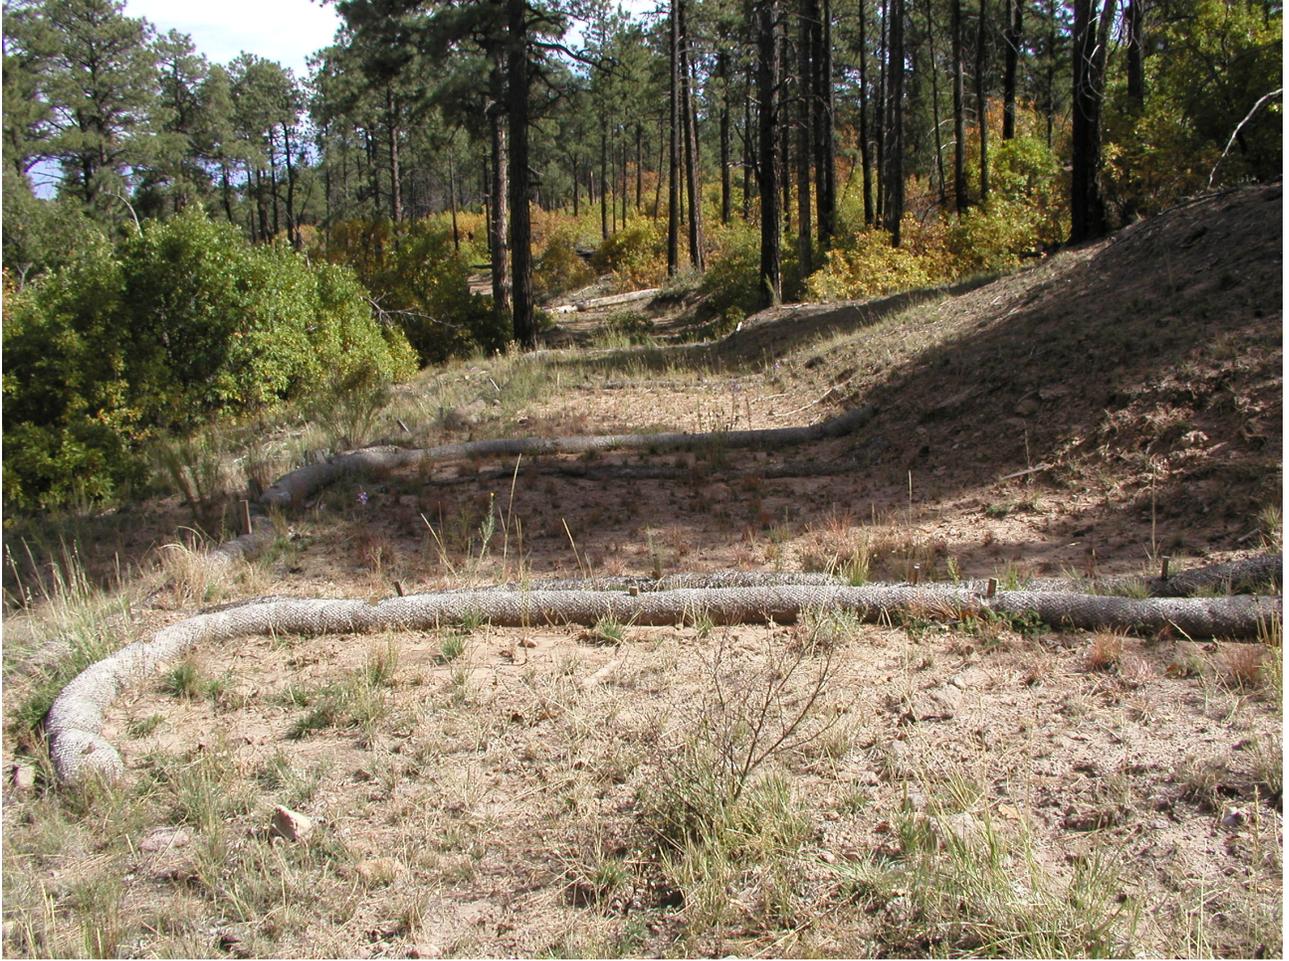
Figure 6 View east on access road into Fishladder Canyon (2012)

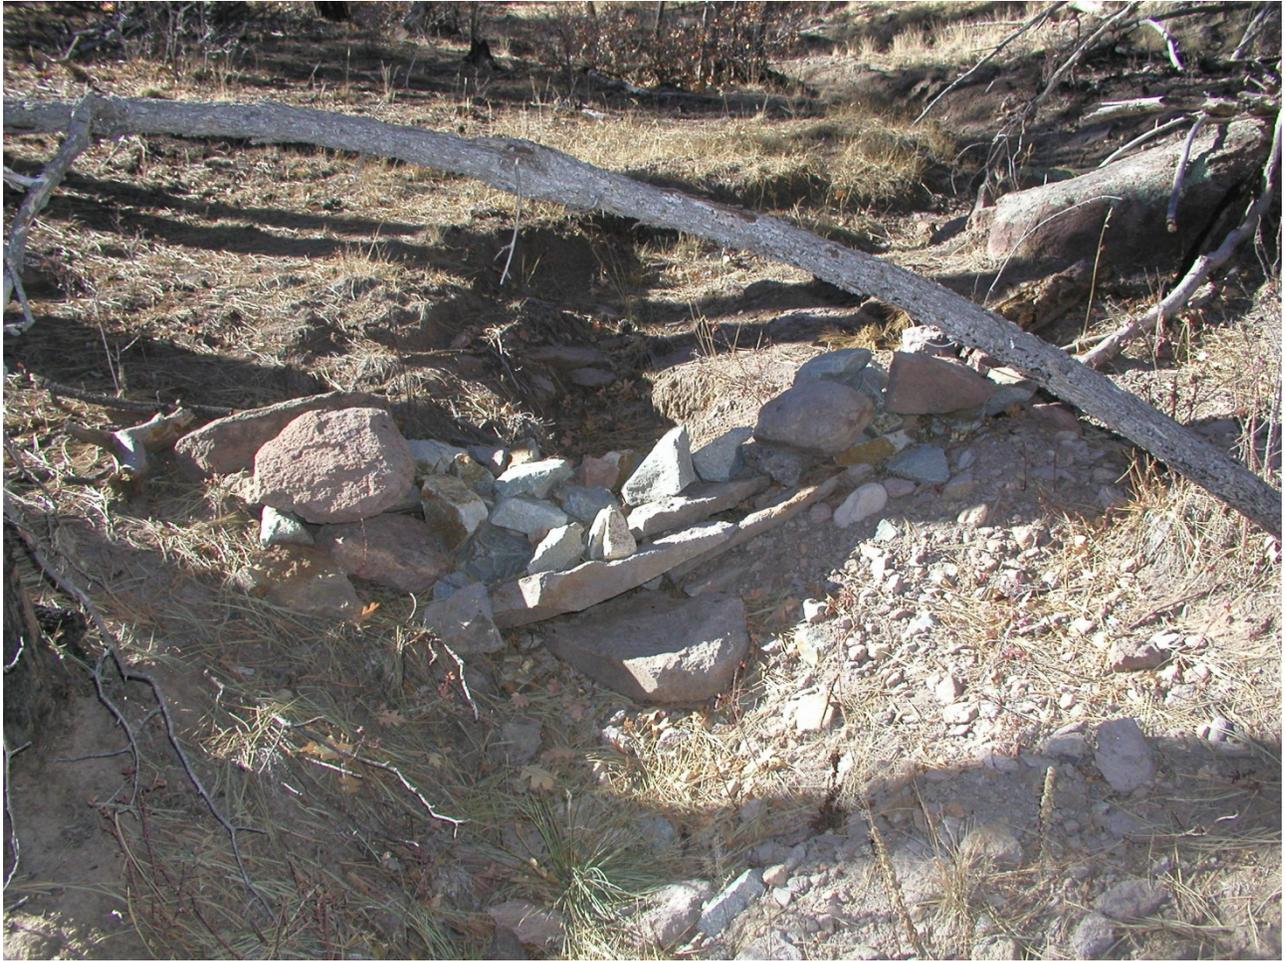
Figure 7 Rock check dam in the bottom of Fishladder Canyon (2012)

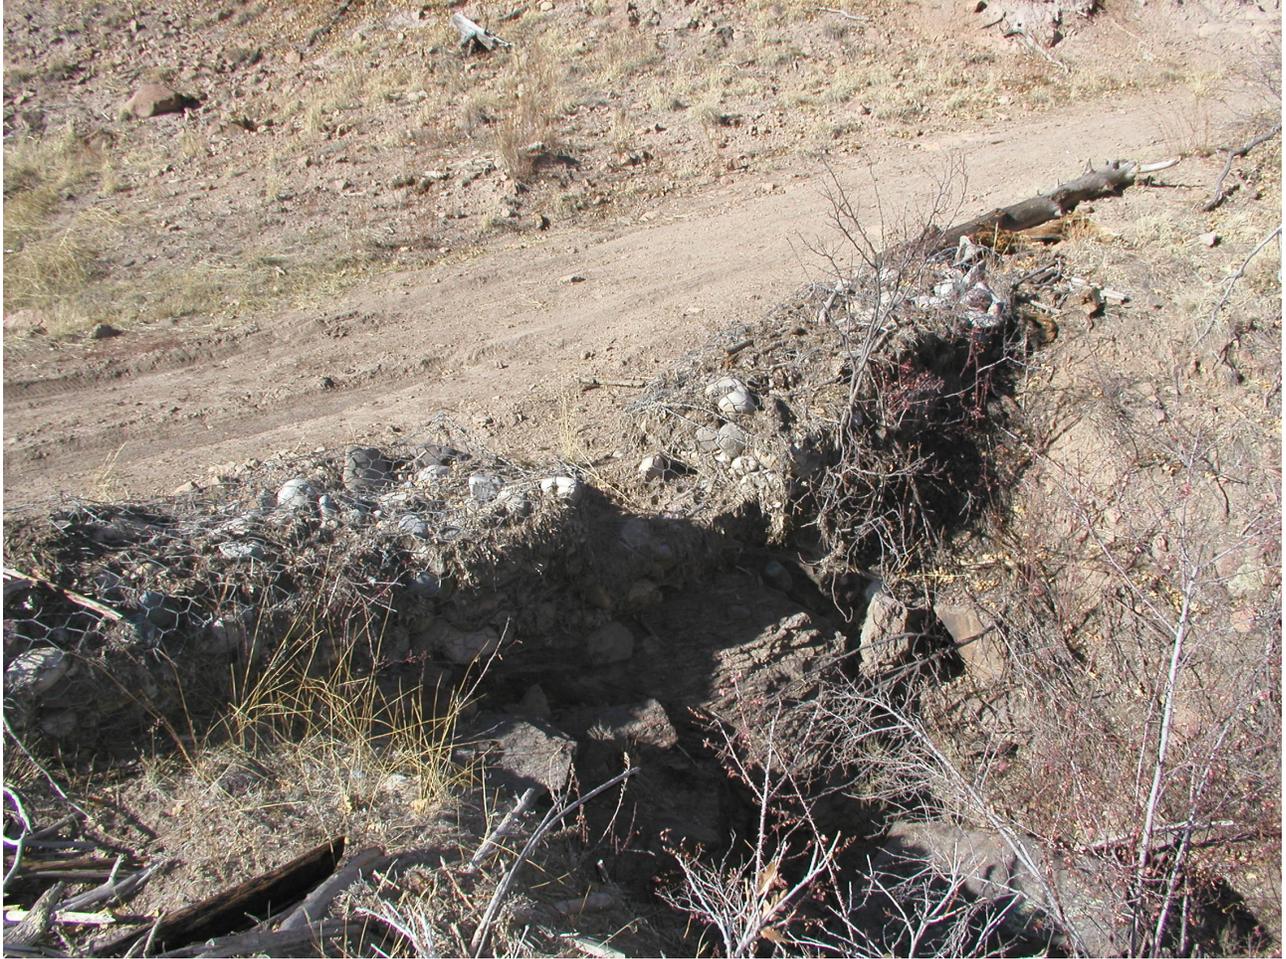
Figure 8 Gabions at the crossing of the access road in Fishladder Canyon (2012)
