Refer To: ADESH-15-173

LAUR: 15-29176

**Subject: Submittal of the Inspection and Maintenance of Erosion Controls Associated with Fishladder Canyon [Solid Waste Management Unit 16-003(o)]**

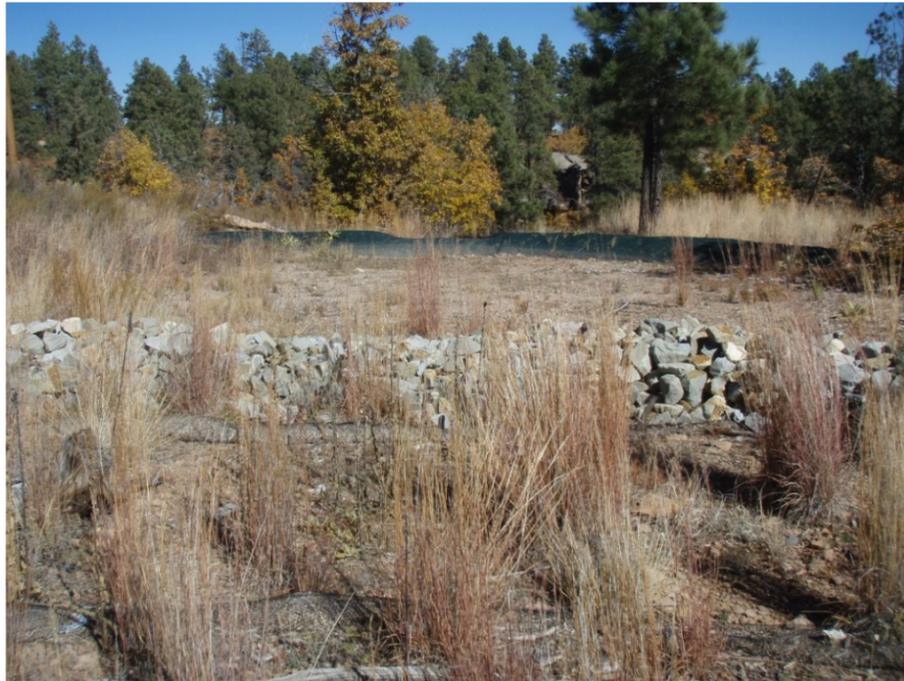
**Figure 2** Rock berm (V00703120026) and earth berm (V00703010027) at the top of drainage into Fishladder Canyon (11/4/2015)

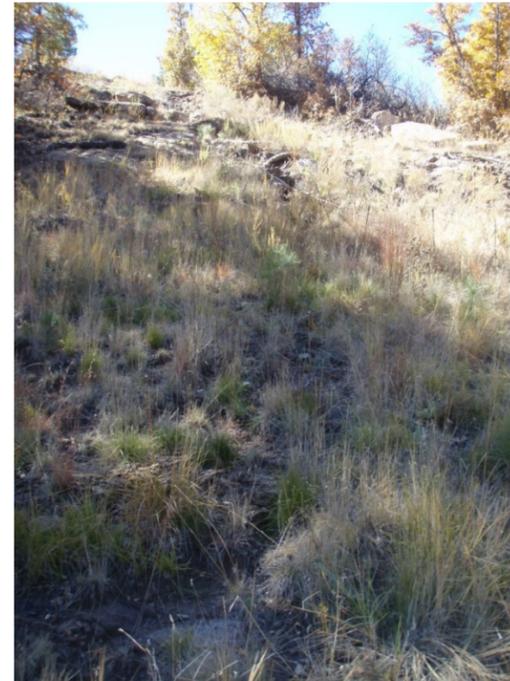
6. The IP annual erosion evaluation was completed on October 28, 2015. Inspection findings recommended replacing straw wattle (-0028); a follow-up inspection was completed on November 4, 2015, and determined the area below wattle (-0028) is stable and well vegetated. No additional action needs to be completed.

**Figure 3** View looking upslope out of Fishladder Canyon (11/4/2015). Straw wattle (V007030600028) is located in middle of photo.

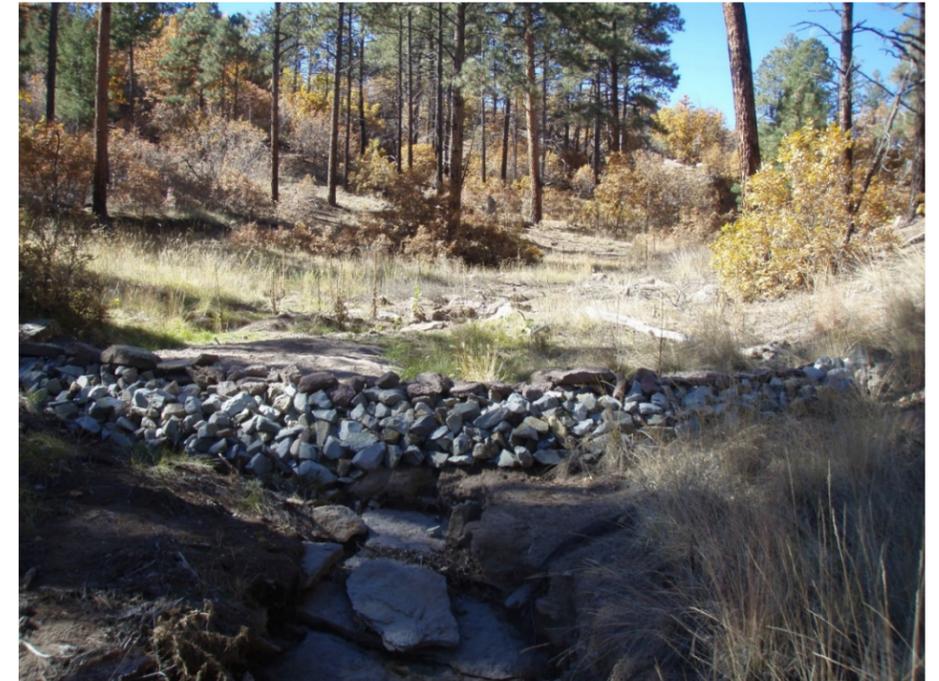
3. A third rain event inspection was completed on August 10, 2015, for the rain events occurring on July 29, July 31, August 1, and August 2, 2015. Inspection findings recommended adding additional rock to rock check dam (-0024). On August 25, 2015, additional rock was added to check dam (-0024).

**Figure 4** Rock check dam (V00706010024) in Fishladder Canyon (11/4/2015)

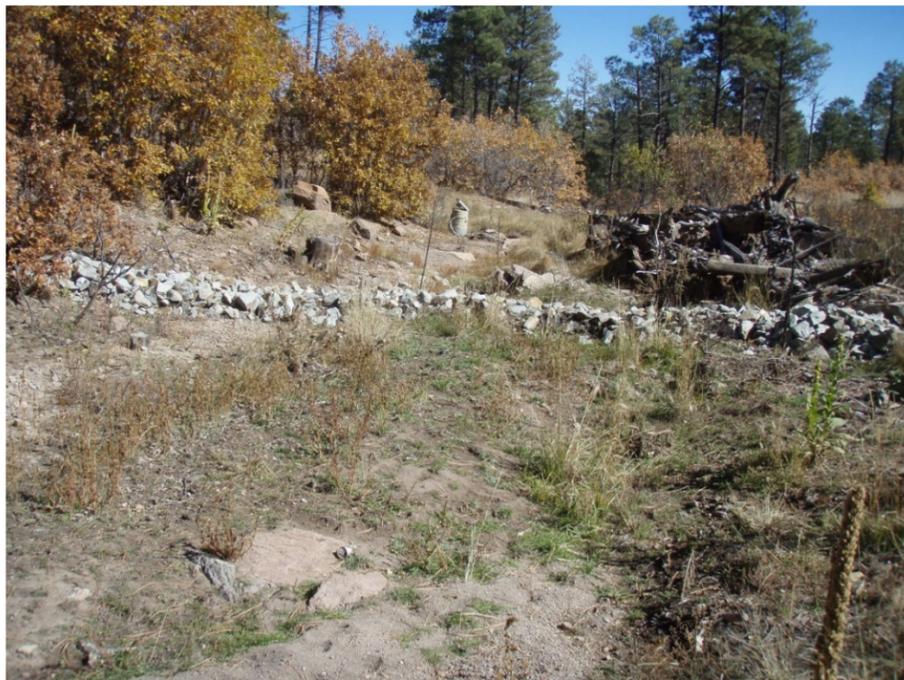
2. A second rain event inspection was completed on July 27, 2015, for rain events occurring on July 12 and July 20, 2015. Inspection findings recommended replacing the straw wattle (-0023) and removing leaf litter from rock check dam (-0025). On August 11, 2015, a new wattle (-0030) was installed directly upgradient of the existing wattle (-0023), and leaf litter was removed from rock check dam (-0025). Wattle (-0023) was retired and replaced with wattle (-0030), shown in Figure 1.

**Figure 5** Rock check dam (V00706010025) in Fishladder Canyon (11/4/2015)

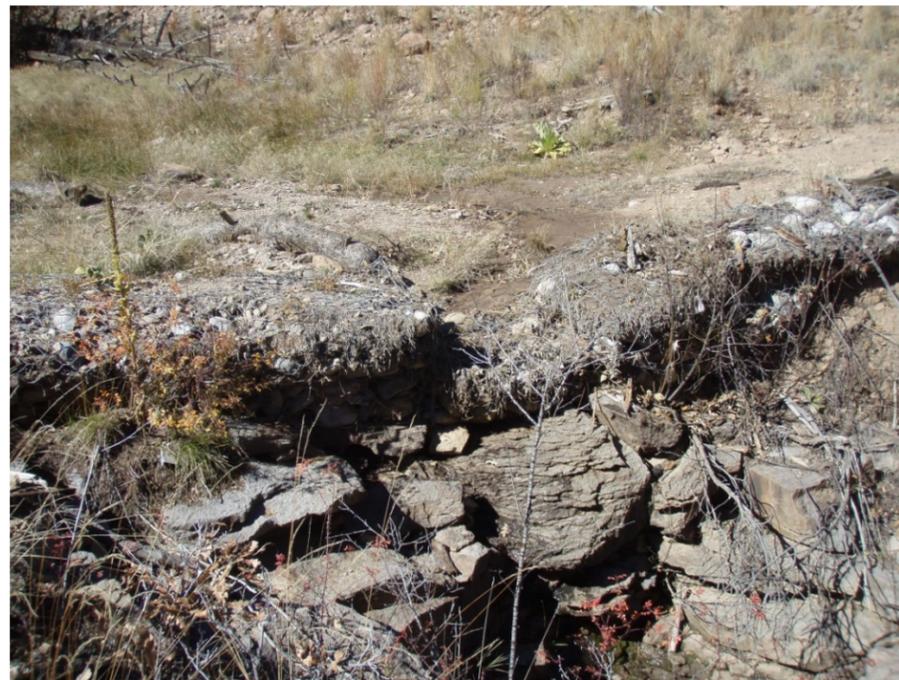
**Figure 6** Gabion (V00707010002) at access road crossing in Fishladder Canyon (11/4/2015)

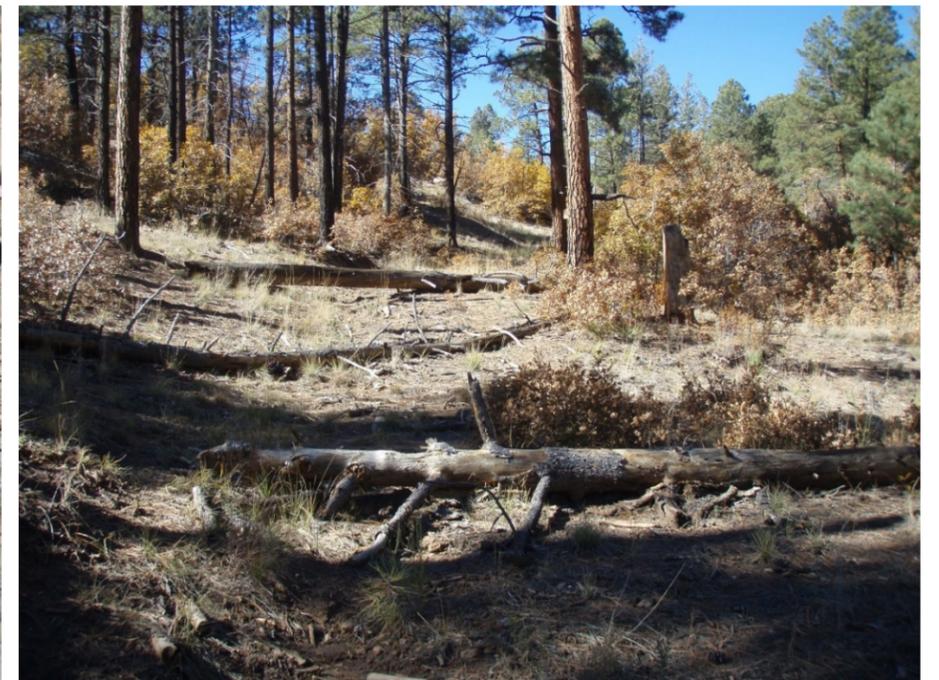
**Figure 7** View west of former access road in Fishladder Canyon (11/4/2015). Straw wattle (V007030600030) is located at the western end of the former road.
