Subject: Submittal of Revised Inspection and Maintenance of Erosion Controls Associated with Fishladder Canyon [Solid Waste Management Unit 16-003(o)] and Response to Review of the Inspection and Maintenance Report

REVISED FIGURES

**Response to the Review of the 2015 Inspection and Maintenance Report of Erosion Controls
Associated with Fishladder Canyon [Solid Waste Management Unit 16-003(o)],
EPA ID# NM0890010515 HWB-LANL-15-062
Dated January 13, 2016**

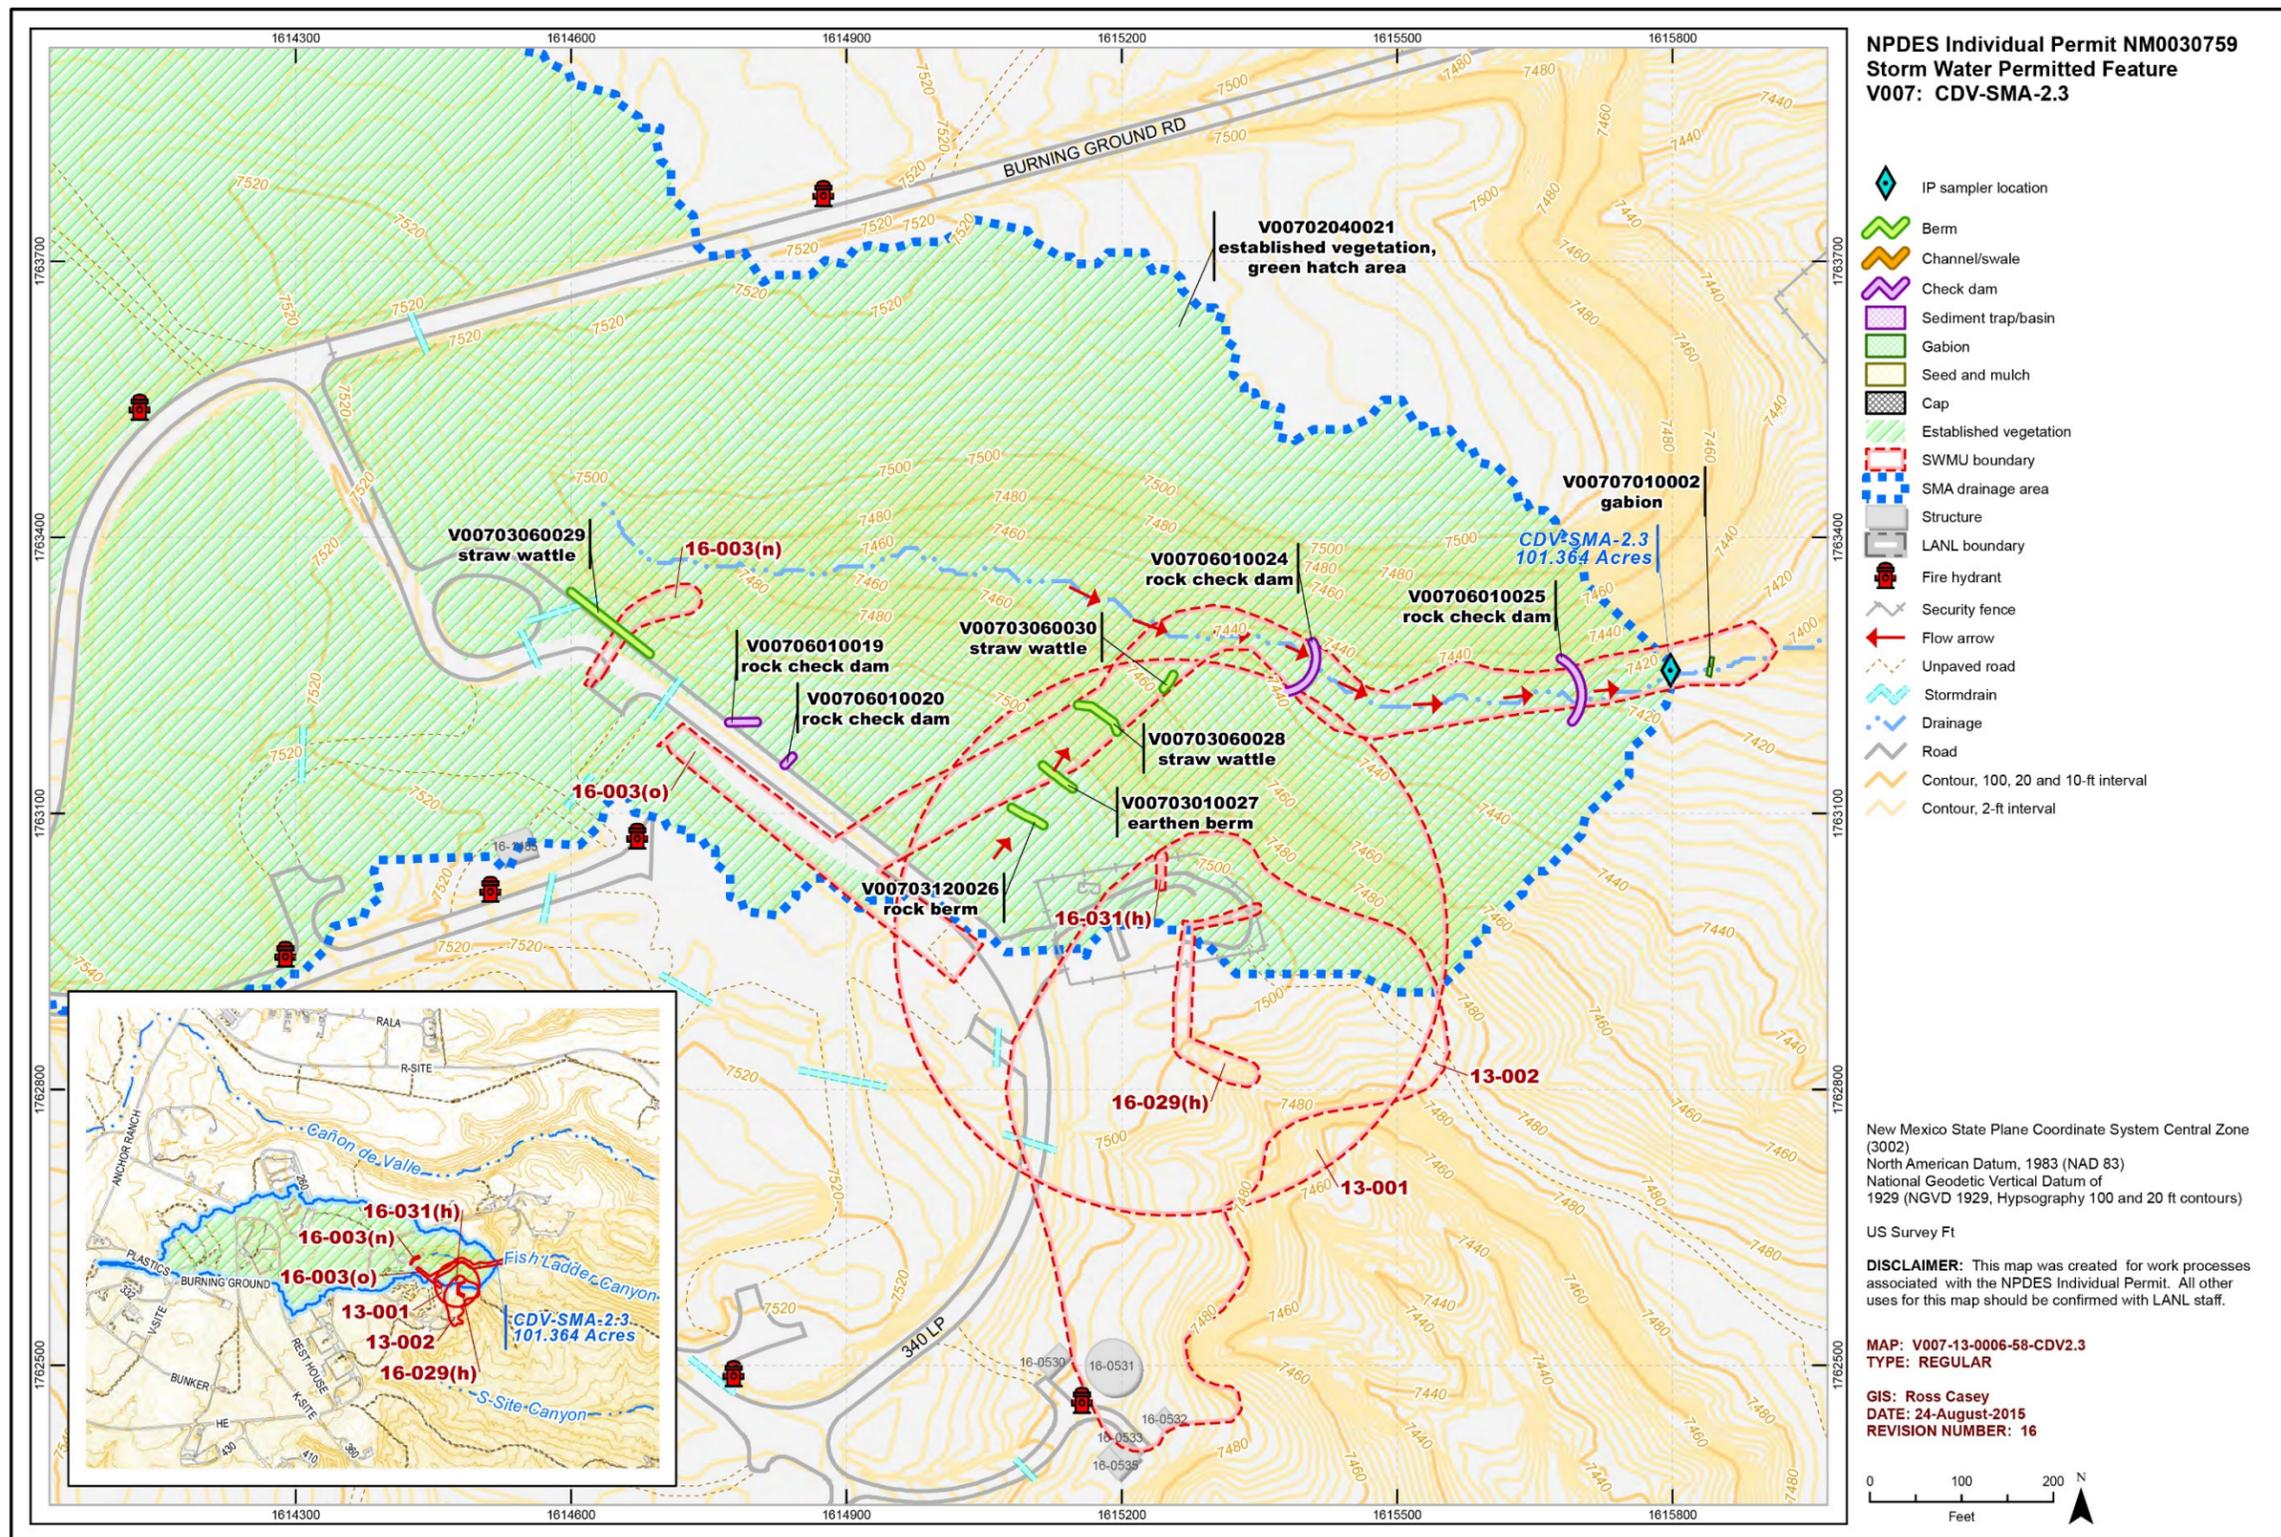
The gabion/rock check dam at the access road crossing continues to be inspected under the IP. Additional controls designed to reduce flow velocities, erosion potential, and sediment transport have been installed per IP requirements at SWMU 16-003(o) and are shown in Figure 1, which is an IP site monitoring area (SMA) map showing the IP sampler location, IP storm water controls, and SWMUs associated with the SMA. Storm water controls associated with Fishladder Canyon [SWMU 16-003(o)] consist of a small gabion structure (-0002), earthen berm (-0027), straw wattles (-0028 and -0030), and rock check dams/berms (-0024, -0025, and -0026), as shown in Figures 2 through 6. Figure 7 shows the former access road. Other storm water controls in this SMA are associated with SWMU 16-003(n) and are not discussed.

2. A second rain event inspection was completed on July 27, 2015, for rain events occurring on July 12 and July 20, 2015. Inspection findings recommended replacing the straw wattle (-0023) and removing leaf litter from the rock check dam (-0025). On August 11, 2015, a new wattle (-0030) was installed directly upgradient of the existing wattle (-0023), and leaf litter was removed from the rock check dam (-0025). A wattle (-0023) was retired and replaced with a new wattle (-0030), as shown in Figure 1.

Figure 1 Locations of the IP sampler, IP storm water controls, and SWMUs associated with the IP site monitoring area

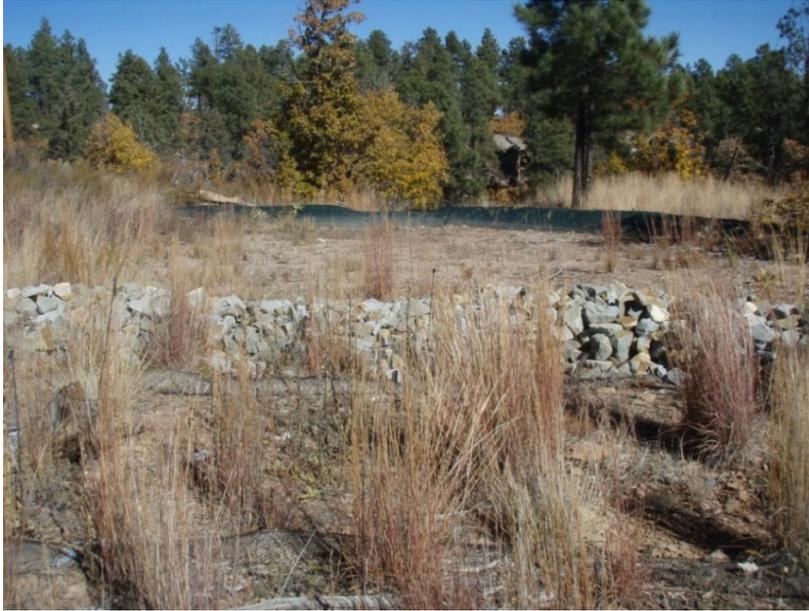
Figure 2 Rock berm (V00703120026 - middle of photo) and earth berm (V00703010027- upper third of photo) at the top of drainage into Fishladder Canyon (11/04/2015). Condition of controls – excellent.

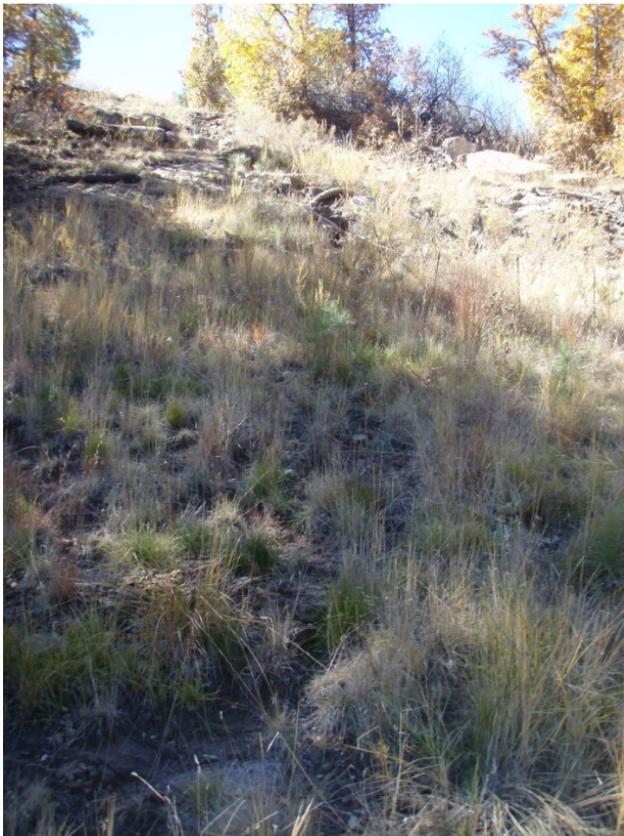
6. The IP annual erosion evaluation was completed on October 28, 2015. Inspection findings recommended replacing the straw wattle (-0028); a follow-up inspection was completed on November 4, 2015, and determined the area below wattle (-0028) is stable and well vegetated as shown in Figure 3. Note that the wattle is not visible because of the vegetative cover (grasses). Figure 4 shows the vegetated slope from the intersection with the canyon drainage. Based on the established vegetative cover, lack of erosional features, and best professional judgment, no additional action needs to be completed.

Figure 3 View looking upslope at the former fishladder location (11/04/2015). Straw wattle (V007030600028 - located in the upper third of photo) is hidden by established vegetation. Condition of controls – very good.

1. The annual erosion evaluation under the Individual Permit was completed on October 28, 2015. Inspection findings recommended replacing the straw wattle (V007030600028); a follow-up inspection was completed on November 4, 2015, and determined the area below wattle -0028 is stable and well vegetated, as shown in Figure 3. Note that the wattle is not visible because of the vegetative cover (grasses). Figure 4 shows the vegetated slope from the intersection with the canyon drainage. Based on the established vegetative cover, lack of erosional features, and best professional judgment, no additional action needs to be completed.

3. Figure 3 shows a view looking upslope at the former fishladder location on November 4, 2015. Straw wattle V007030600028, located in the upper third of photograph, is hidden by established vegetation.

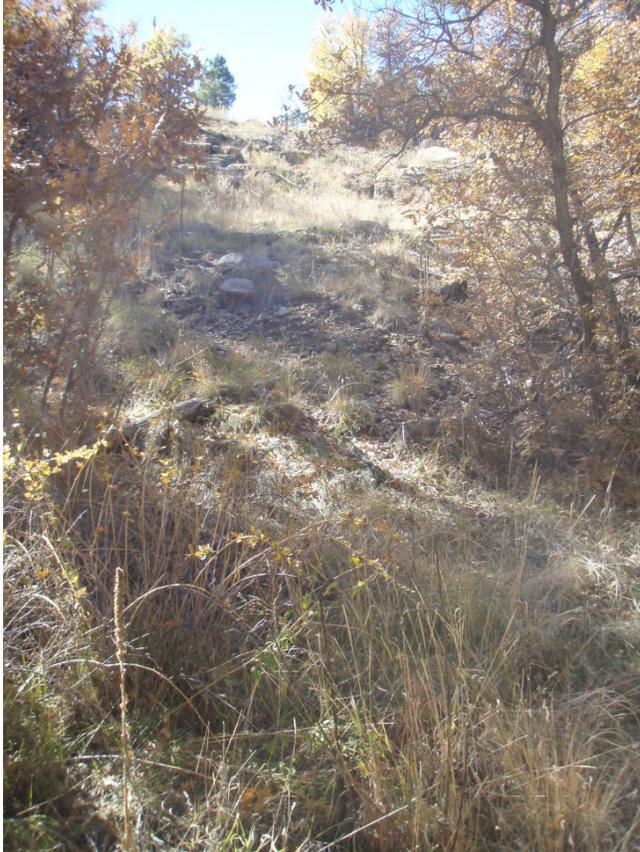
Figure 4 View upslope of the former fishladder location from the canyon bottom. Note established vegetative cover and lack of erosional features. Controls are not visible in photo.

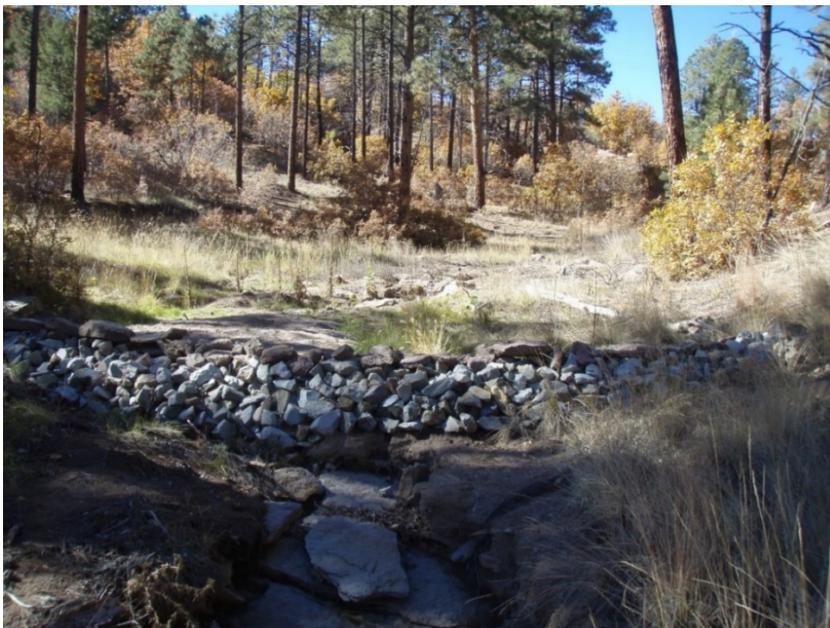
3. A third rain event inspection was completed on August 10, 2015, for the rain events occurring on July 29, July 31, August 1, and August 2, 2015. Inspection findings recommended adding additional rock to rock check dam (-0024). On August 25, 2015, additional rock was added to the check dam (-0024).

Figure 5 Rock check dam (V00706010024 – lower third of photo) in bottom of Fishladder Canyon (11/04/2015). Condition of control –excellent.

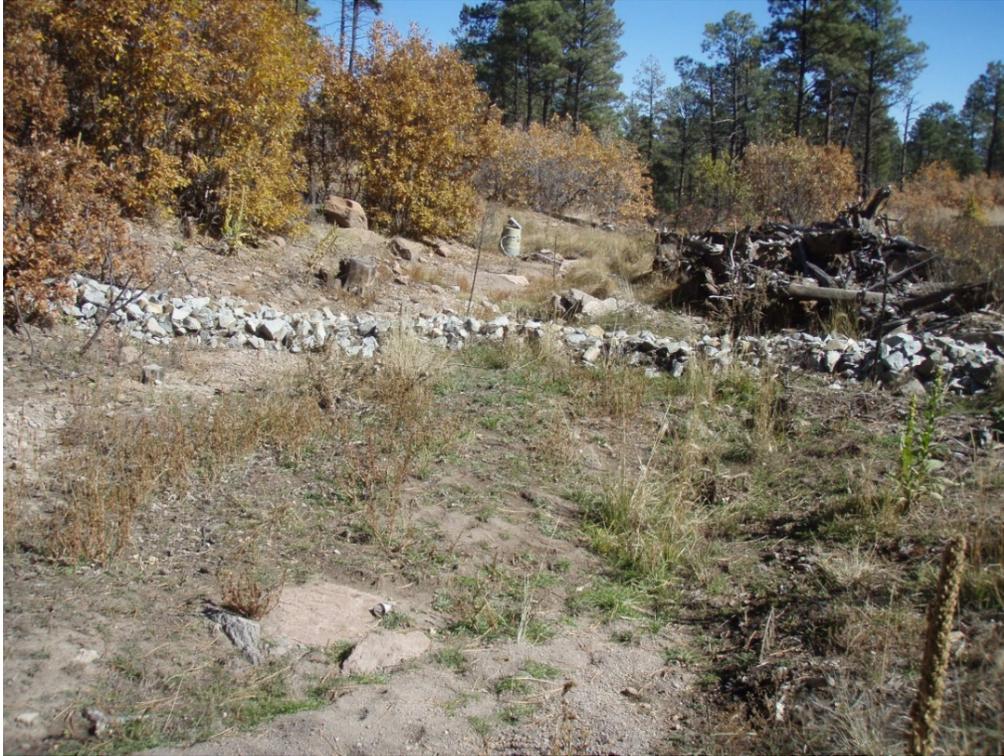
Figure 6 Rock check dam (V00706010025 – middle of photo) in bottom of Fishladder Canyon (11/04/2015). Condition of control – very good.

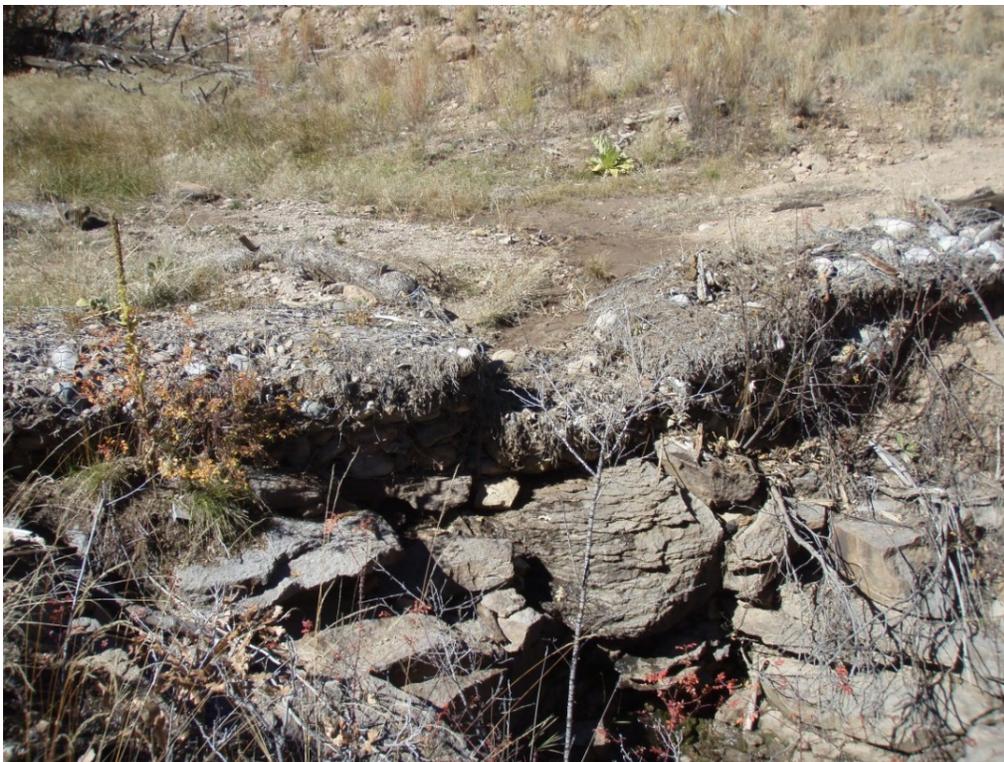
Figure 7 Gabion (V00707010002 – middle of photo) at access road crossing in bottom of Fishladder Canyon (11/04/2015). Condition of control – good.

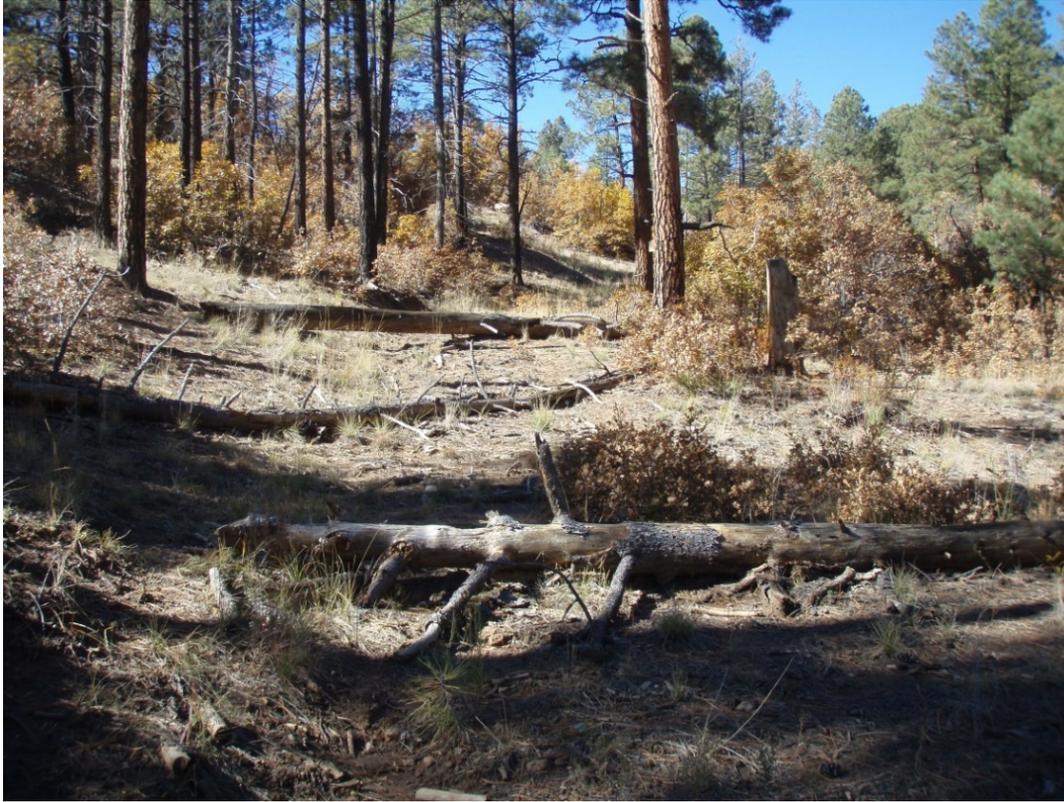
Figure 8 View west of former access road in Fishladder Canyon (11/04/2015). Straw wattle (V007030600030 – not visible in photo) is located at the western end of the former access road. Note vegetative cover and downed trees along the former access road. Condition of controls – excellent.
