SUBJECT: STATUS OF ACTIVITIES AT MATERIAL DISPOSAL AREA R

RE: Letter Report – Fire Suppression at MDA-R, Revised

RE: Letter Report – Fire Suppression at MDA-R - Update

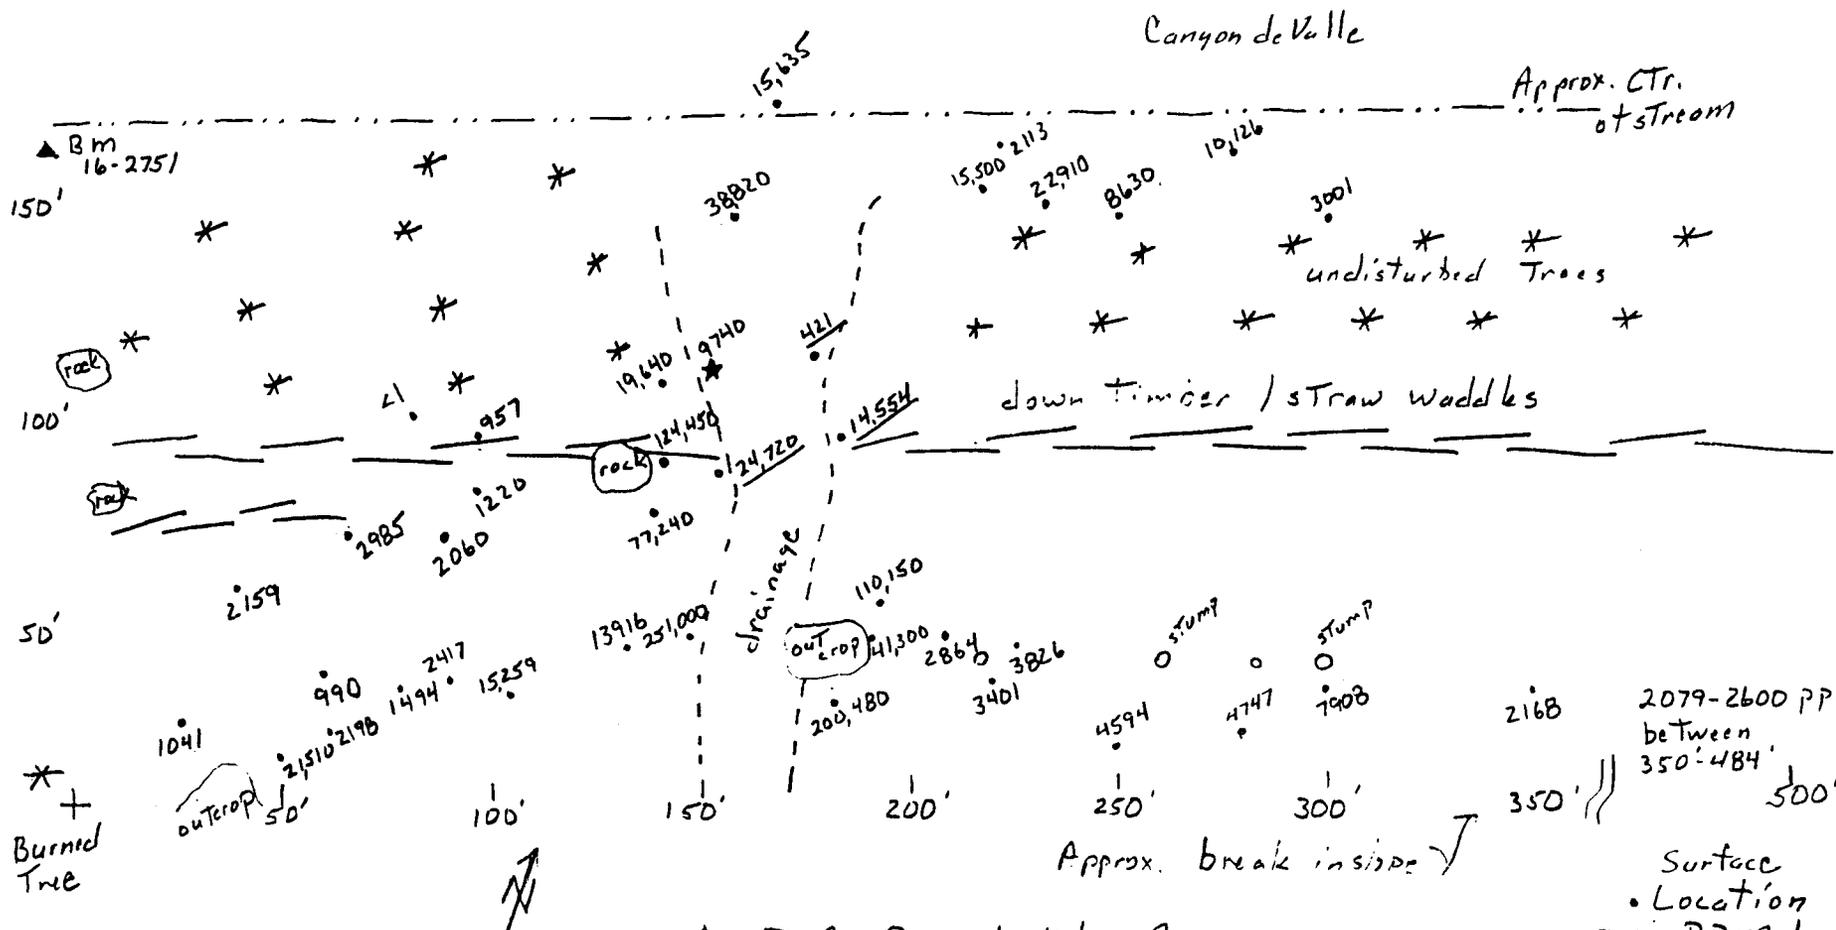
MDA-R sketch Map
- Barium concentrations

The XRF survey of the residual landfill materials and slopes indicates that soils contaminated with barium remain in the central area. Surface concentrations of barium locally exceed 200,000 parts per million (ppm) near the former drainage arroyo, decreasing to a few tens of thousands ppm east and west from the arroyo. The apparent extent of contamination is skewed eastward downslope. A few shallow, subsurface samples, ≤ 1 foot depth, indicate that contamination $>14,000$ ppm is present at shallow depth. A crude map of the results is attached. All of the upper slopes were disturbed or excavated during the fire suppression efforts. These efforts may have exposed contaminated soils at the surface where they did not exist before the fire. The contamination also appears to extend downslope into the existing standing, unburned trees. These areas were not disturbed during the fire suppression efforts.

On Friday, during the field screening survey, we discovered numerous intact pieces of barium nitrate. All of these were located within the area of highest barium contamination near the former drainage. These pieces varied in size from an inch or two in diameter to over foot across. Many were masked by a thin coating of soil. Some were partially dissolved and crumbled when handled. These pieces had been overlooked during the fire suppression efforts because they blended in with the many pieces of white plaster in the landfill. We removed these pieces to eliminate further contaminant migration. Approximately 100 pounds of suspect barium nitrate was placed in a lined 55-gallon drum and removed from the area for management.

- The slopes of MDA-R that exhibit elevated concentrations of barium should be removed. A significant volume of contaminated landfill materials remain in place. The fire suppression and stabilization efforts were not directed at removal of the entire landfill, only those portions that were obviously on fire or suspected to cover a buried fire. The contaminated area appears to be largely confined to the central area around the former drainage arroyo. Some contaminated materials were exposed to the surface during the fire suppression. Although run-on water is now diverted westward, it will be difficult to maintain slope stability and therefore it will be difficult to prevent further contaminant migration. It appears that the majority of heavy metal contamination is associated with the central part of the landfill where the barium pieces were found. Buried contamination may also reside in the far western areas.
