Date: November 2, 2005
 Refer to: ER2005-0783

SUBJECT: DP CANYON QUARTERLY INSPECTION REPORT FOR FOURTH QUARTER FISCAL YEAR 2005

DP Canyon Quarterly Inspection Report for Fourth Quarter, Fiscal Year 2005

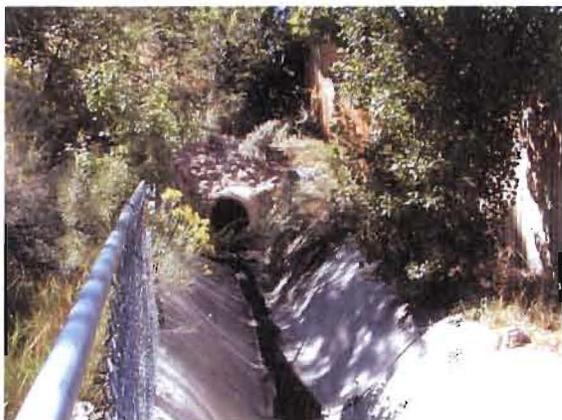
Location 1. Standing water at the head of DP Canyon (September 2005 inspection)

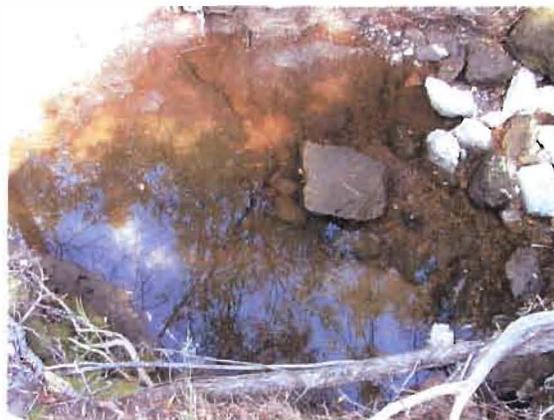
Location 2. Standing water at the upstream location (September 2005 inspection)

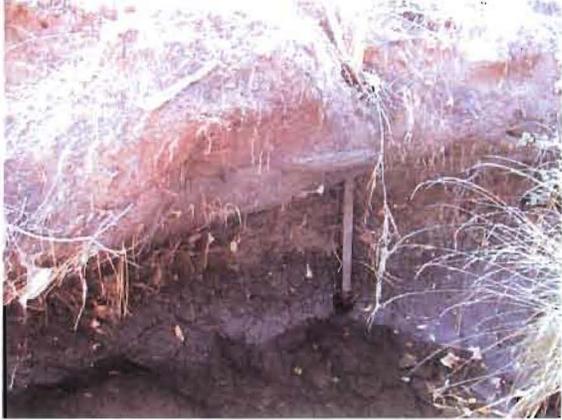
Location 3. Cut bank at the upstream location (September 2005 inspection)

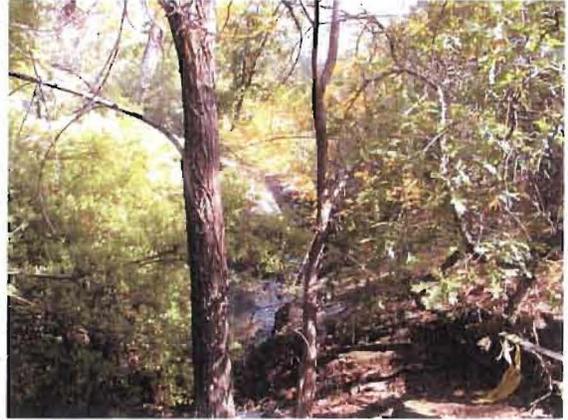
Location 4. Stream channel, looking downstream from sample location 21-11136 (September 2005 inspection)

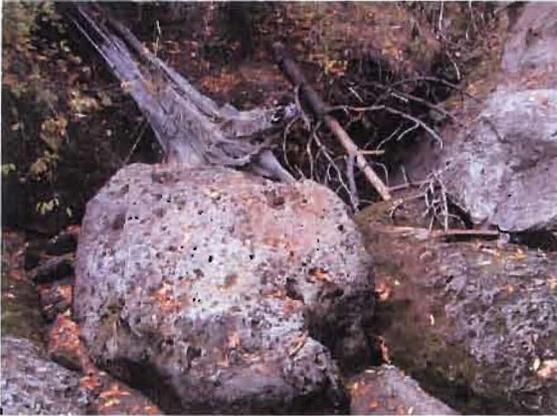
Location 5. Downstream seep location (September 2005 inspection)

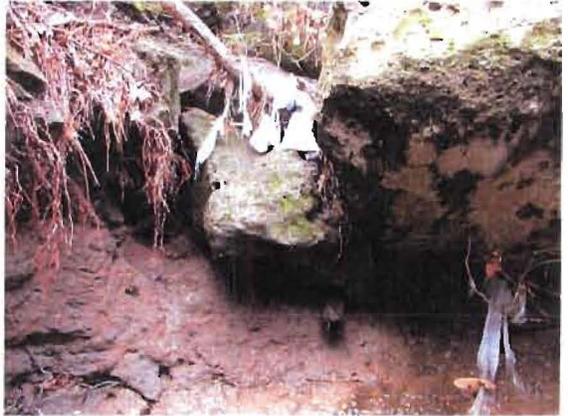
Location 6. Cut bank at the downstream location (September 2005 inspection)

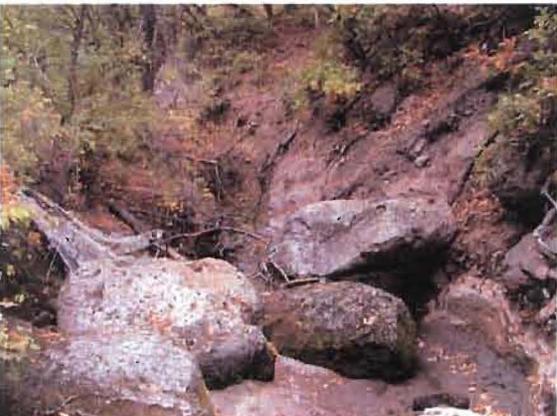
Location 7. Stream channel, looking upstream from sample location 21-11176 (September 2005 inspection)
