SUBJECT: PHOTOGRAPHS OF THE STORMWATER CONTROLS, AND BMPS ASSOCIATED WITH THE NMED-DOE OVERSIGHT BUREAU INSPECTION OF THE TA-21 MDA-V PROJECT

TA-21 MDA-V Project Stormwater Controls

06/07/06 NMED – DOE Oversight Bureau Inspection

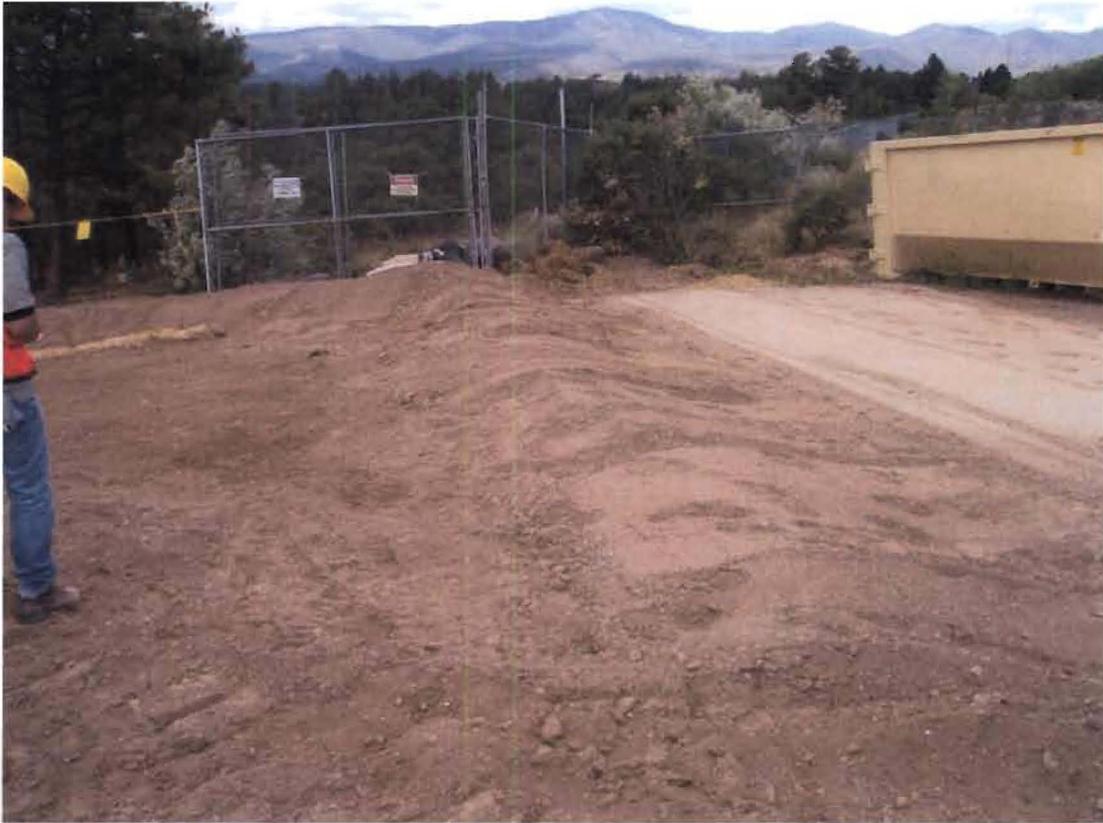
Soil berm installed on West side of MDA-V excavation site to divert on-site stormwater run on.

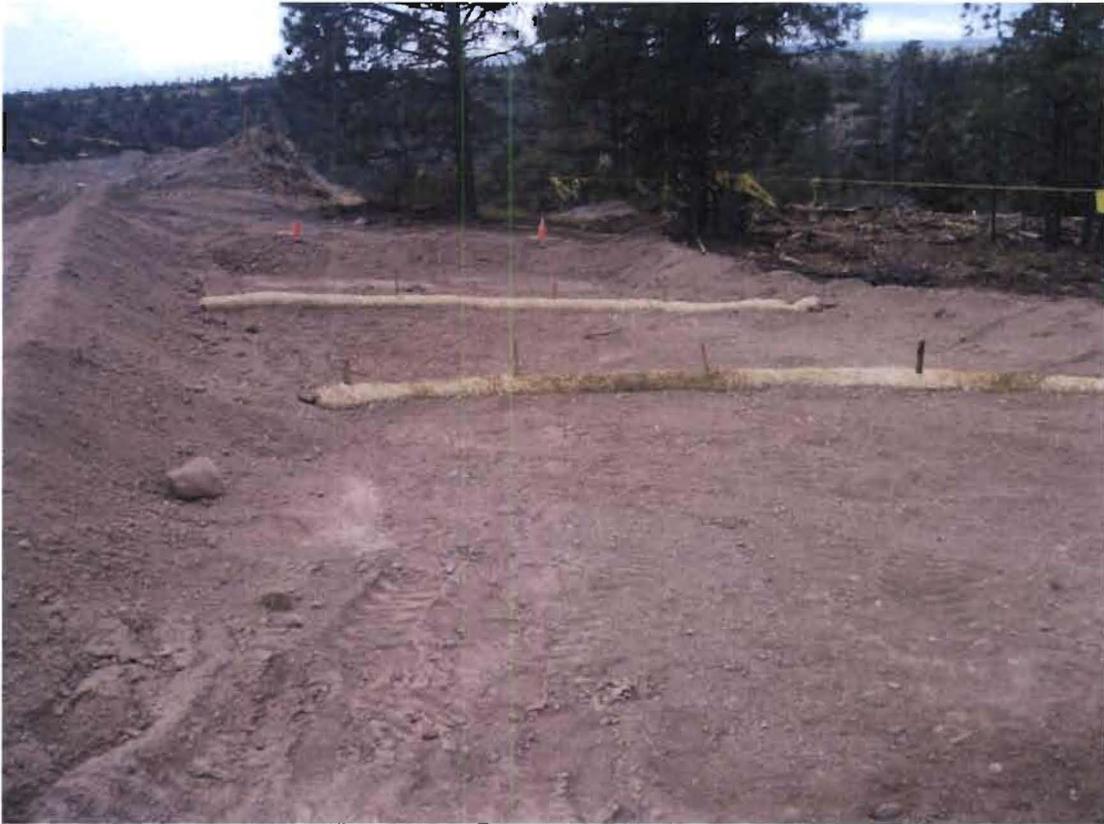
Straw wattles installed on West side of project to dissipate stormwater velocity, attenuate flow and limit sediment transport.

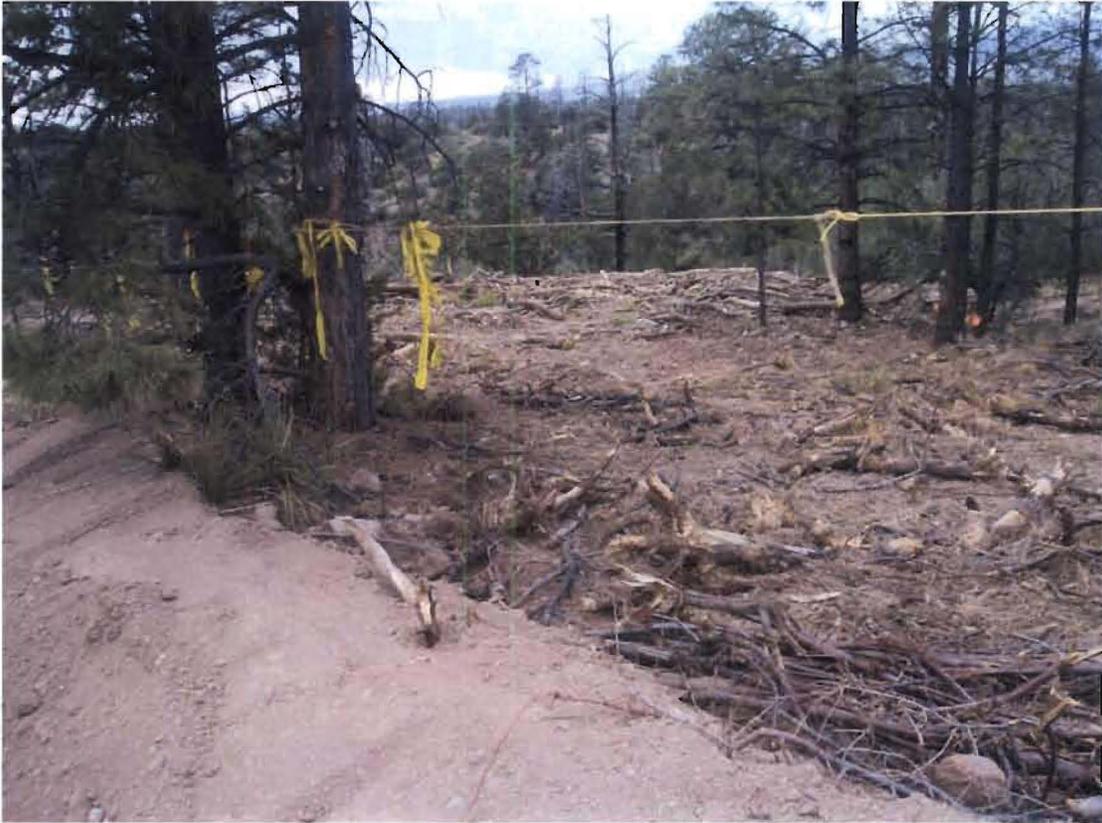
Mulched-native vegetation on ground surface implemented to dissipate stormwater flow and assist with TA-21 MDA-V site stabilization.

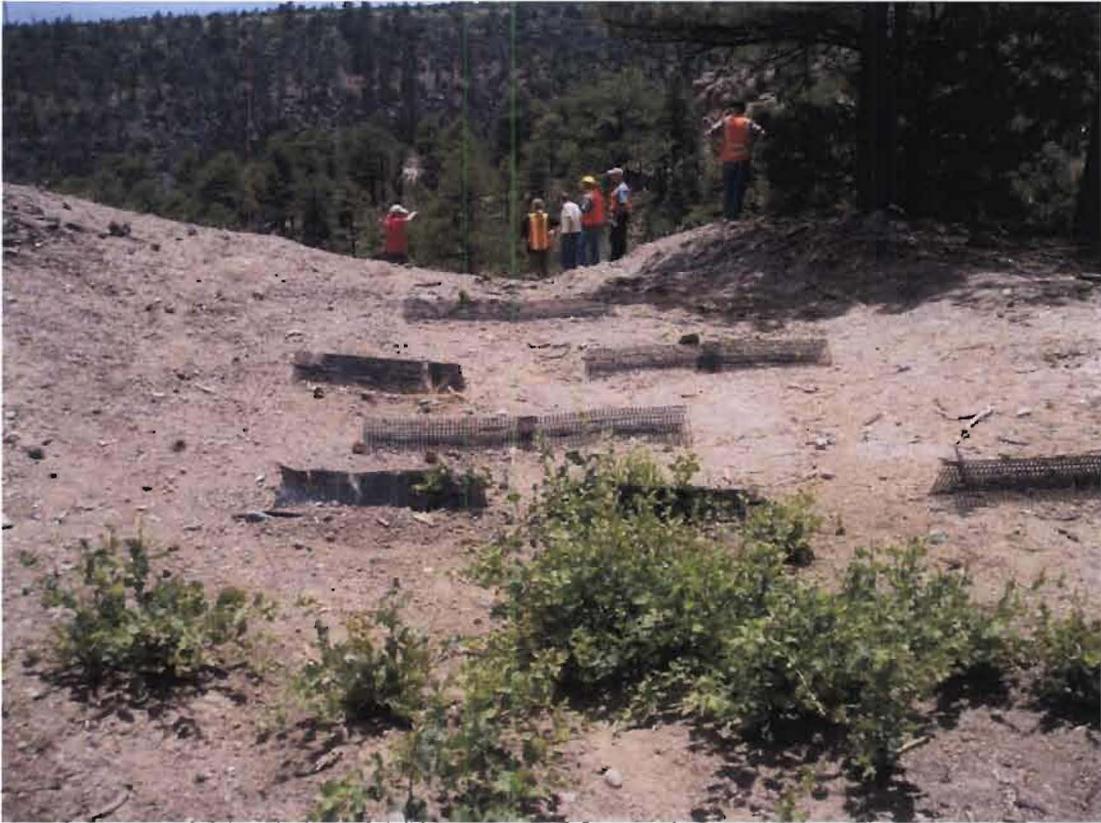
Geo-Ridges implemented to dissipate runoff velocity above the slope at the Southwest side of MDA-V.

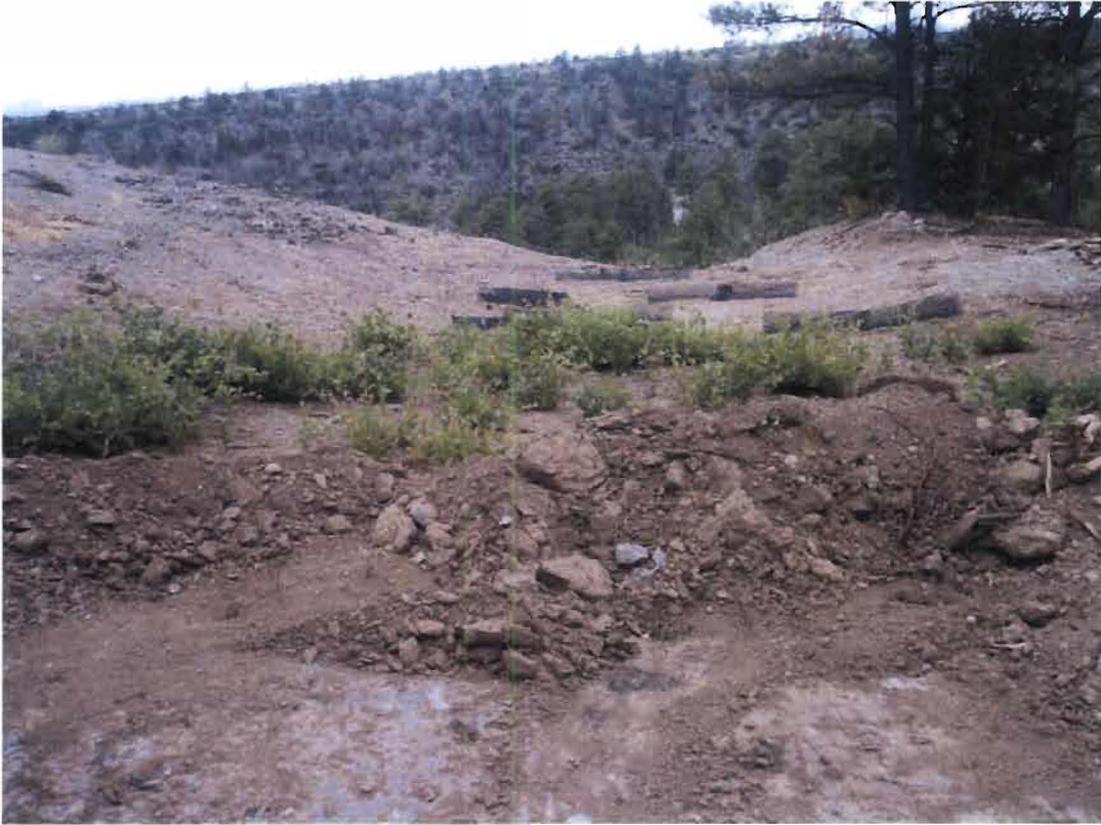
Flow Dissipation BMPs - Soil berm, natural vegetation and Geo-Ridges above the slope on the Southwest side of MDA-V.

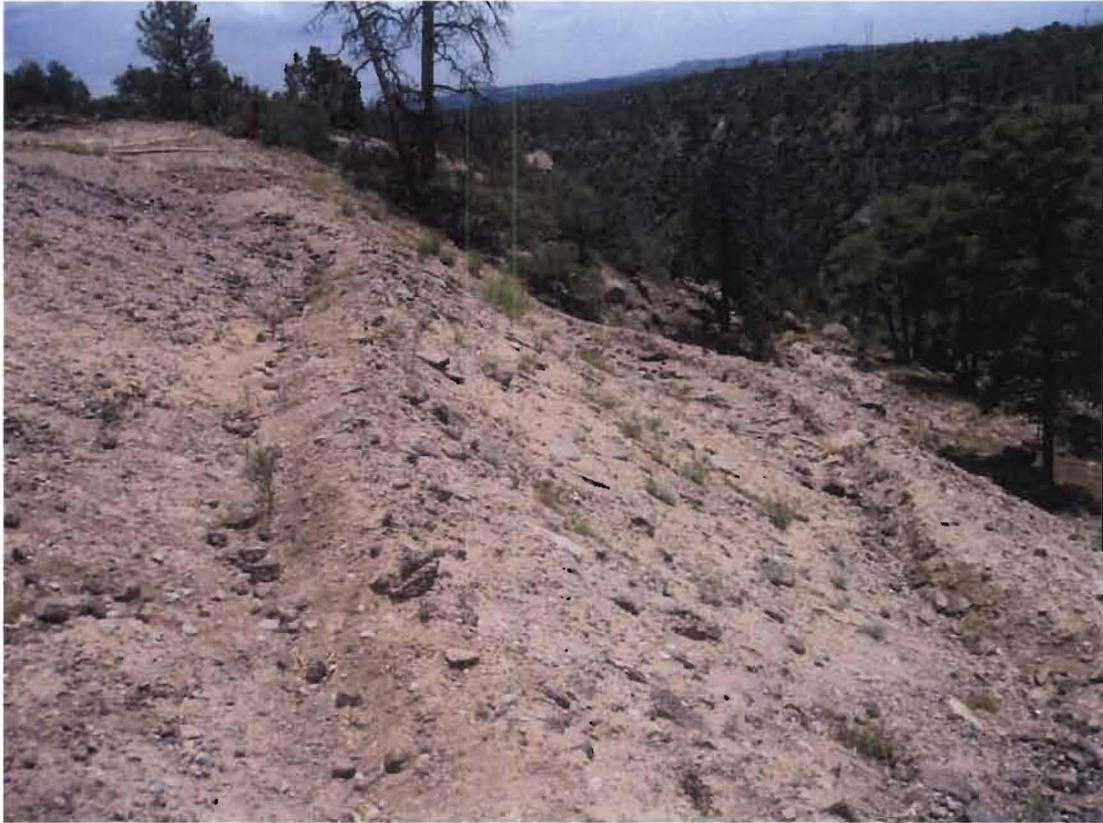
Terraced slope and vegetation on South side of MDA-V.

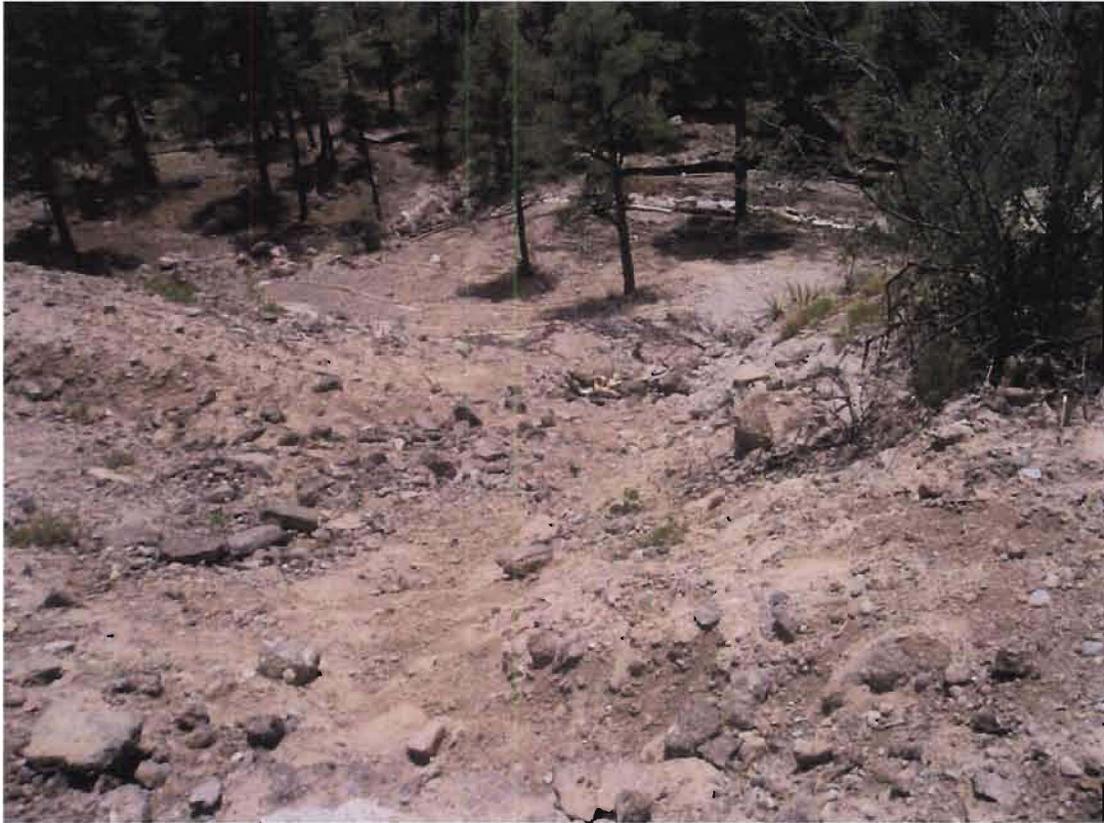
Downslope view of South side of MDA-V. Stormwater controls including straw wattles, silt fence, terracing, sand bags, and check dams have been implemented.

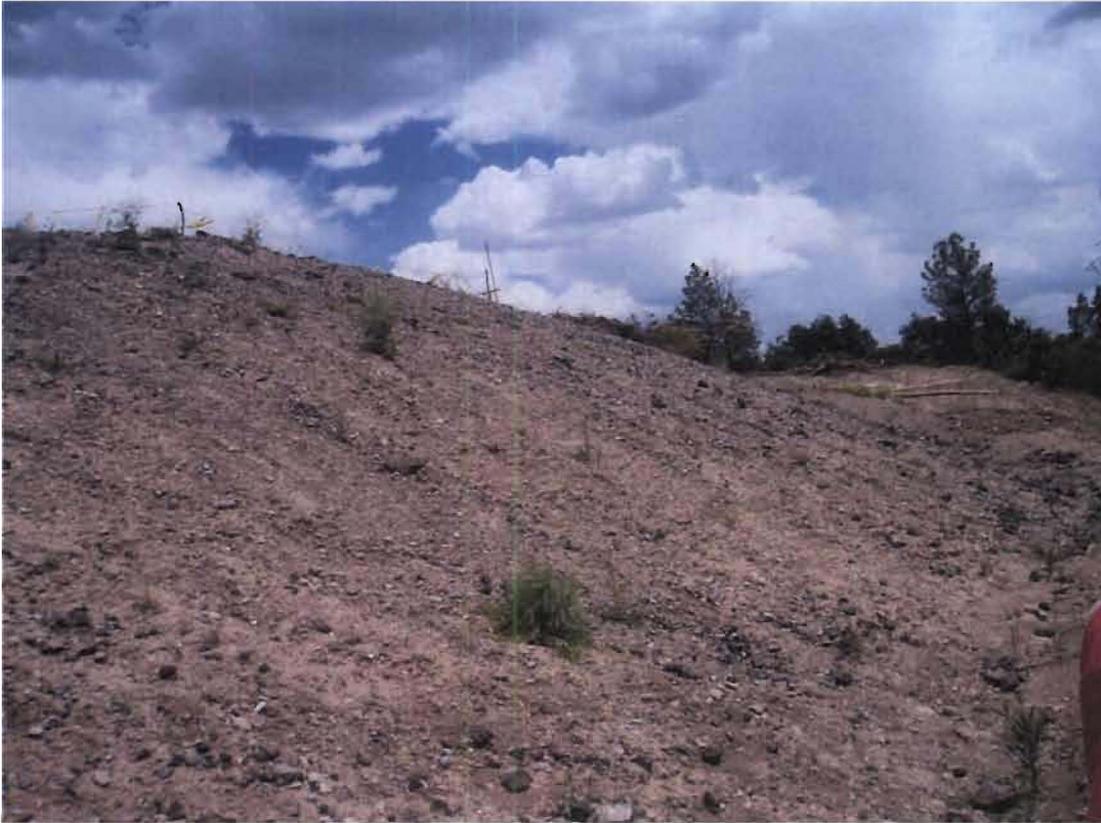
Cross-view of MDA-V South Slope.

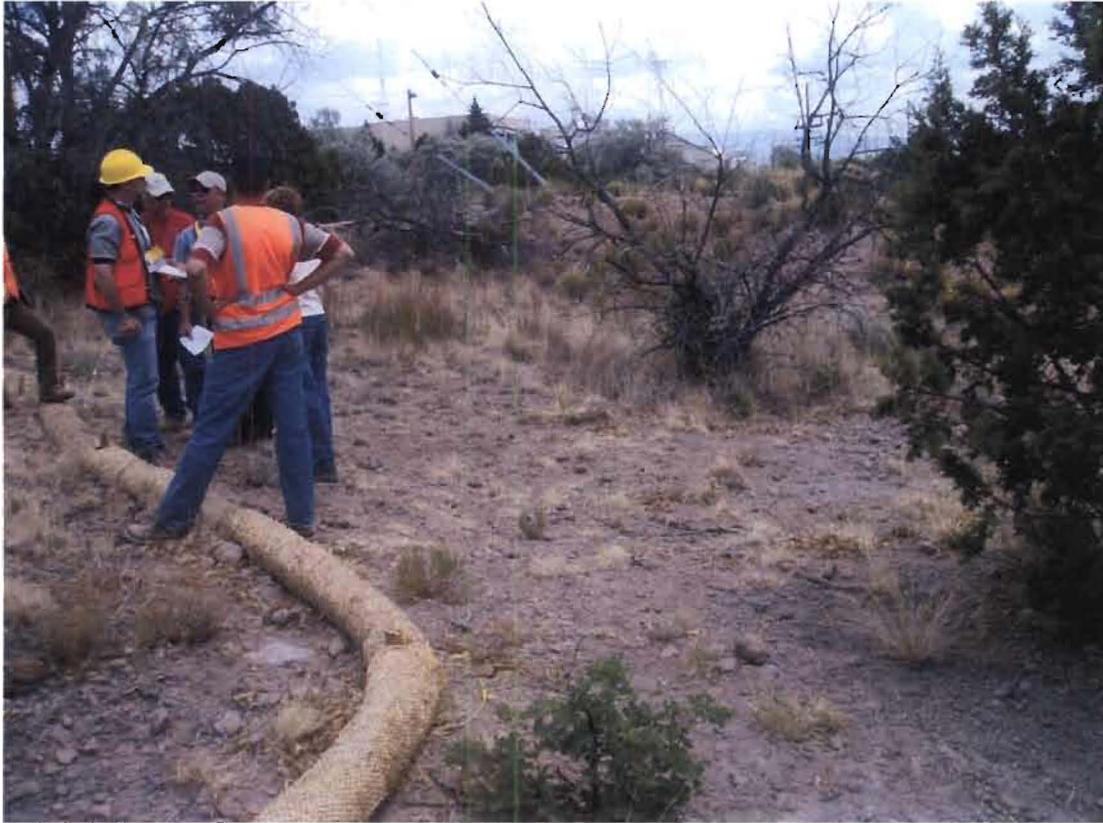
Straw wattles at Southeast corner of MDA-V.
