# Los Alamos National Laboratory

ENVIRONMENTAL RESTORATION

Date: February 27, 1996  
Refer to: EM/ER:96-079

## SUBJECT: STORMWATER ISSUE AT TECHNICAL AREA (TA) 32

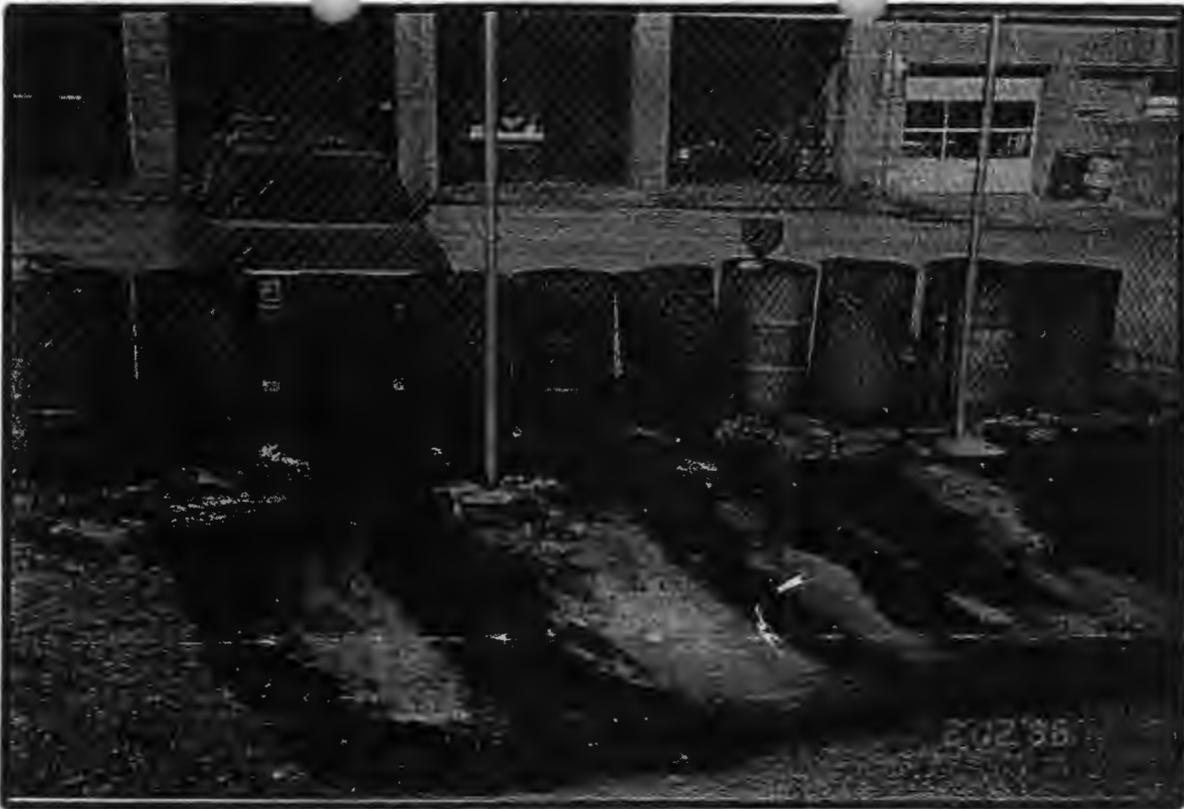
1

Used oil drums stored in Knecht Auto Repair yard.

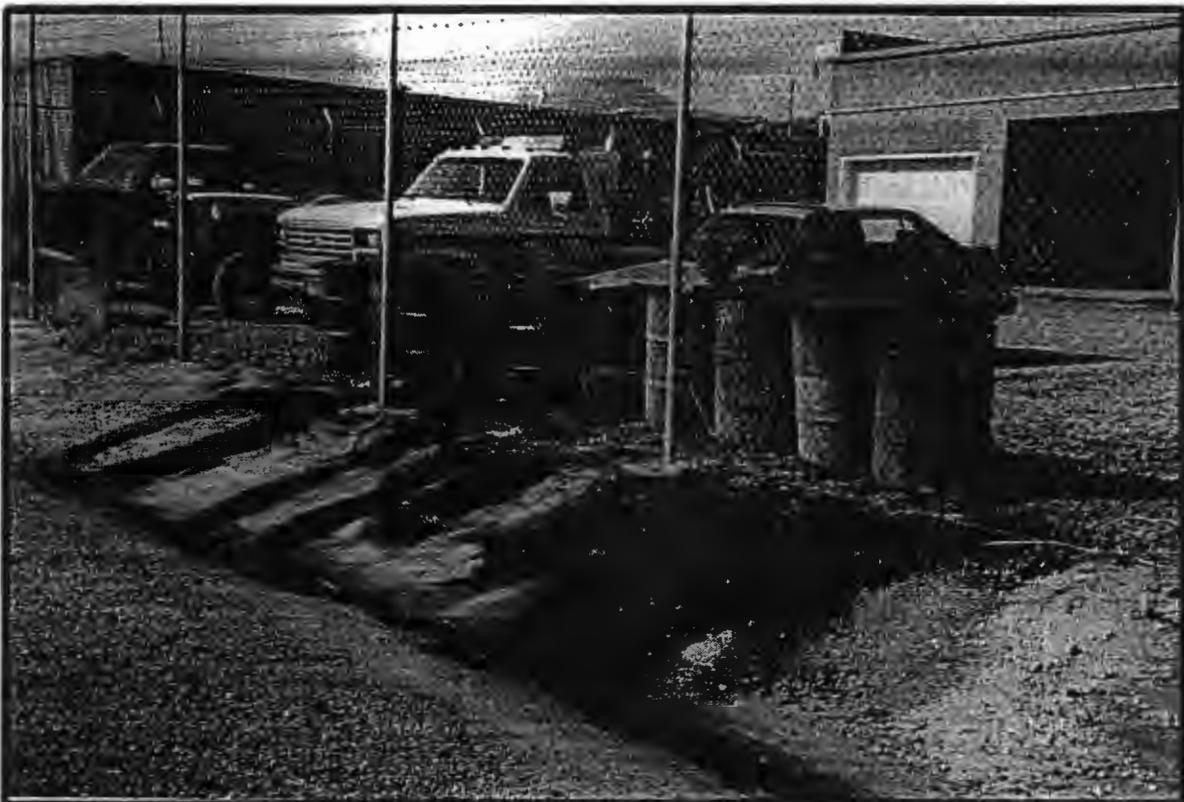
2

Used oil drums in Knecht Auto Repair yard.

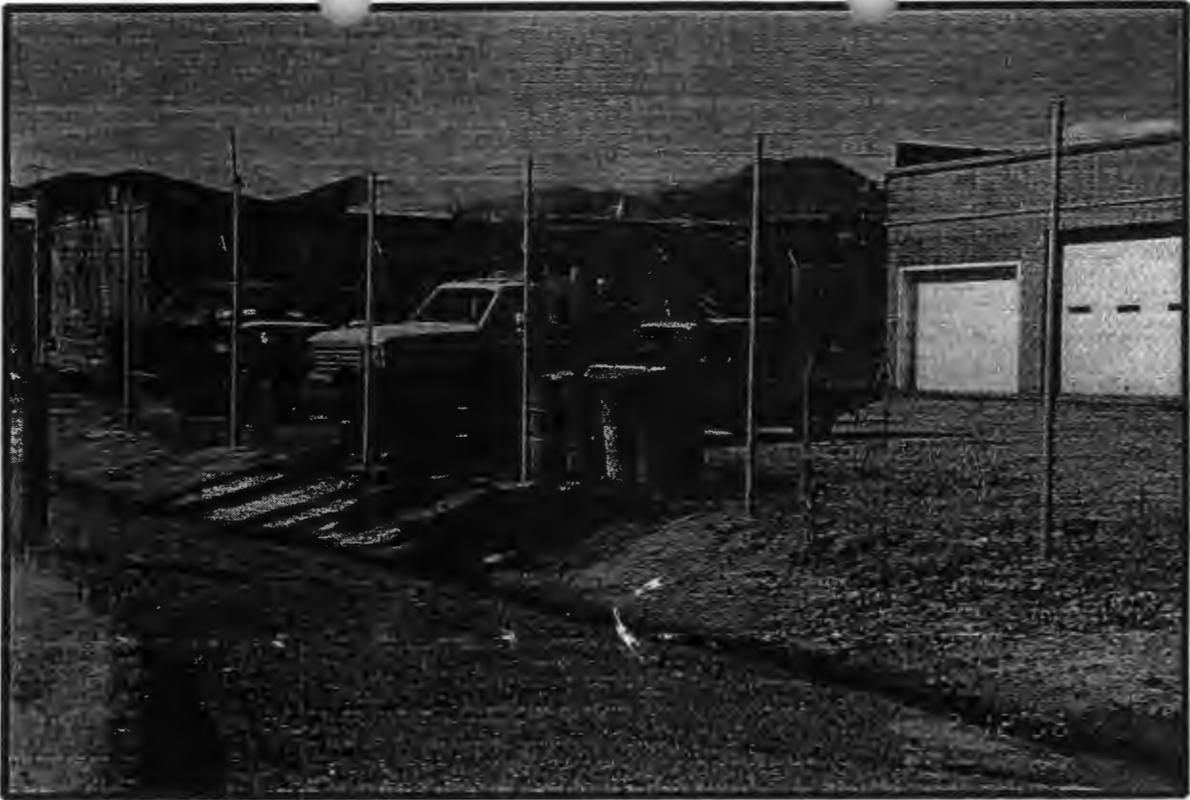
3

Used oil drums stored in Knecht Auto Repair yard.

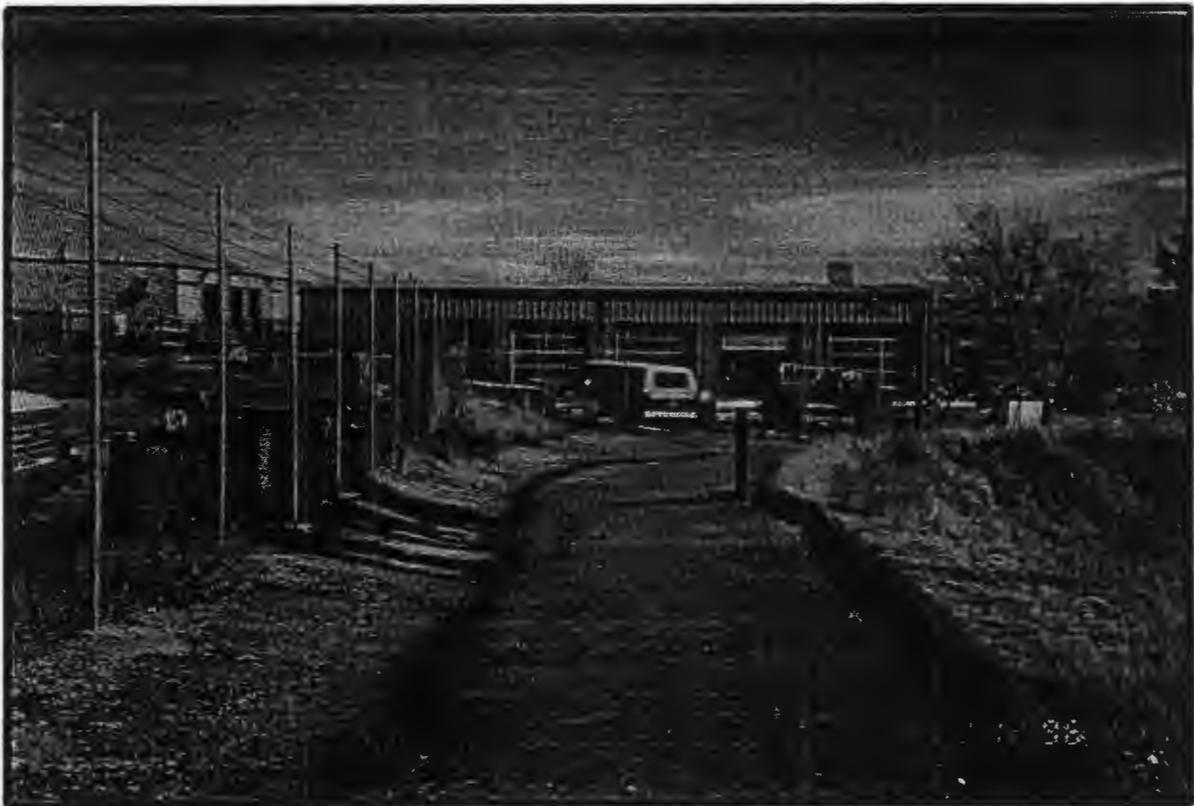
4

Looking East at the paint and body shop. Drums visible to right of photo.

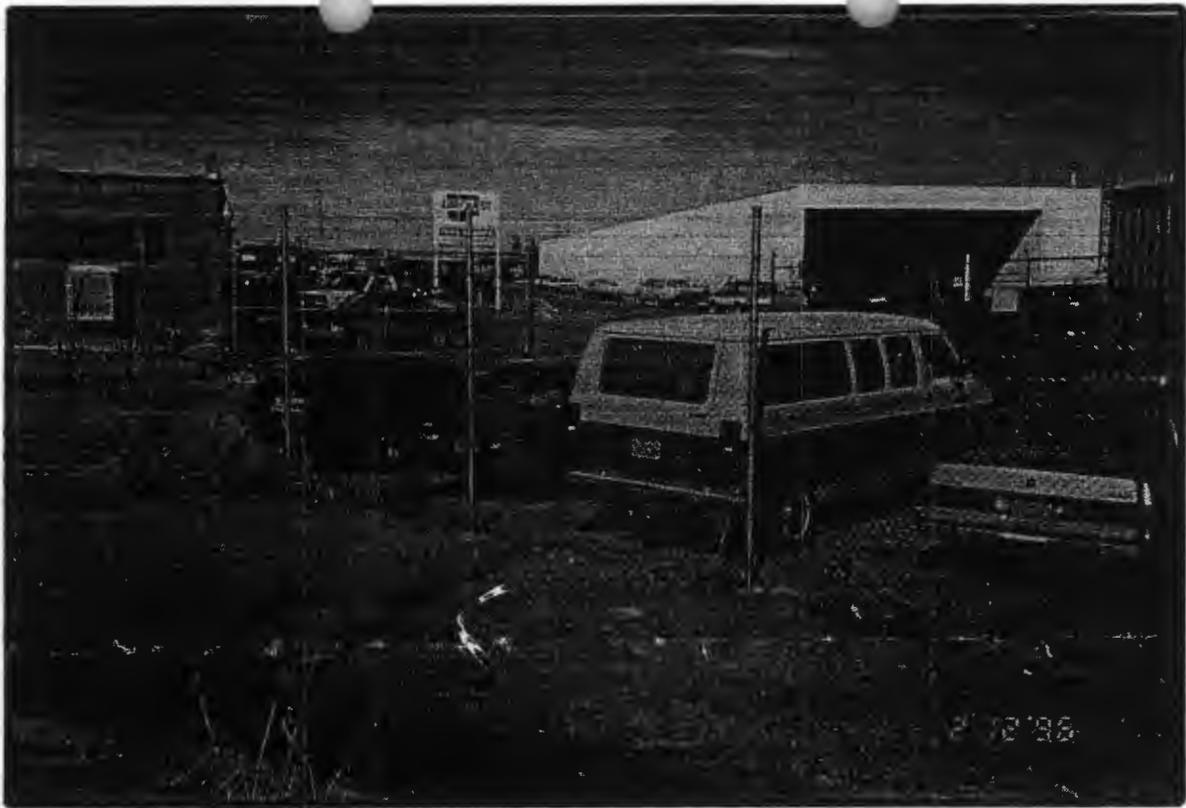
5

Looking North up Knecht Street. Note oil in the drainage channel.

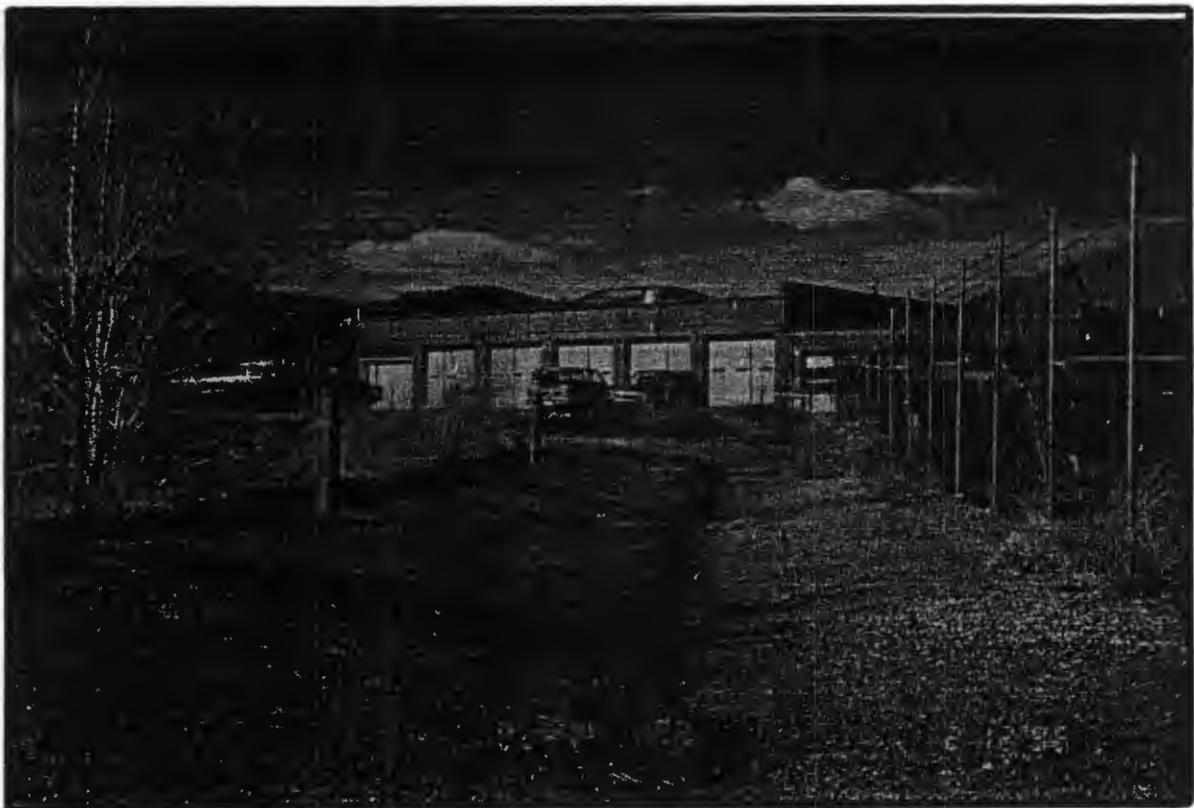
6

Looking NW. Oil staining down center of channel.  
Note 55 gallon oil drums to left rear.
