Los Alamos National Laboratory

ENVIRONMENTAL RESTORATION

Date: February 27, 1996
Refer to: EM/ER:96-084

SUBJECT: STORMWATER ISSUE AT TECHNICAL AREA (TA) 32

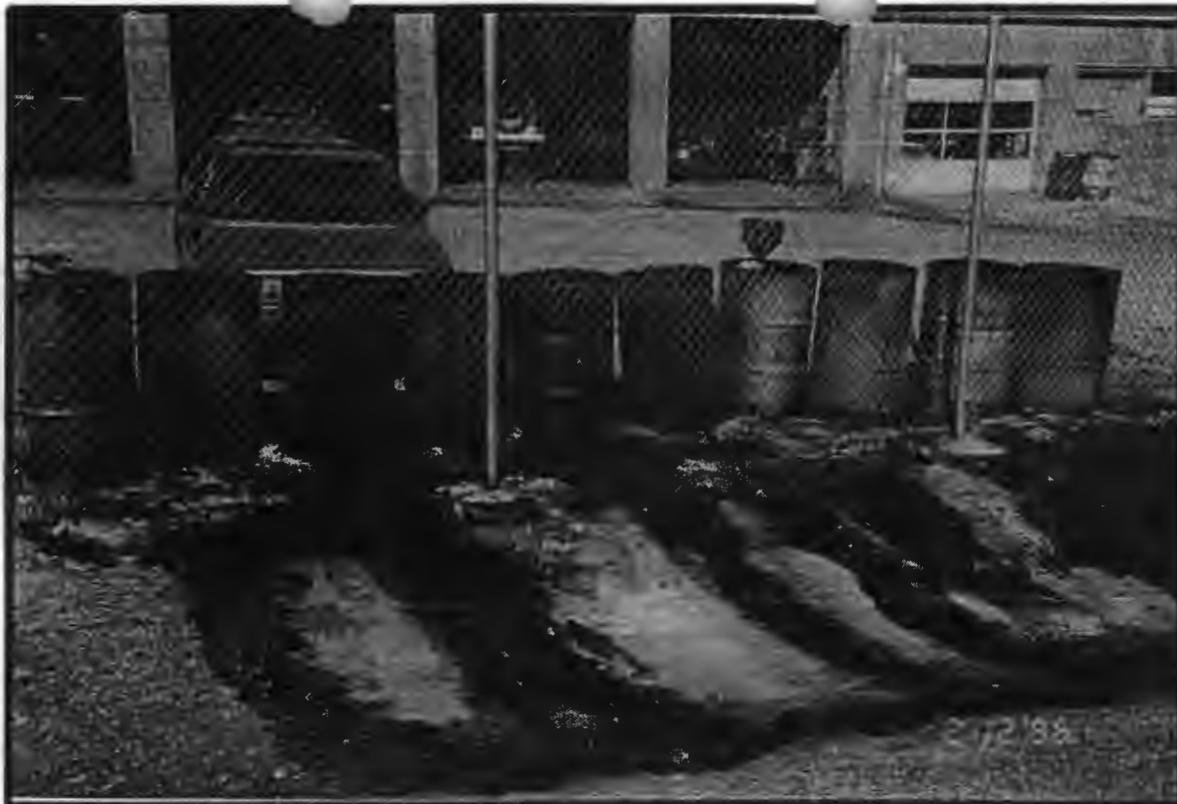
1

Used oil drums stored in Knecht Auto Repair yard.

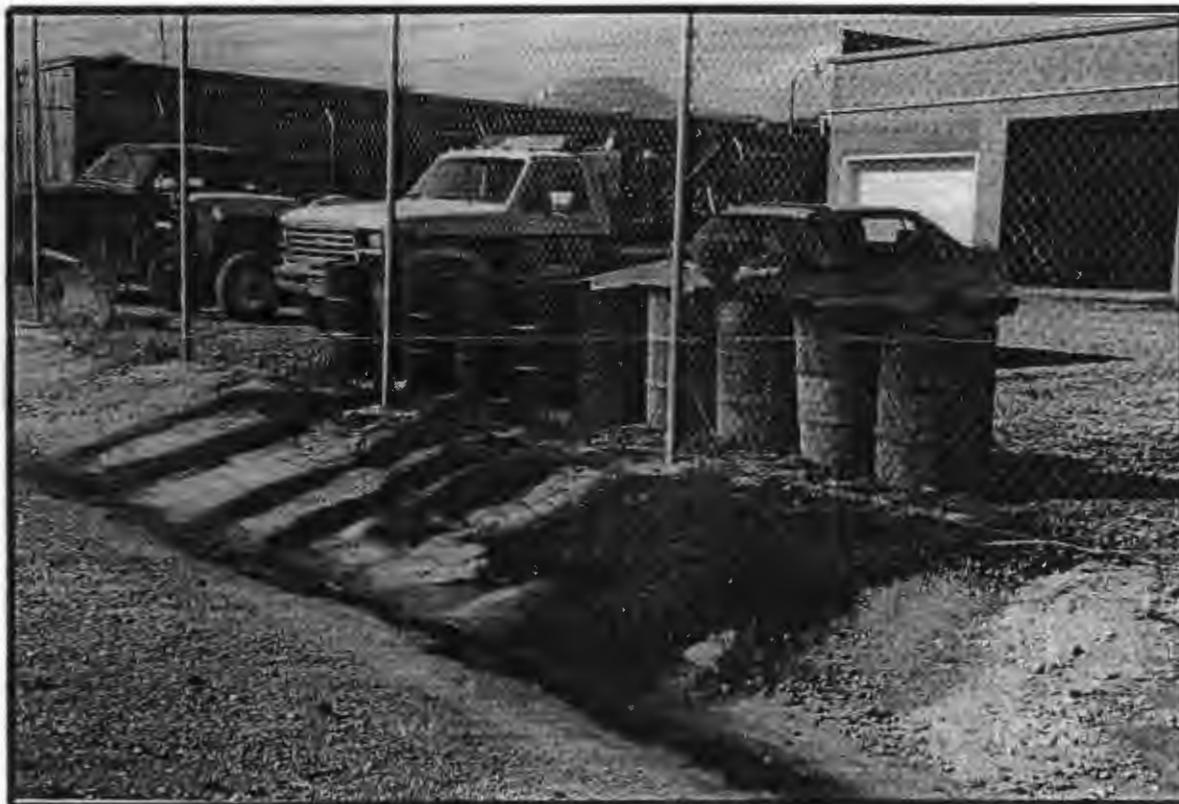
2

Used oil drums in Knecht Auto Repair yard.

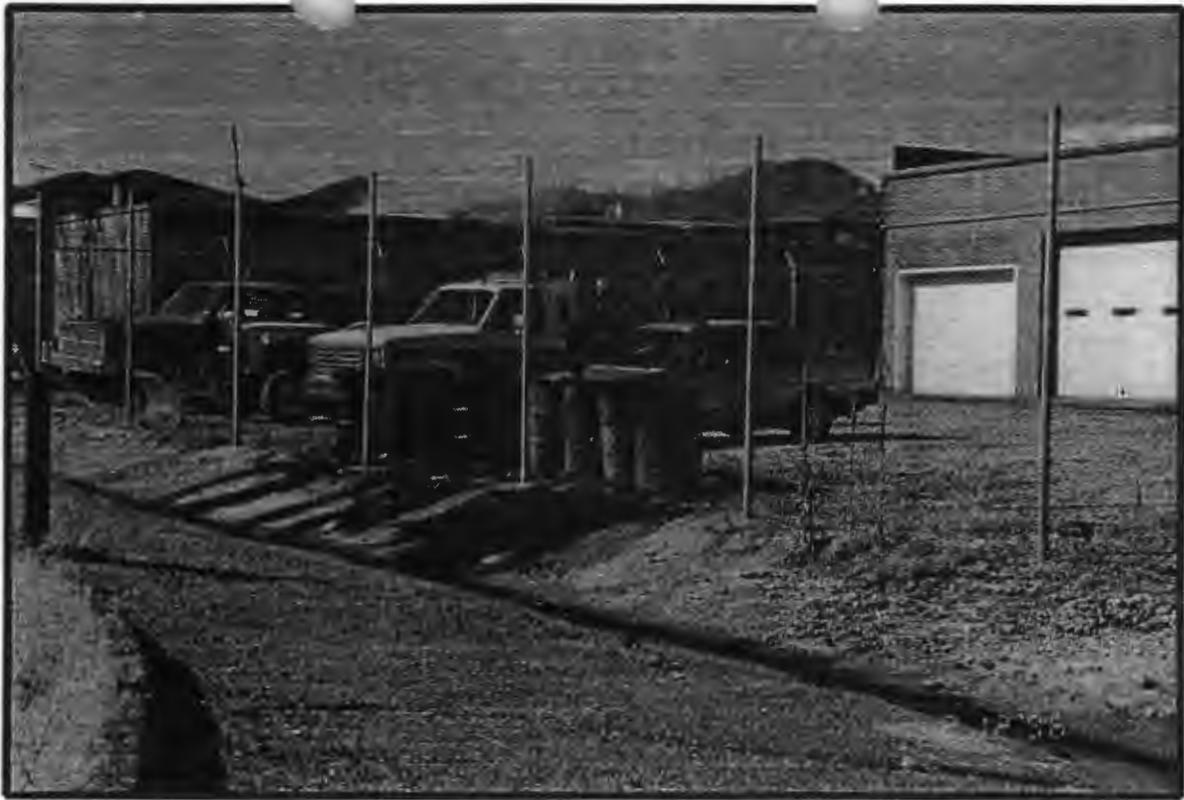
3

Used oil drums stored in Knecht Auto Repair yard.

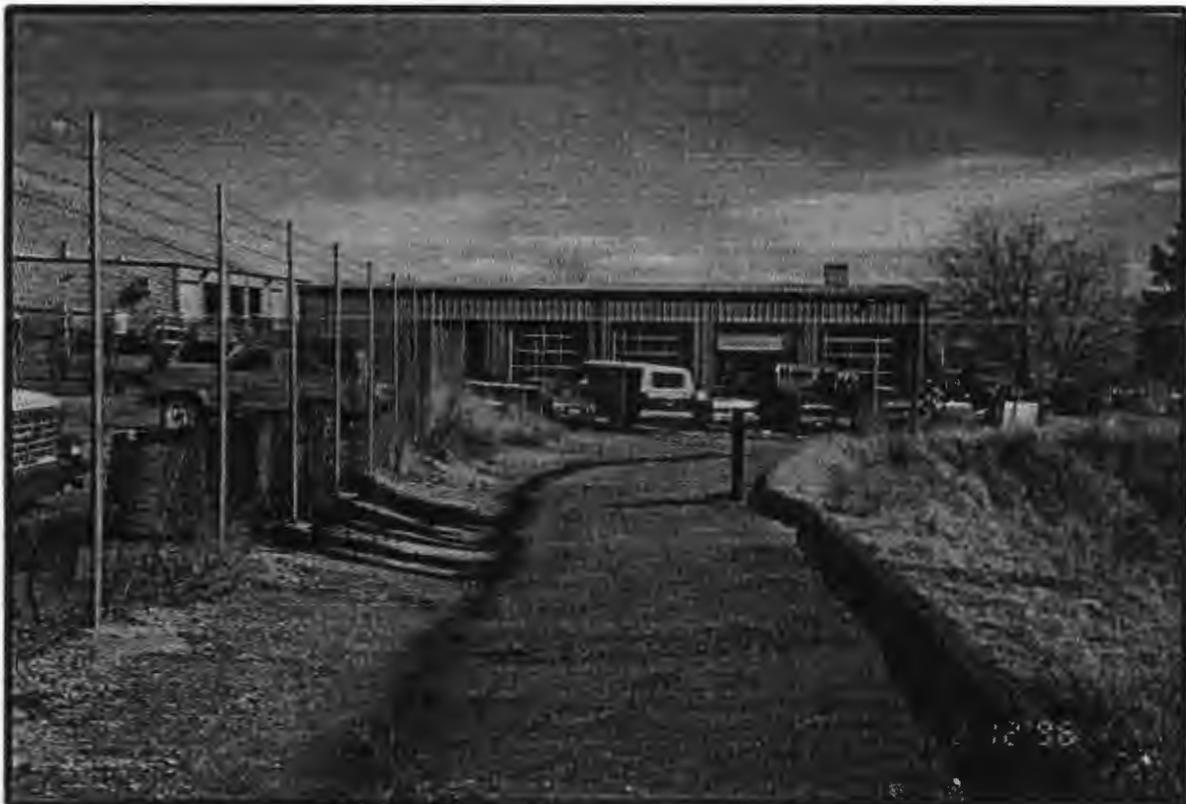
4

Looking East at the paint and body shop. Drums visible to right of photo.

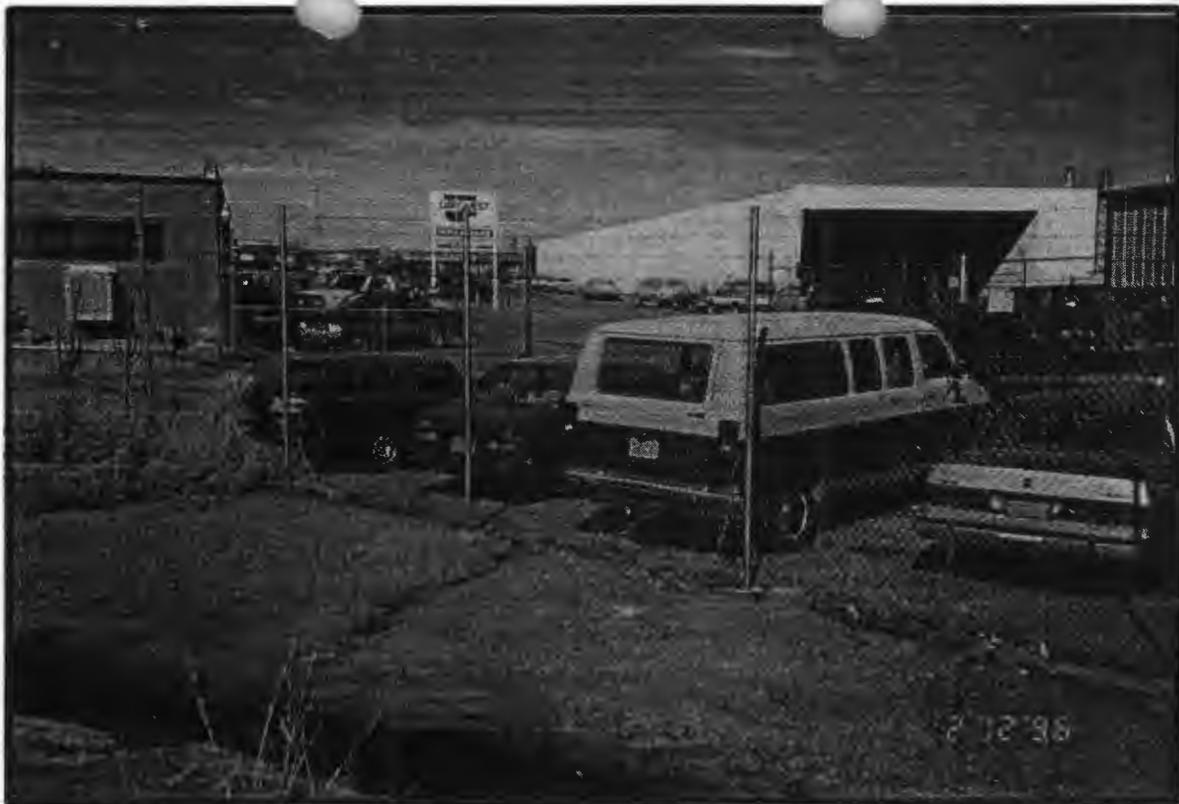
5

Looking North up Knecht Street. Note oil in the drainage channel.

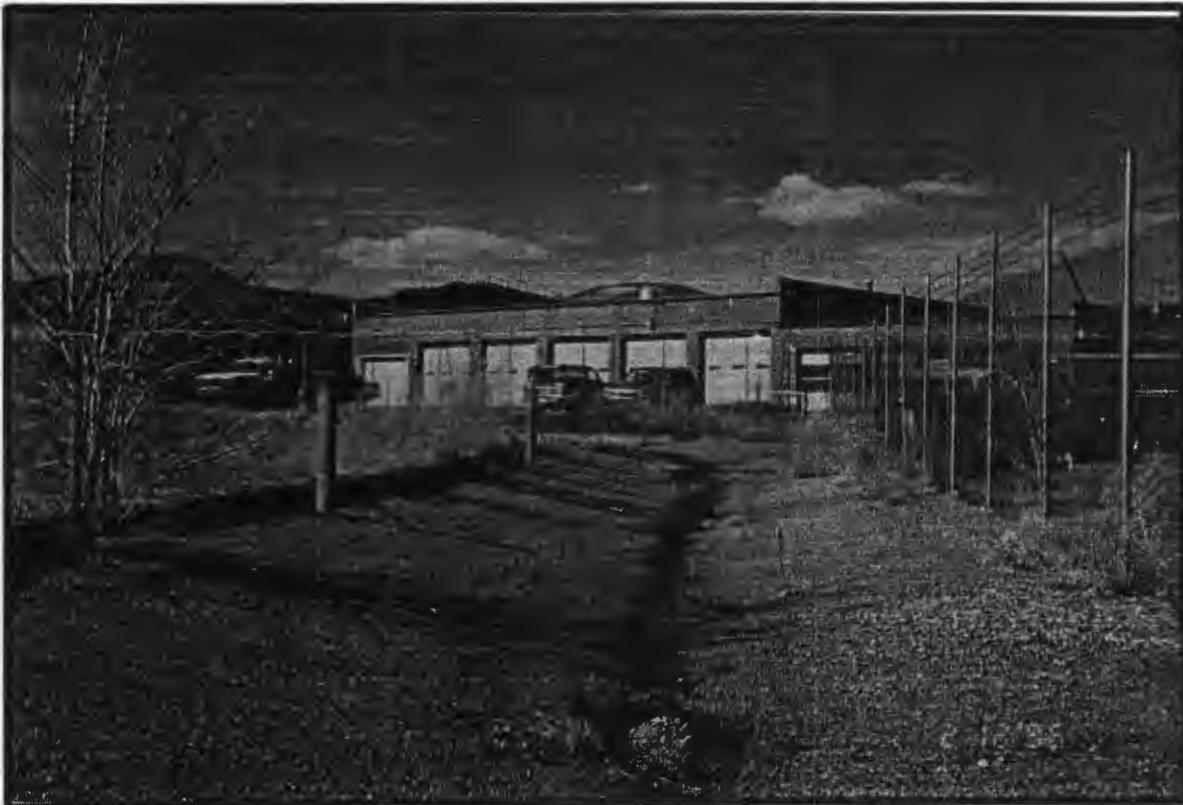
6

**Looking NW. Oil staining down center of channel.
Note 55 gallon oil drums to left rear.**

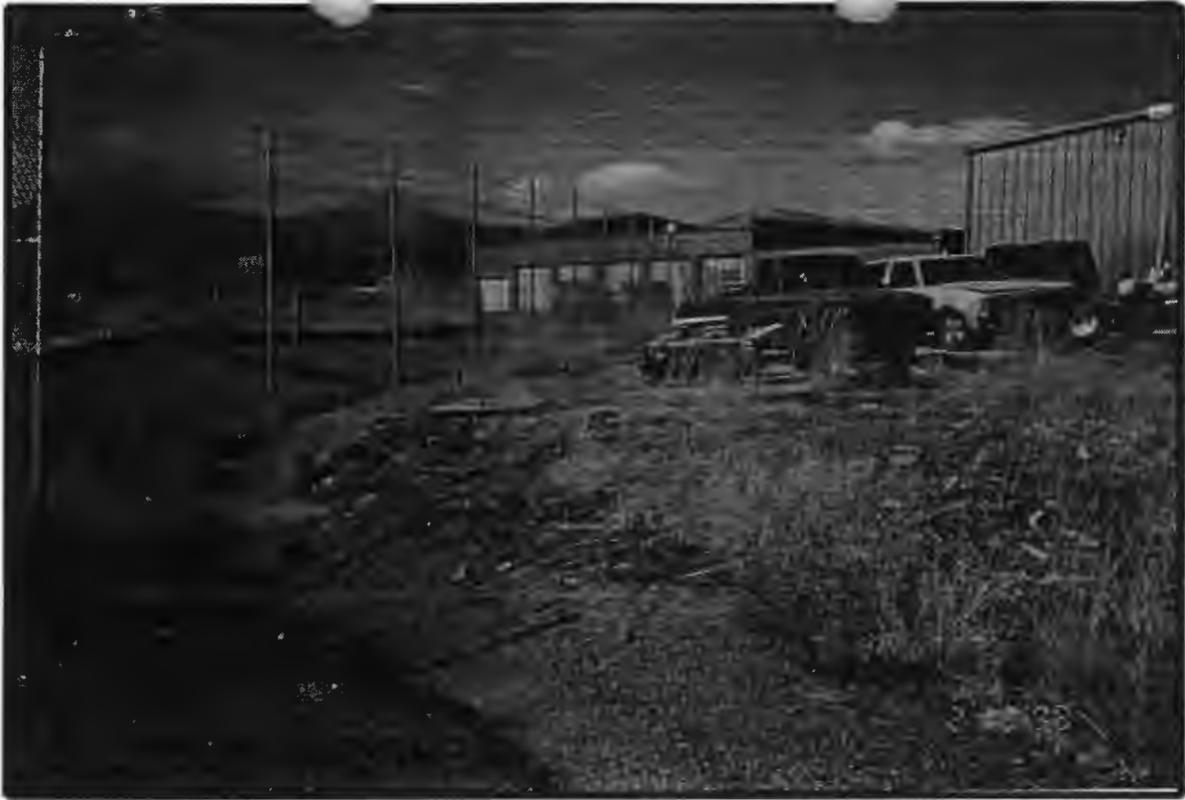
7

Looking NW. Note oil staining in channel and miscellaneous debris on slope. Knecht Auto Repair in background and the body/paint shop to the right.

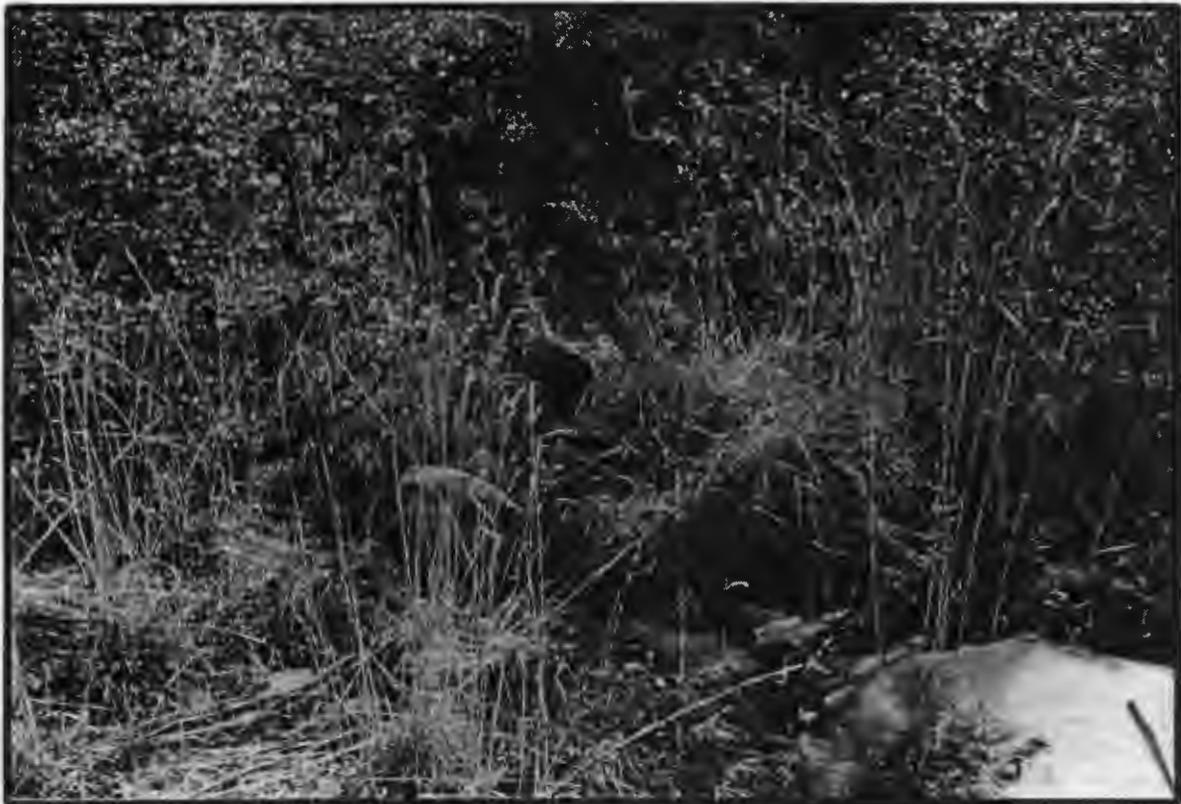
9

Looking South towards PRS 32-004. Note 5 gallon buckets in drainage.
