Los AlamosLos Alamos National Laboratory
Los Alamos, New Mexico 87545**memorandum**

FROM: Charlie Nylander, HSE-8 *cn* SYMBOL: HSE8-86-1354

SUBJECT: OIL SPILL AT TA-35 TSL-125

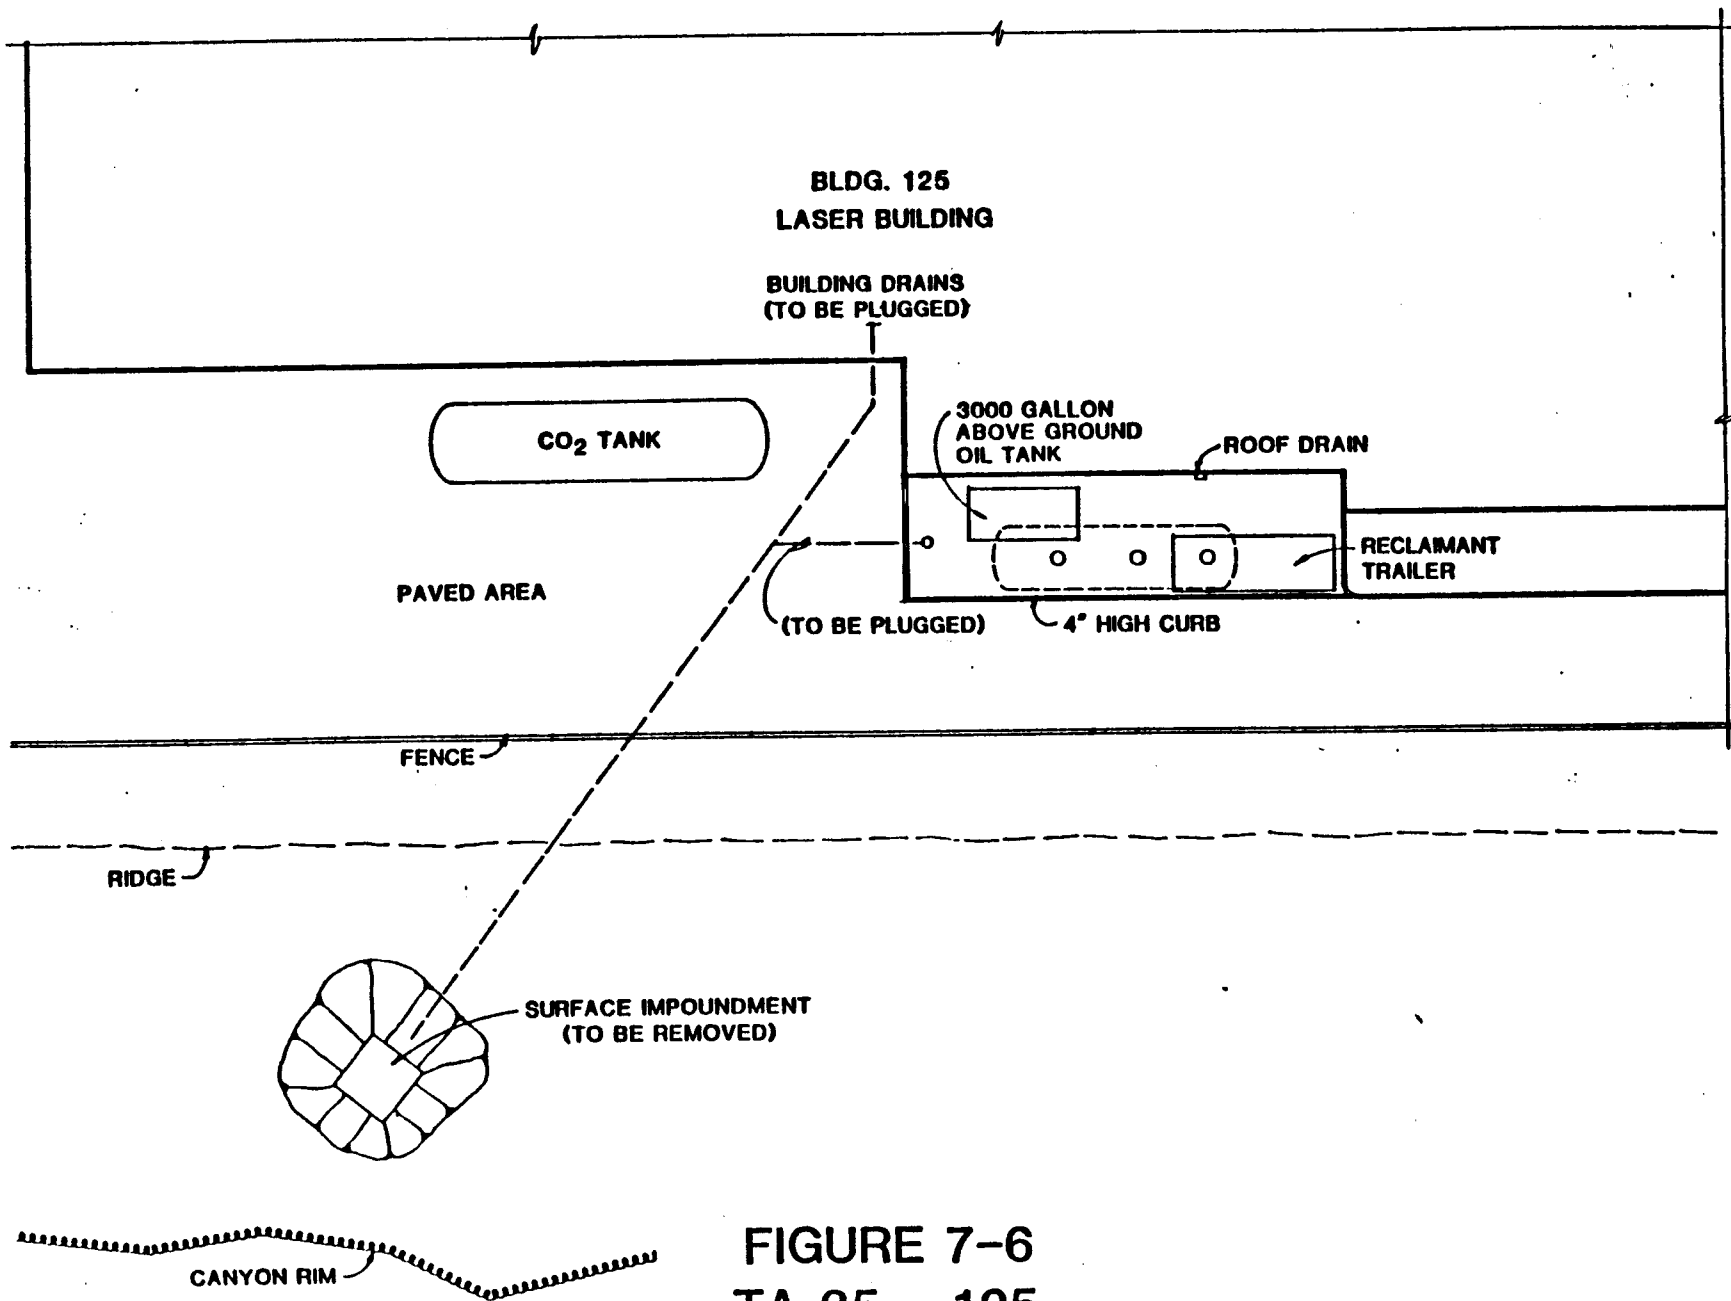
FIGURE 7-6
TA 35 - 125
EXISTING OIL STORAGE & COLLECTION

A variety of high-voltage equipment that uses dielectric oil is located in this building for the laser research that is conducted here. Any oil spills that occur in the building are collected in a sump that drains to a gunite-lined surface impoundment south of the building on the canyon rim (Figure 7-6).

Outside, on the south side of the building, is a 24,000-gallon capacity underground tank. Above the tank is a curbed area with a 4,200-gallon volume. This area contains a 3,000-gallon horizontal tank and a dielectric oil reclamation trailer with a 1,000-gallon capacity. The curbed area receives storm runoff from the building roof and drains to the surface impoundment.

The surface impoundment will be removed and the building and curbed area drains plugged to prevent an overflow of oil out of the impoundment and into Mortandad Canyon.

New programs are anticipated for TA 35-125 and the exact nature of the spill control and secondary containment that is needed depends on the oil usage of the future equipment. If the above-ground and the underground tanks are still used in the new program, the roof drain will be rerouted to discharge outside the curbed area, a sump will be installed in the down-grade
