SUBJECT: REPLY TO SEPTEMBER 8, 1988 INQUIRY

The following text and attachments respond to your September 8, 1988 request for information regarding the spill control facility located near Technical Area (TA) 35, Building 125. Historically, experimental work was conducted in Building 125 utilizing high-voltage equipment and dielectric oil. Because of the volume of oil utilized in and around the building, spill prevention and control facilities were constructed to capture oil spills that could occur inside and outside the building and divert them to a gunite-lined surface impoundment located south of the building on the canyon rim. The impoundment was constructed for total retention of spills, however, a low point along the southeast bank could serve as an overflow point (a spillway was not constructed, per se) and liquids could spill over into the adjacent ephemeral canyon if over-filling occurred.

SUBJECT: OIL SPILL AT TA-35 TSL-125

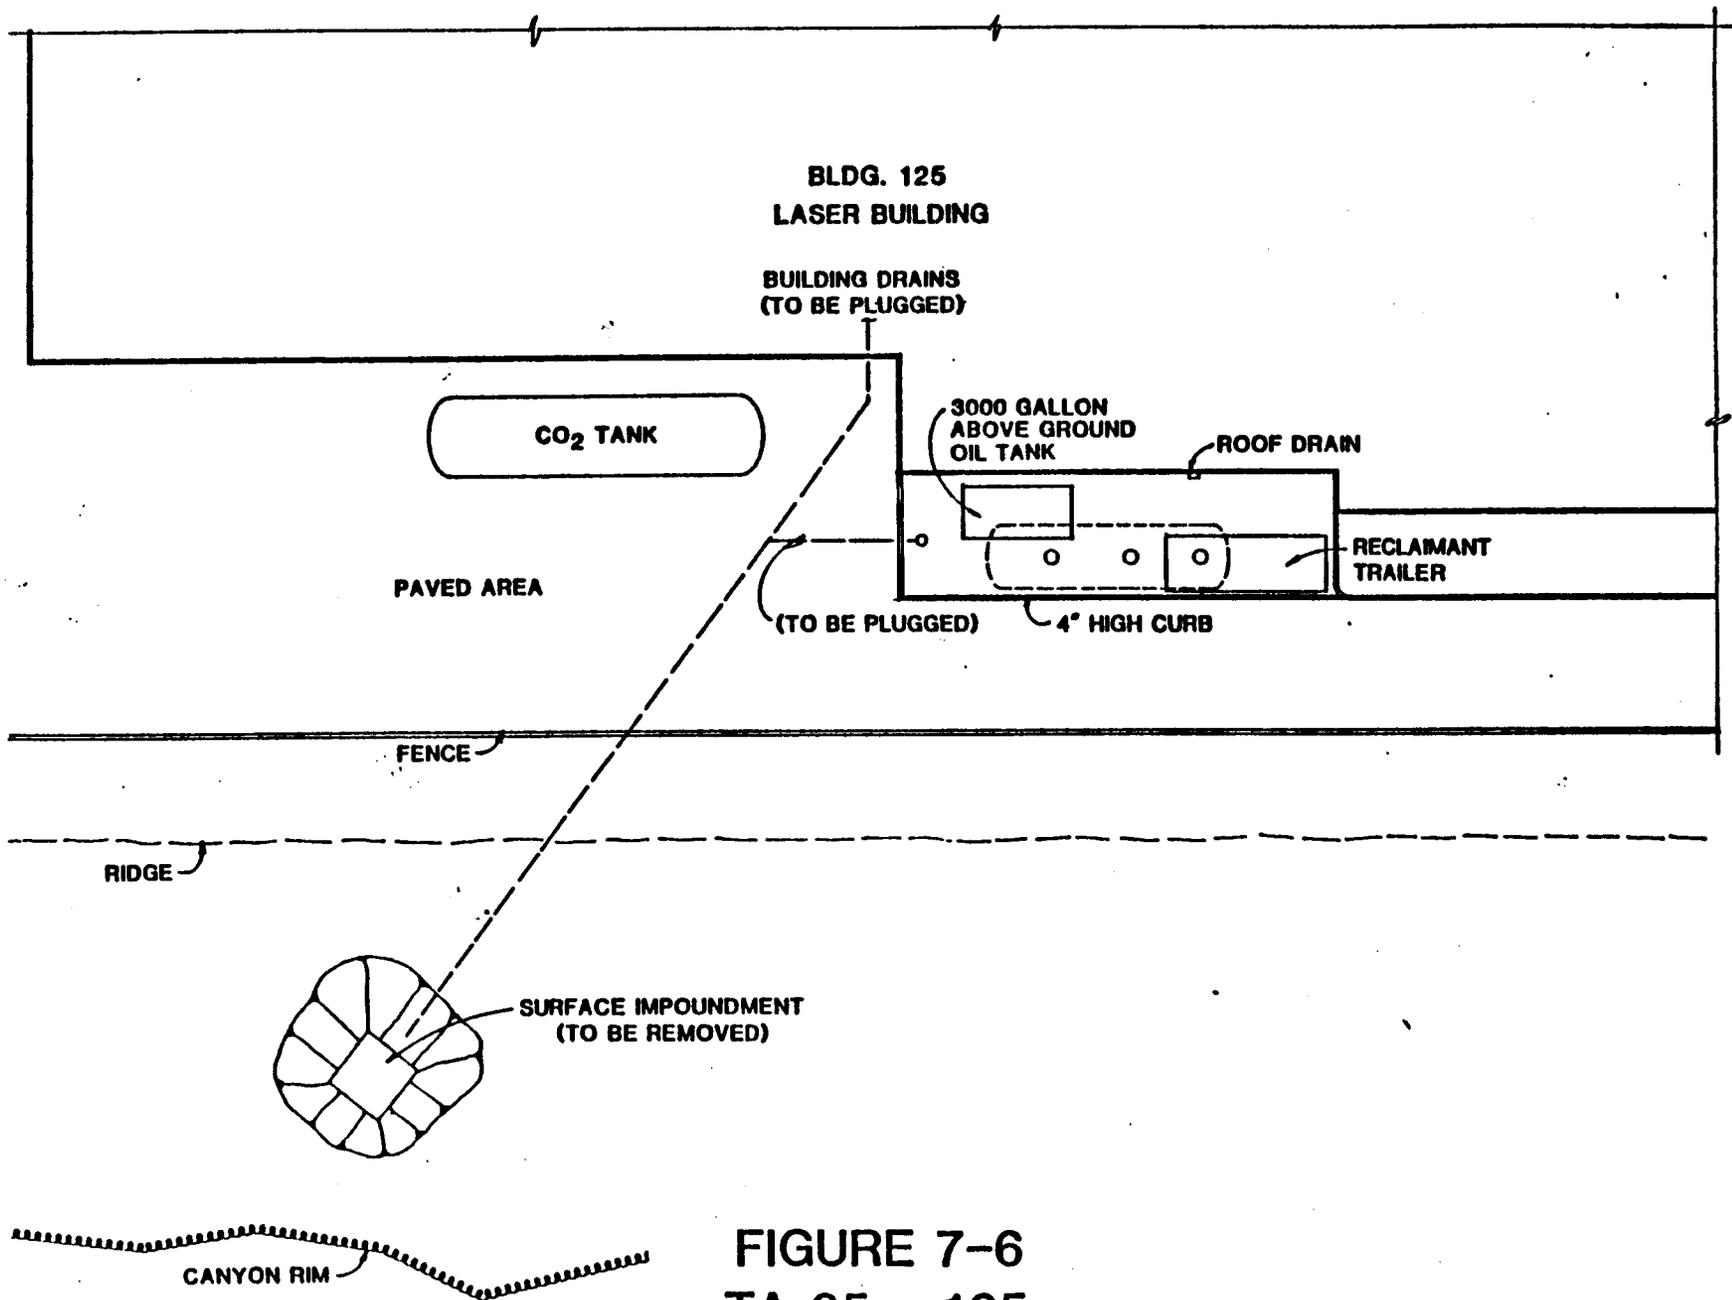
FIGURE 7-6
TA 35 - 125
EXISTING OIL STORAGE & COLLECTION

A variety of high-voltage equipment that uses dielectric oil is located in this building for the laser research that is conducted here. Any oil spills that occur in the building are collected in a sump that drains to a gunite-lined surface impoundment south of the building on the canyon rim (Figure 7-6).

Outside, on the south side of the building, is a 24,000-gallon capacity underground tank. Above the tank is a curbed area with a 4,200-gallon volume. This area contains a 3,000-gallon horizontal tank and a dielectric oil reclamation trailer with a 1,000-gallon capacity. The curbed area receives storm runoff from the building roof and drains to the surface impoundment.

The surface impoundment will be removed and the building and curbed area drains plugged to prevent an overflow of oil out of the impoundment and into Mortandad Canyon.

New programs are anticipated for TA 35-125 and the exact nature of the spill control and secondary containment that is needed depends on the oil usage of the future equipment. If the above-ground and the underground tanks are still used in the new program, the roof drain will be rerouted to discharge outside the curbed area, a sump will be installed in the down-grade
