**SUBJECT: DISCHARGE PERMIT DP-857 QUARTERLY REPORT, THIRD QUARTER 2013, TA-46 SANITARY WASTEWATER SYSTEMS PLANT**

Monthly inspection photographs of the  
SERF evaporation basins

Photographs of the repairs made to the  
Northeast SERF Evaporation Basin

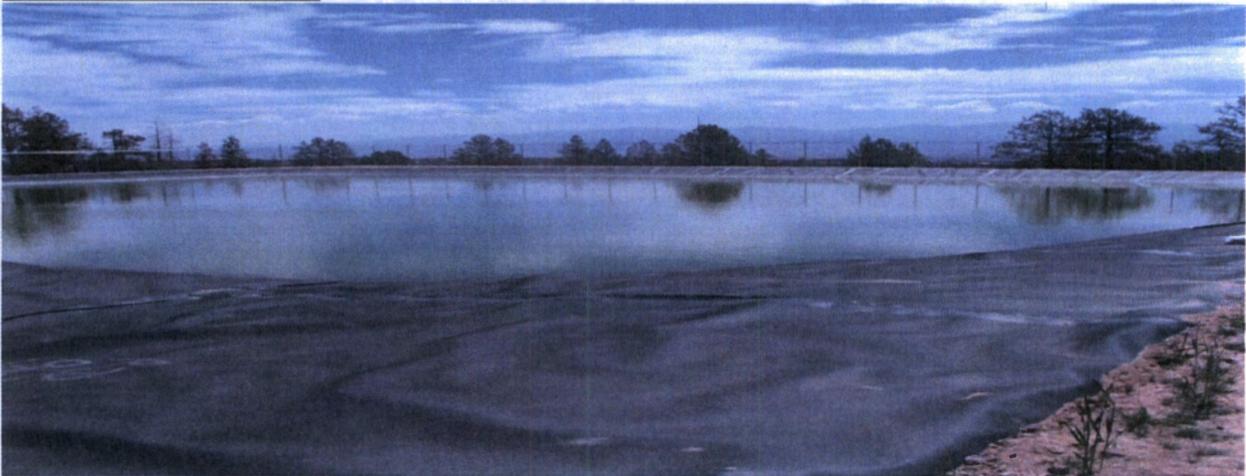
**Northeast Basin and Ports**

Table 4.0 and Enclosure 2 present the results from monthly inspections of the leak collection ports at the SERF evaporation basins located on Sigma Mesa for the third quarter of 2013. All leak collection ports were dry except for the northeast SERF evaporation basin. A leak in the primary liner is not indicative of a leak to the environment; all SERF evaporation basins were constructed with primary and secondary liners. The presence of water in northeast SERF evaporation basin's leak collection ports demonstrates that the secondary liner is functioning as intended.

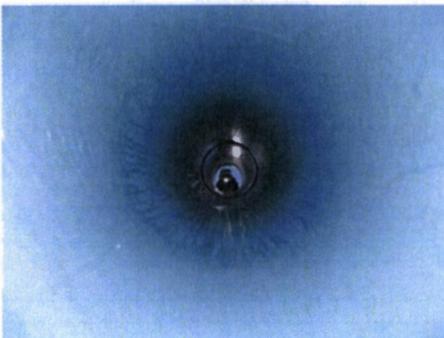
Port 1 column height: 195", water column 100"

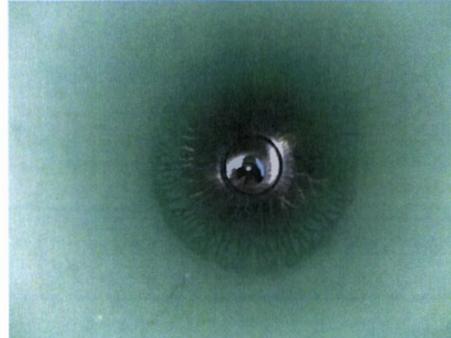
Port 2 column height: 198", water column 99.5"

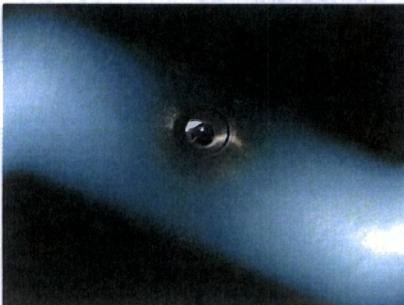
Port 1 column height: 195", water column 120"

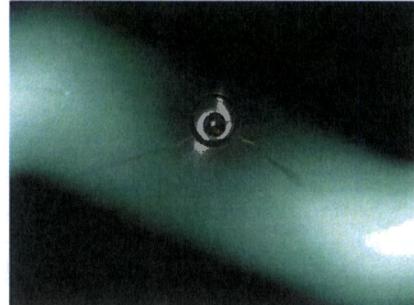
Port 2 column height: 198", water column 118"

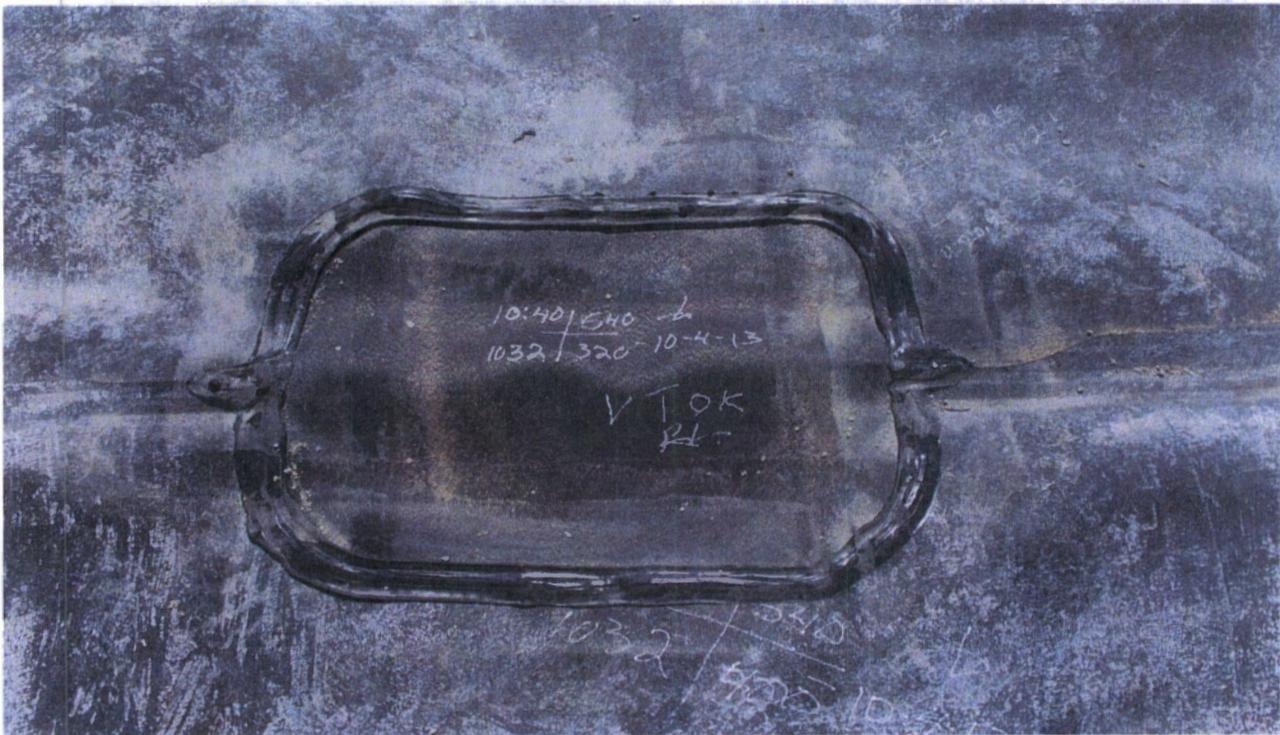
Figure 1. Photograph of a repair patch to the Northeast SERF Evaporation Basin's primary liner.

Repairs to the northeast SERF evaporation basin were initiated in late-September 2013. First, the northeast SERF evaporation basin was emptied and the liner cleaned. Next, on October 3-4, 2013, the subcontractor responsible for the original installation located and repaired the leaks. After repairs were completed the northeast SERF basin was returned to service. Enclosure 3 contains photographs of the repair work.

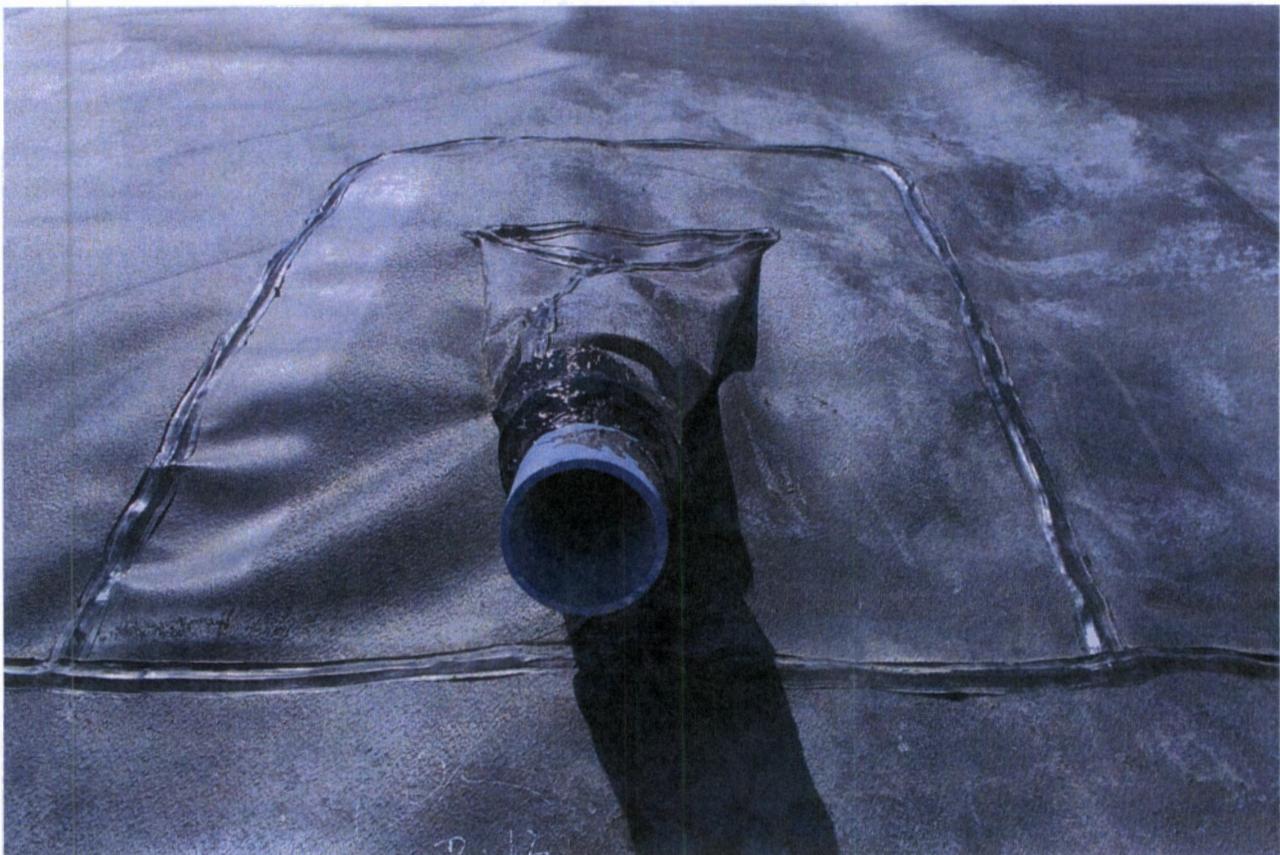
Figure 2. Photograph of repair work to the Northeast SERF Evaporation Basin's fill pipe.

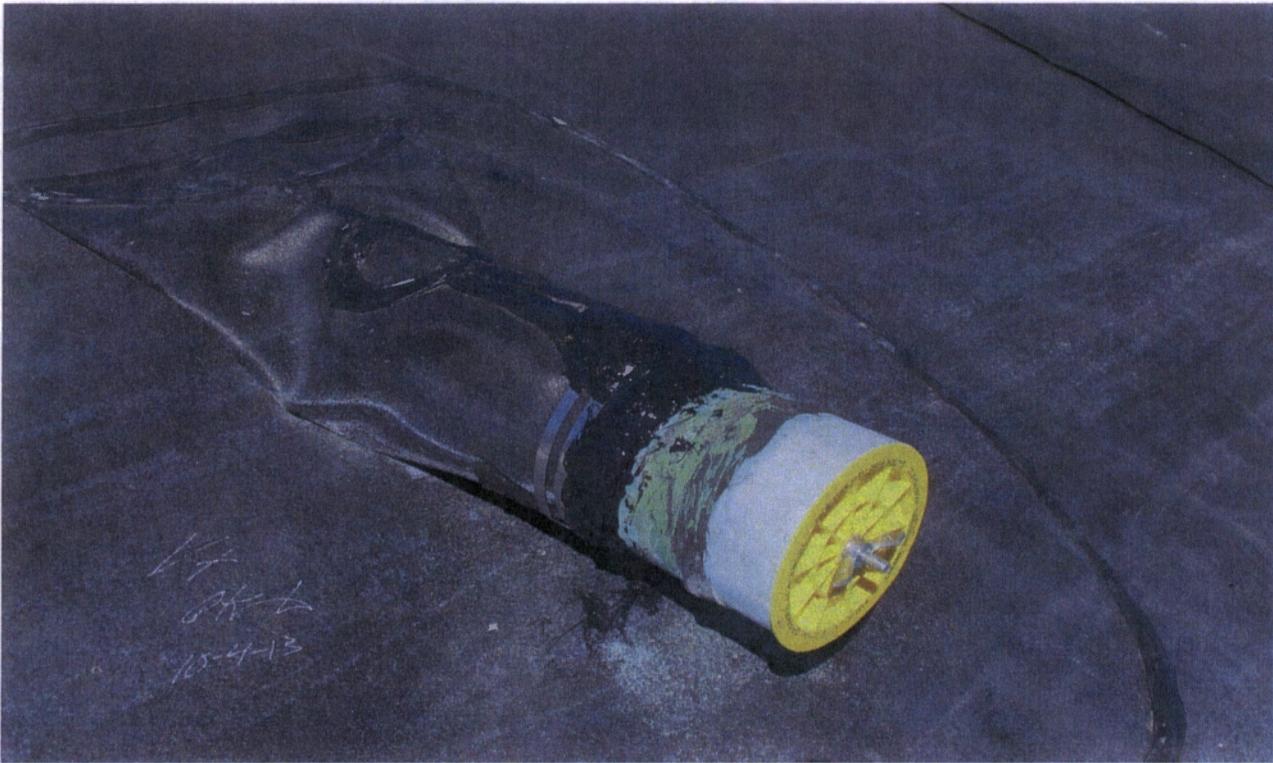
Figure 3. Photograph of repair work to the Northeast SERF Evaporation Basin's overflow pipe.

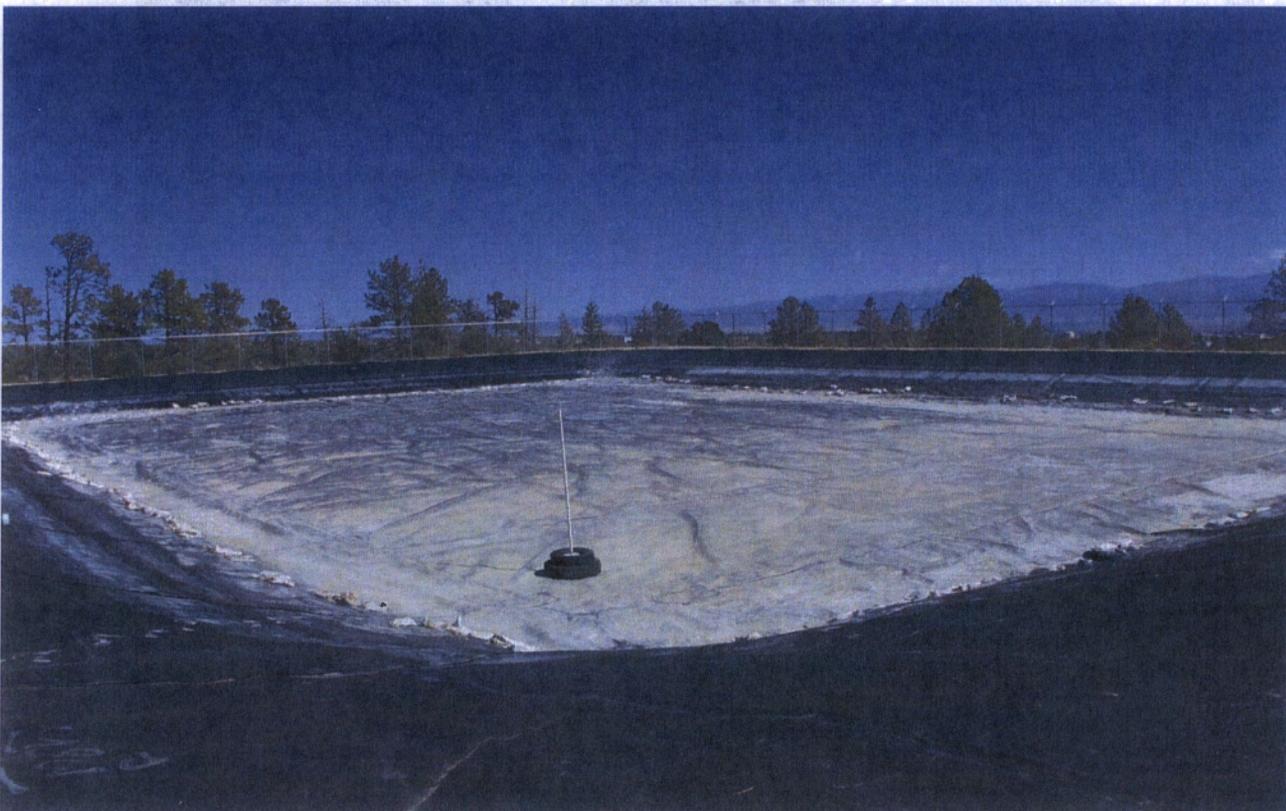
Figure 4. Photograph of the Northeast SERF Evaporation Basin following cleaning and repair.
