Subject: DP-857, Modified Corrective Action Plan, Sigma Mesa Evaporation Basins, Primary Liner Leaks

Liner Repair Report for the Northeast Sigma Mesa Evaporation Basin

**LOS ALAMOS NATIONAL LABORATORIES
NORTHEAST POND LINER**

Job Number: 15-187-10	Date: 9-1-15
Project Name: LANL (NORTH EAST POND)	
Location: Los Alamos, NM

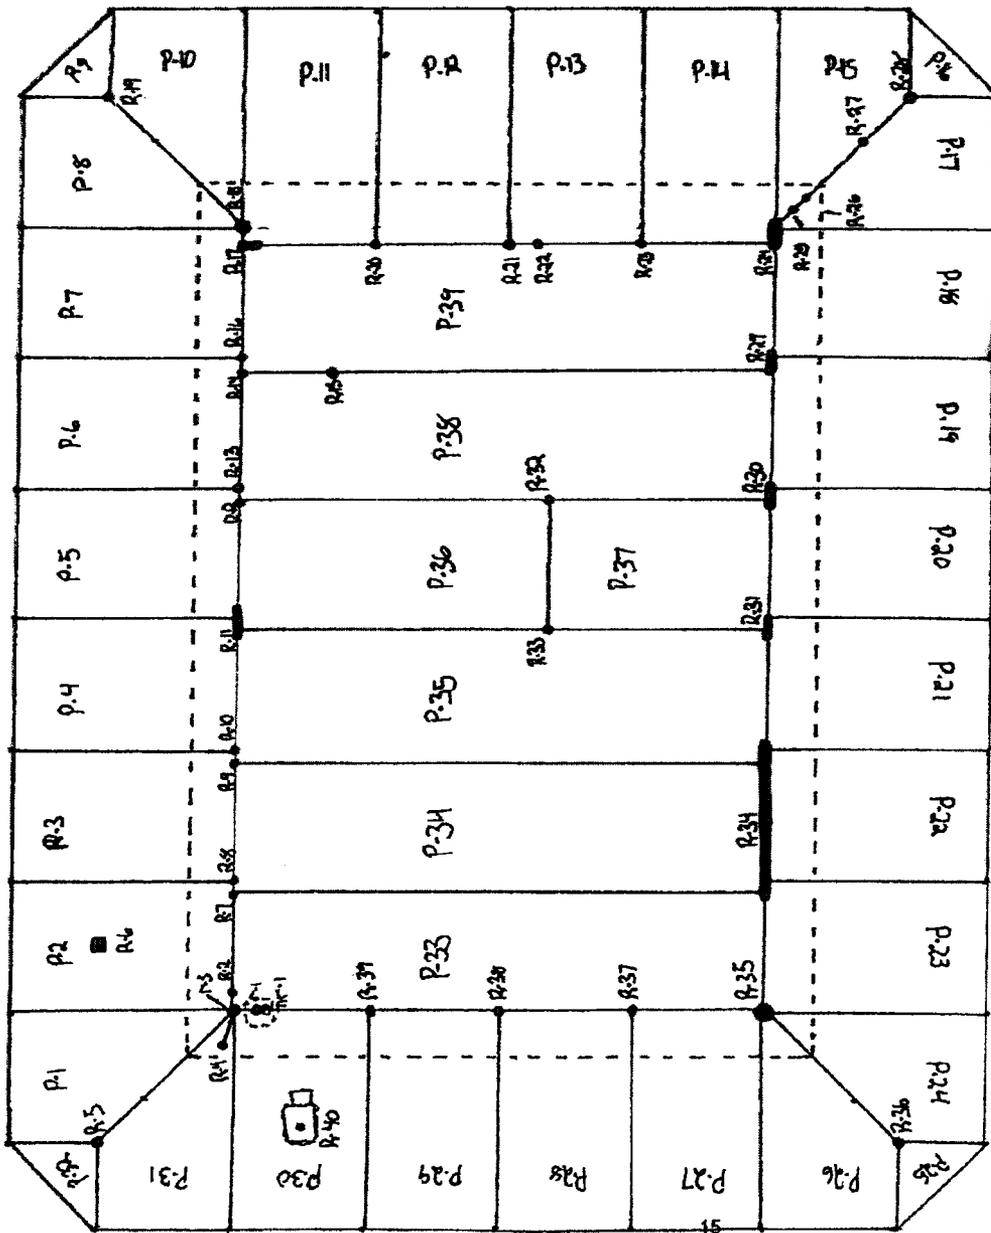
Inspected North East Pond by method of visual inspection, seam test with flat head screw driver and vacuum testing. A total of one tear was found, repaired and tested for leaks.

Repair No.	Technician	Machine No.	Date Welded	Location	Date Tested	Technician	Pass/Fail
R-1				P-30/P-33	8/25	M.H	P
R-2				P-2/P-33	1	1	P
R-3				P-1/P-2/P-30/P-31/P-33	8/25	M.H	P
R-4				P-31	1	1	P
R-5				P-31/P-32/P-1	8/25	M.H	P
R-6				P-3 Slope	1	1	P
R-7				P-2/P-33/P-34	8/25	M.H	P
R-8				P-2/P-3/P-34	1	1	P
R-9				P-3/P-34/P-35	8/25	M.H	P
R-10				P-3/P-4/P-35	1	1	P
R-11				P-4/P-5/P-35/P-36	8/25	M.H	P
R-12				P-5/P-36/P-38	1	1	P
R-13				P-5/P-6/P-36	8/25	T.L	P
R-14				P-6/P-38/P-39	1	1	P
R-15				P-38/P-39	8/25	T.L	P
R-16				P-6/P-7/P-39	1	1	P
R-17				P-7/P-39/P-11	8/25	T.L	P
R-18				P-7/P-8/P-10/P-11	1	1	P
R-19				P-8/P-9/P-10	8/25	T.L	P
R-20				P-39/P-11/P-12	1	1	P
R-21				P-39/P-12/P-13	8/25	T.L	P
R-22				P-39/P-13	1	1	P
R-23				P-39/P-13/P-14	8/25	T.L	P
R-24				P-39/P-14/P-15/P-17/P-18	1	1	P
R-25				P-15/P-17	8/25	T.L	P
R-26				1	1	1	P
R-27				P-15/P-17	8/25	T.L	P
