Re: Observations resulting from Department of Energy Oversight Bureau (DOE OB) tour of TA-54, LANL Low-Level Solid Waste Management Area

Notes on the March 18, 2008 ESH-18, TA-54 Storm Water Pollution Prevention Plan audit conducted by LANL ESH-18. The following are the observations, comments, and recommendations of the DOE OB representative. The numbers of each bullet correlate with numbered locations on the map provided.

TA-54 AREA G - LANL LOW-LEVEL SOLID WASTE MANAGEMENT AREA

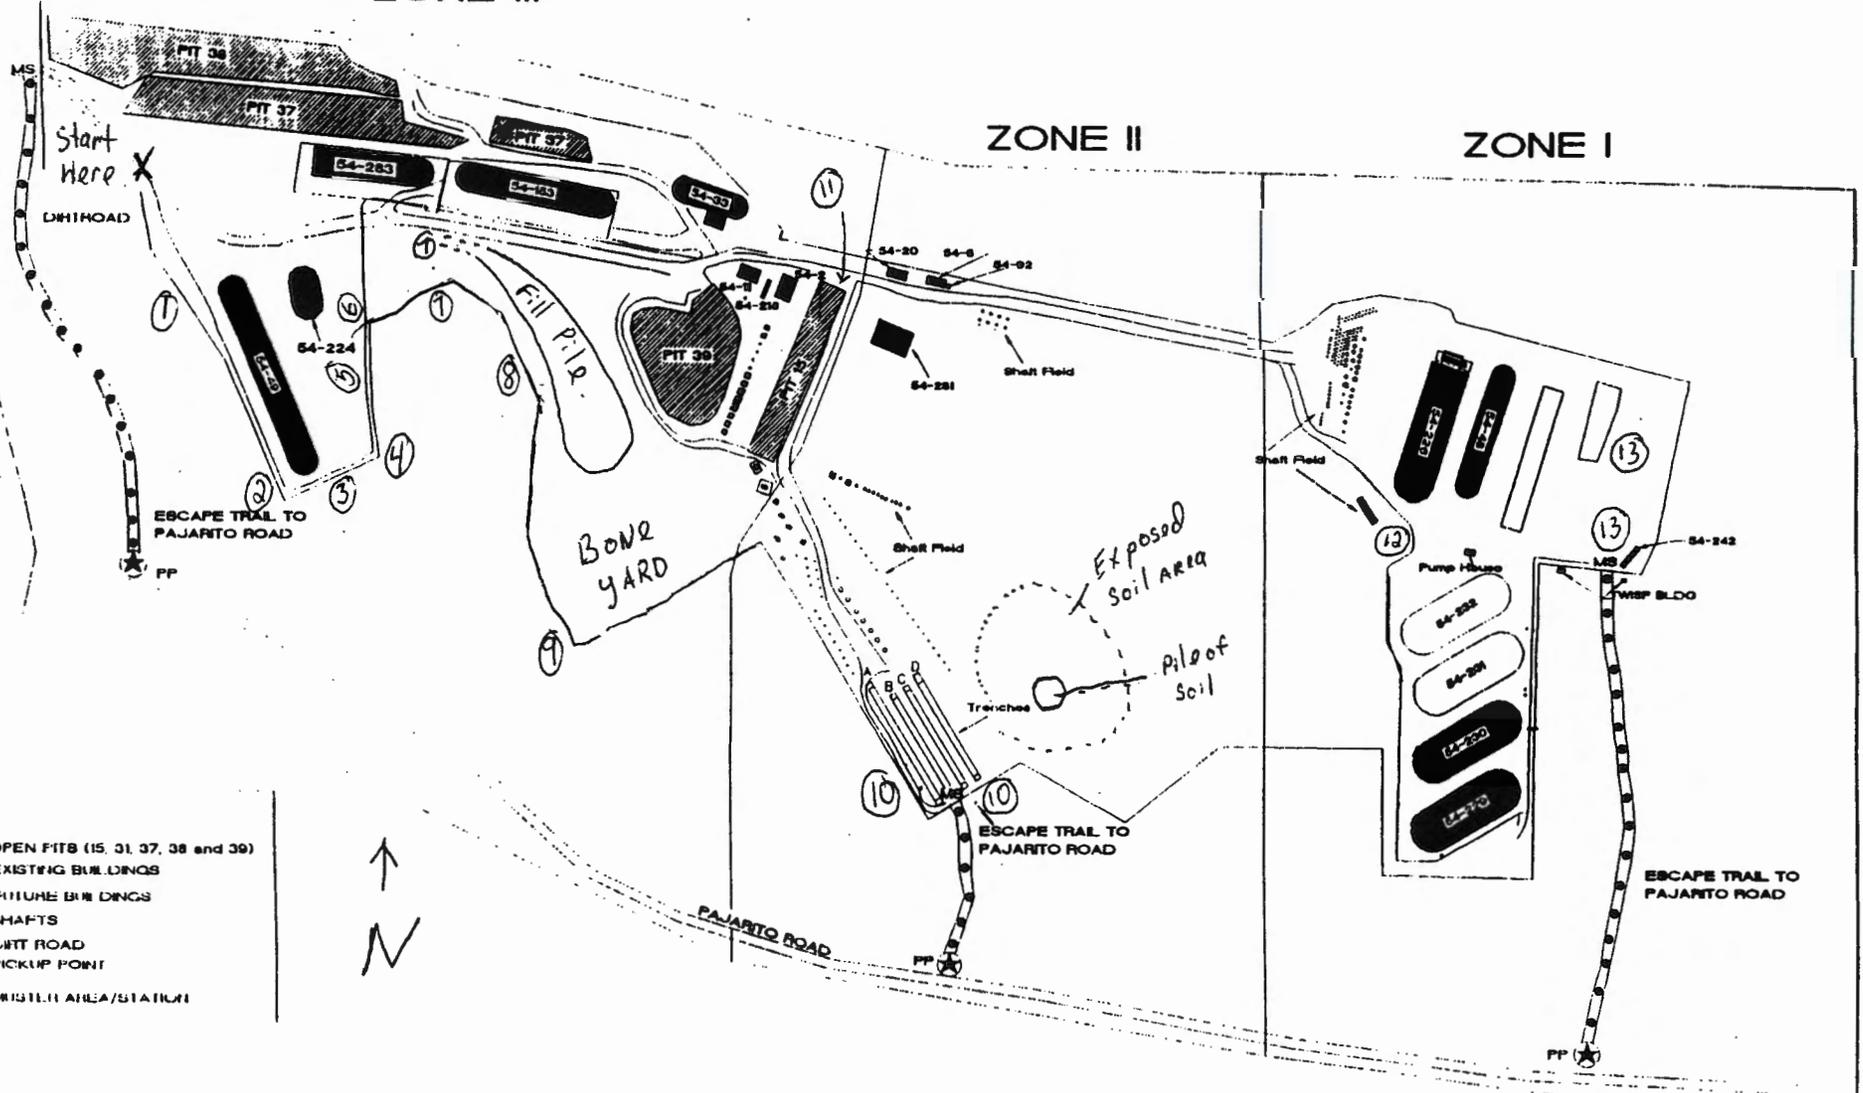
1. Following the fence line along mesa top in southeast direction, paralleling Building 54-49, it was noted that the silt fence was in need of major repairs (e.g., gaps at bottom, fasteners to fence torn).

2. At SW corner, a rock sediment trap outside of fence is filled with sediment. This should be cleaned out and provided with additional sediment trapping capacity (e.g., silt fence down gradient). Hay bales and silt fence in corner are in good shape.

3. Following fence line to the east, there is a failure approximately half-way to corner, where sediment is escaping from silt fence.
4. At the corner, where fence line heads north, the silt fence needs cleaning out, the hay bales are rotted and need replacement.

5. Following fence line north, there is a section of silt fence that has been buried from regrading conducted above near bld 54-224.
6. The silt fence below cement and rock channel (draining Bldg. 54-224) is failed and runoff is bypassing the silt fence (located down gradient, in area detailed in next bullet) and getting offsite.
Erosion channels are evident below cement and rock runoff channels draining Bld. 54-224 area.

7. The temporary roadway that bulldozers are using to access the fill pile is eroding and needs reinforcement. The sediment from this roadway along with discharge from a culvert underlying the permanent roadway are collecting at the silt fence, located about 100 ft down gradient. This location would be ideal to install a sediment retention pond.

8. The fence along the fill pile, where boulders of tuff have collected, does not appear to be discharging sediment (the boulders are trapping sediment).

9. The fence around the bone yard has no BMPs, but does not appear to be a point source for sediment discharge or runoff.
10. The road that follows the fence along the High-Level tritium shafts, and the disposal trenches, are directing runoff toward the corner (where the escape trail to Pajarito Road exits). There is evidence of discharge at the corner and under the gate for the escape trail.
Continuing past the escape trail gate, the security fence has recently been upgraded. There are no BMPs in place and erosion is evident along the fence. This corner collects runoff from a large area of exposed soils, east of the TRU shafts. There is a pile of soil located in this area which is helping to slow runoff but may also contribute to the overall problems in this area.

11. Near Bldg. 54-28 (E, on road) there is a storm water culvert surrounded by a silt fence. The silt fence should be improved. This discharges to Canada del Buey.

12. Nearing the Transuranic Waste Inspectable Storage Project (TWISP) Bldg. 54-226, near a fire hydrant, regrading of the area has directed storm water to the fire hydrant area and has resulted in a large discharge of loose fill. The silt fence has been filled and appears to have over-topped. The area needs to be reenforced with gabion structures, similar to the structures around the four domes to the SE (54-232,231,230,& 229).

13. The corner near Bldg. 54-242 is collecting storm water runoff and sediment from the exposed Pad 4 area. Pad 4 has no BMPs in place and regrading of area has altered runoff patterns so that the retention pond installed at the NE corner is no longer effective. This should be evaluated considering the requirements of the TWISP, 1993, compliance order.
