# Los Alamos National Laboratory

## Surface Water Assessment Erosion Matrix for PRS R-22

6/14/01 HWP R-22  
 HSWA LAND HWP R-22

Los Alamos National Laboratory  
SURFACE WATER  
SITE ASSESSMENT

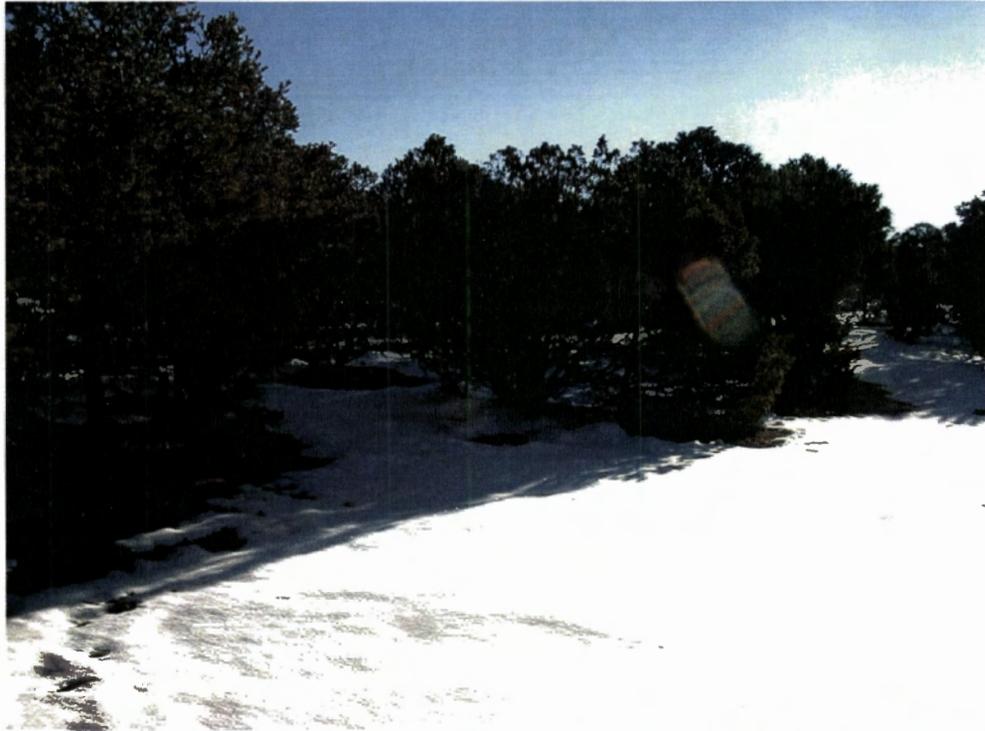
**View of mesa top discharge area. Approximately 60 yards East of well site.**

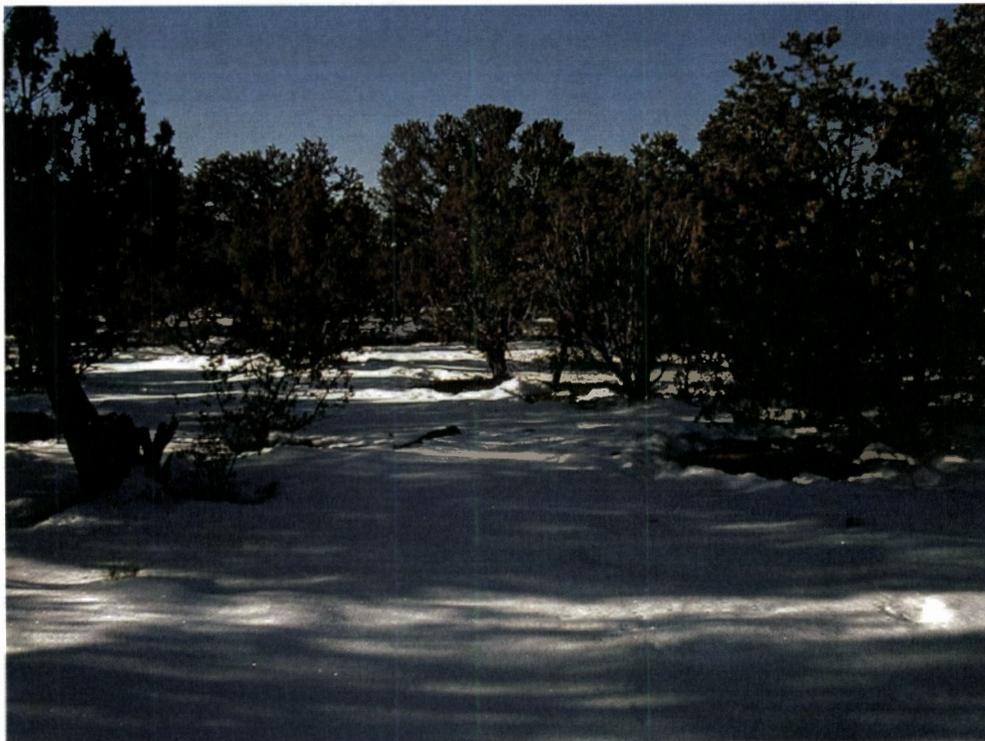
**View of mesa top discharge area. Approximately 60 yards North east of well site.**

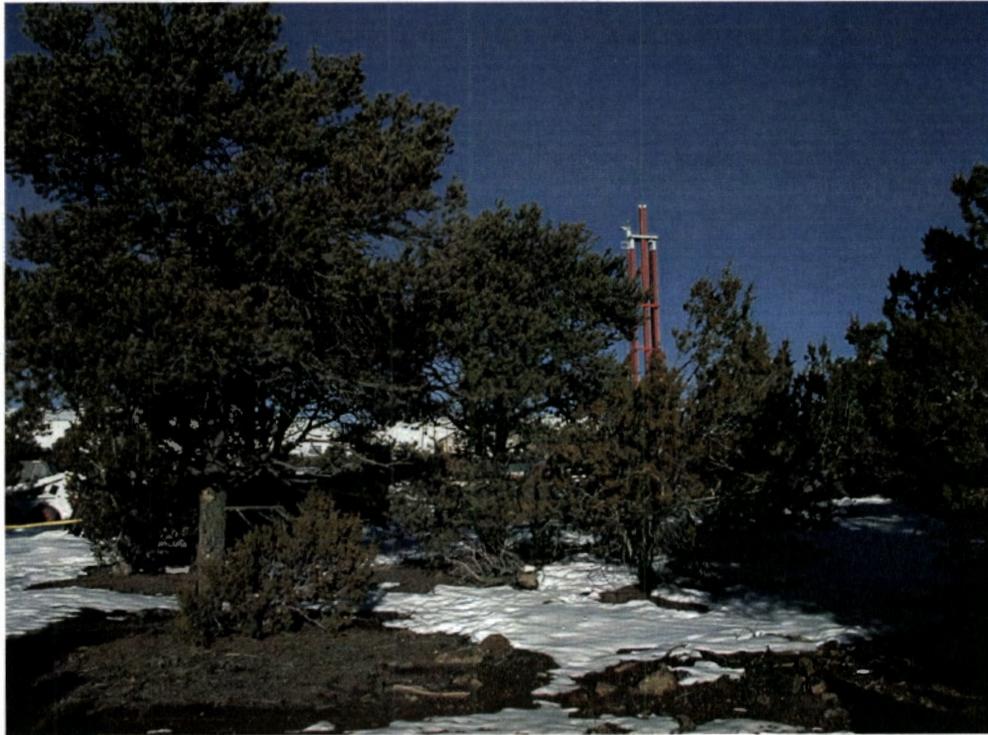
**View towards the R-22 well from the proposed water discharge area.**
