**Subject: Submittal of the 2011 Annual Inspection Report for Los Alamos County
Airport Landfill, Solid Waste Management Units 73-001(a) and 73-001(d),
Technical Area 73**

LA-UR-12-0671
February 2012
EP2012-0018

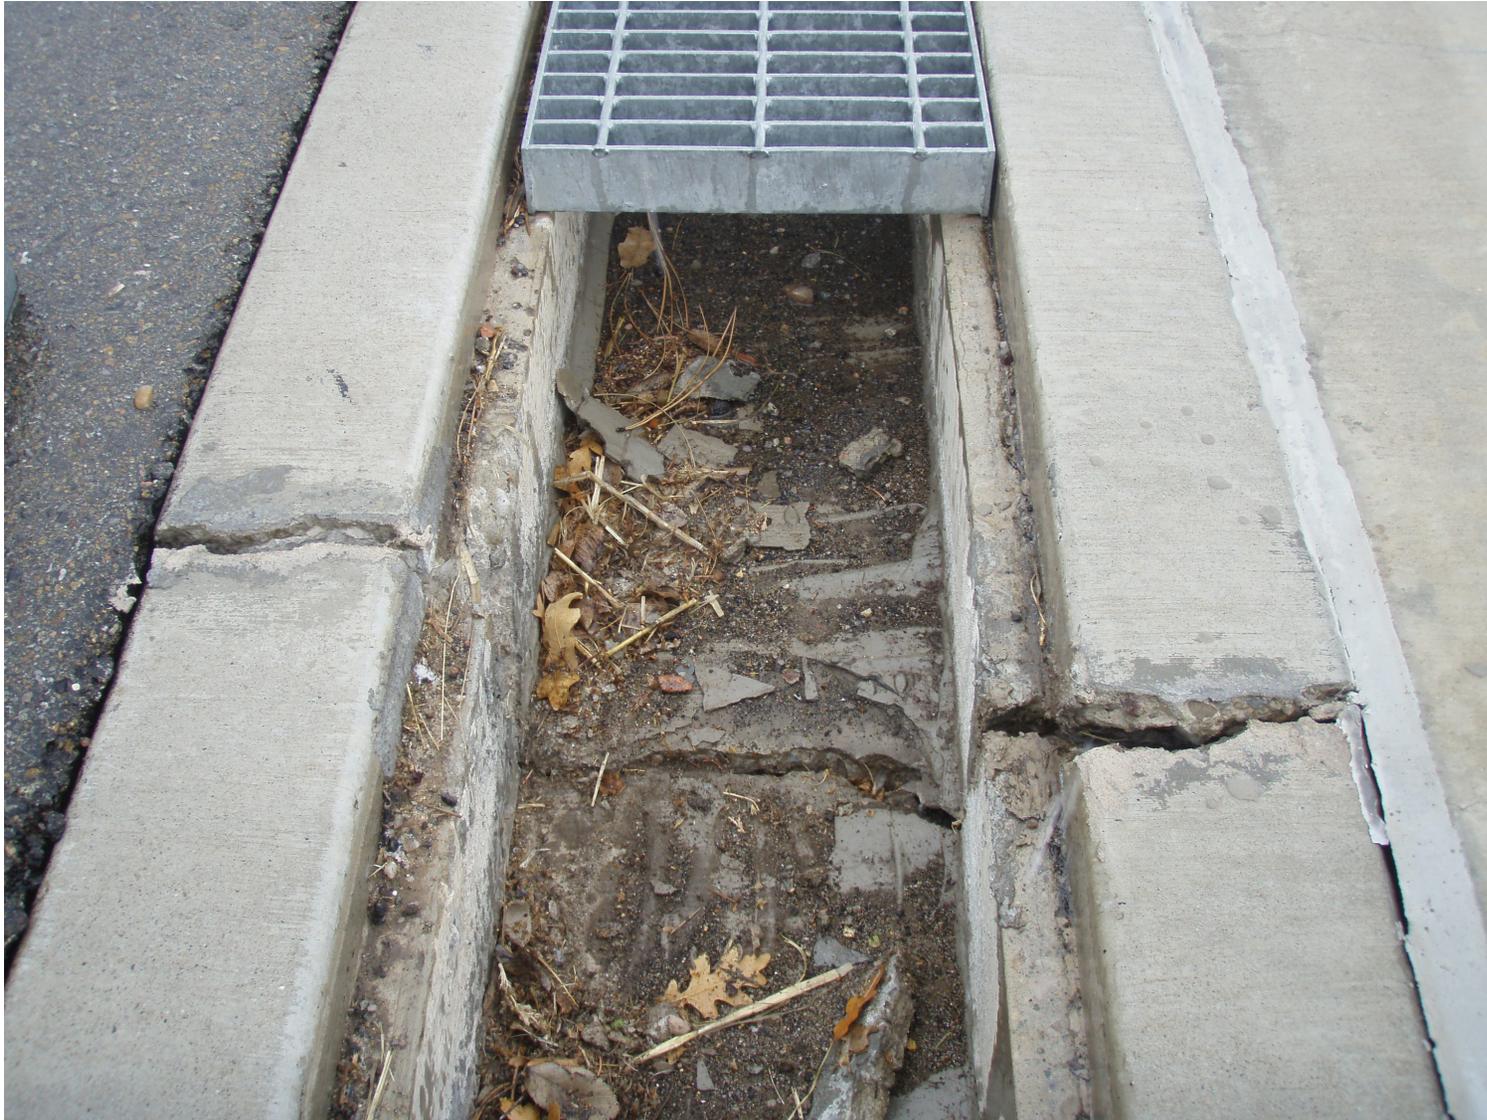
Crack in trench drain at Pad #1, note separation at expansion joint.

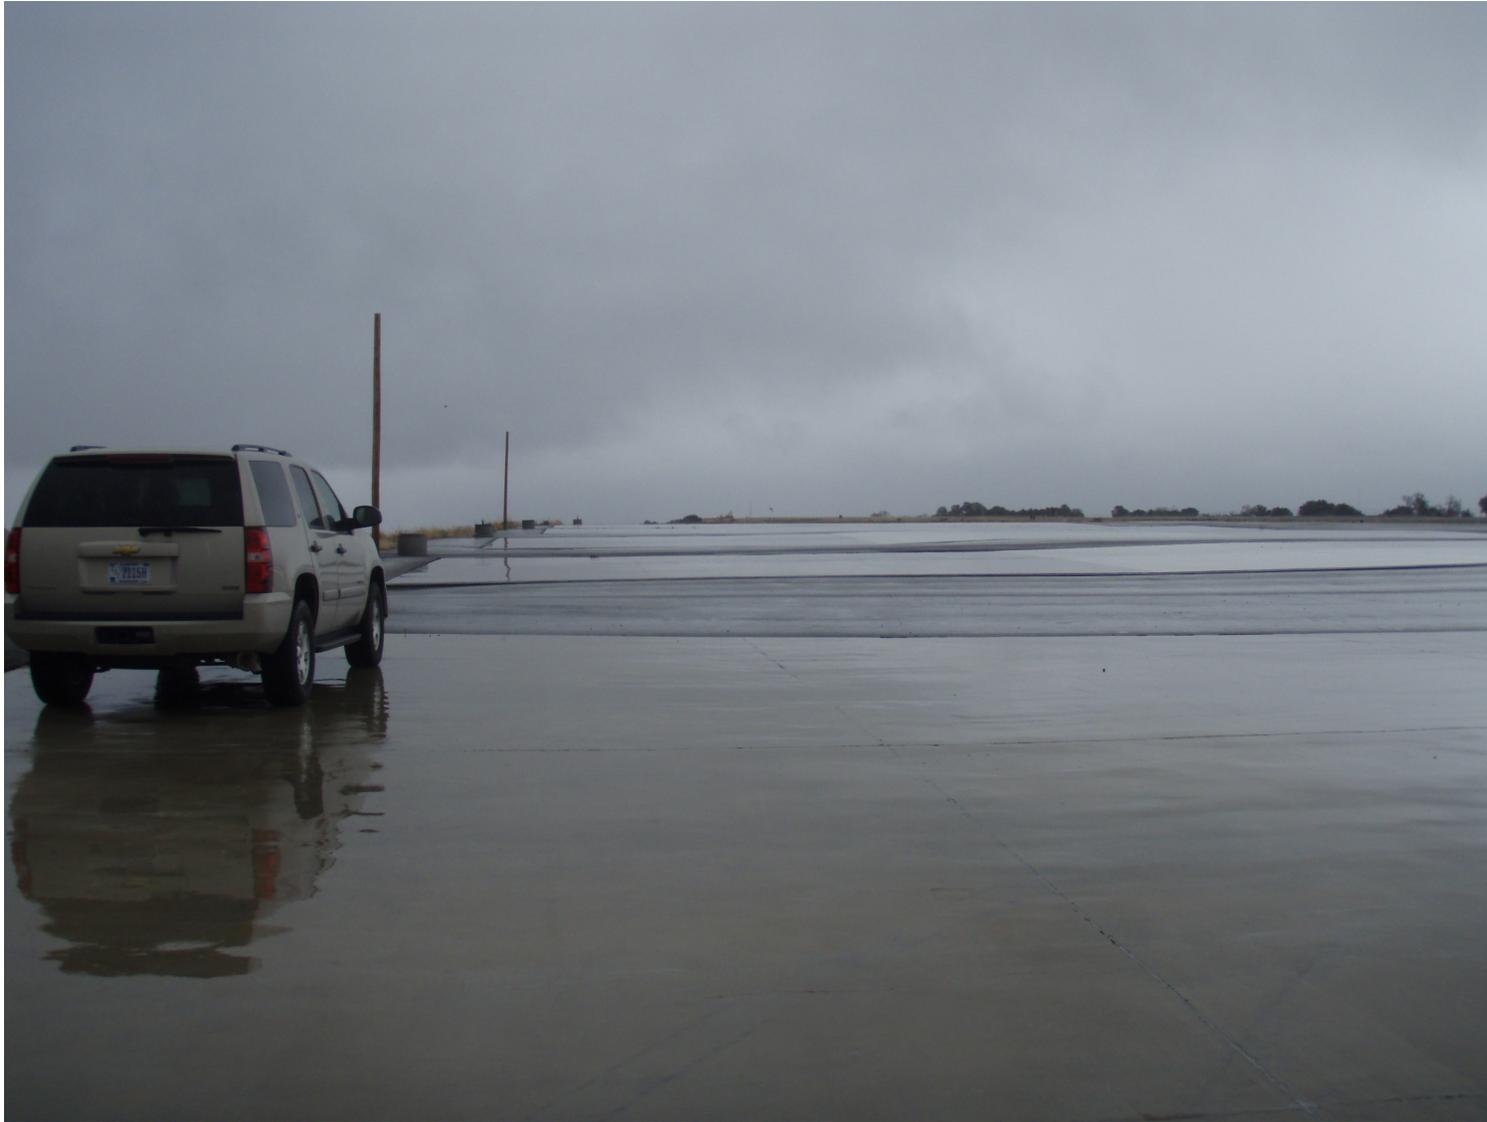
Looking east from Pad #1, note uneven, rolling nature of Pads 2 & 3 and associated MATCON pavement.

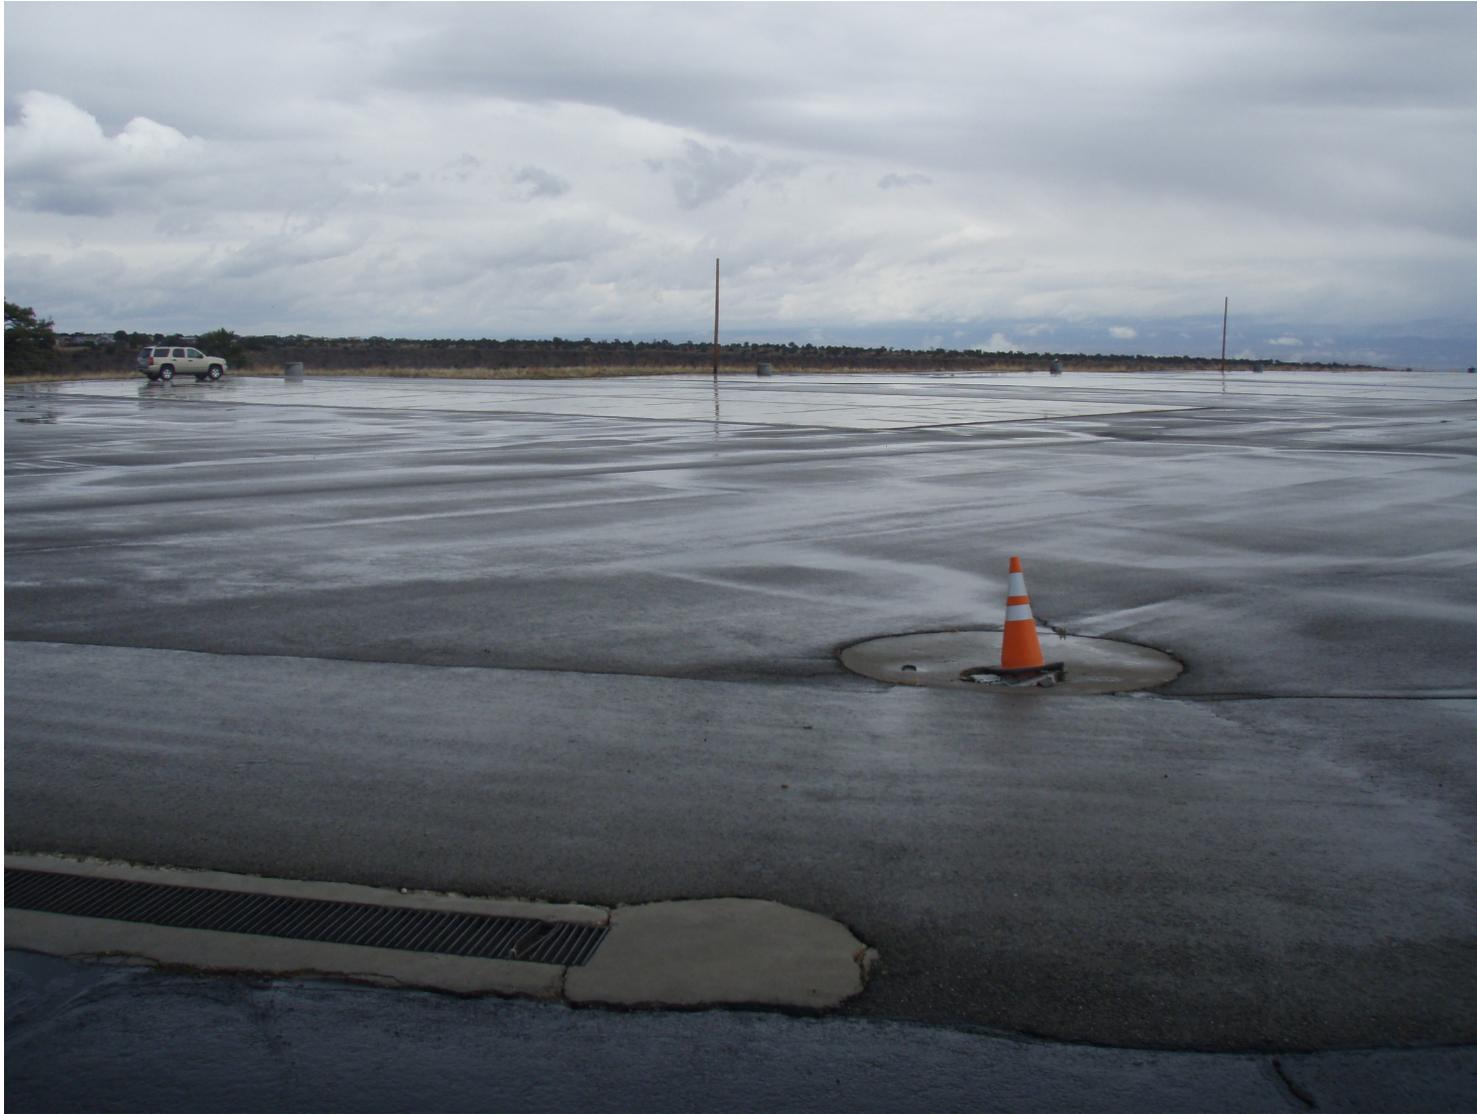
Looking NE at hangar pads, note damaged grate at cone.

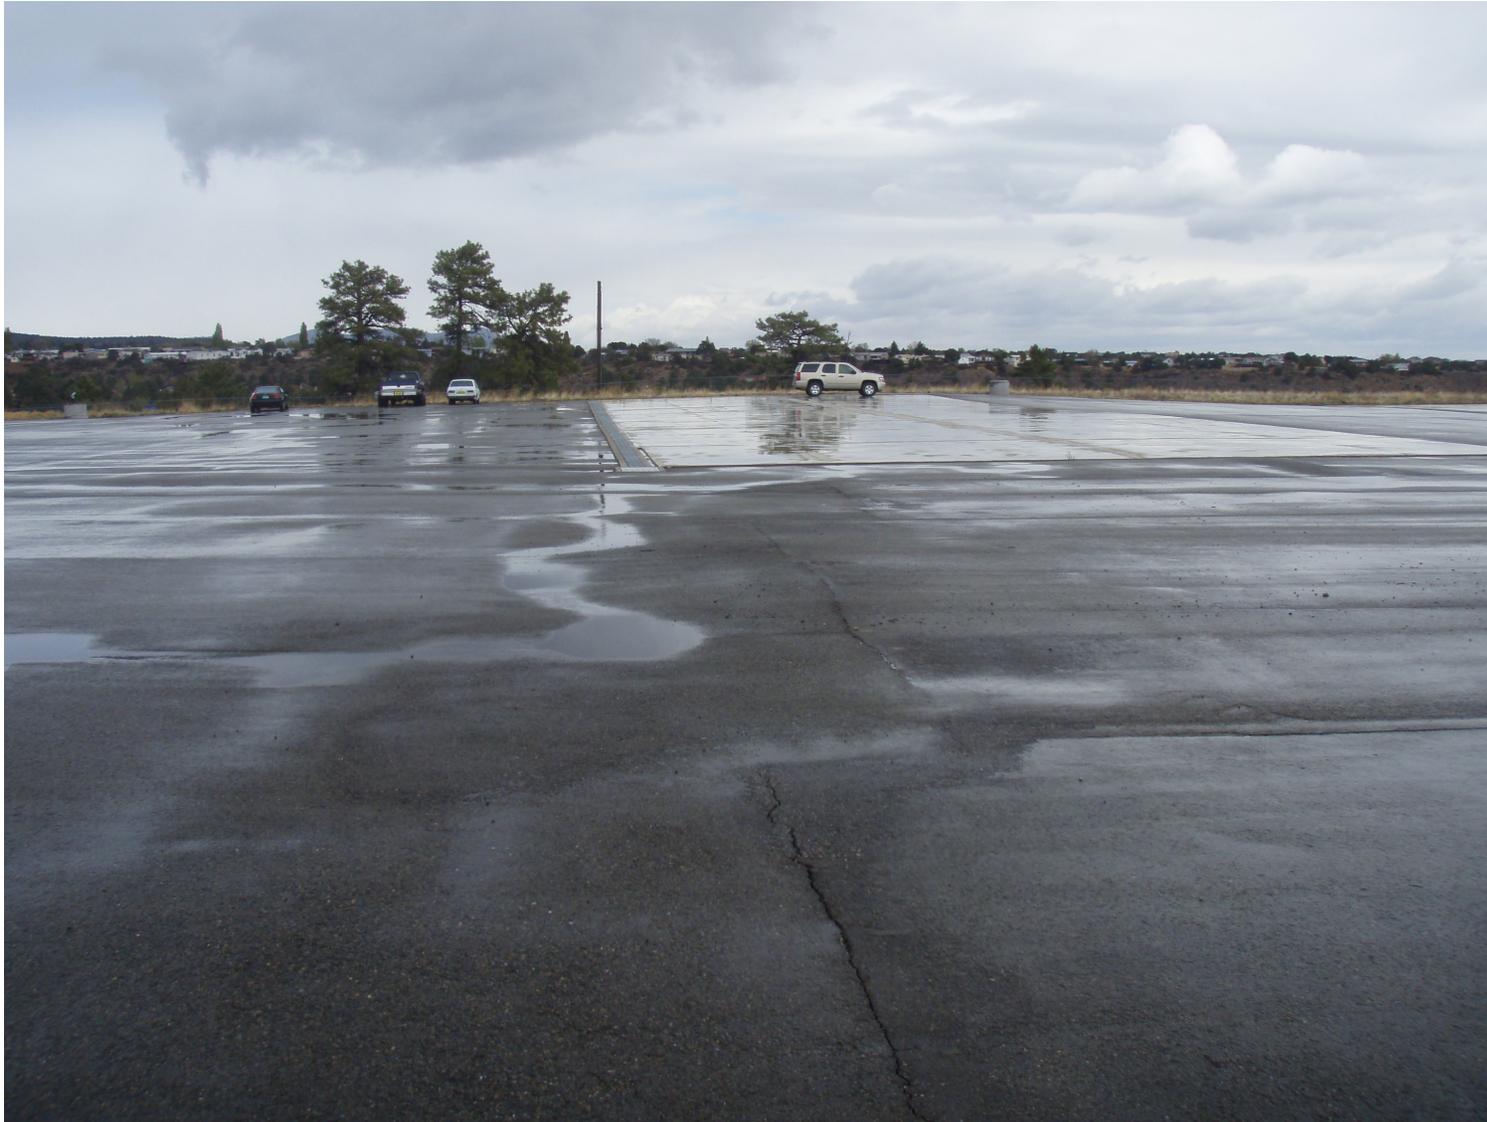
Looking north at Pad #1, note cracks in MATCON pavement

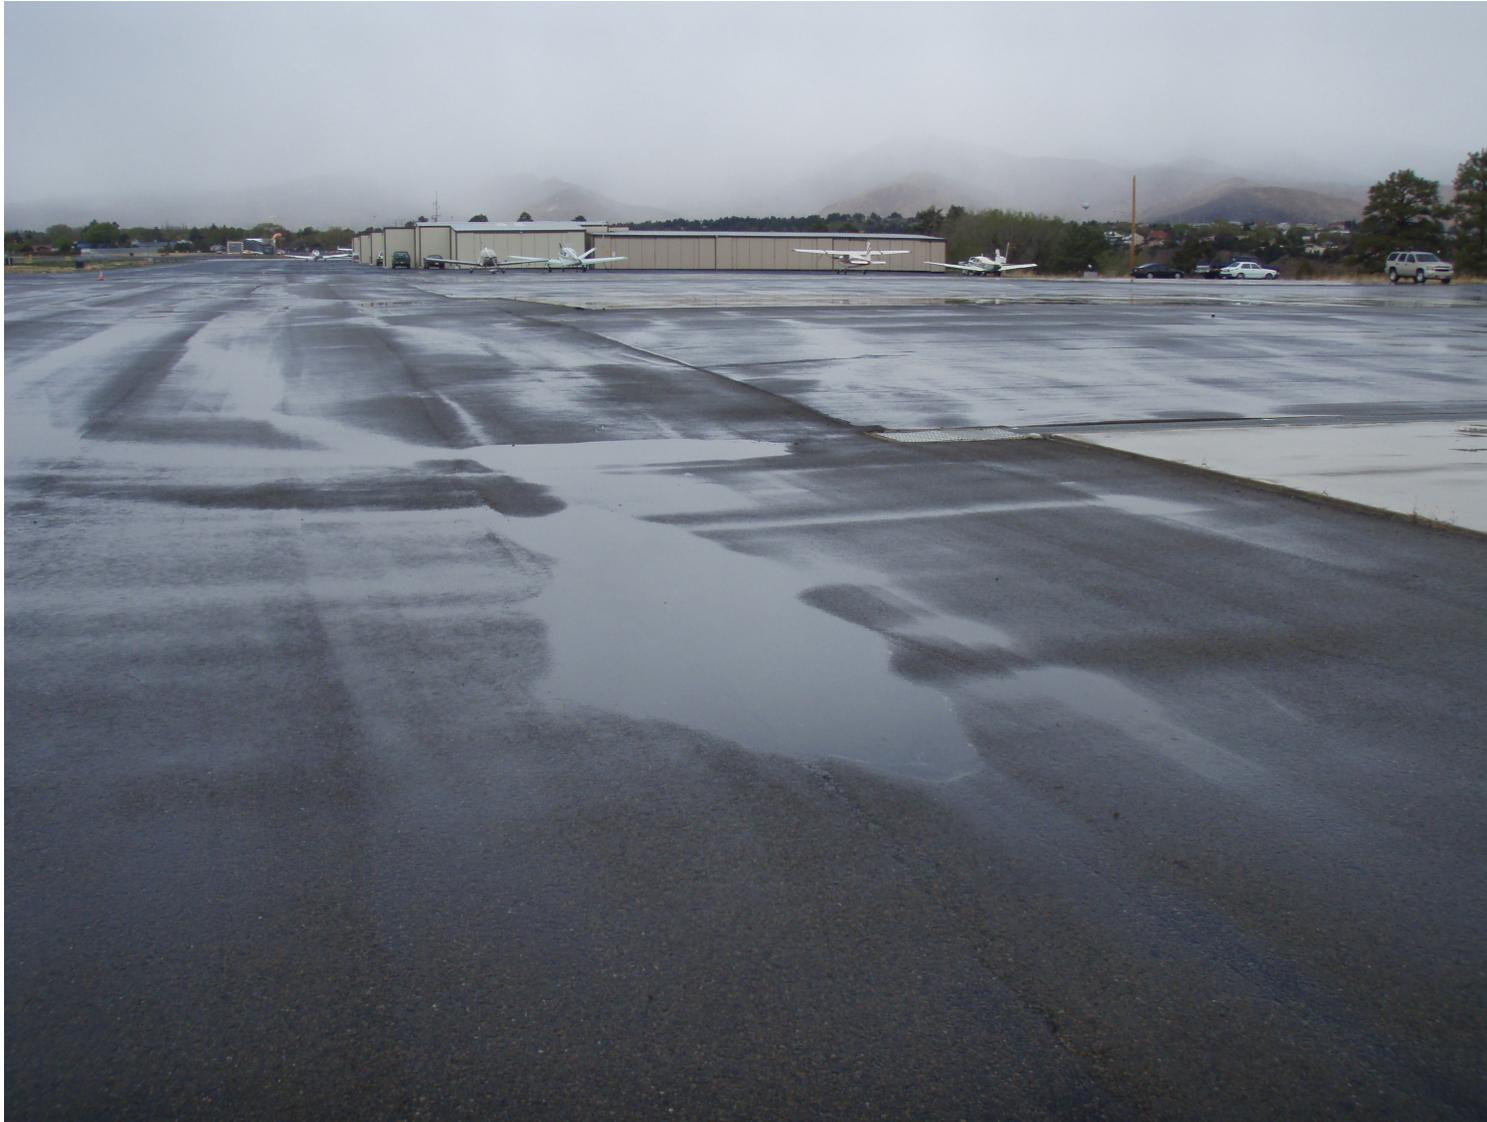
Looking west towards Pad #1, note puddle does not drain and is forming over cracks in MATCON pavement.

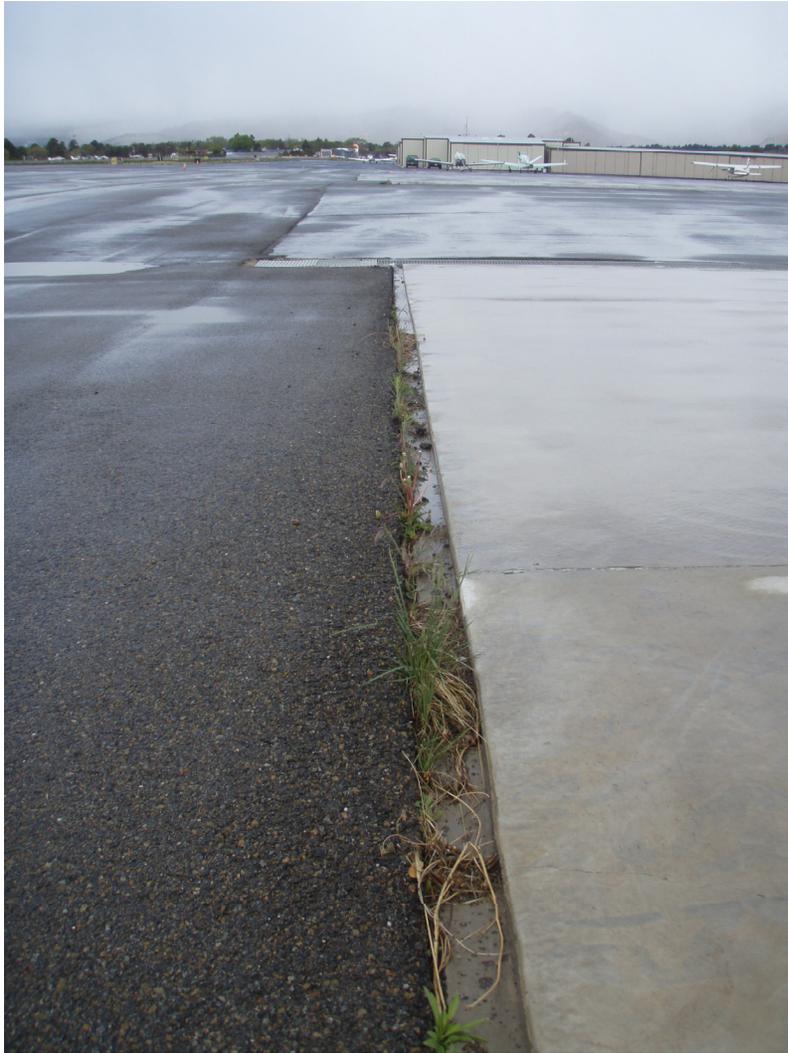
Vegetation along seam between MATCON pavement and concrete at Pad #2

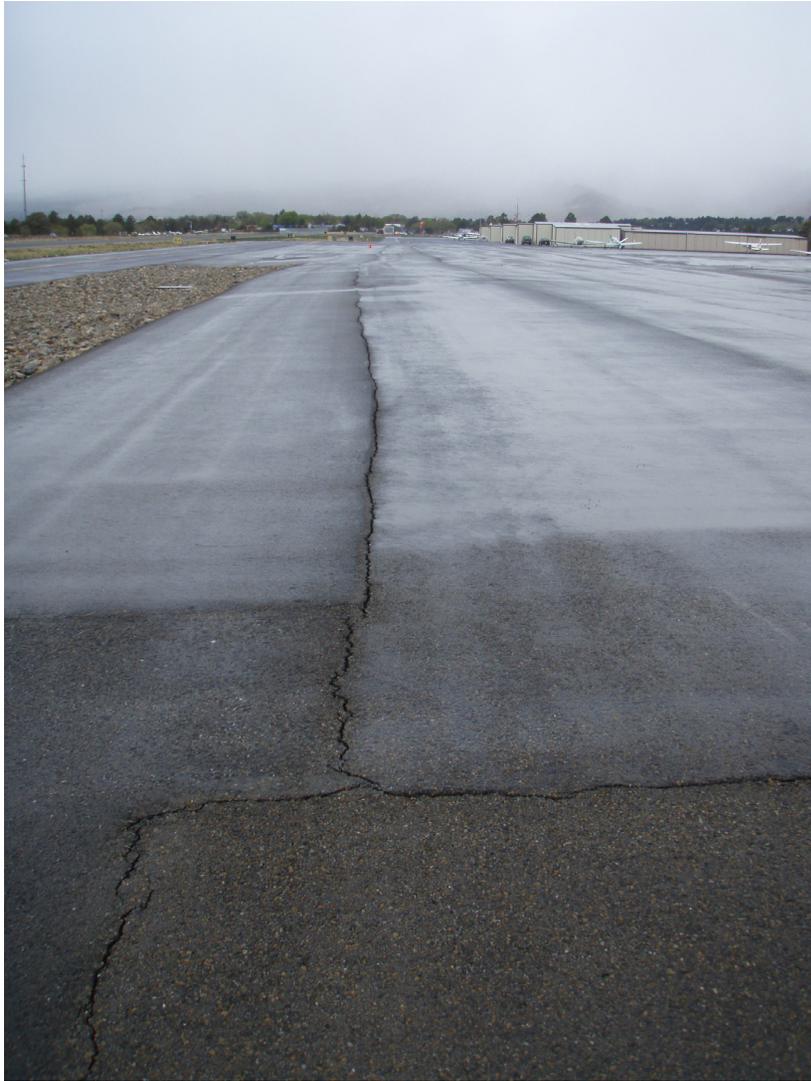
Looking west at cracks in MATCON along paving lanes

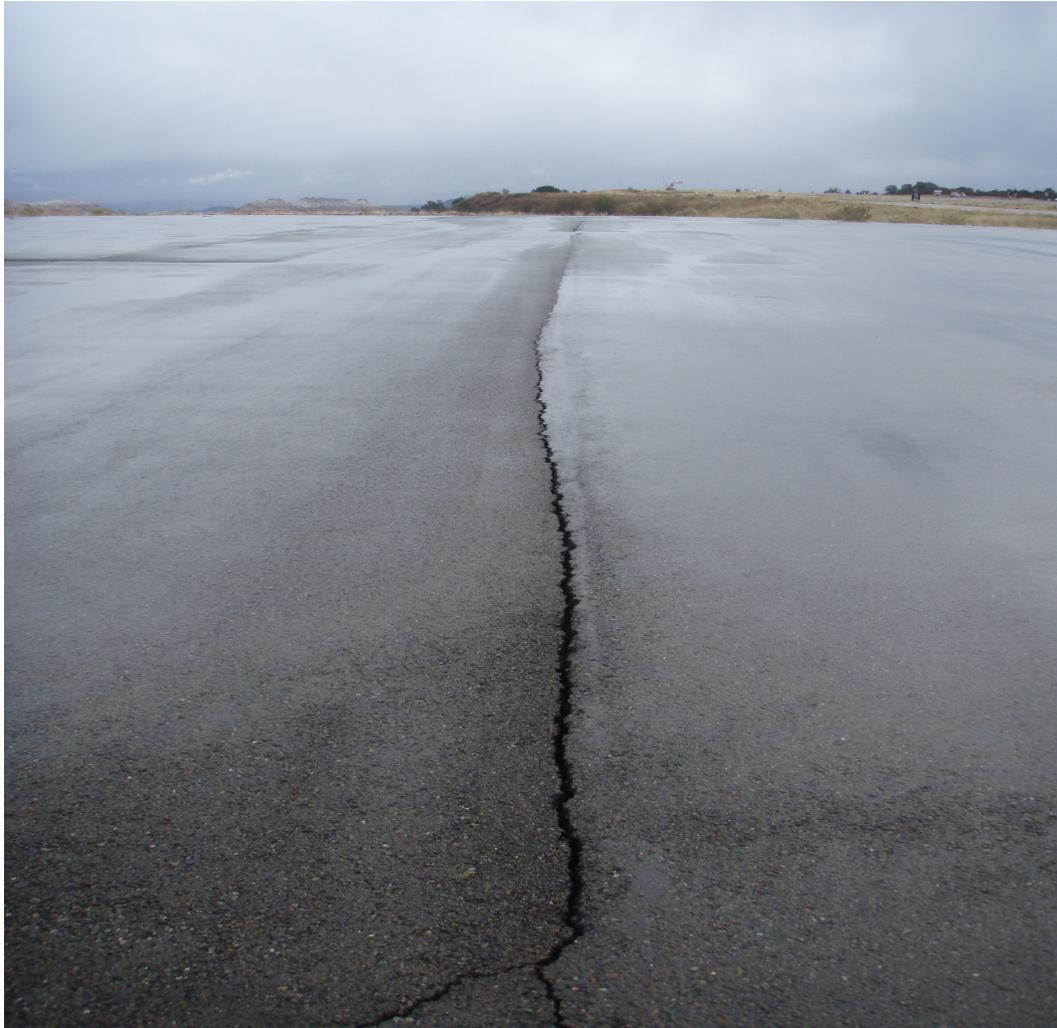
Looking east at crack in MATCON pavement

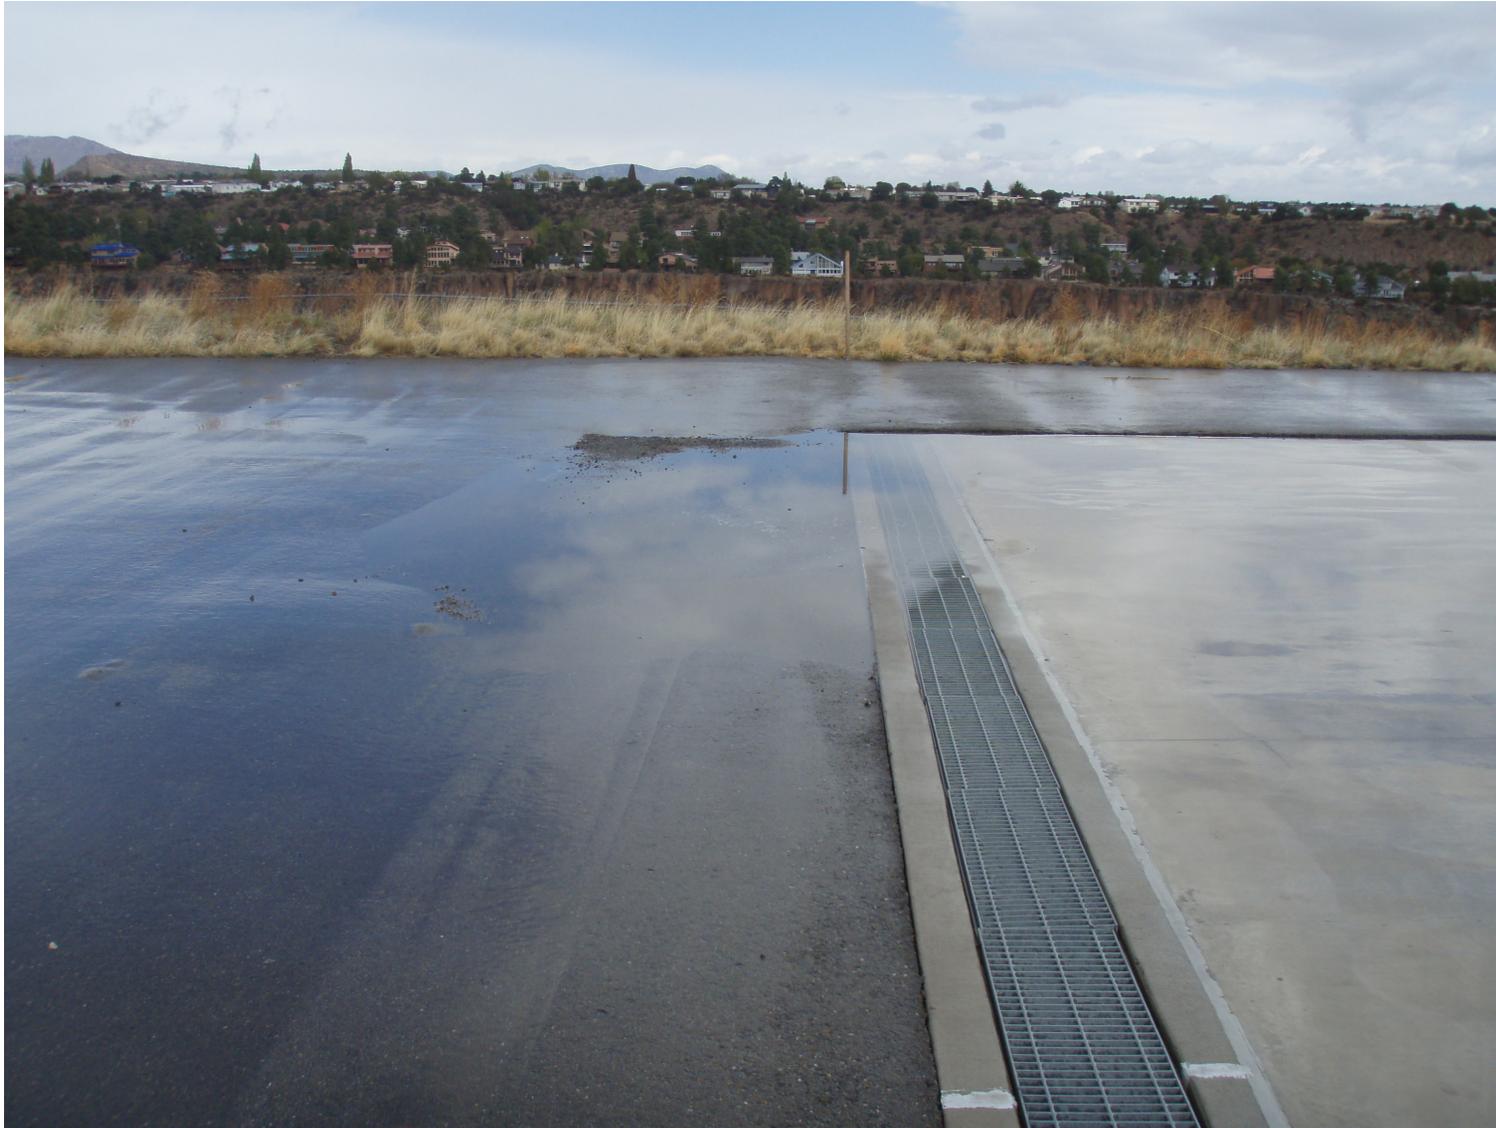
Looking north at NW corner of Pad #3, note large puddle. Subsidence does not allow for water to drain correctly in the trench drain. Also note previously repaired crack in trench drain.

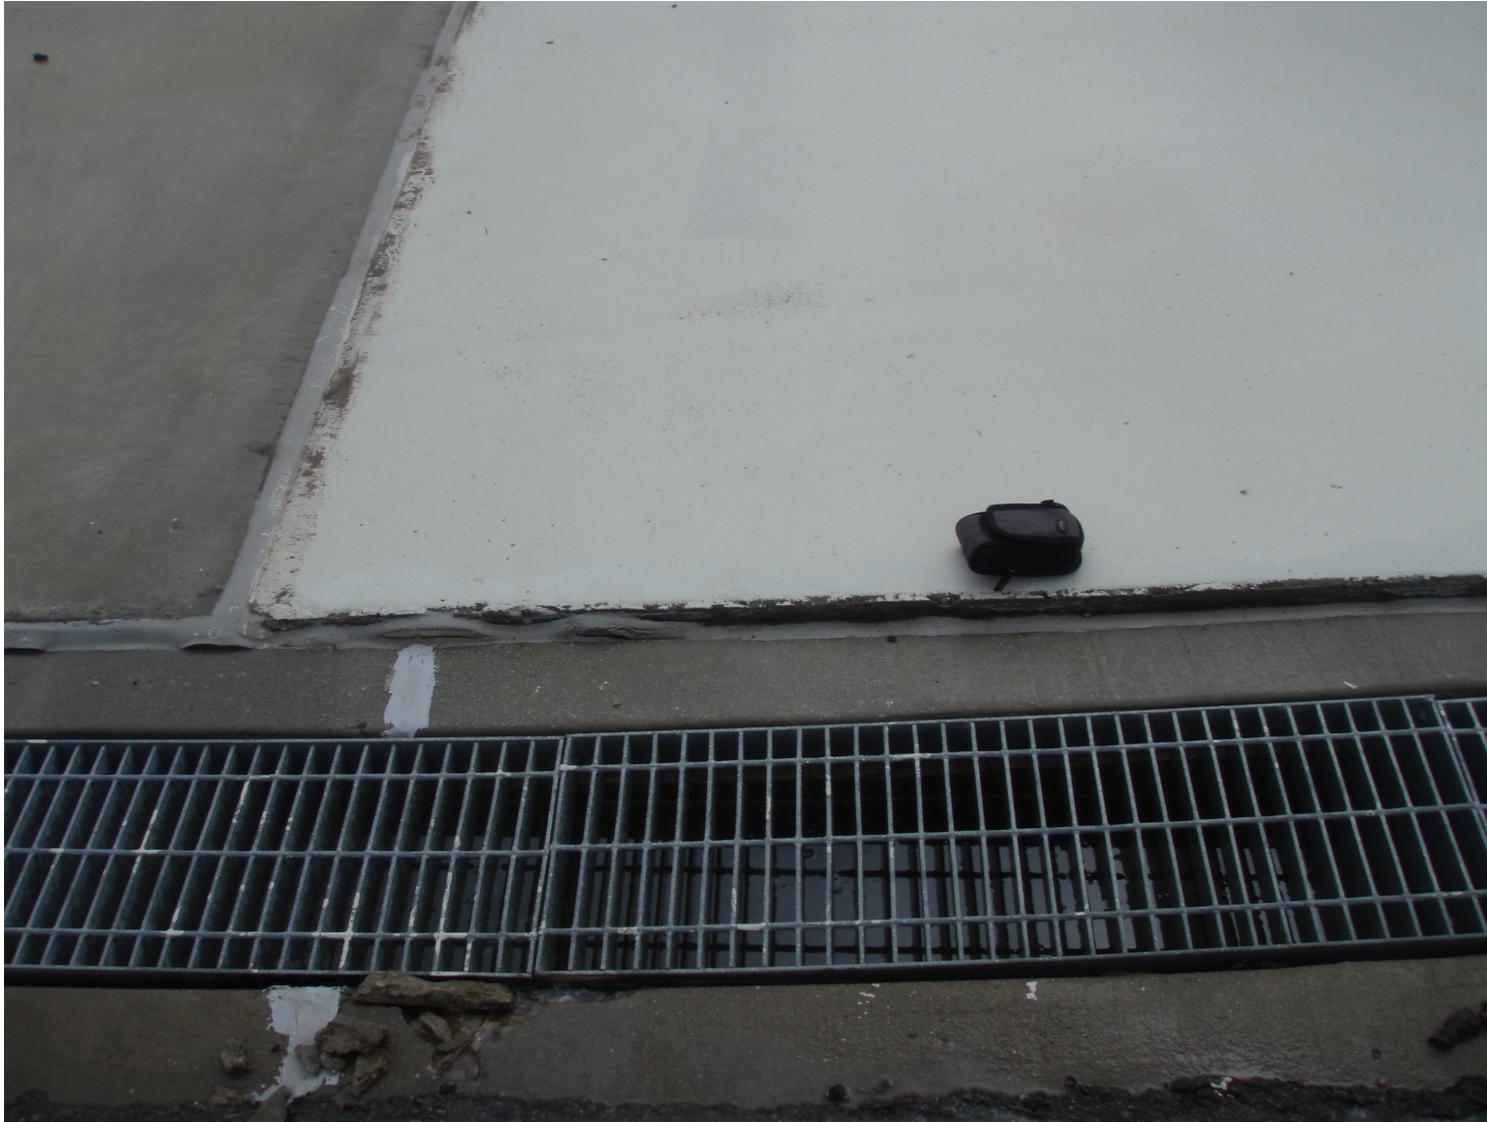
Looking at trench drain along Pad #3. Note previously repaired crack, new cracking and subsidence/lifting of pad.

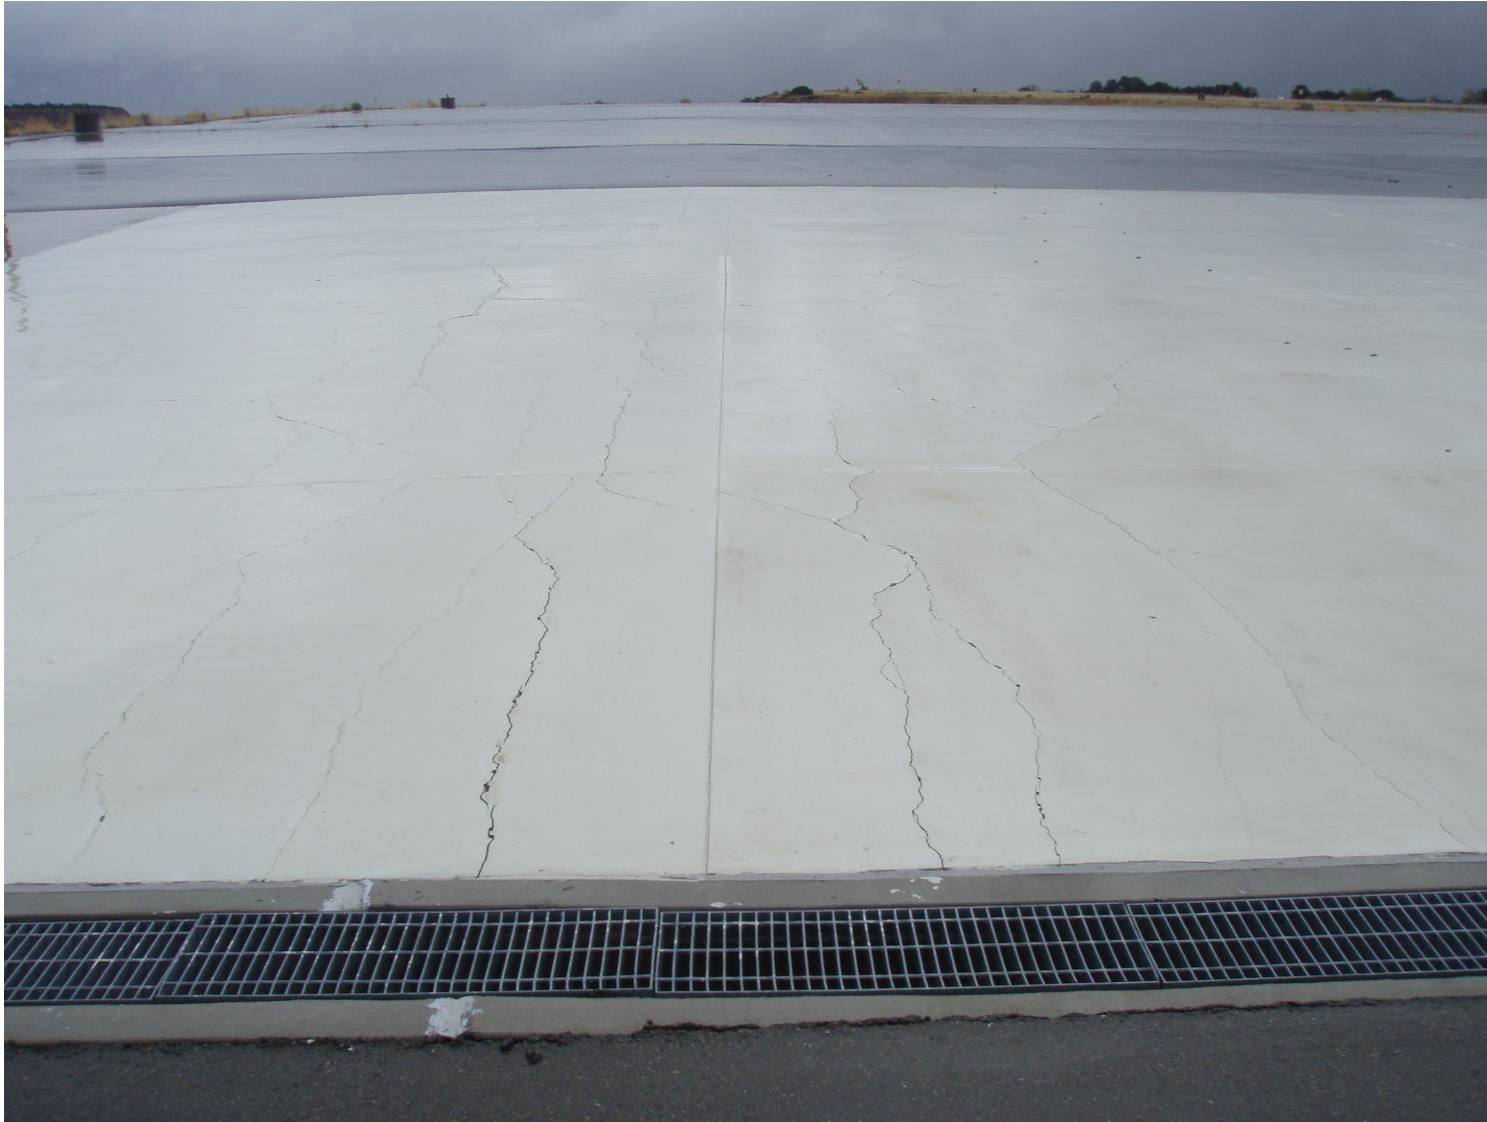
Looking east at cracking in middle of Pad #3, note previously repaired crack in trench drain.

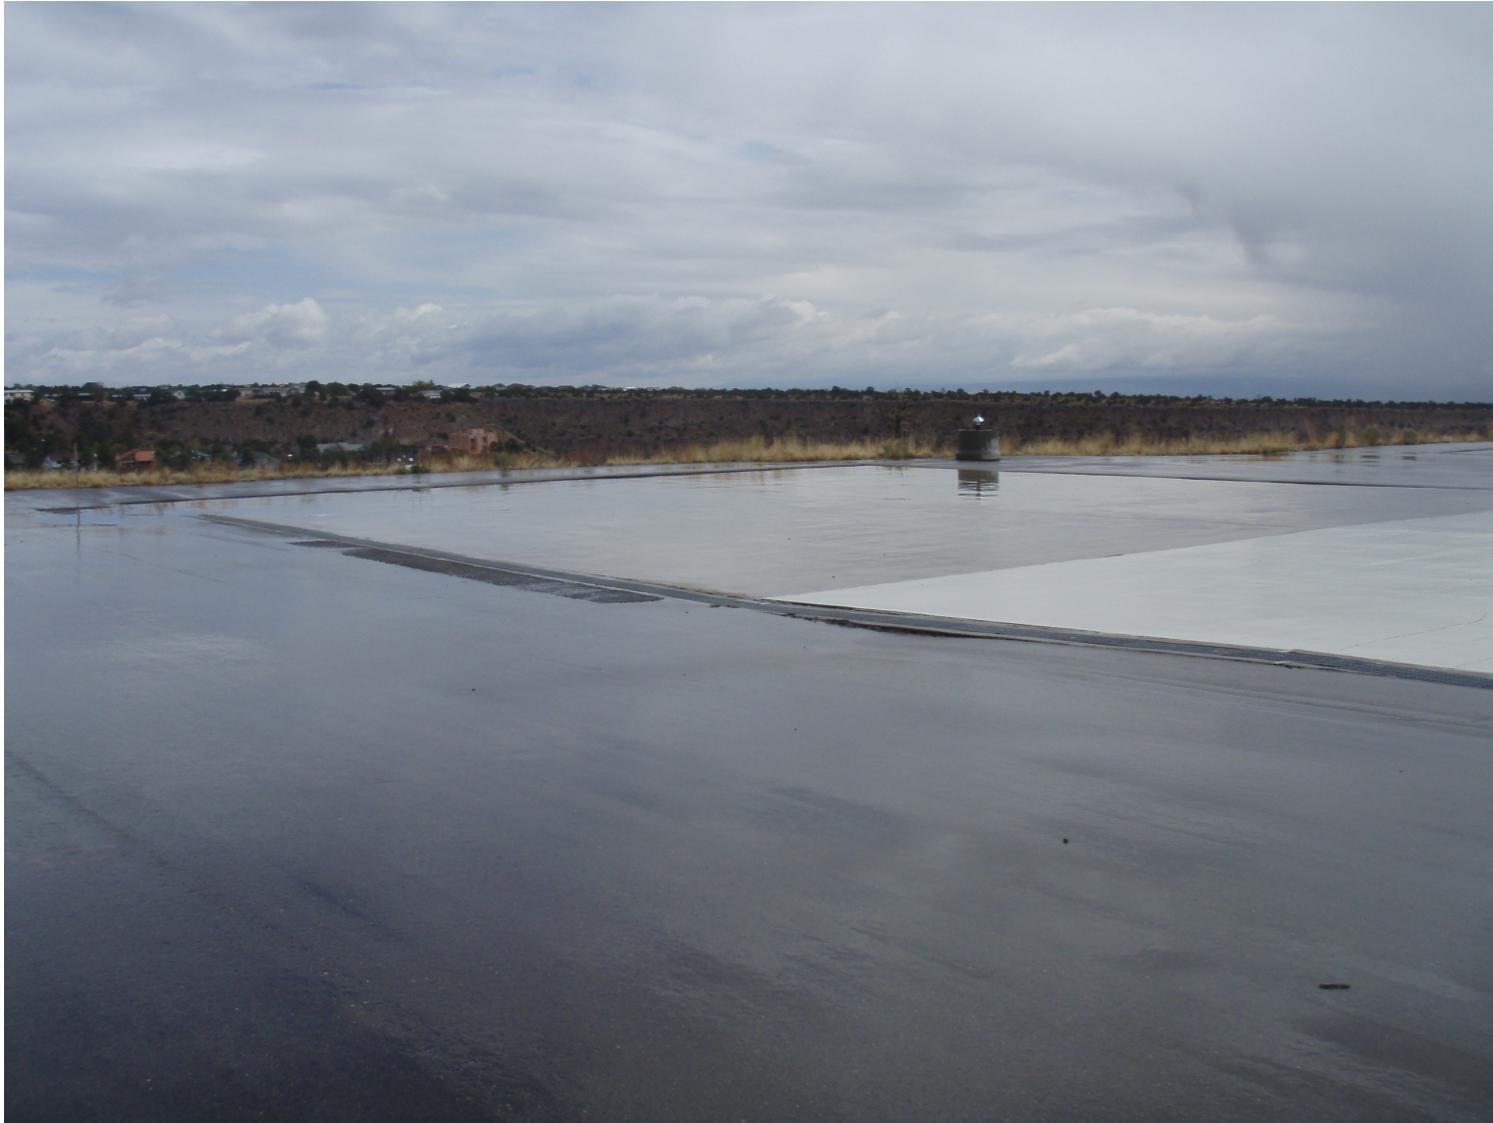
Looking at NW corner of Pad #3. Note puddle, improper drainage of trench drain, separation/subsidence of MATCON and trench drain, and asphalt patch along trench drain.

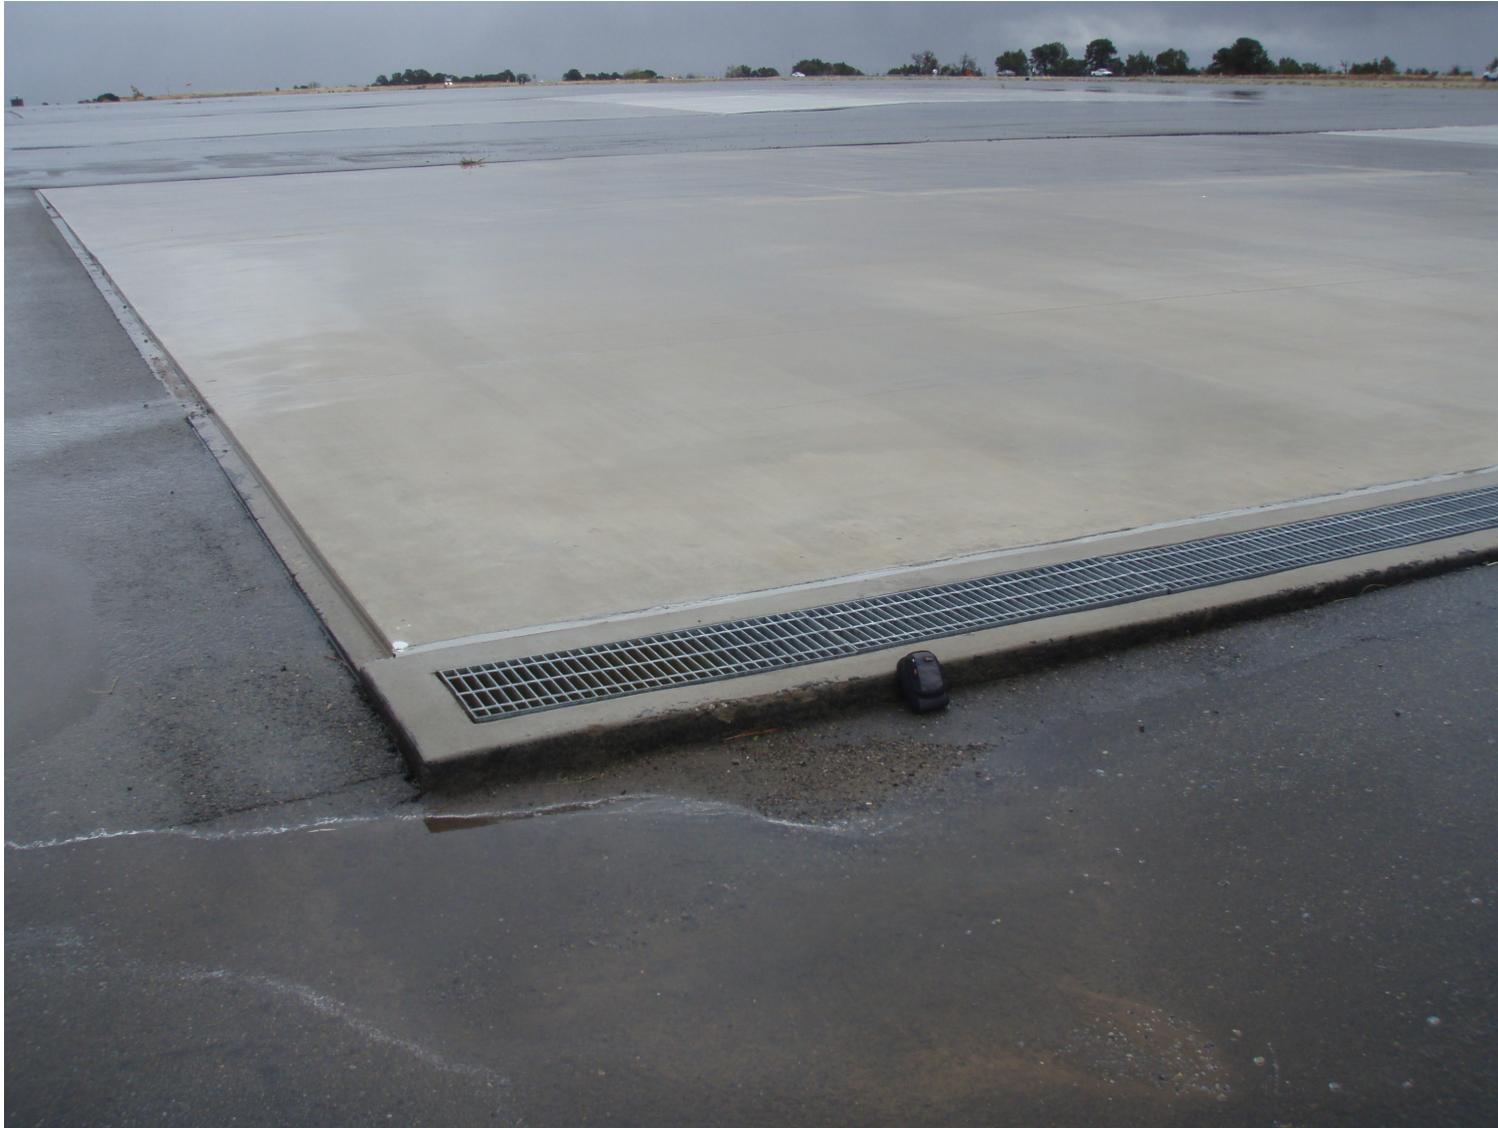
Subsidence of Matcon and puddling at NW corner of Pad #2

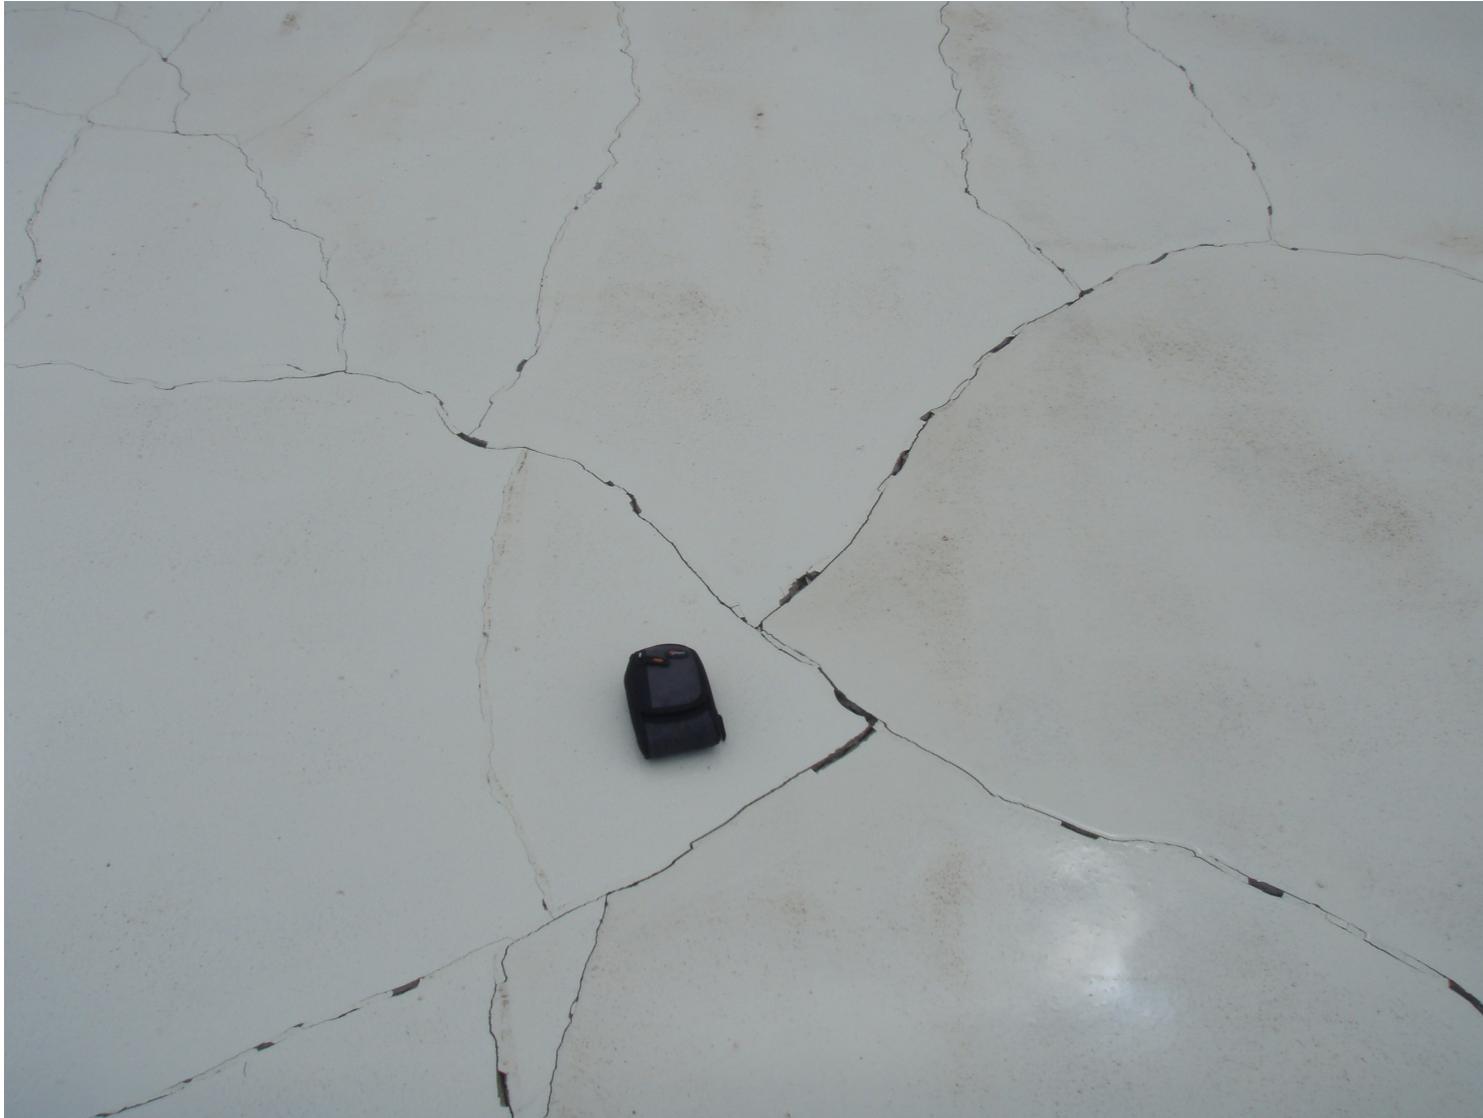
Cracking of Pad #2, similar cracking can be found in all pads with the exception of Pad #5

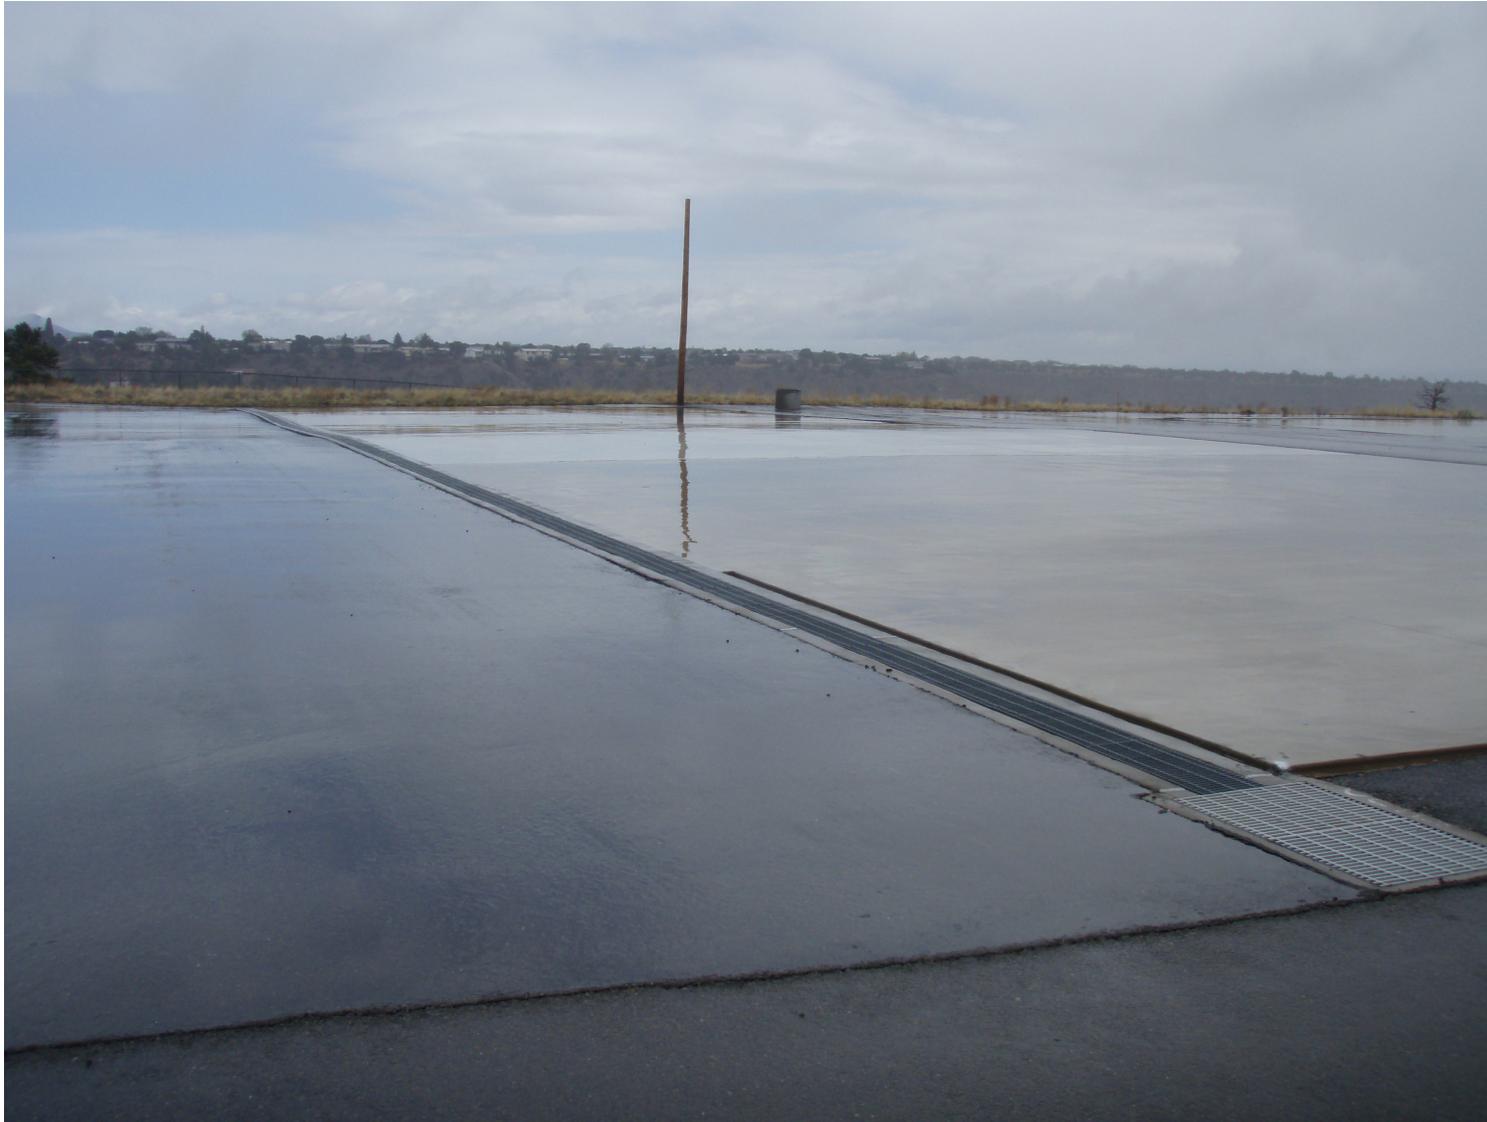
Looking NE at Pad #2, note hoe trench drain drops in elevation at north end of pad.
