**Subject: Submittal of the 2011 Annual Inspection Report for Los Alamos County
Airport Landfill, Solid Waste Management Units 73-001(a) and 73-001(d),
Technical Area 73**

LA-UR-12-0671
February 2012
EP2012-0018

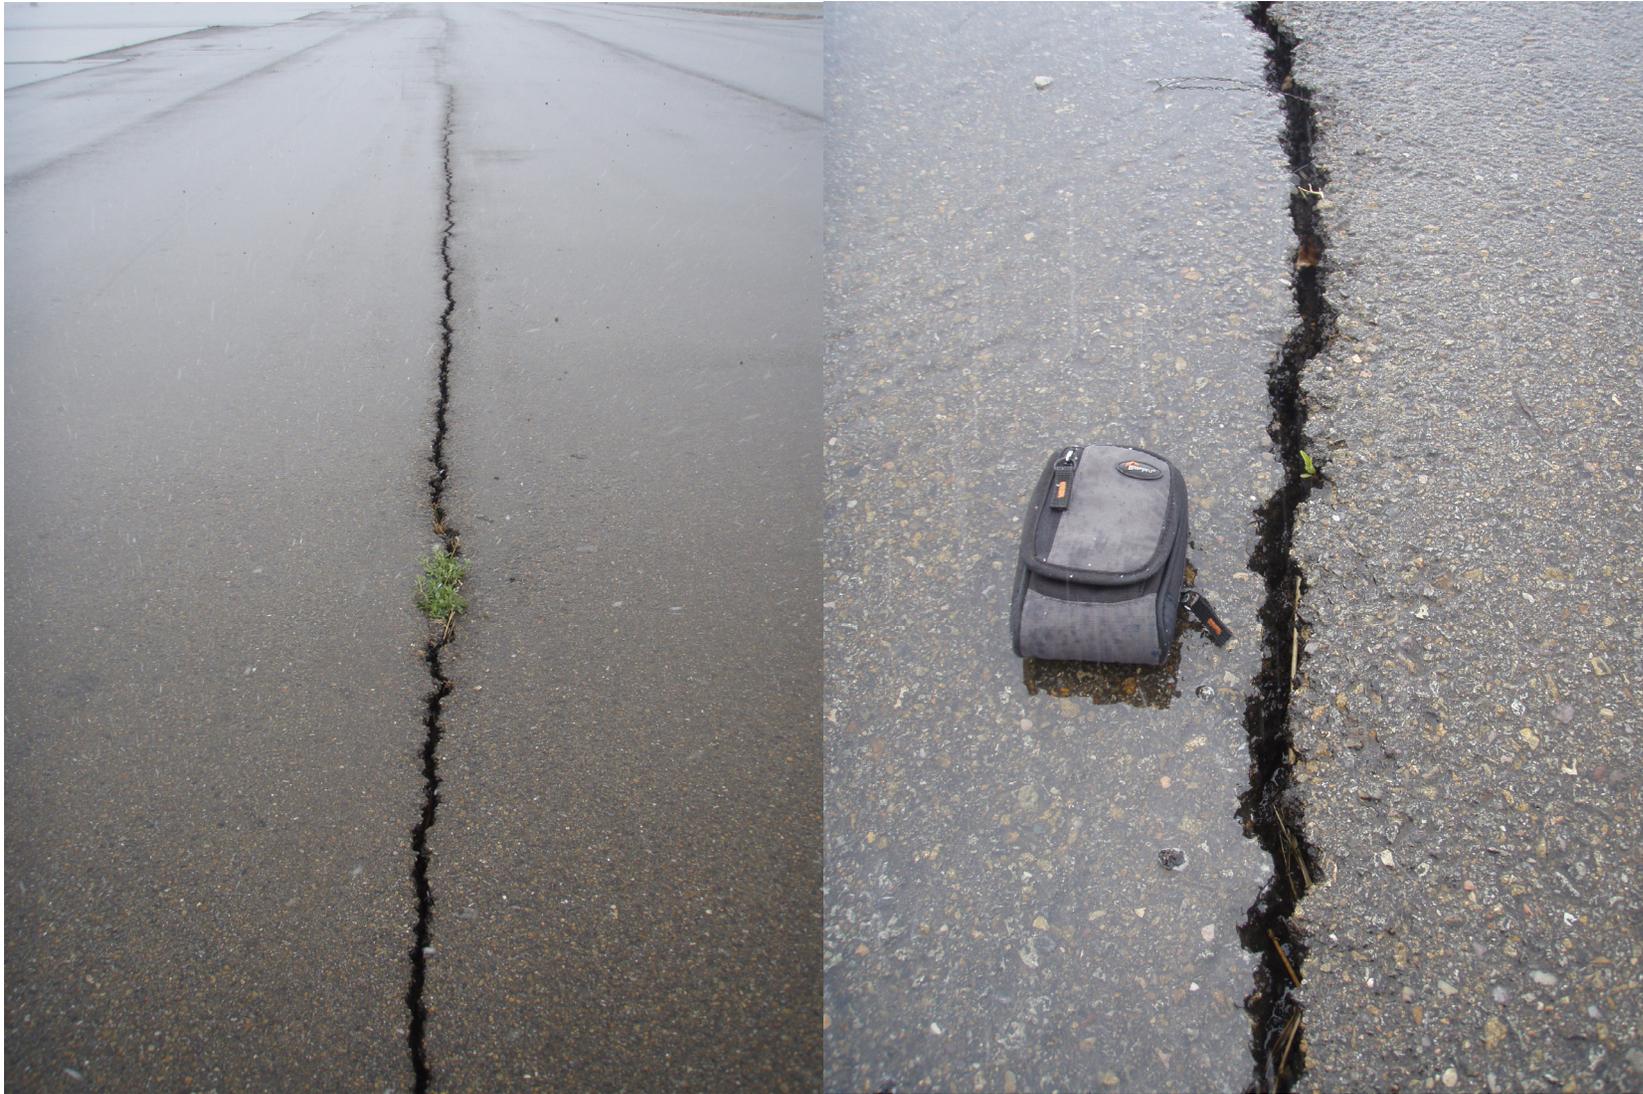
Cracking in MATCON pavement with vegetation growing in cracks. Cracks have been noted up to 1 inch wide, 5+ inches deep, and over 100 ft in length.

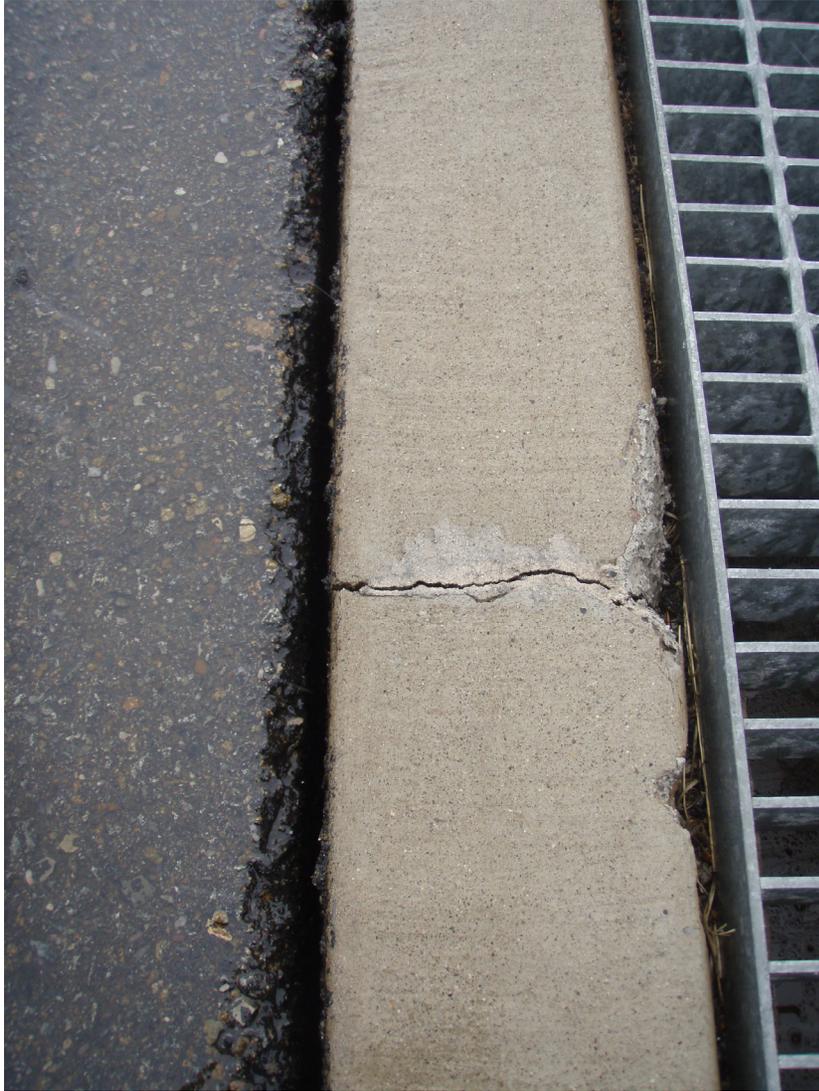
Trench drain along Pad #1, note cracking in drain and separation from MATCON.

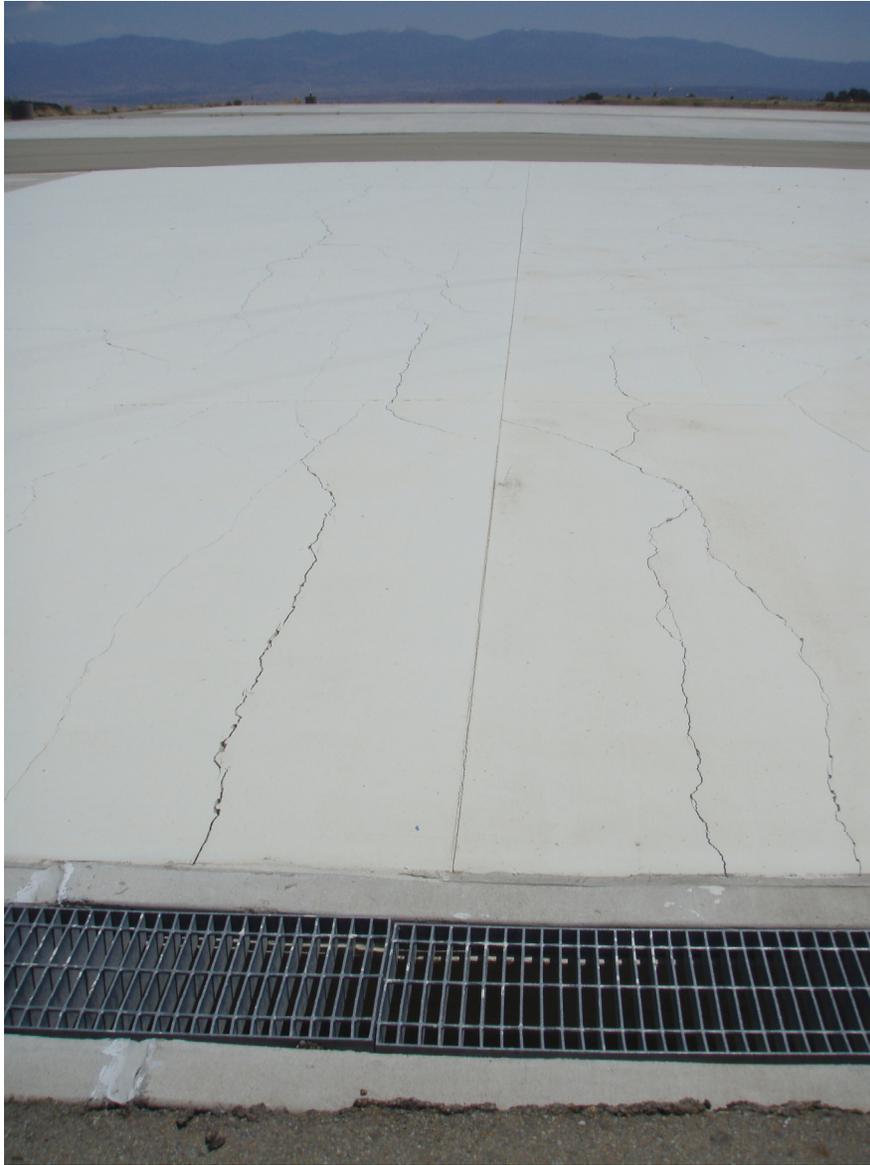
Photo # 3

Cracking in Pad #3. Majority of cracks run east to west.

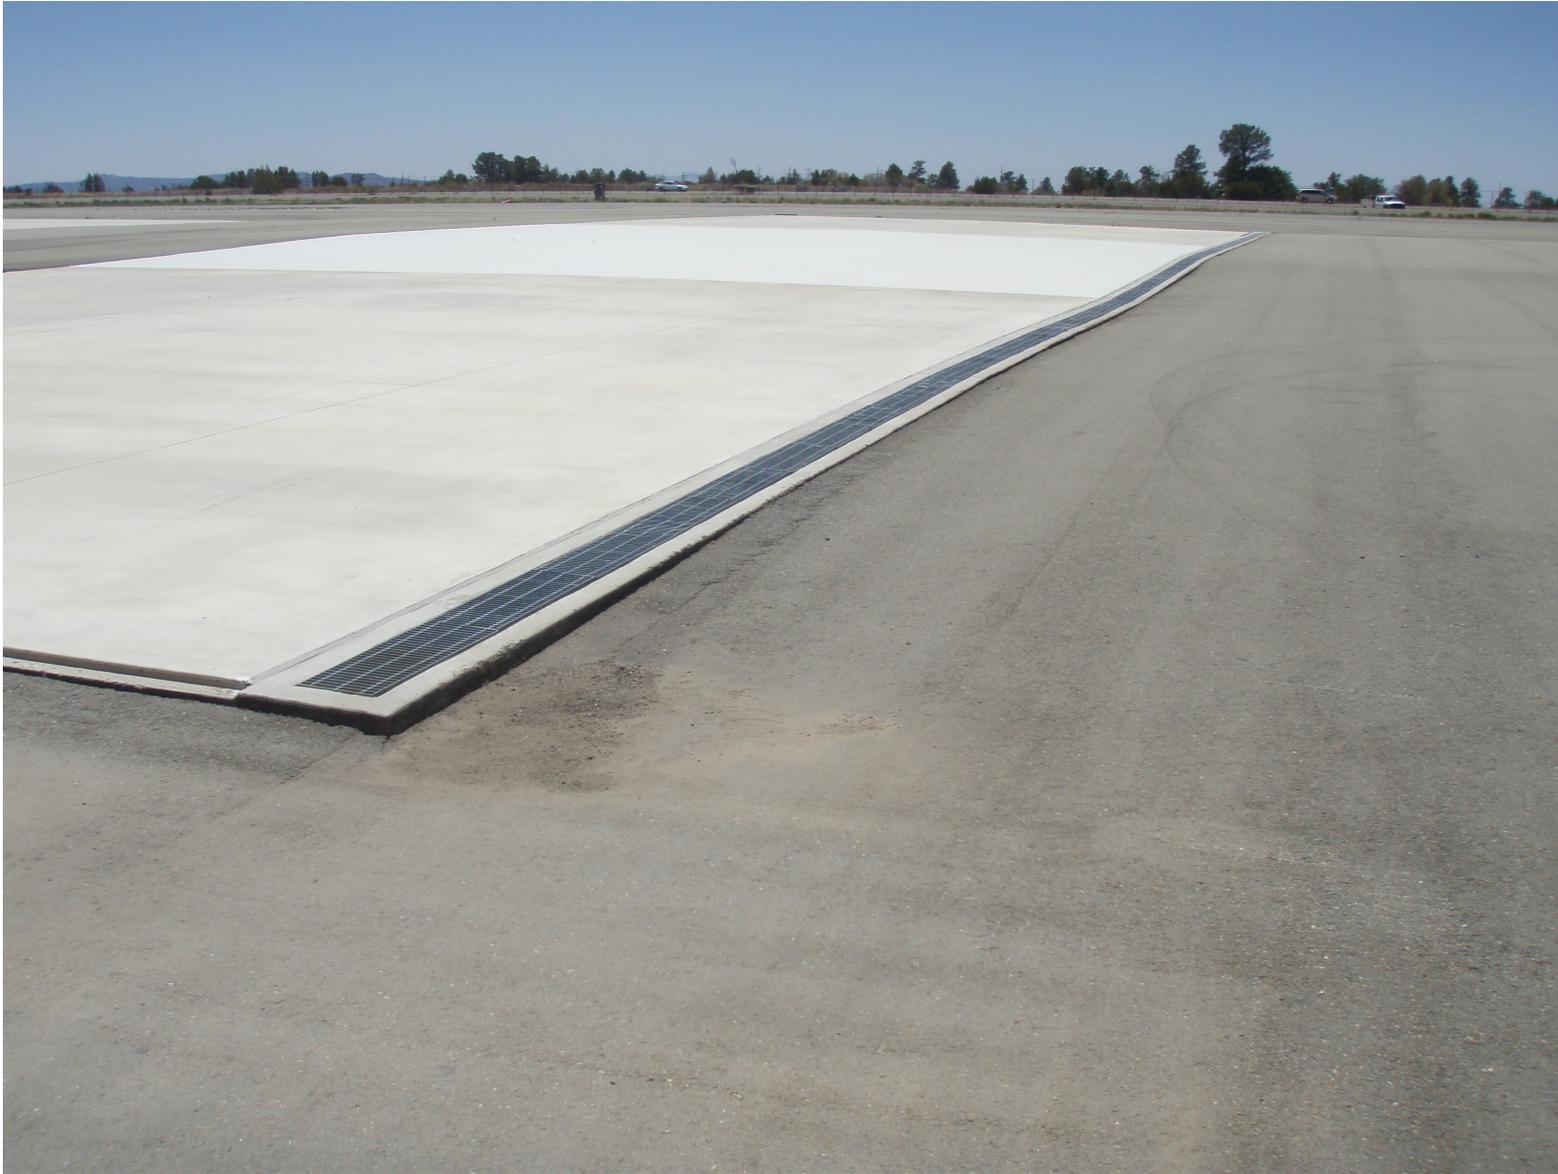
Photo # 4

Subsidence of MATCON at NW corner of Pad #3

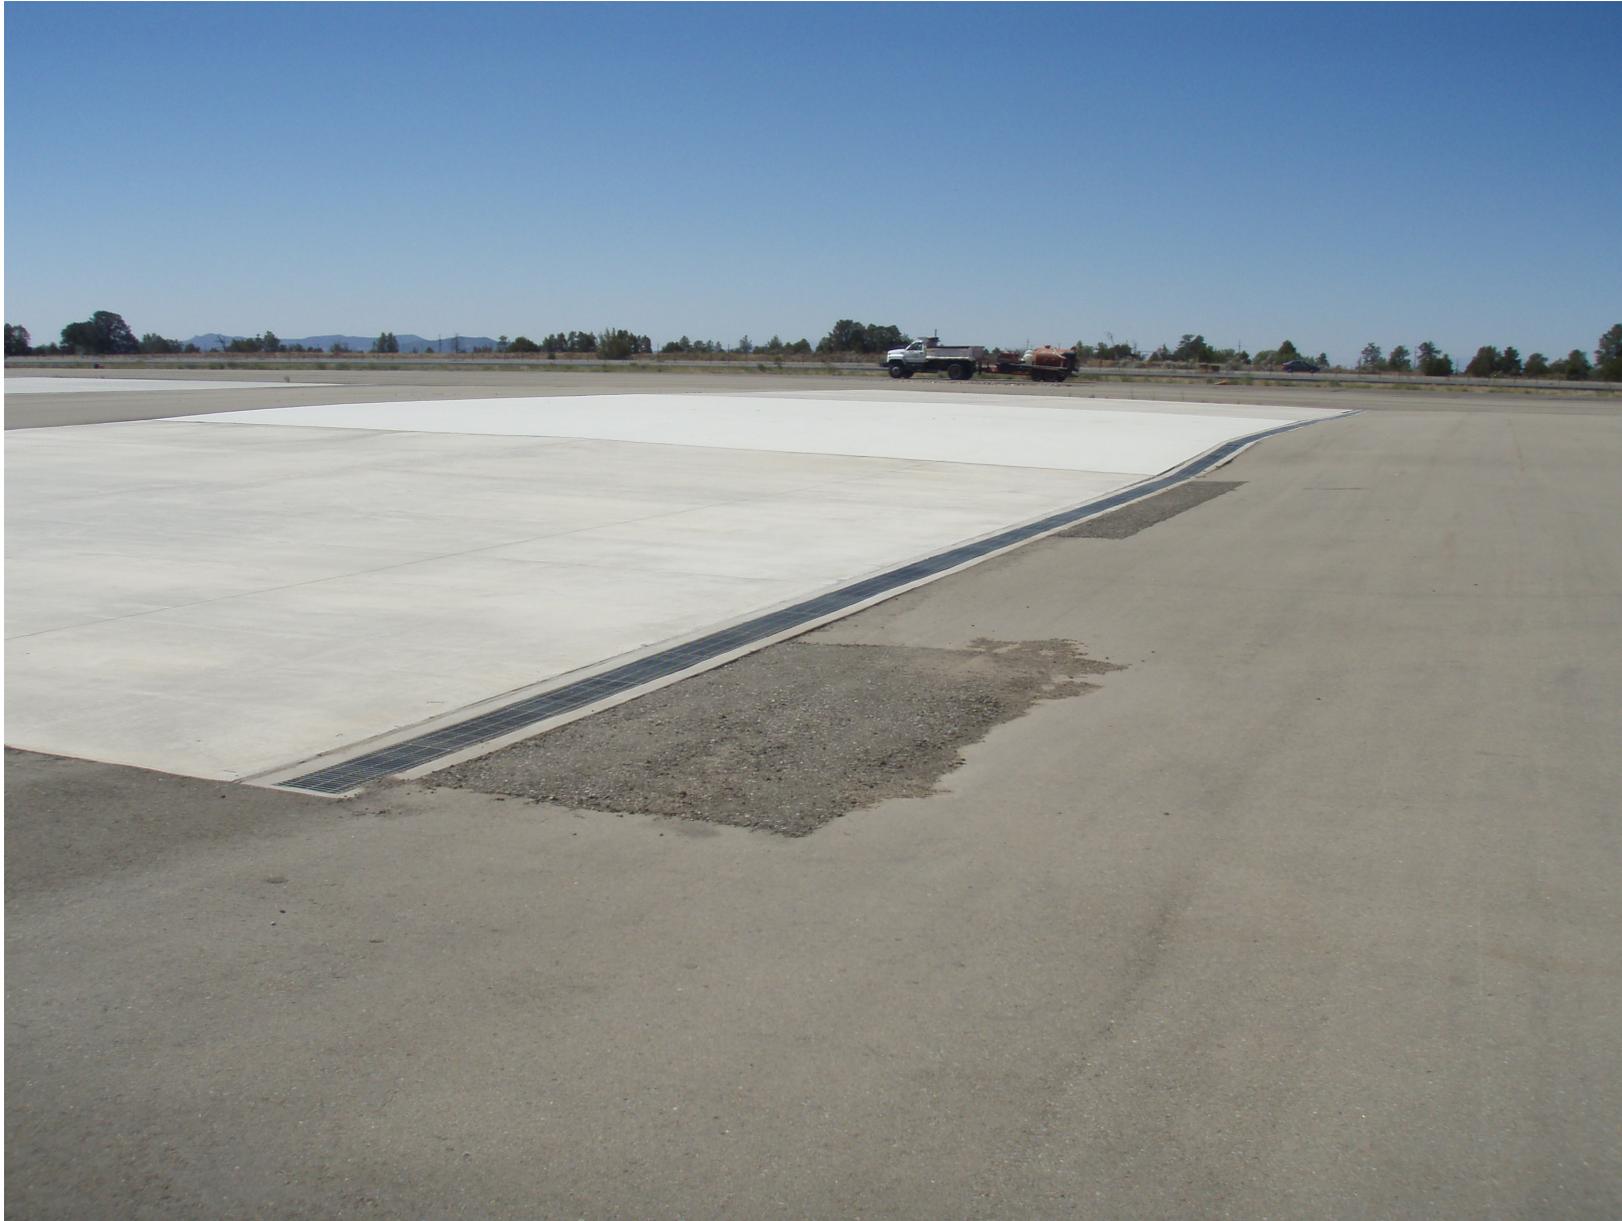
Photo 3: Pad 3, note matcon patches, improper drainage and hinge point towards middle of pad.

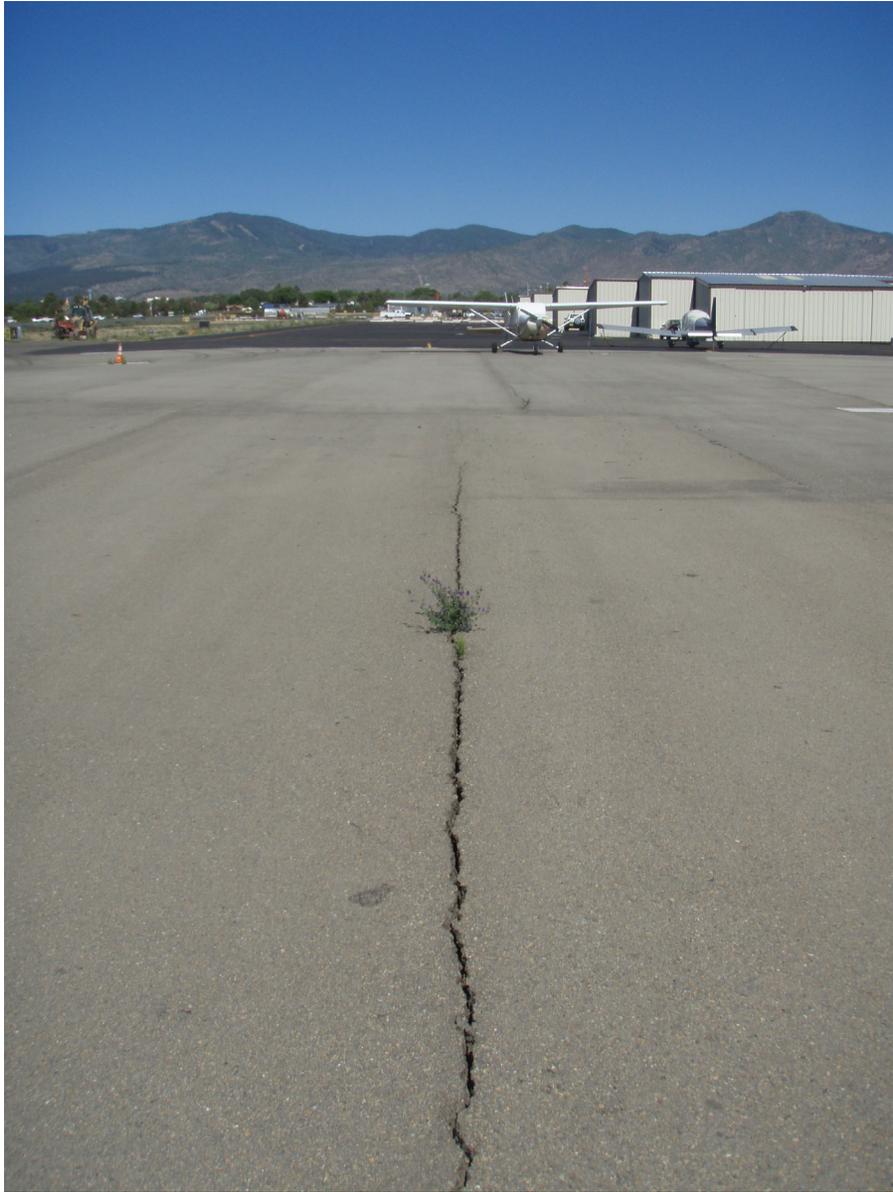
Photo 4: Looking west at crack in matcon with vegetation growing through crack.

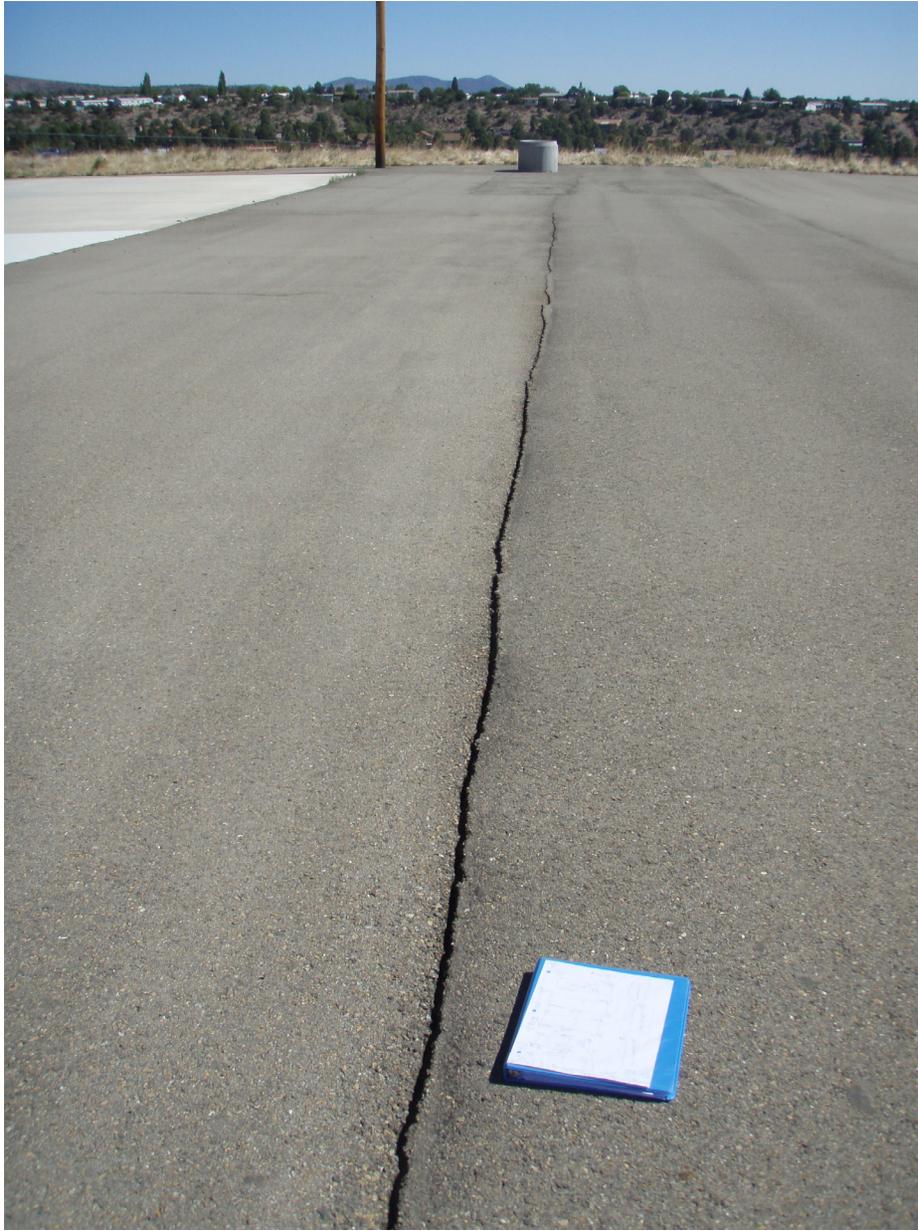
Photo 5: Crack in matcon between pads 2-3.

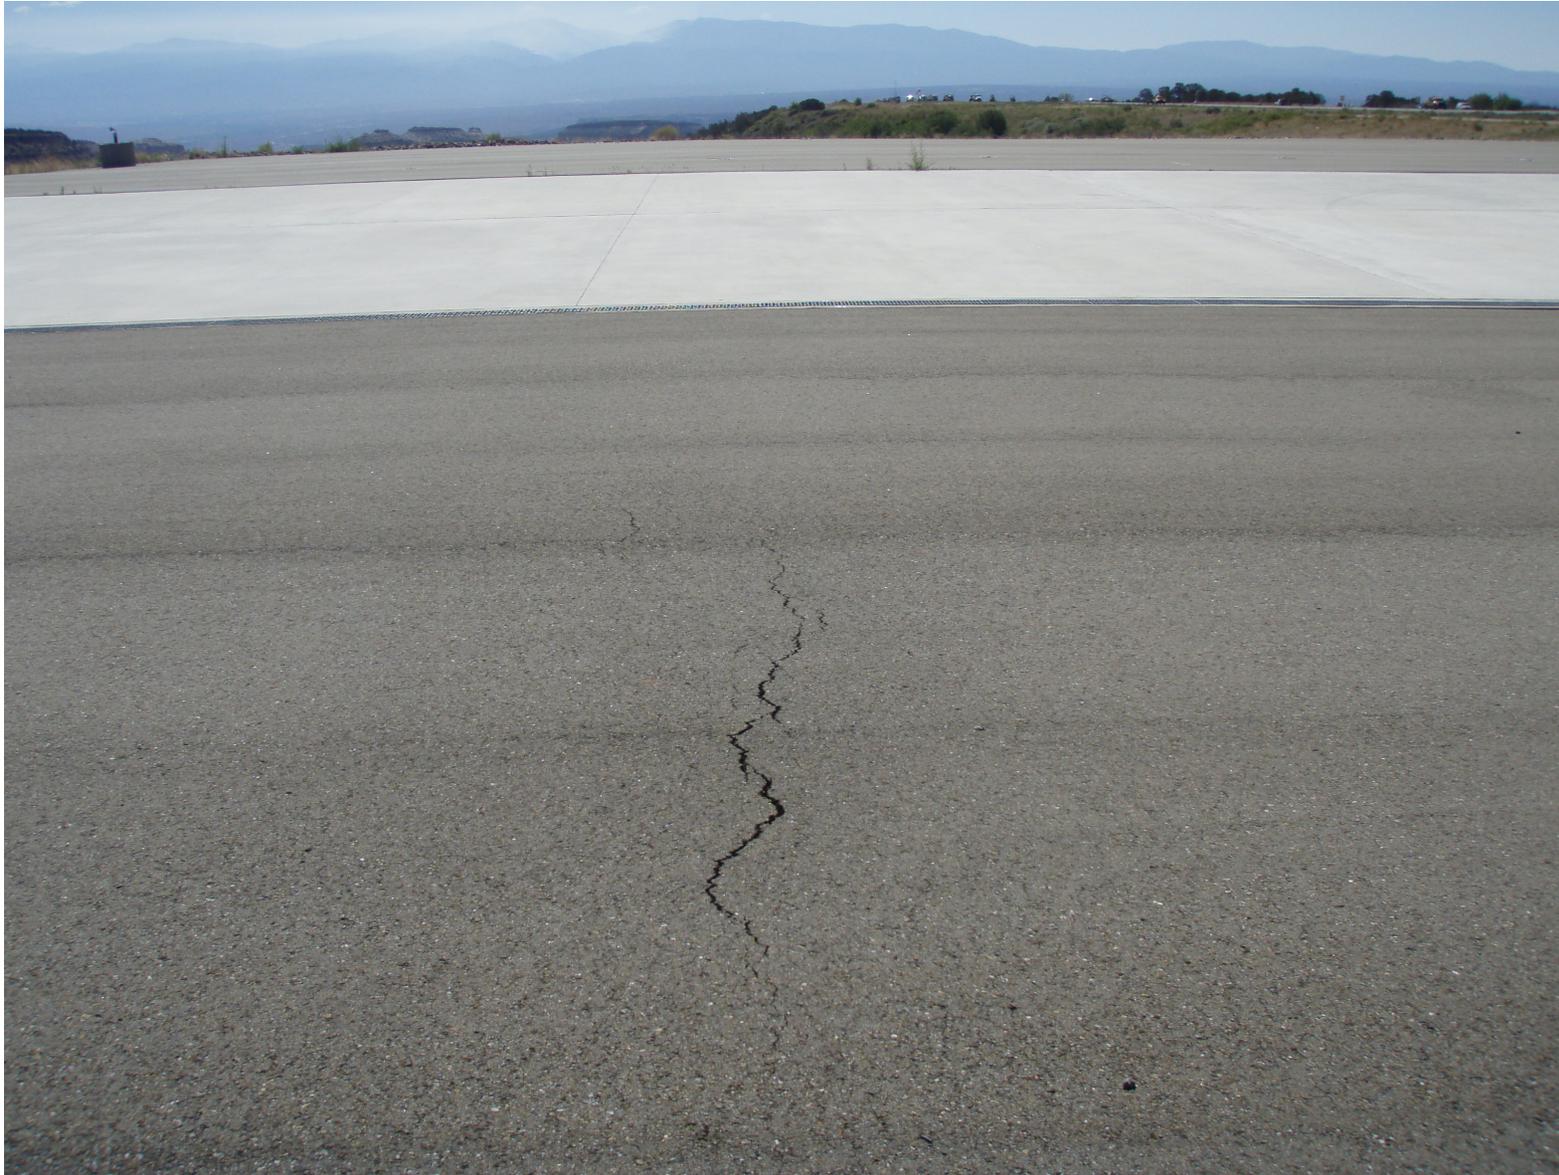
Photo 6: New crack in matcon between pads 4-5. Forming on hinge point similar to pads 1-4.

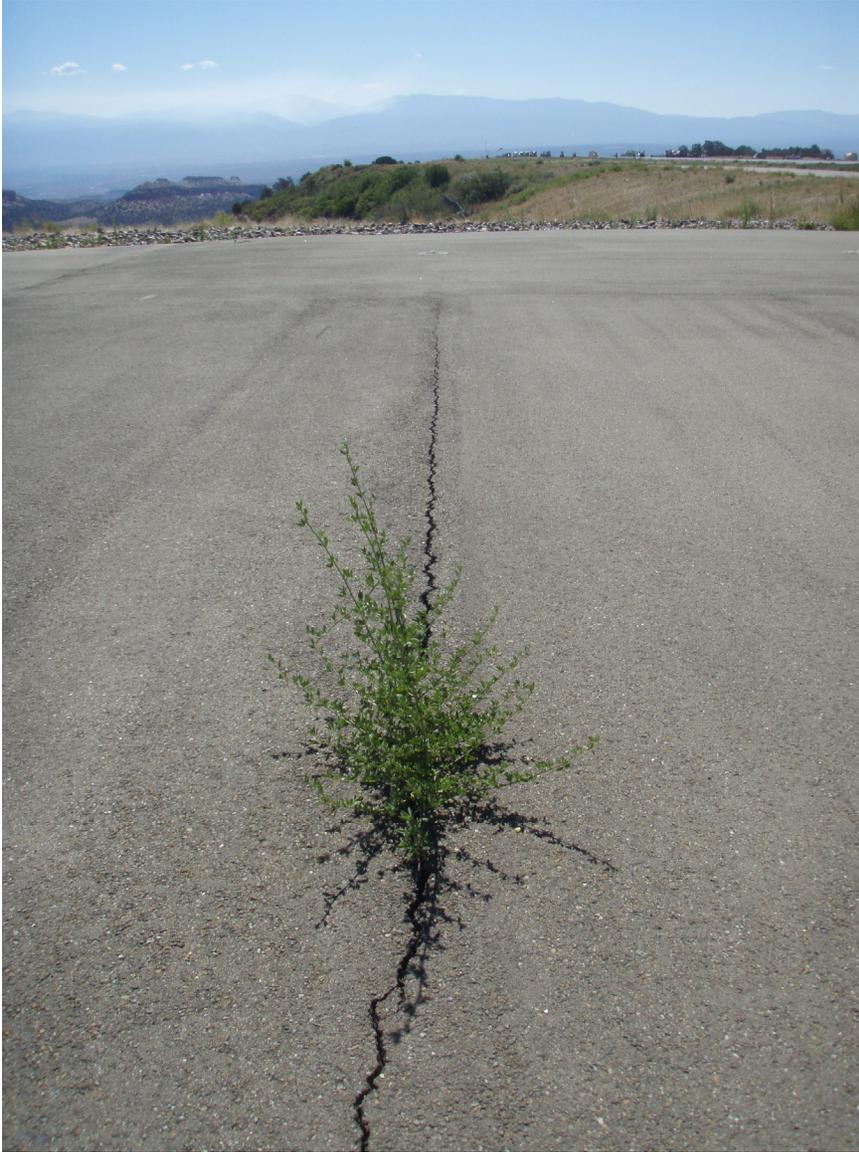
Photo 7: East-west oriented crack along paving lanes.

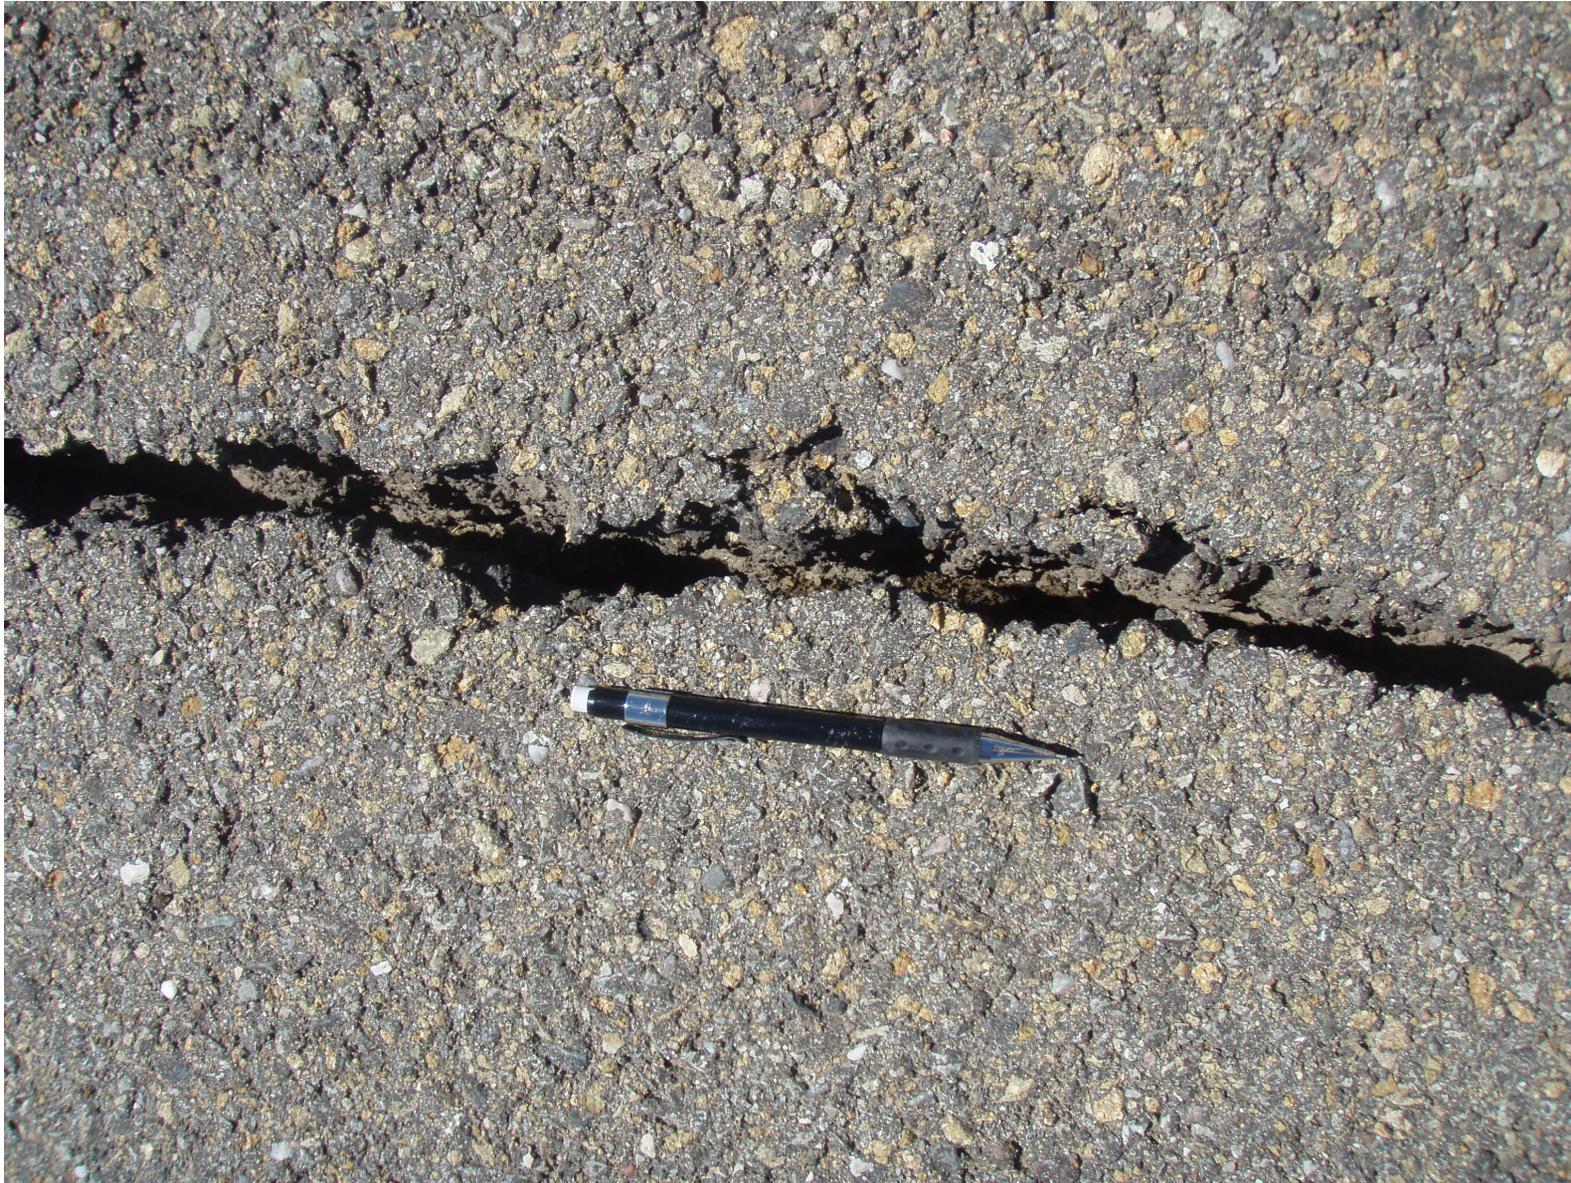
Photo 8: Crack in matcon approximately $\frac{3}{4}$ to 1 inch wide and 5 inches deep. Soil at bottom of crack.

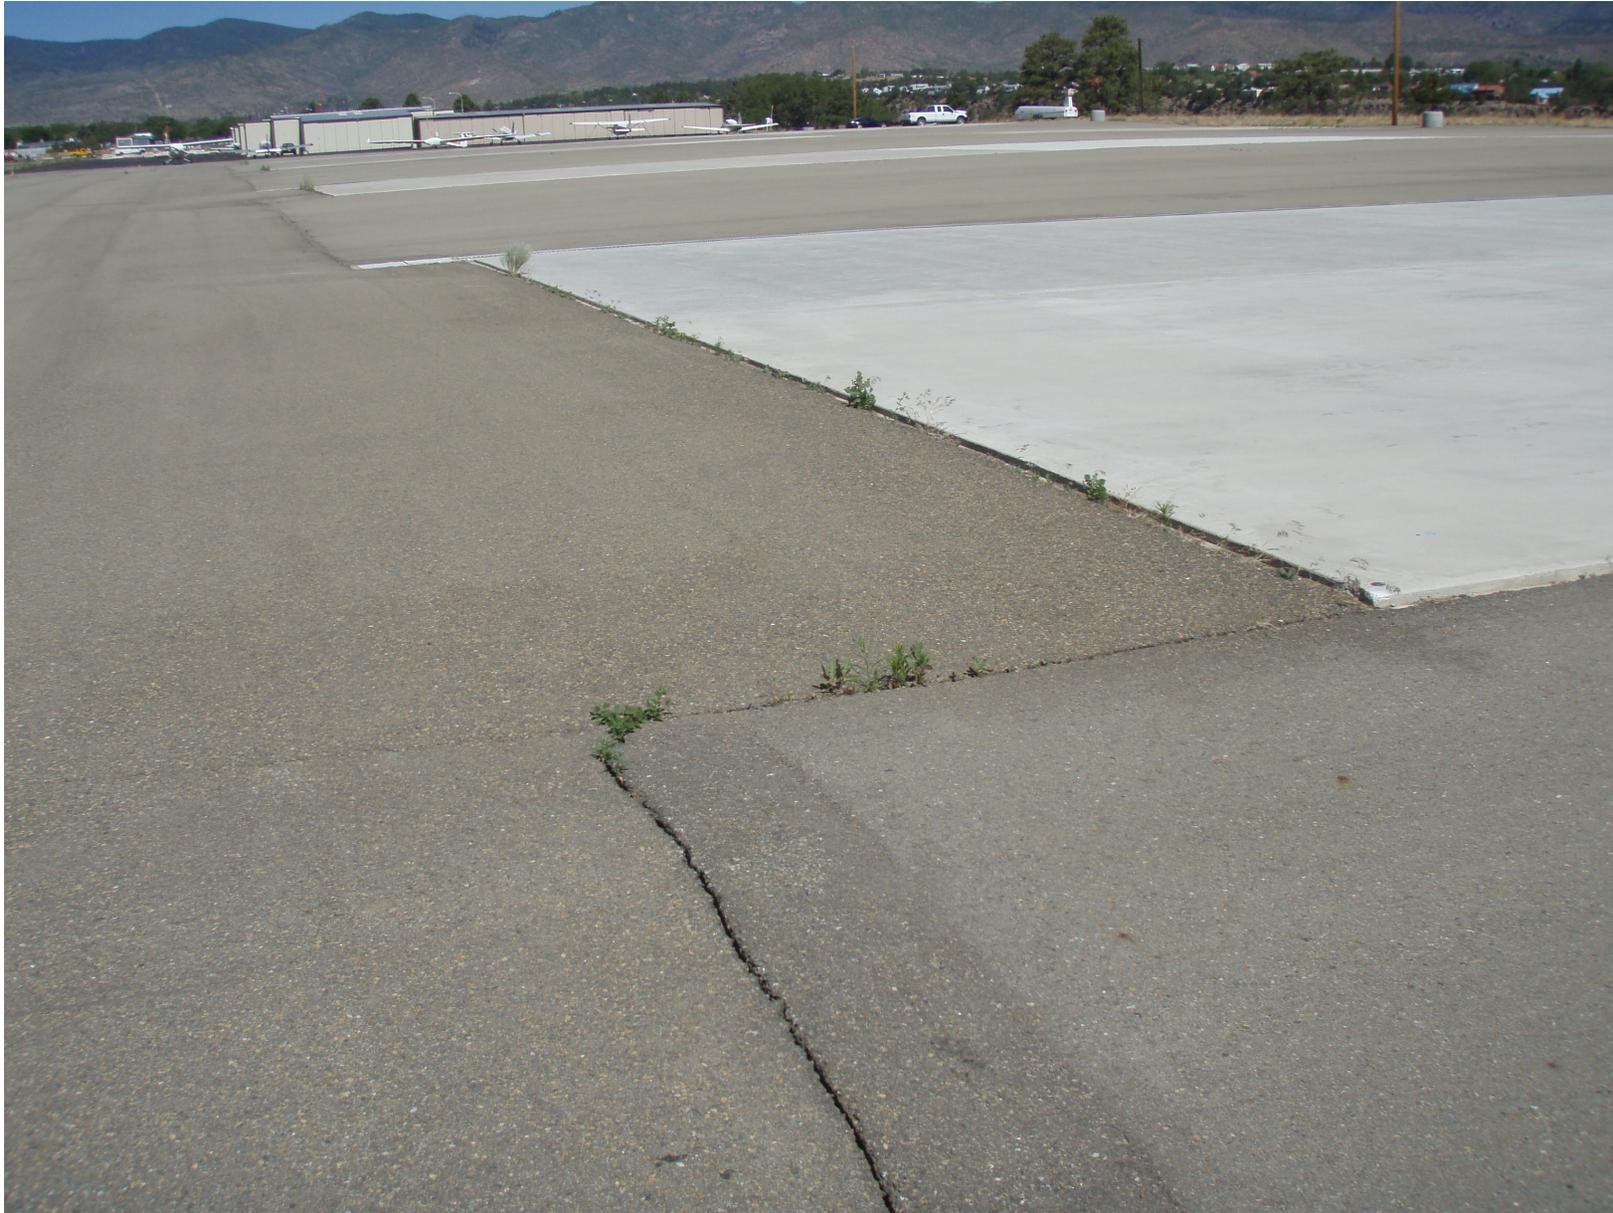
Photo 9: SE corner of Pad 4, note cracks, matcon patch and vegetation.

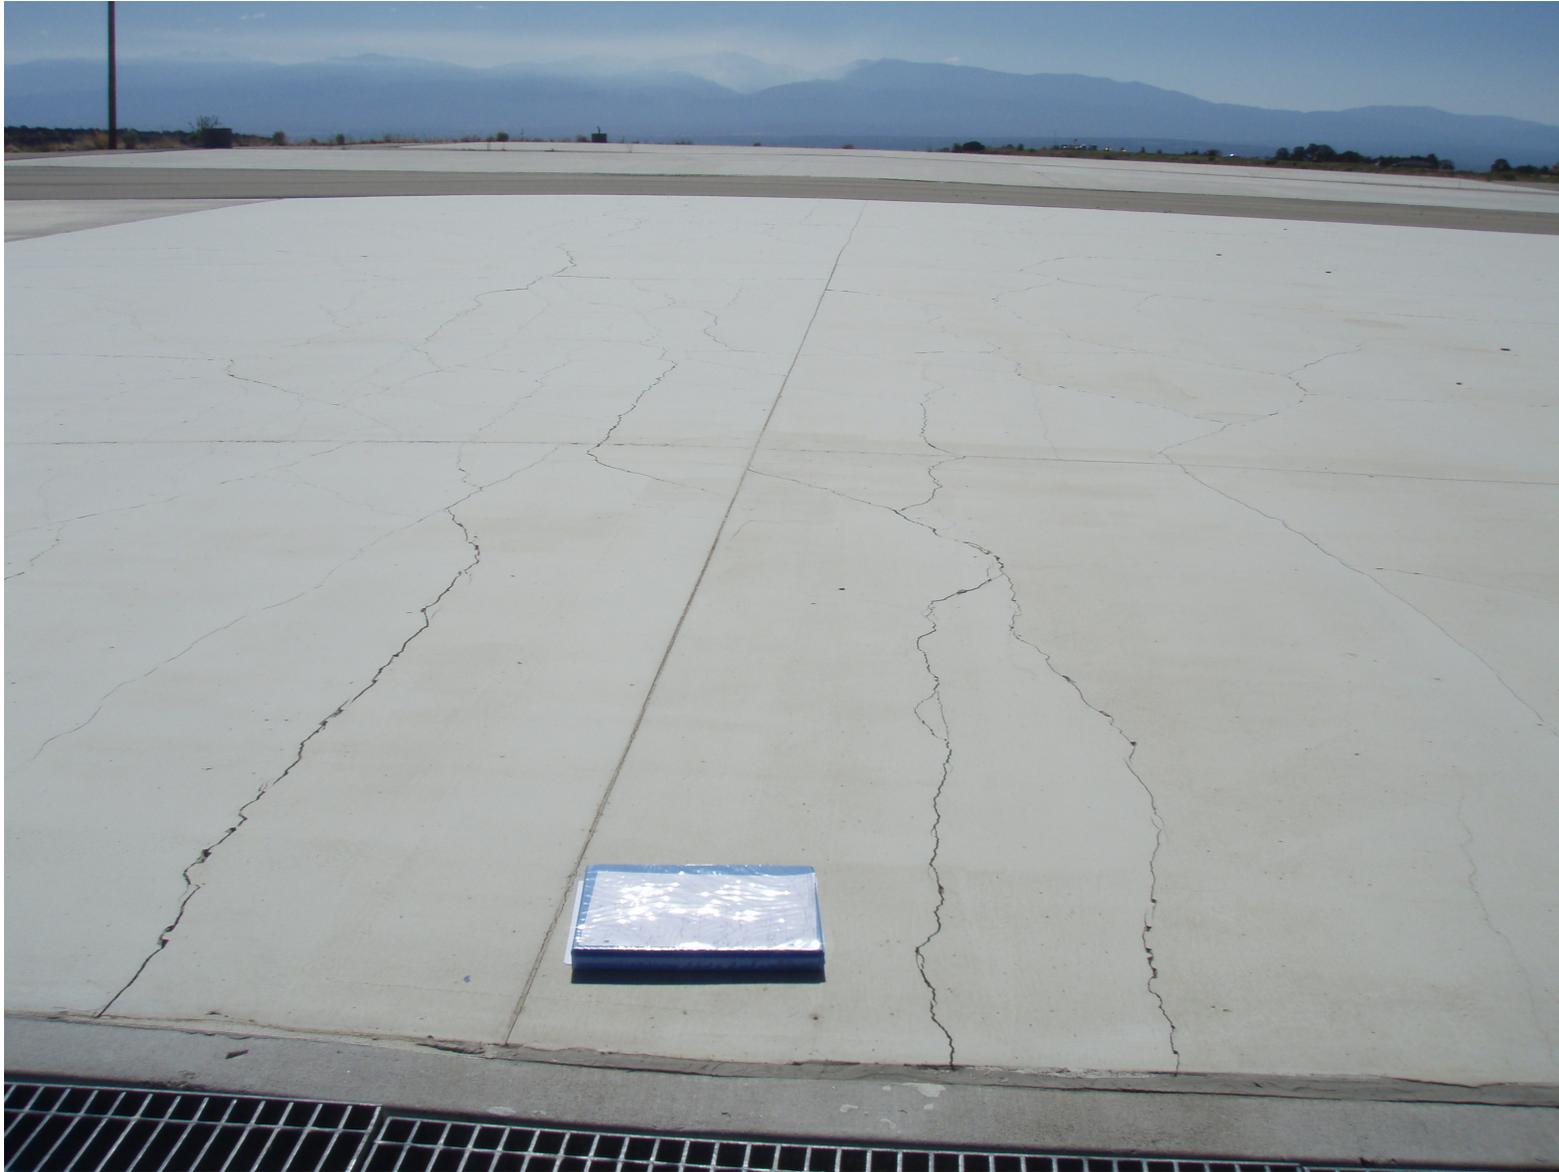
Photo 10: Cracks in pad 3

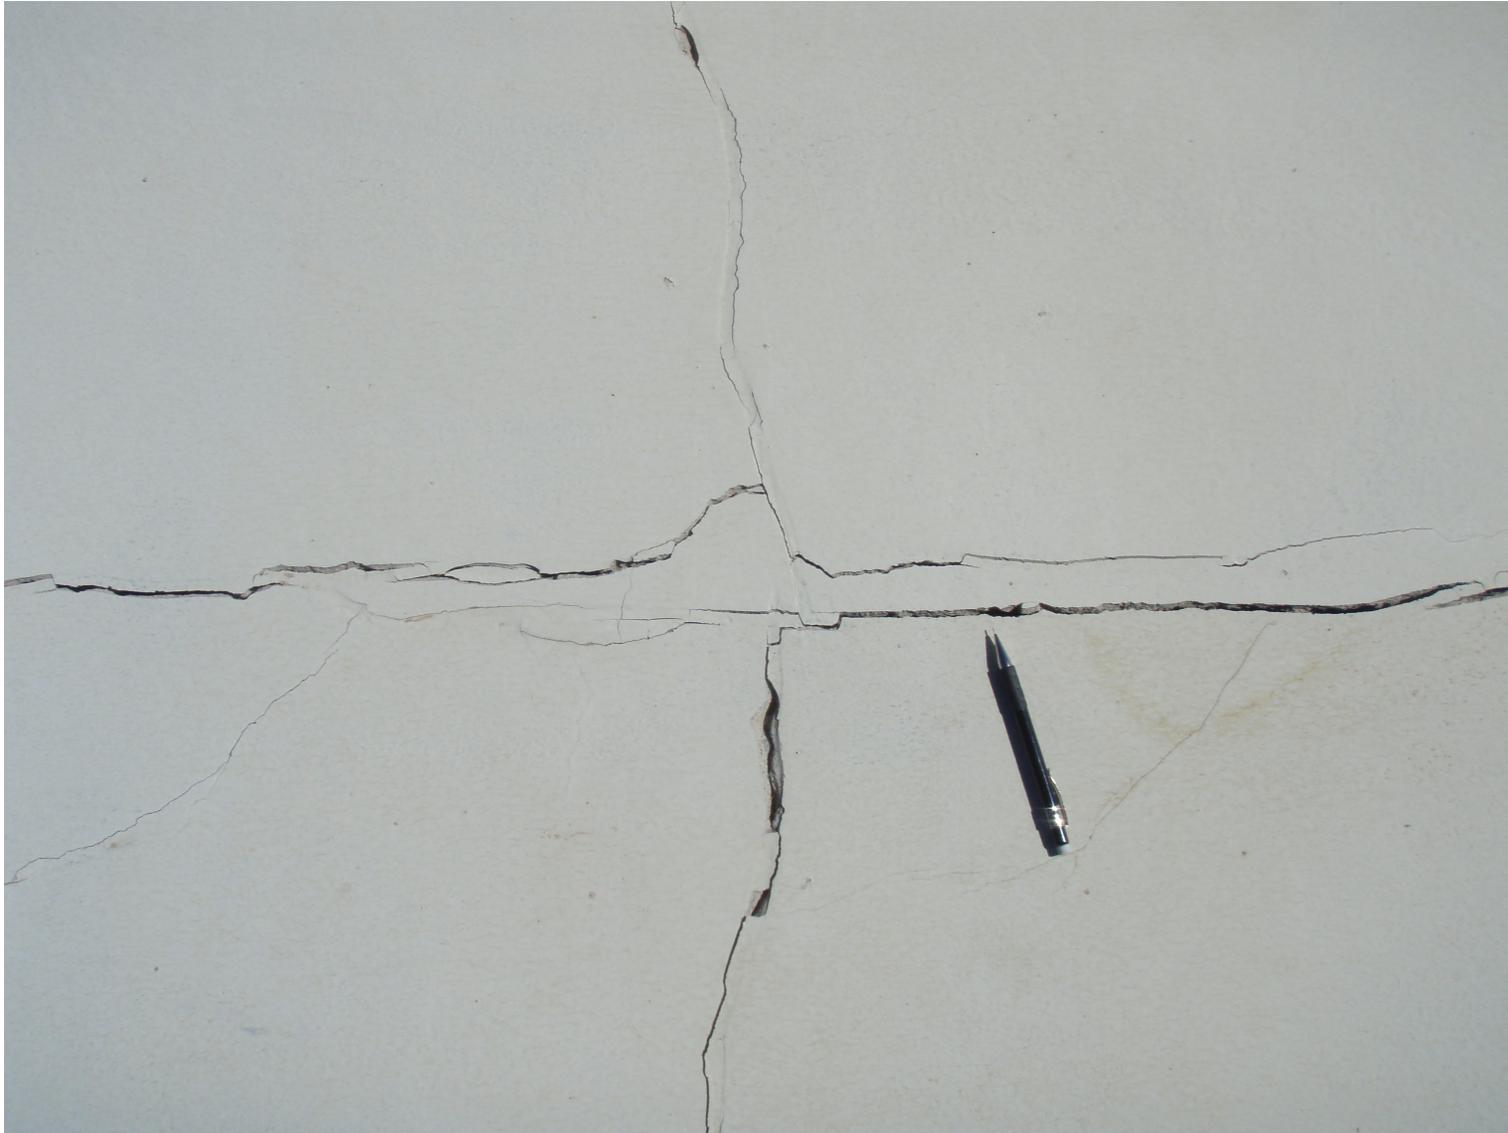
Photo 11: Cracks in pad 3, note previously repaired cracks and new cracks.

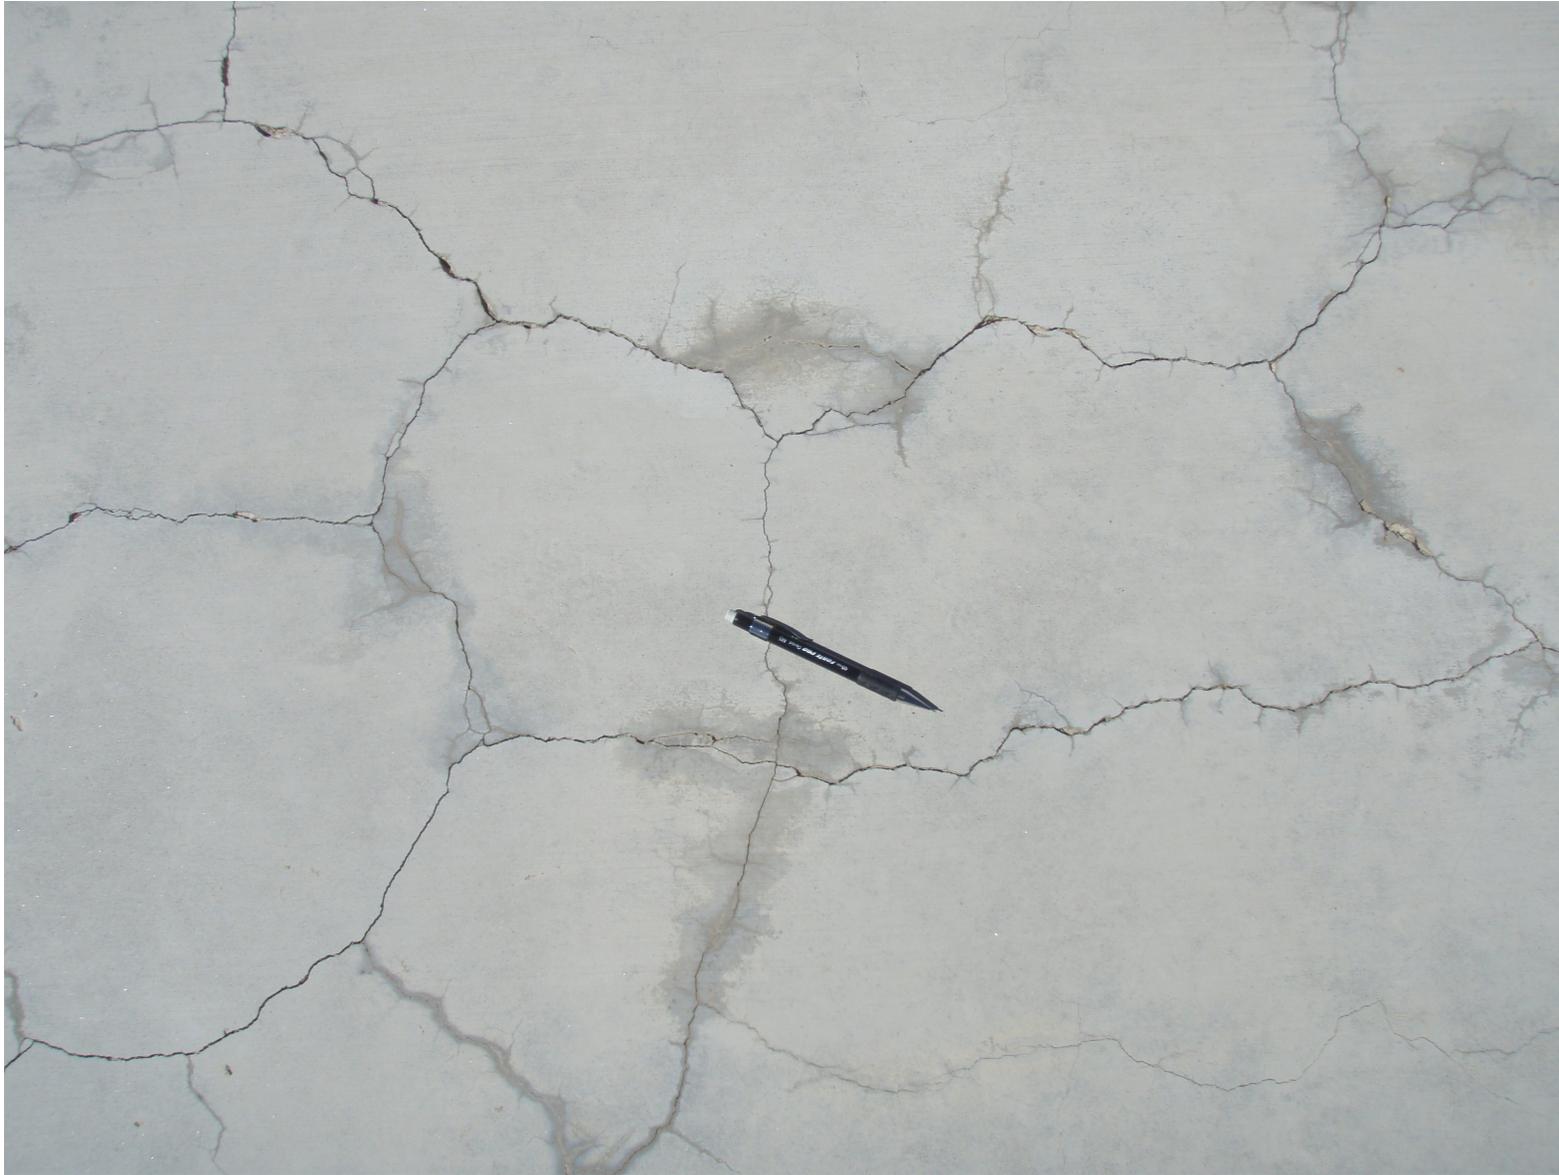
Photo 12: Cracks in pad 4

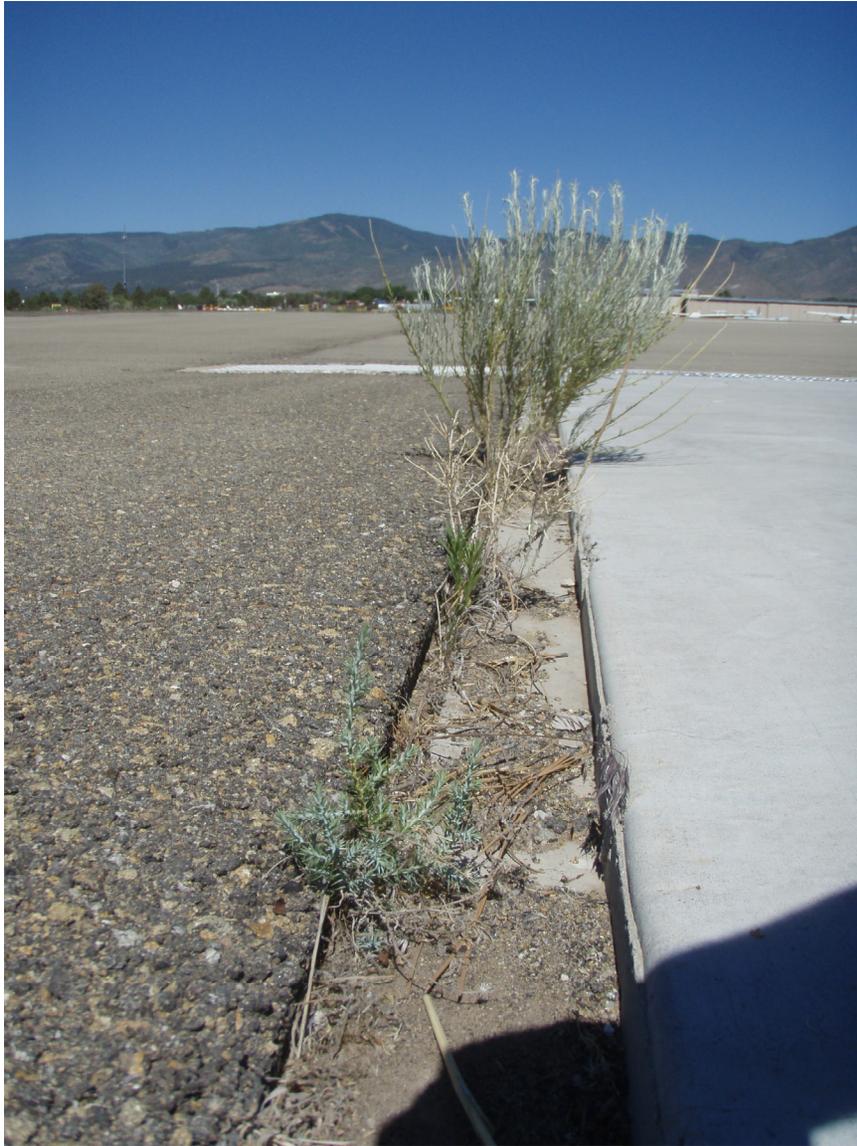
Photo 13: Vegetation along pad edge (juniper, weeds, and deep rooting sage brush)
