**Subject: Submittal of the 2011 Annual Inspection Report for Los Alamos County
Airport Landfill, Solid Waste Management Units 73-001(a) and 73-001(d),
Technical Area 73**

LA-UR-12-0671
February 2012
EP2012-0018

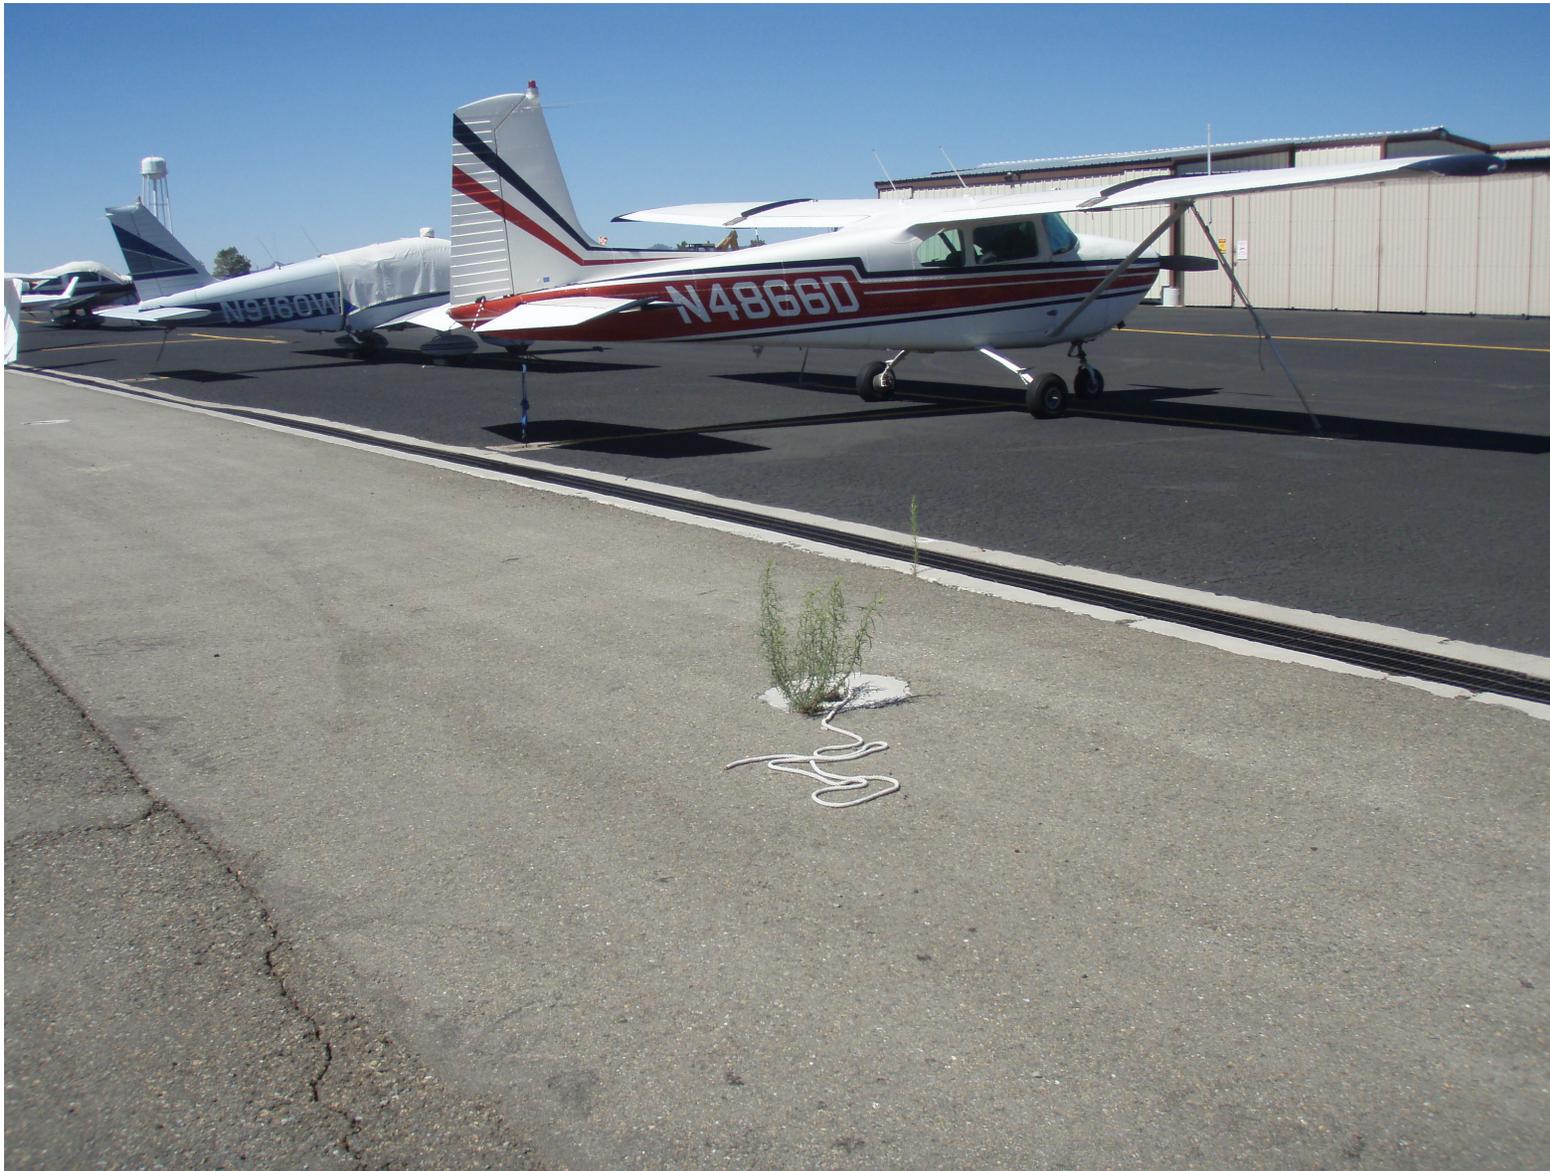
Photo 15: Vegetation growing along contact between matcon and cement at tie down and trench drain. Note no vegetation observed growing in older section of hanger pads and asphalt access areas.

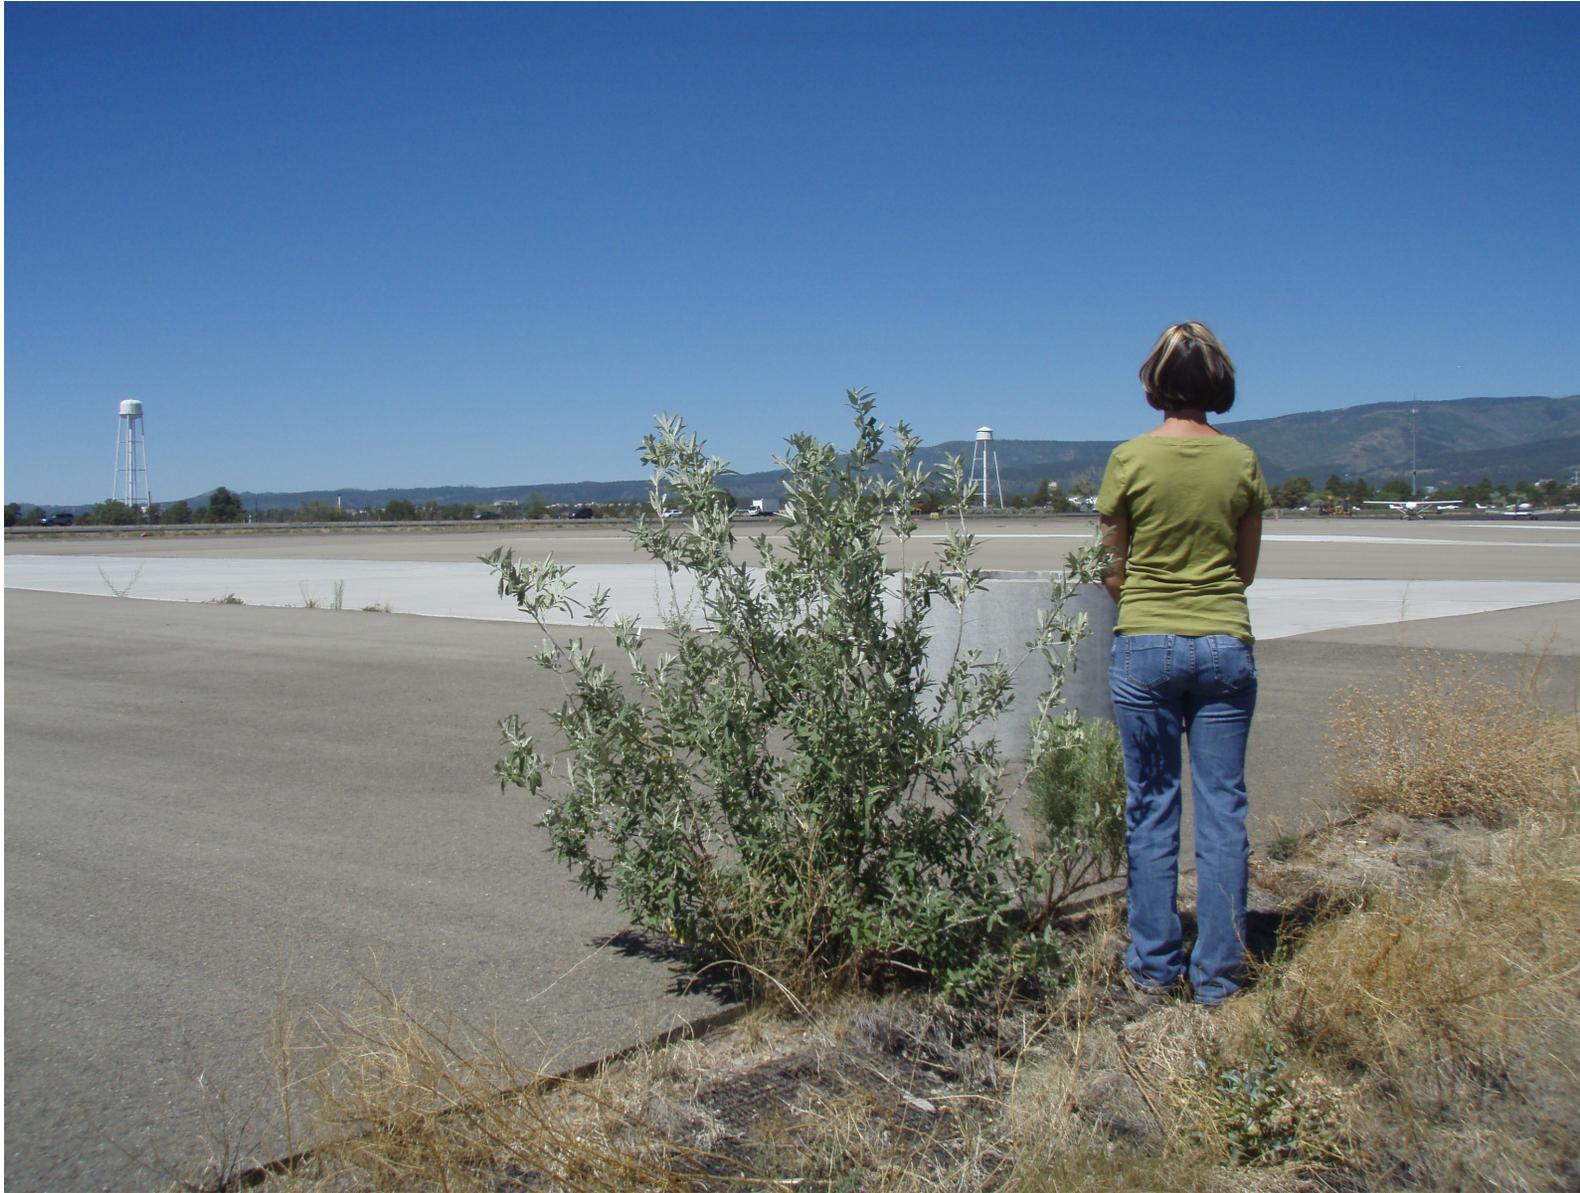
Photo 16: Russian olive growing along edge of matcon, also note vegetation along pad.

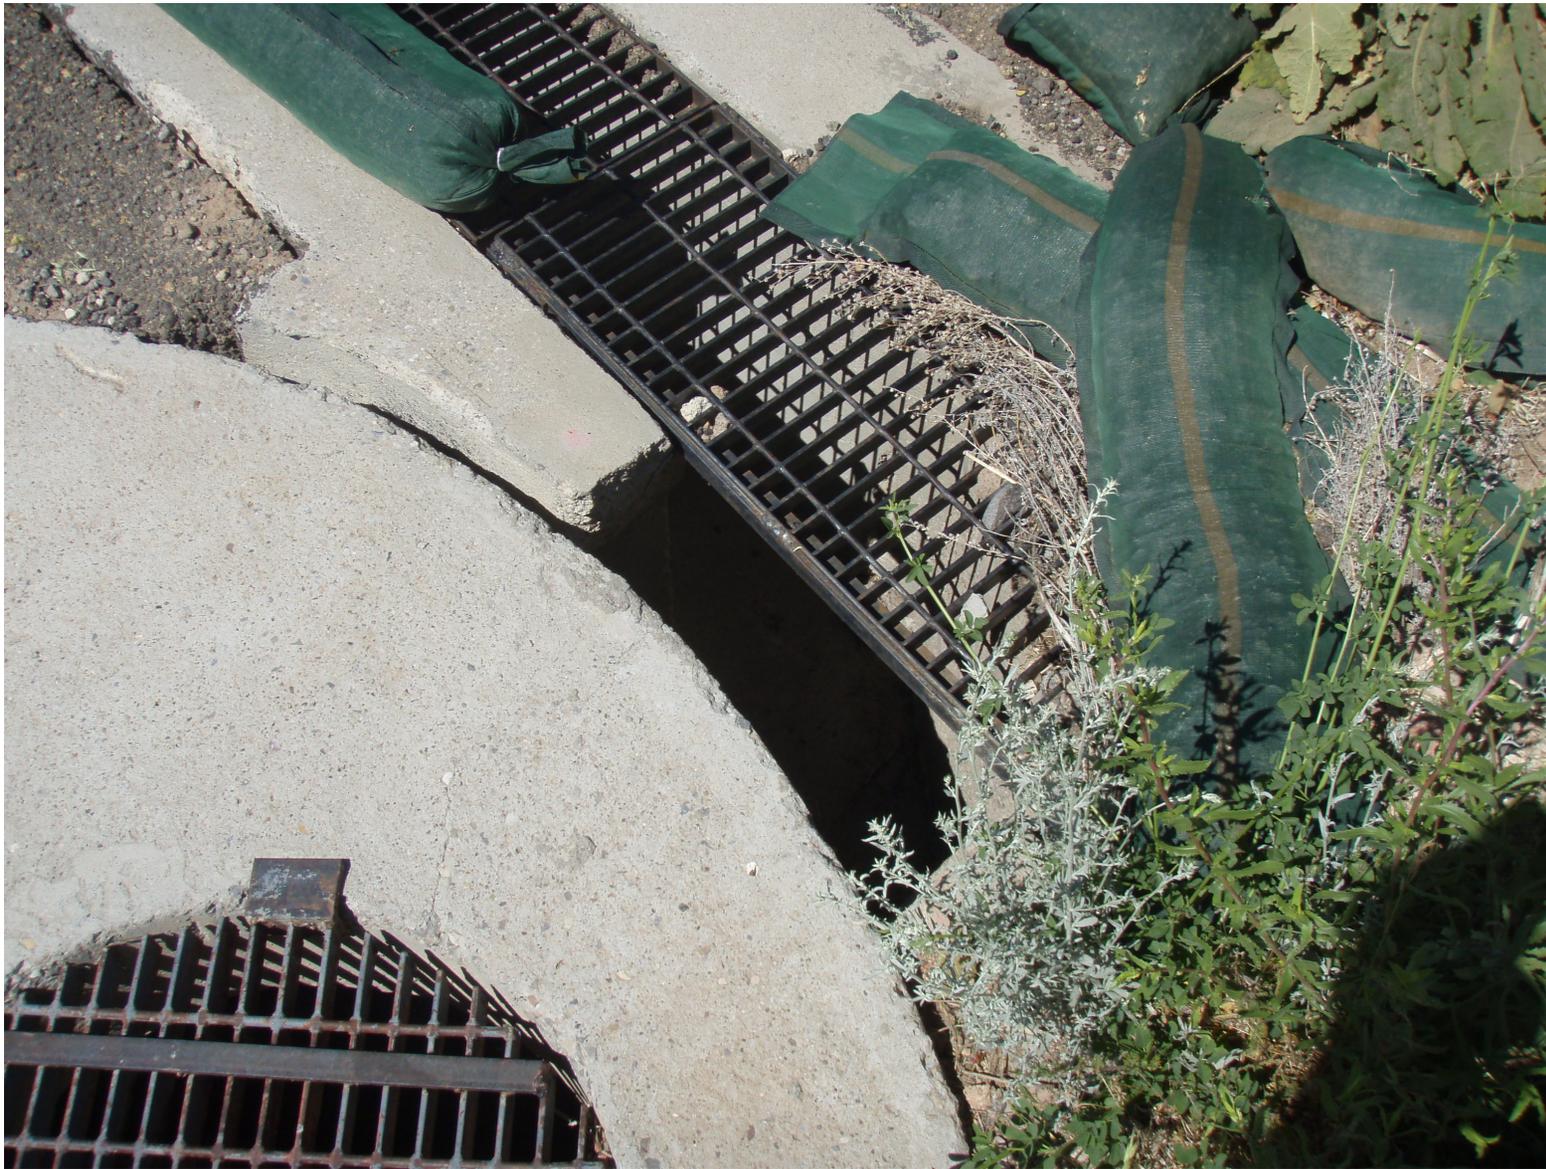
Photo 17: Missing concrete at drop inlet.

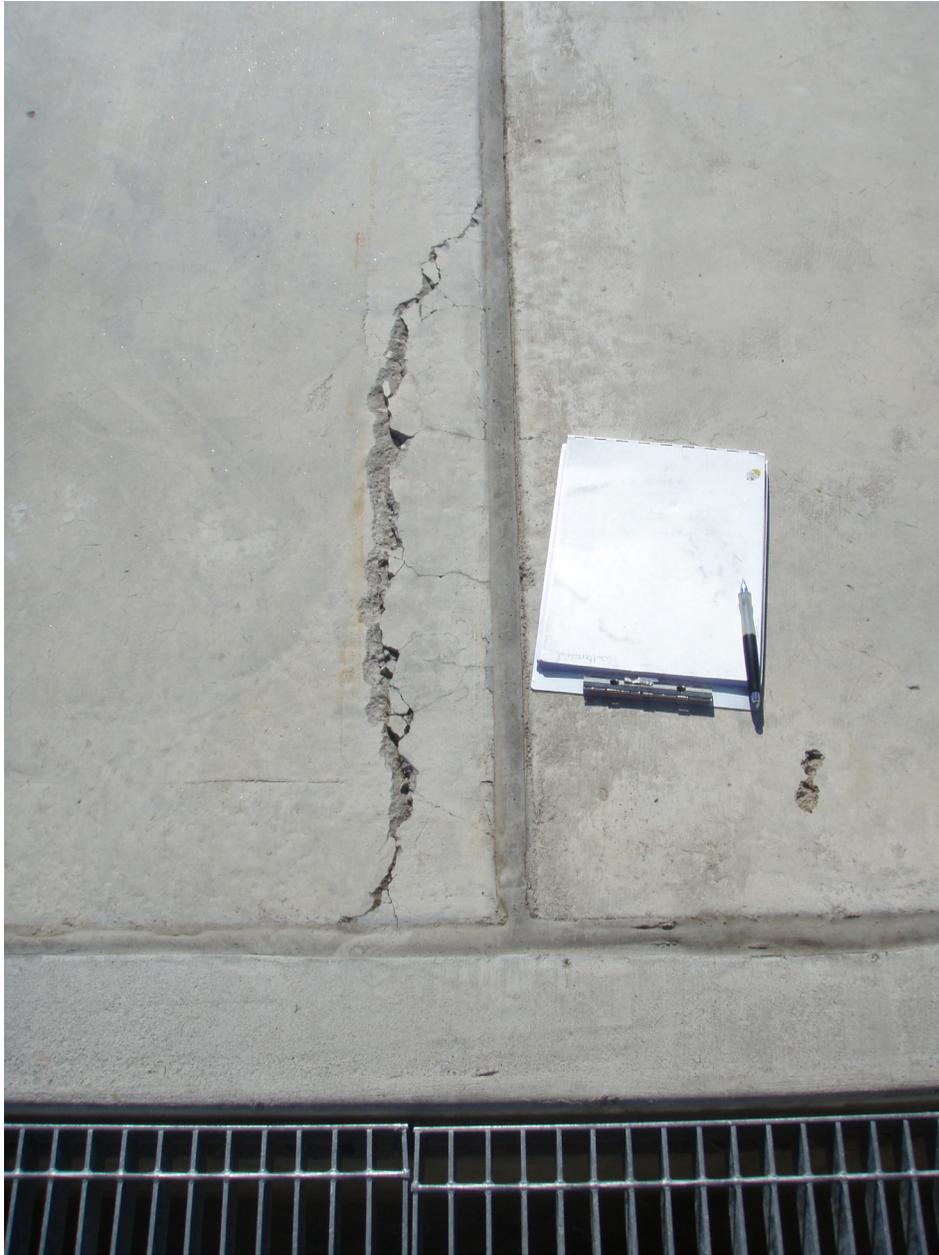
Photo 3: Crack in pad #1.

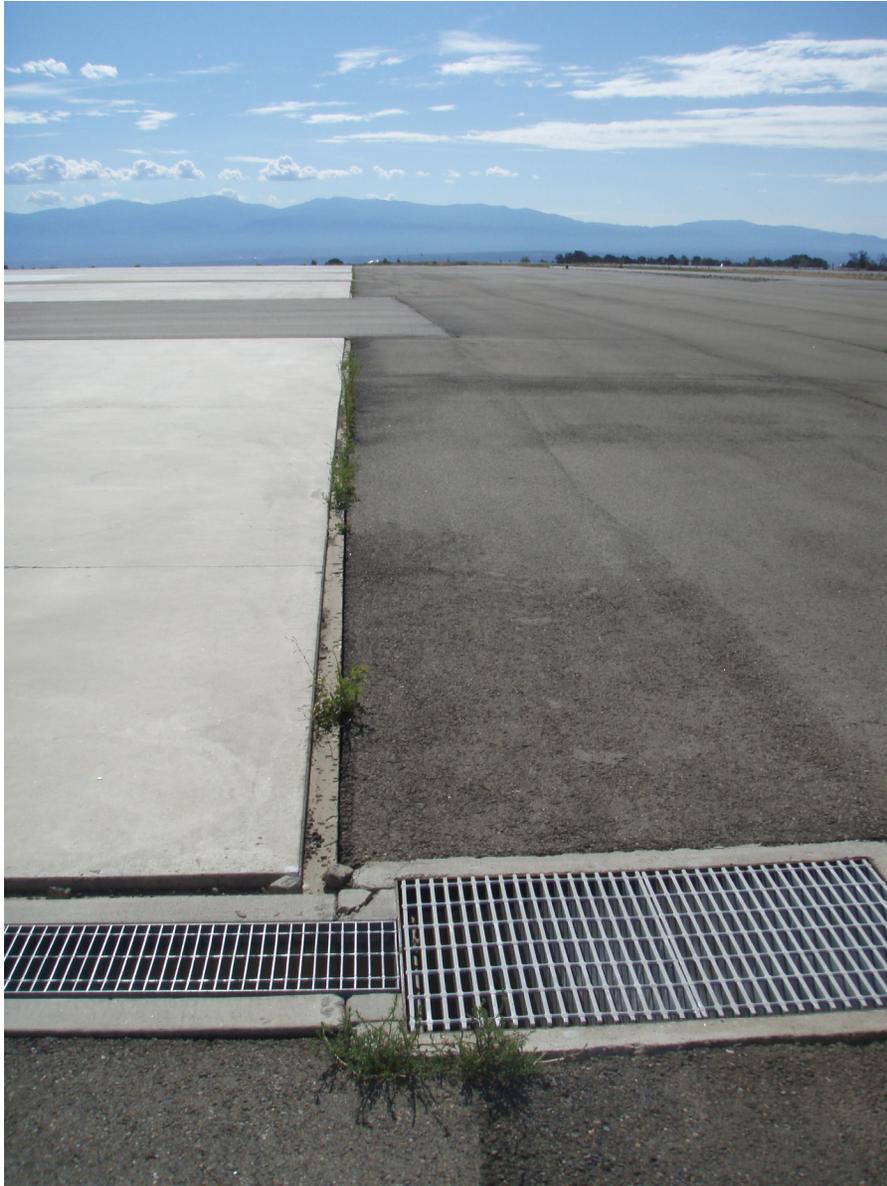
Photo 4: vegetation along contact of pad #1 and asphalt.

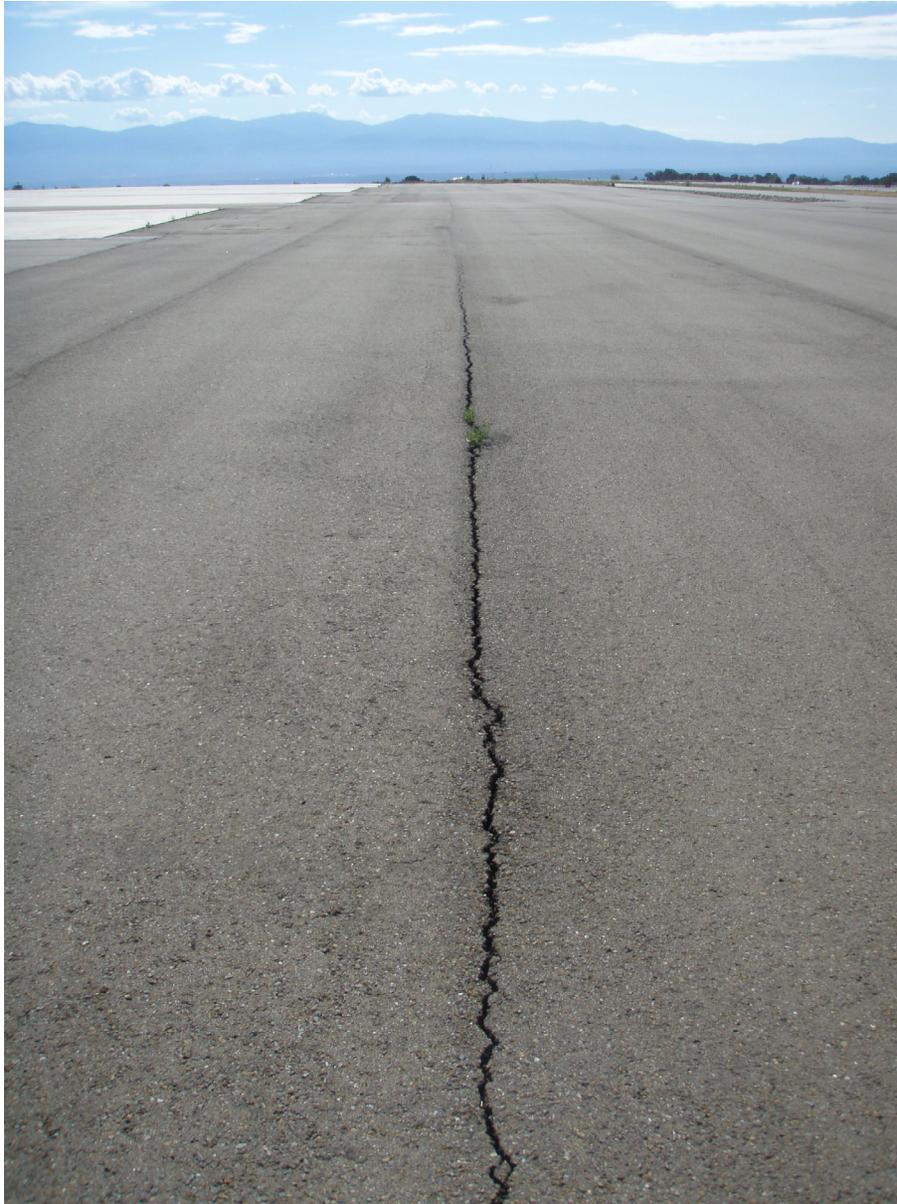
Photo 5: Example of crack in MatCon.

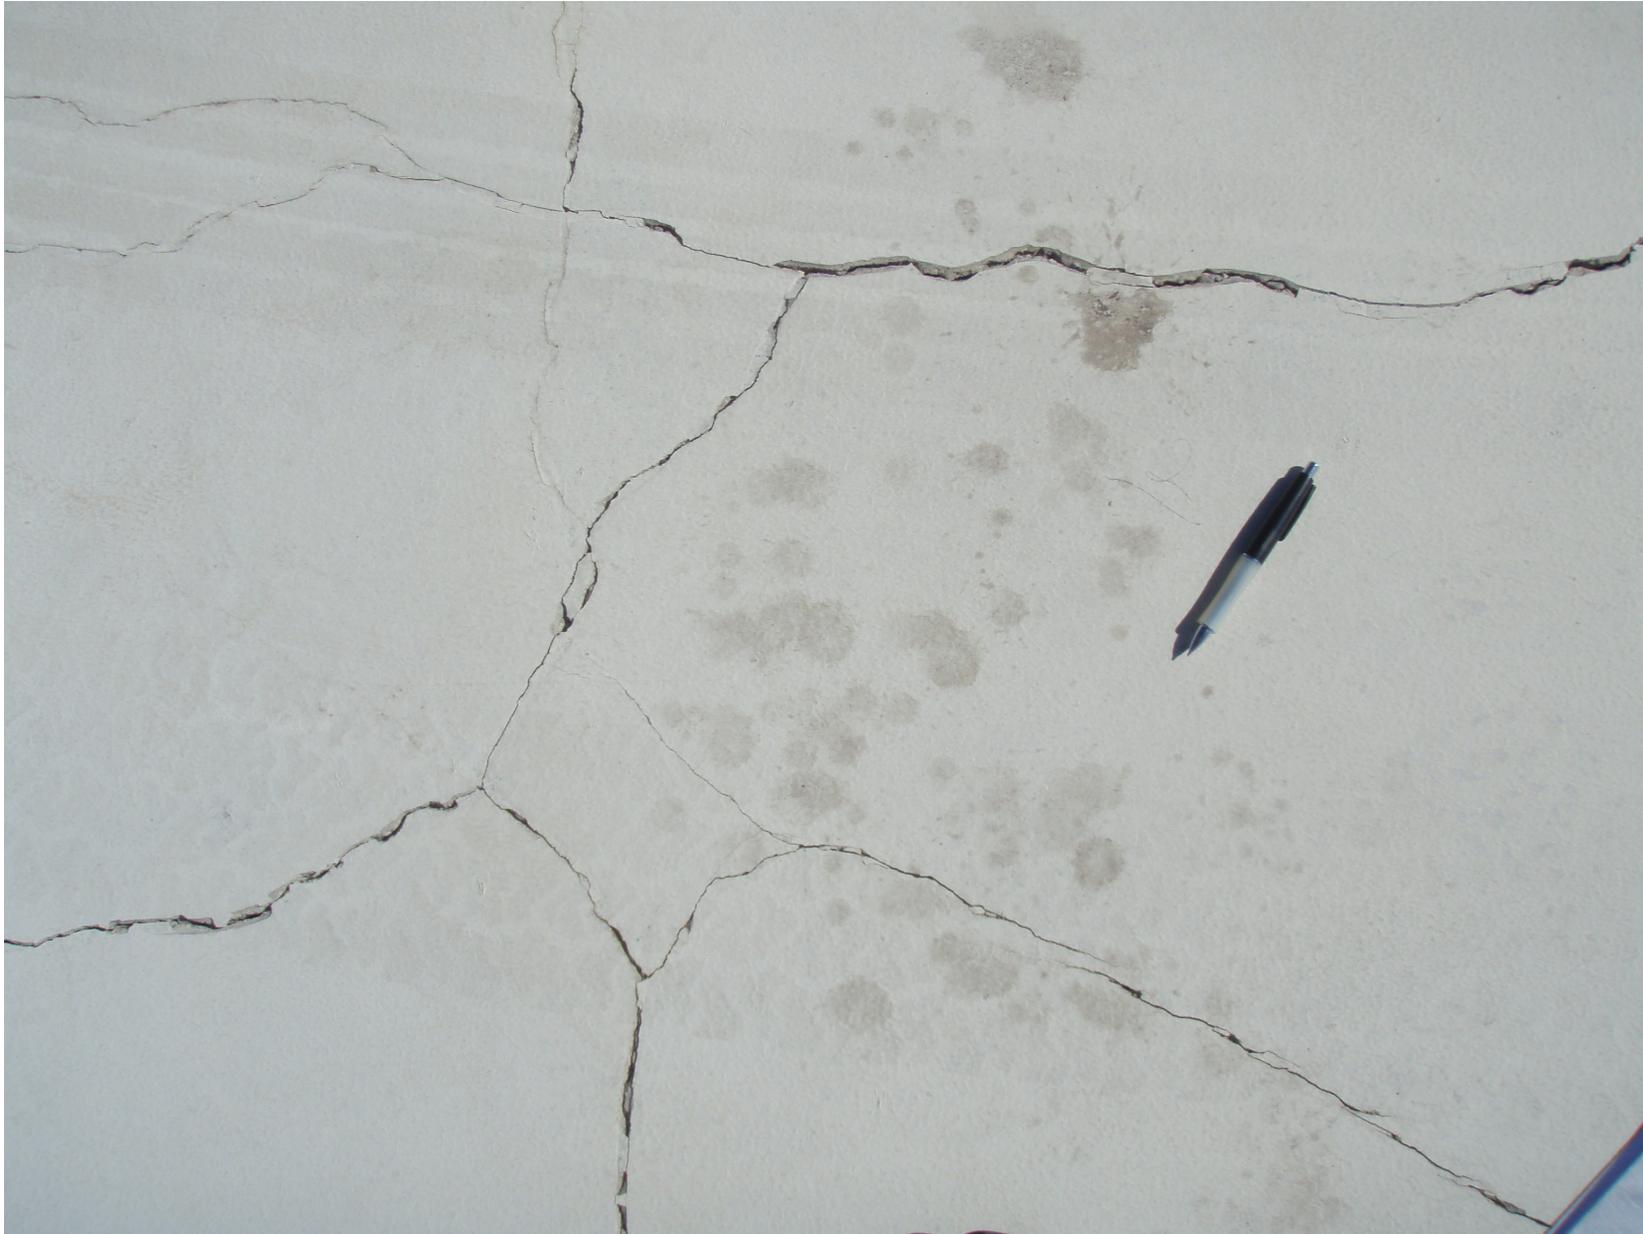
Photo 7: Cracks in pad #2.

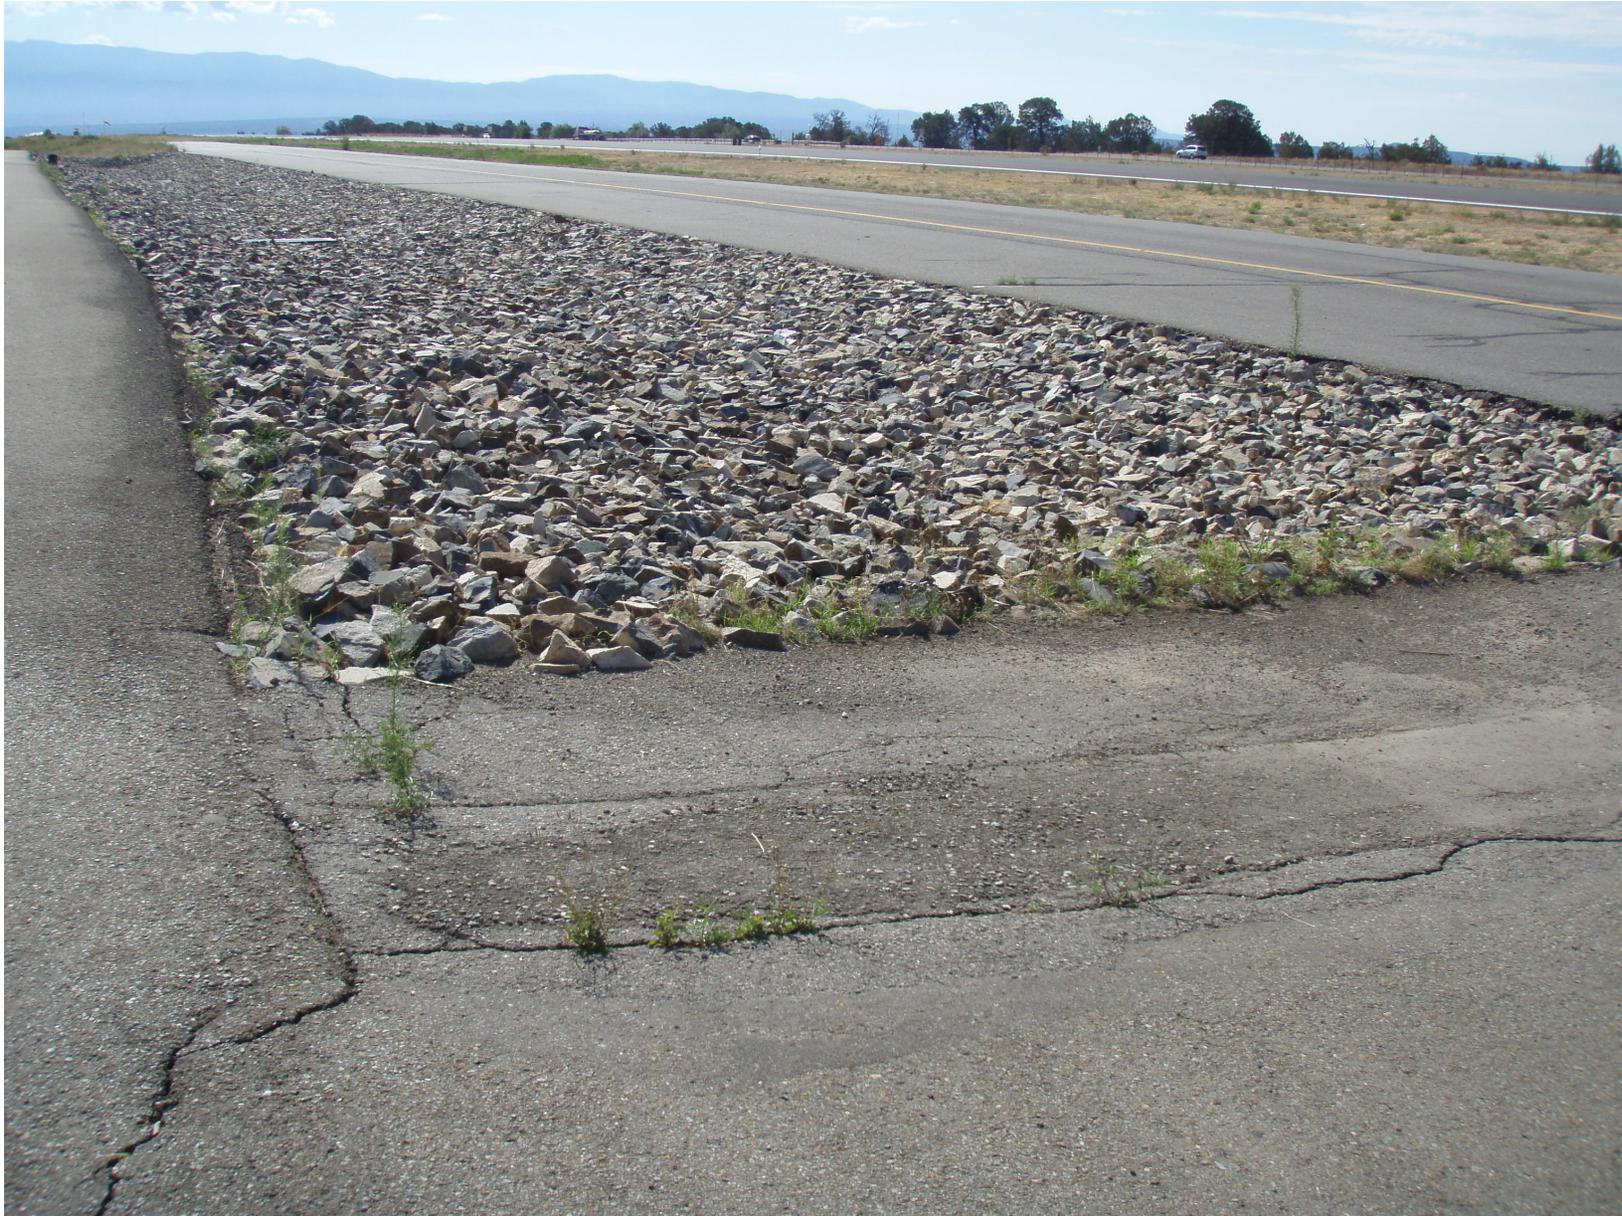
Photo 12: Cracking and vegetation in MatCon.

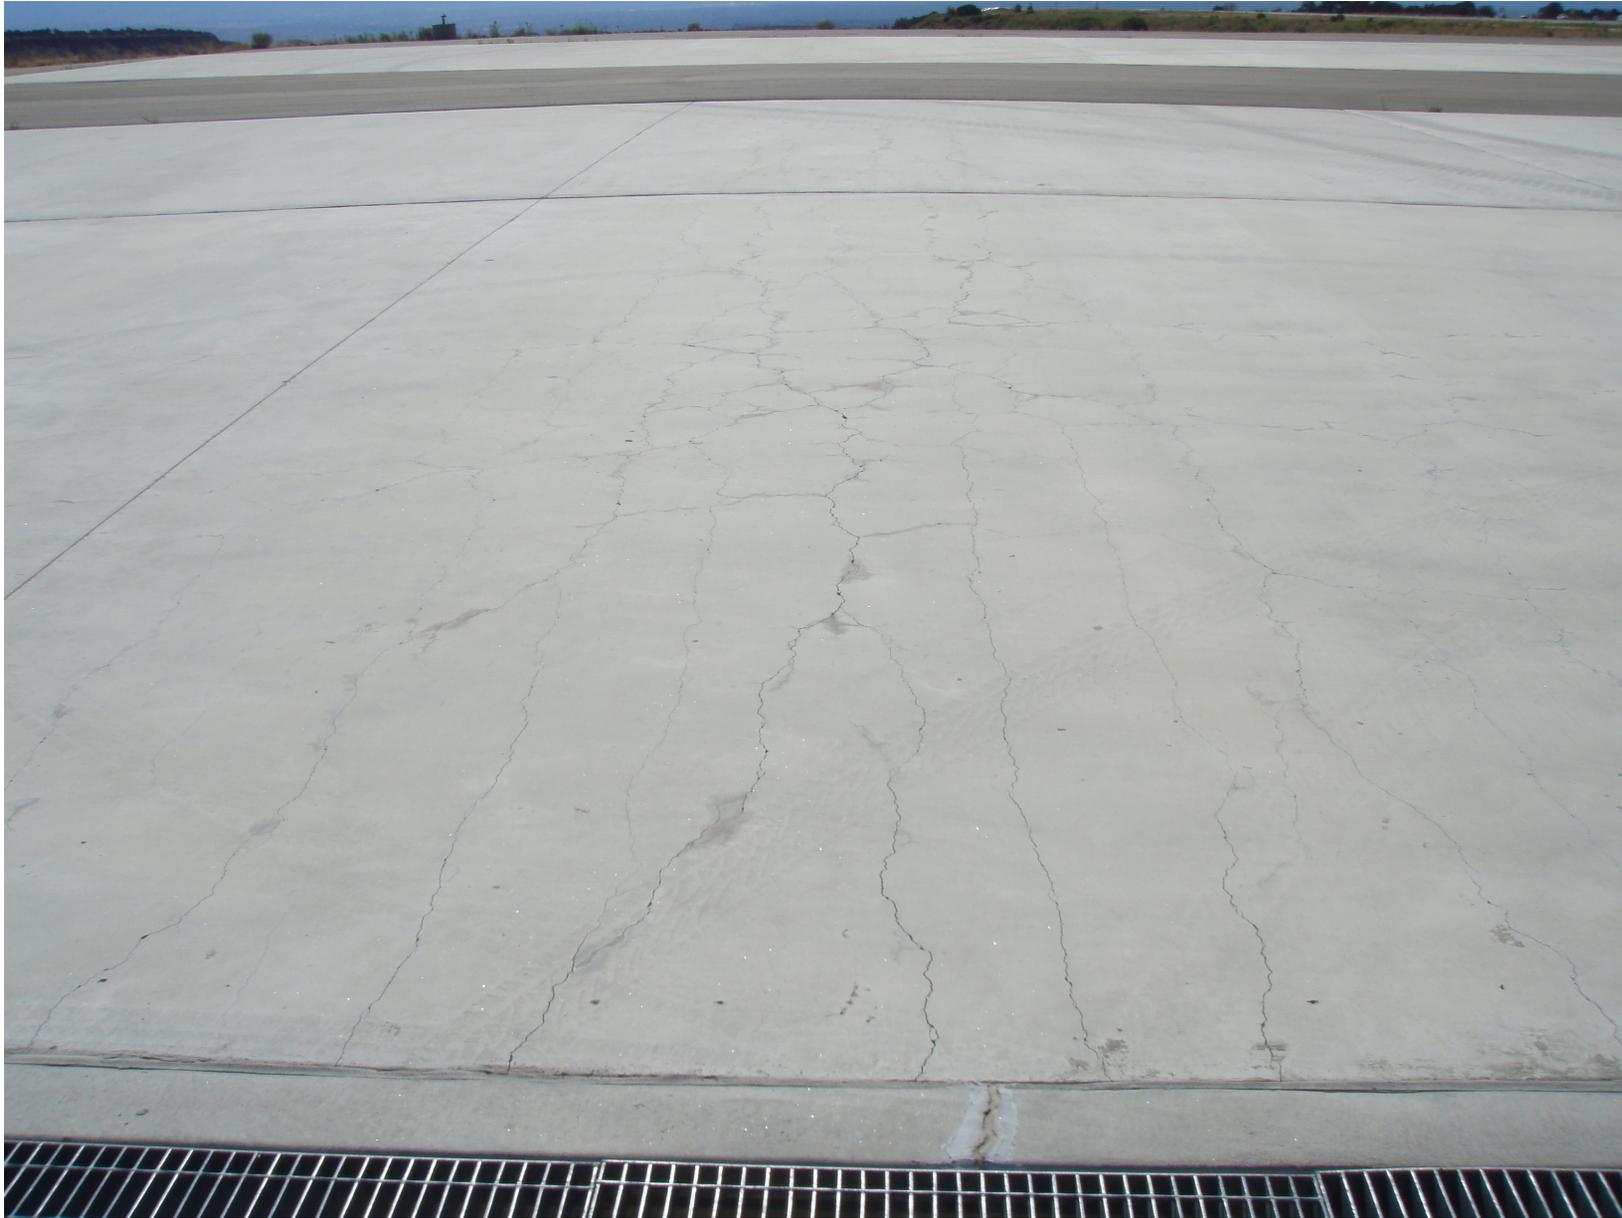
Photo 13: East view of cracking in pad #4.

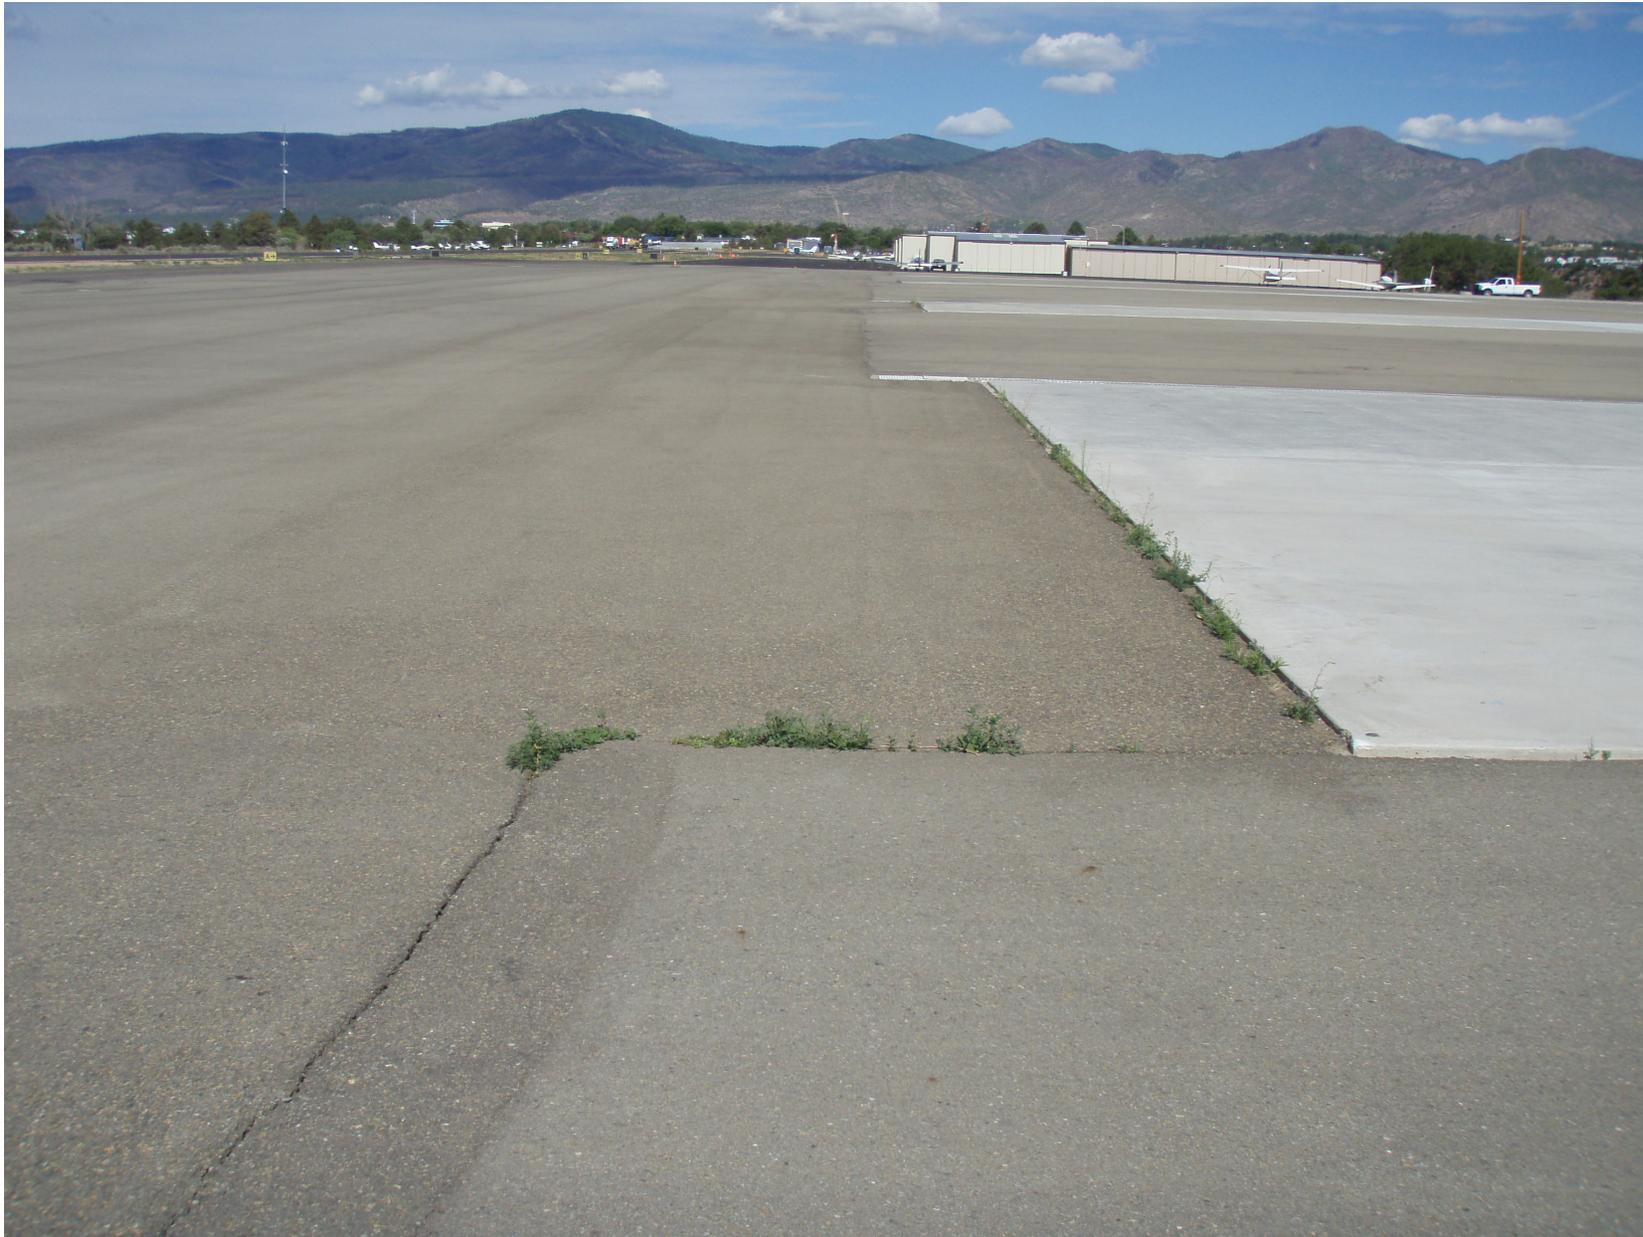
Photo 14: Vegetation and cracking at Southeast corner of pad #4.

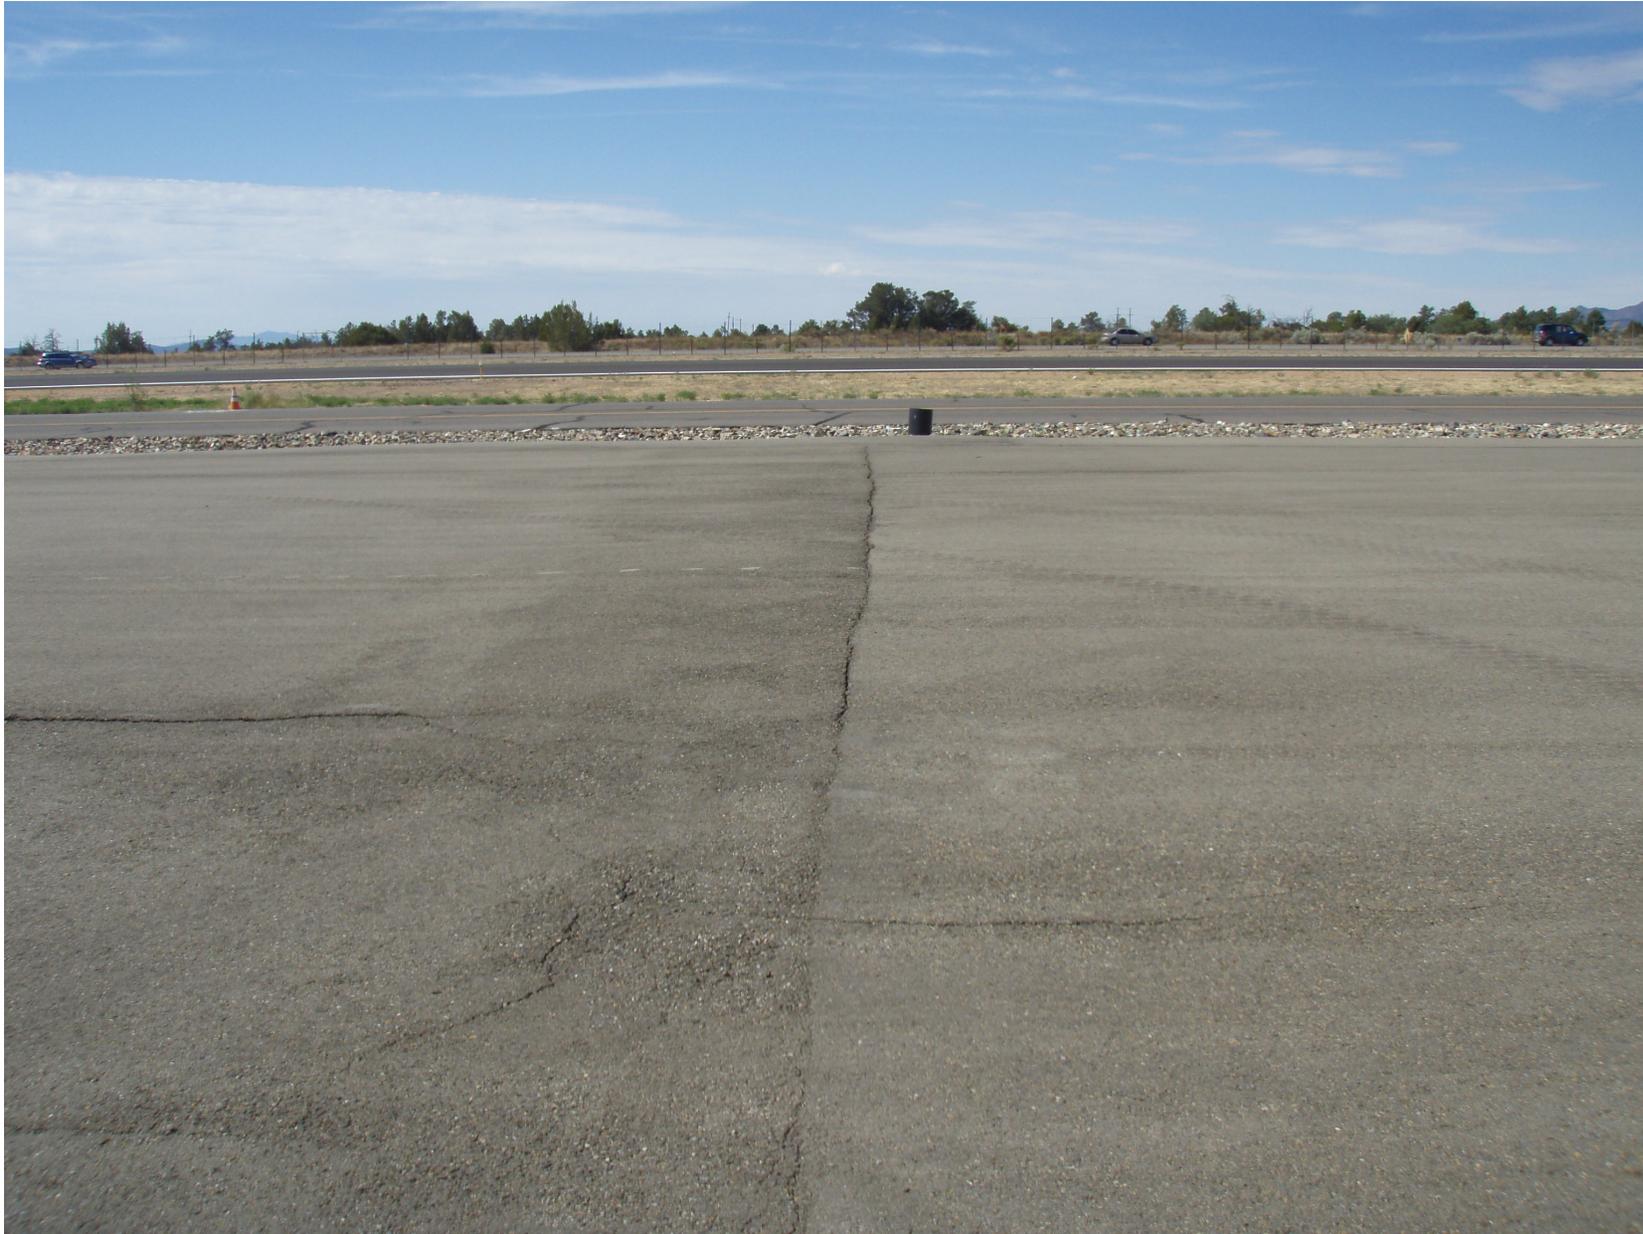
Photo 15: Cracks in MatCon south of pad #4.

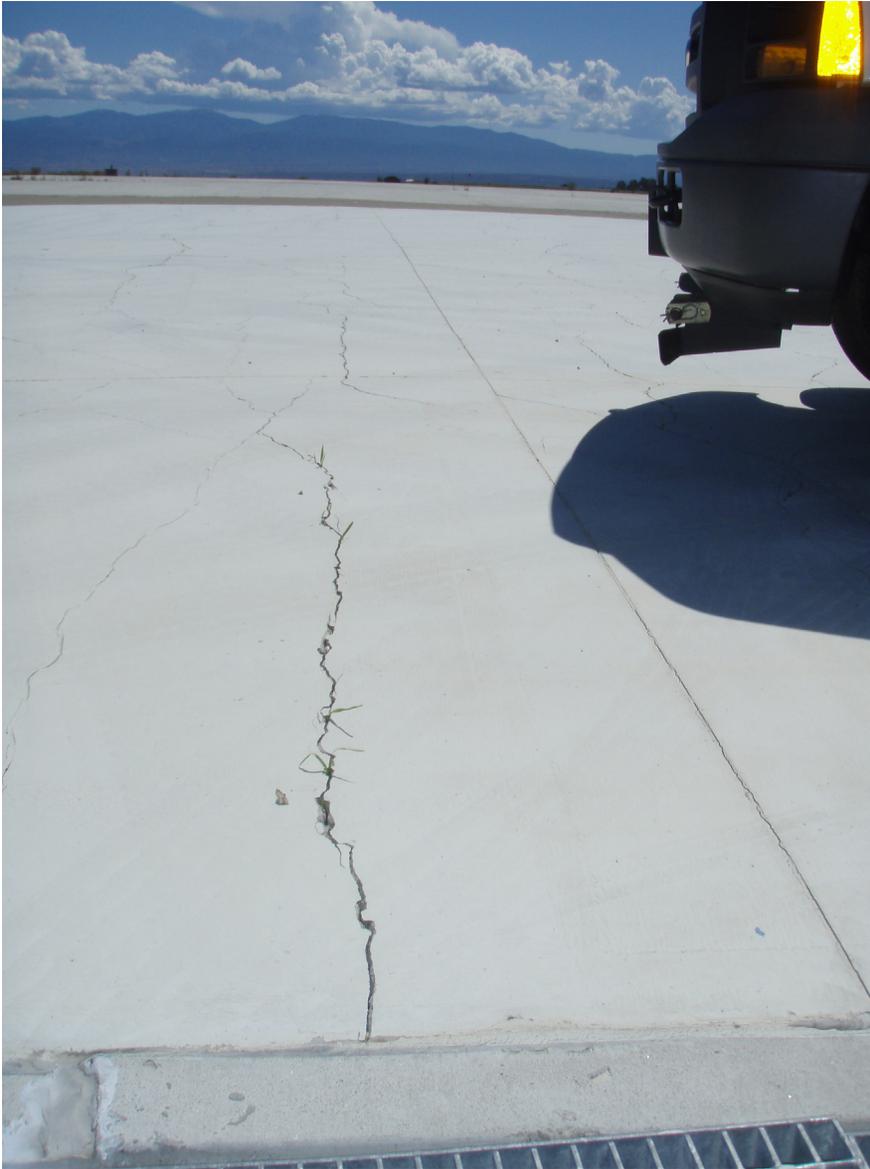
Photo # 2: View west at pad # 3. Grasses growing in east-west oriented crack.

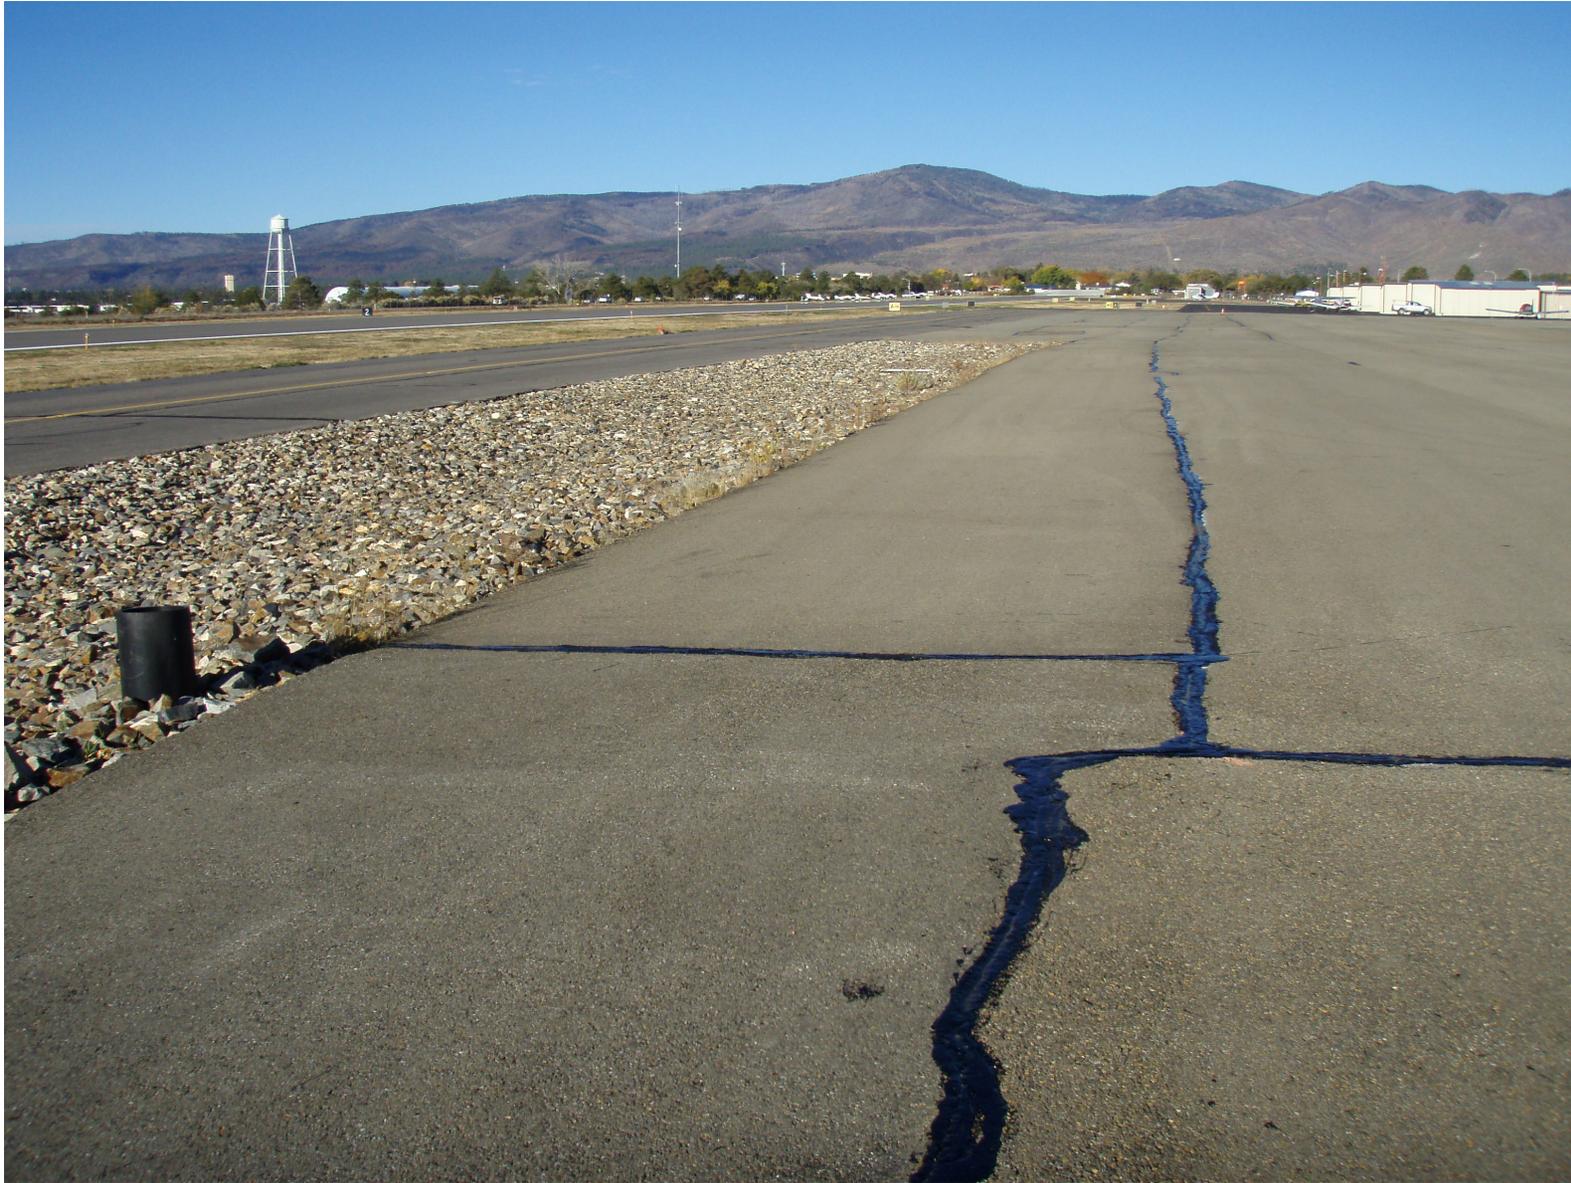
Photo1: Sealed cracks in MatCon
