**Subject: Submittal of the 2011 Annual Inspection Report for Los Alamos County
Airport Landfill, Solid Waste Management Units 73-001(a) and 73-001(d),
Technical Area 73**

LA-UR-12-0671
February 2012
EP2012-0018

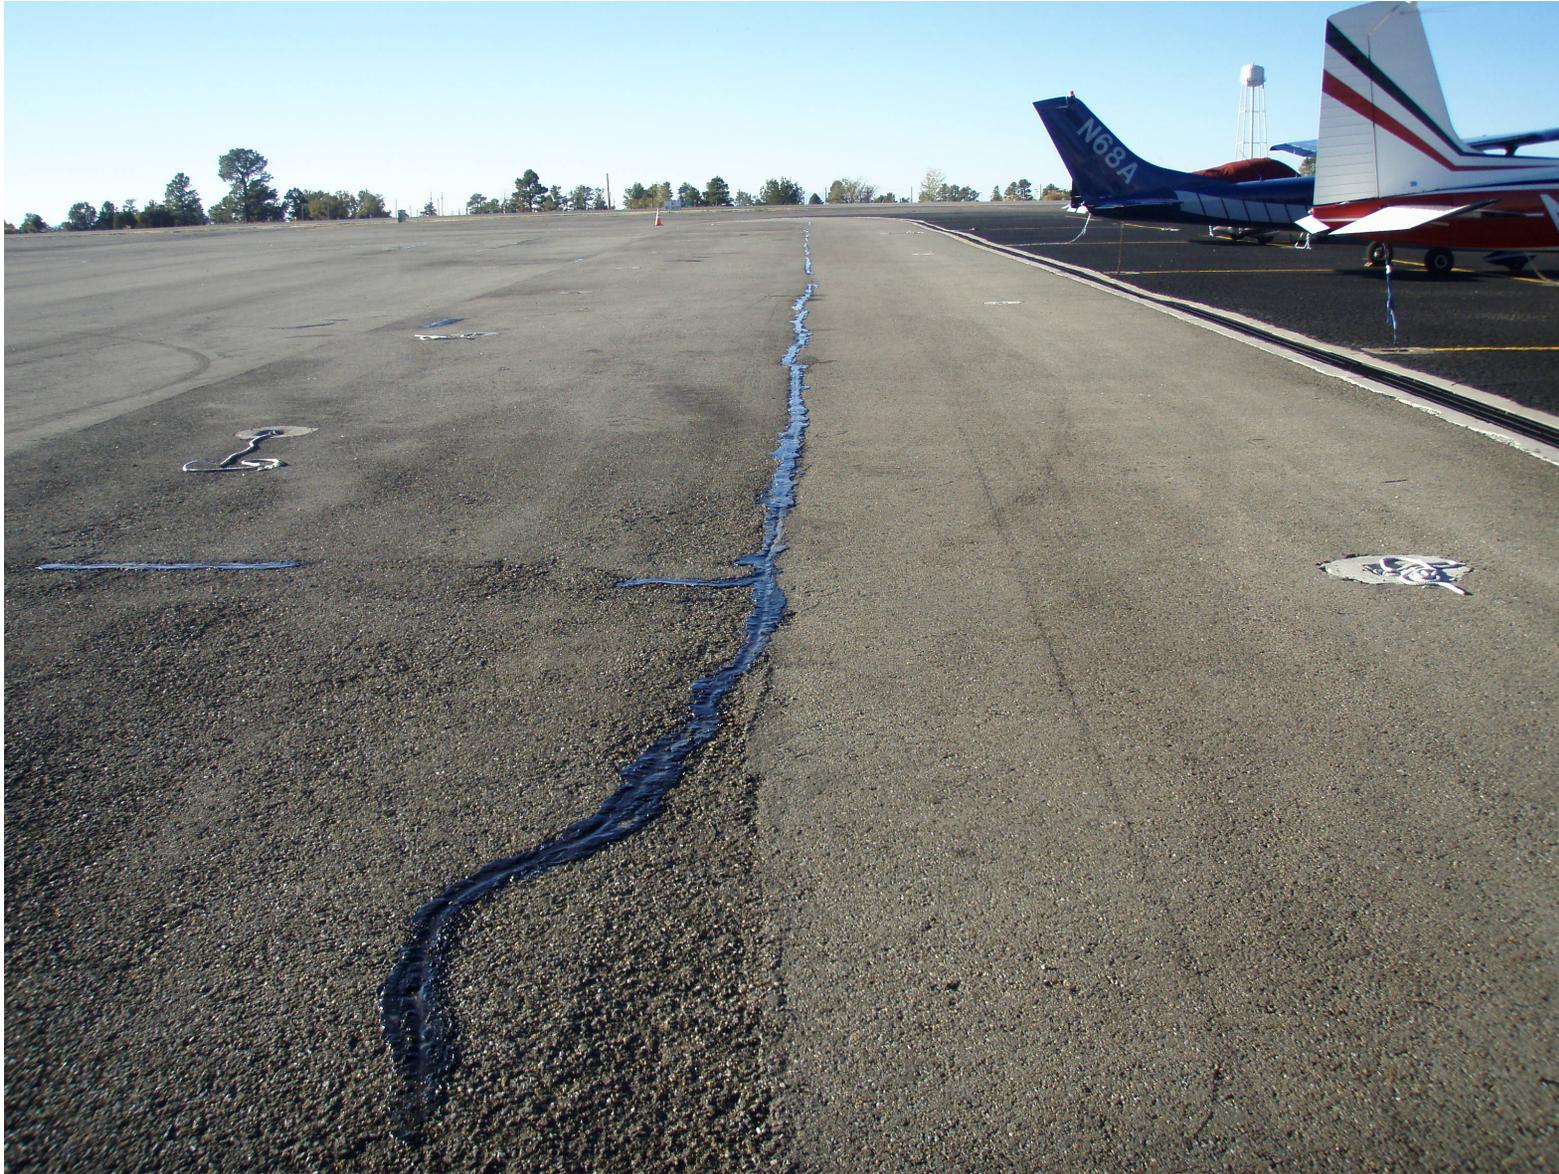
Photo 8: Crack repaired in MatCon. Note tie downs were not sealed and contact with trench drain was not sealed.

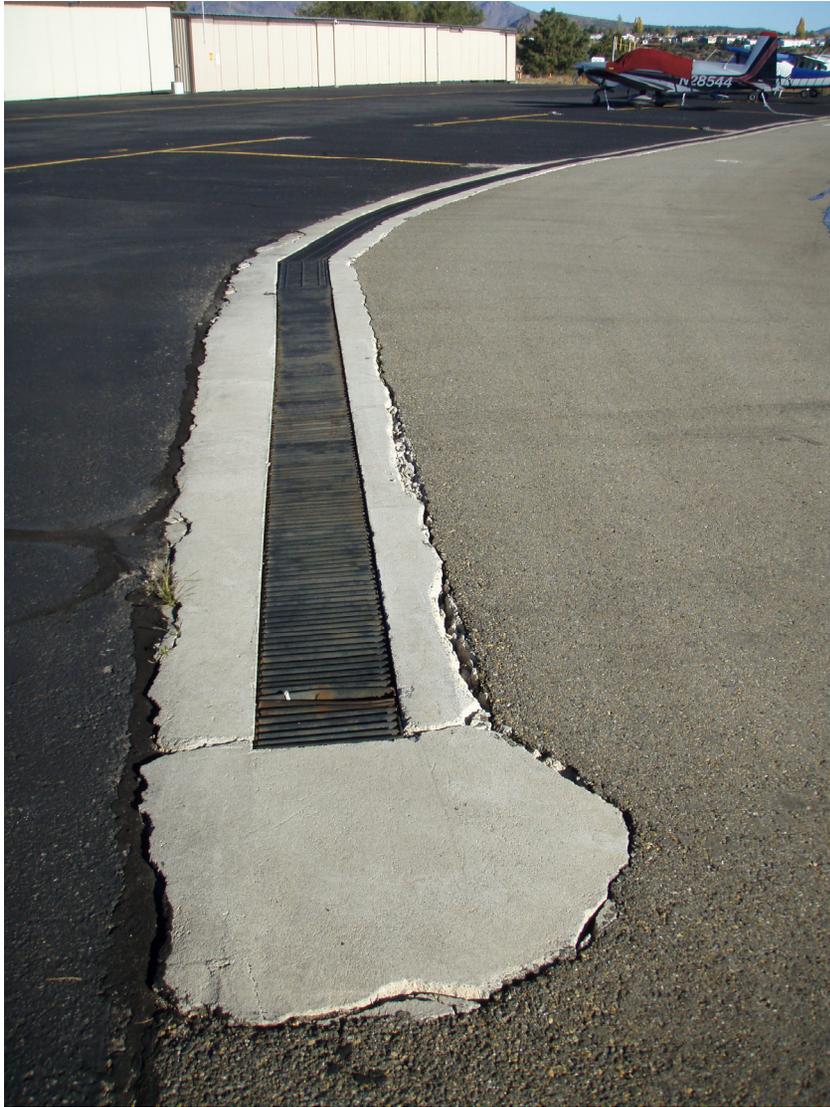
Photo 9: Contact joint with trench drain was not sealed.

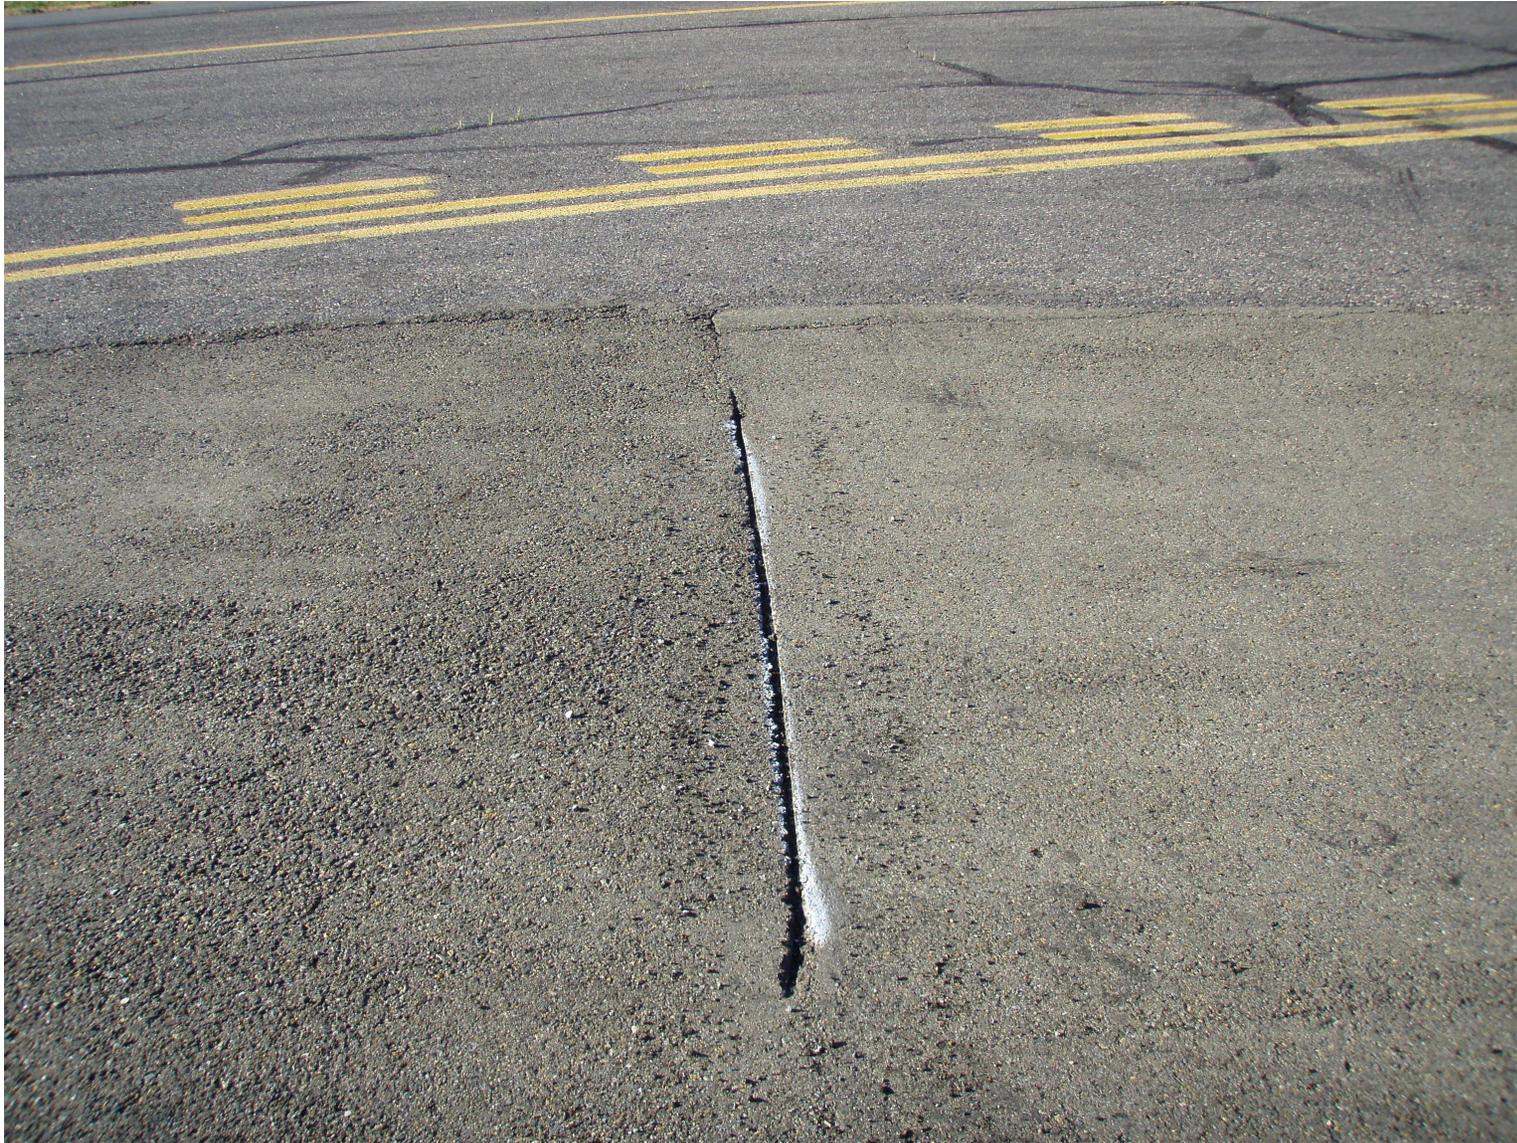
Photo 10: Crack in Matcon was prepared for sealing but was not completed. Note contact joint with tarmac was not sealed.

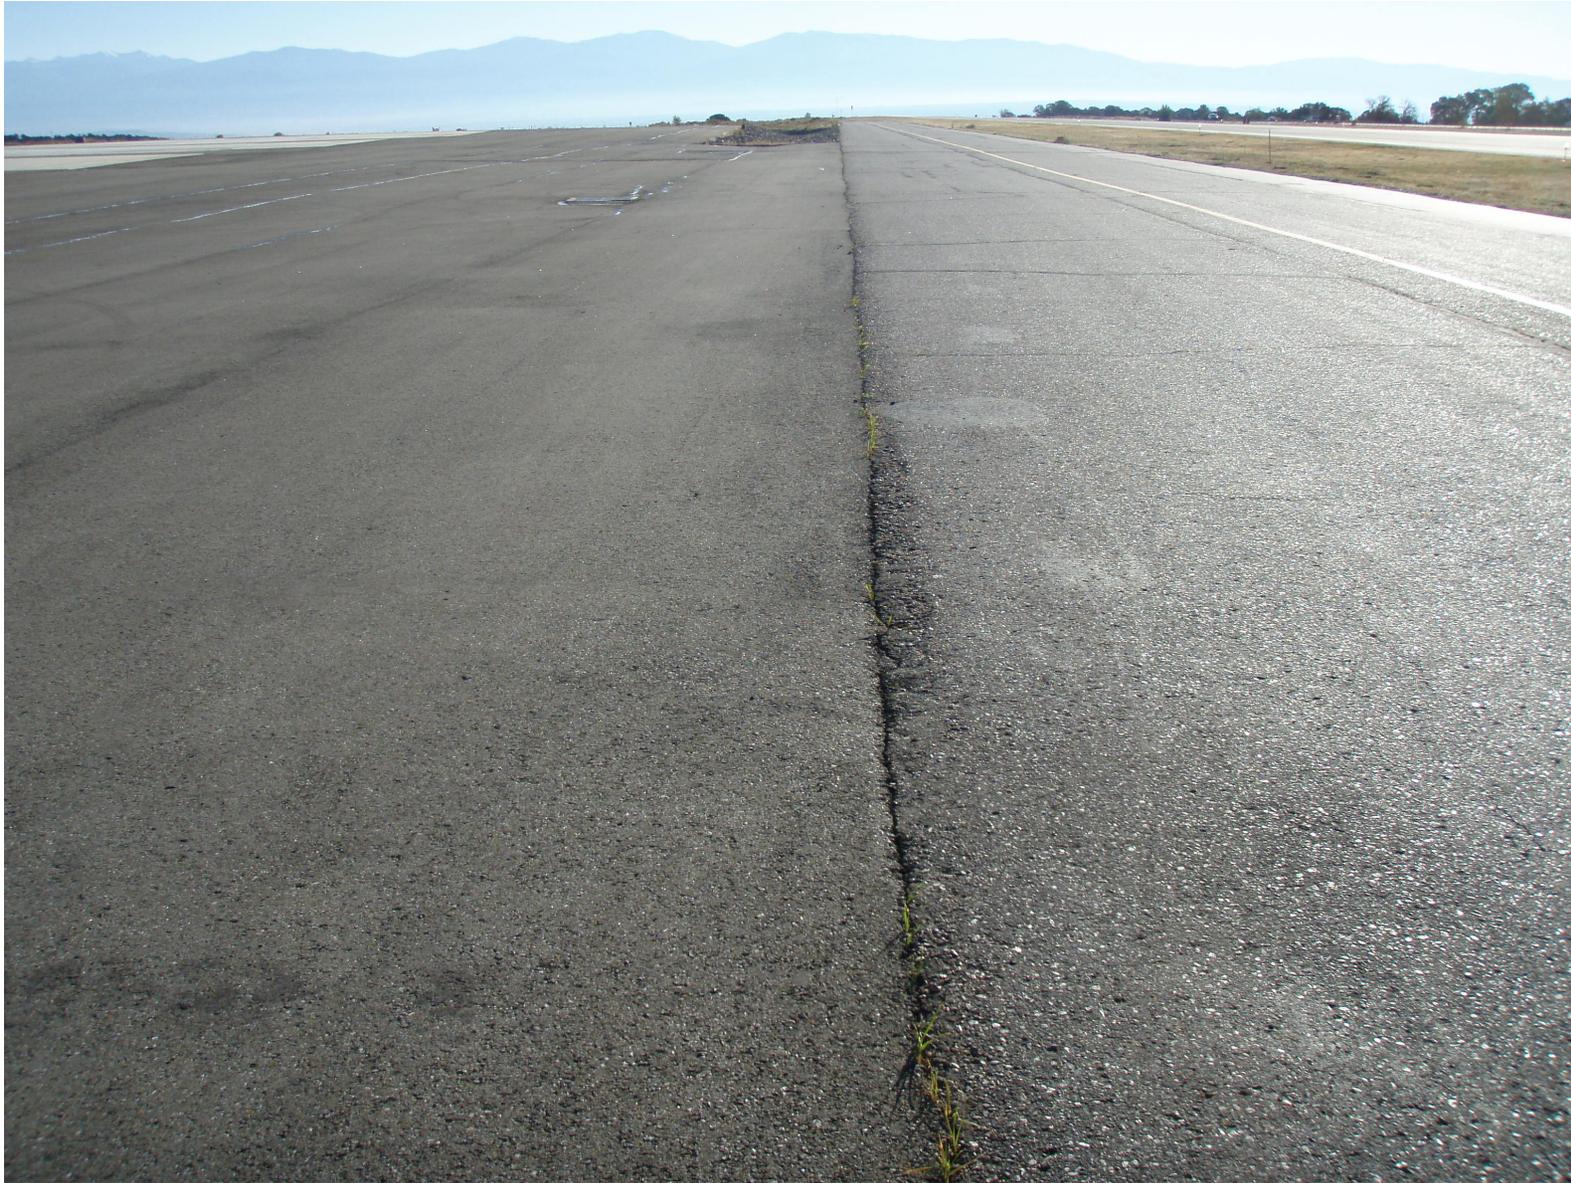
Photo 11: Contact joint between MatCon and access road was not sealed, note vegetation in joint.

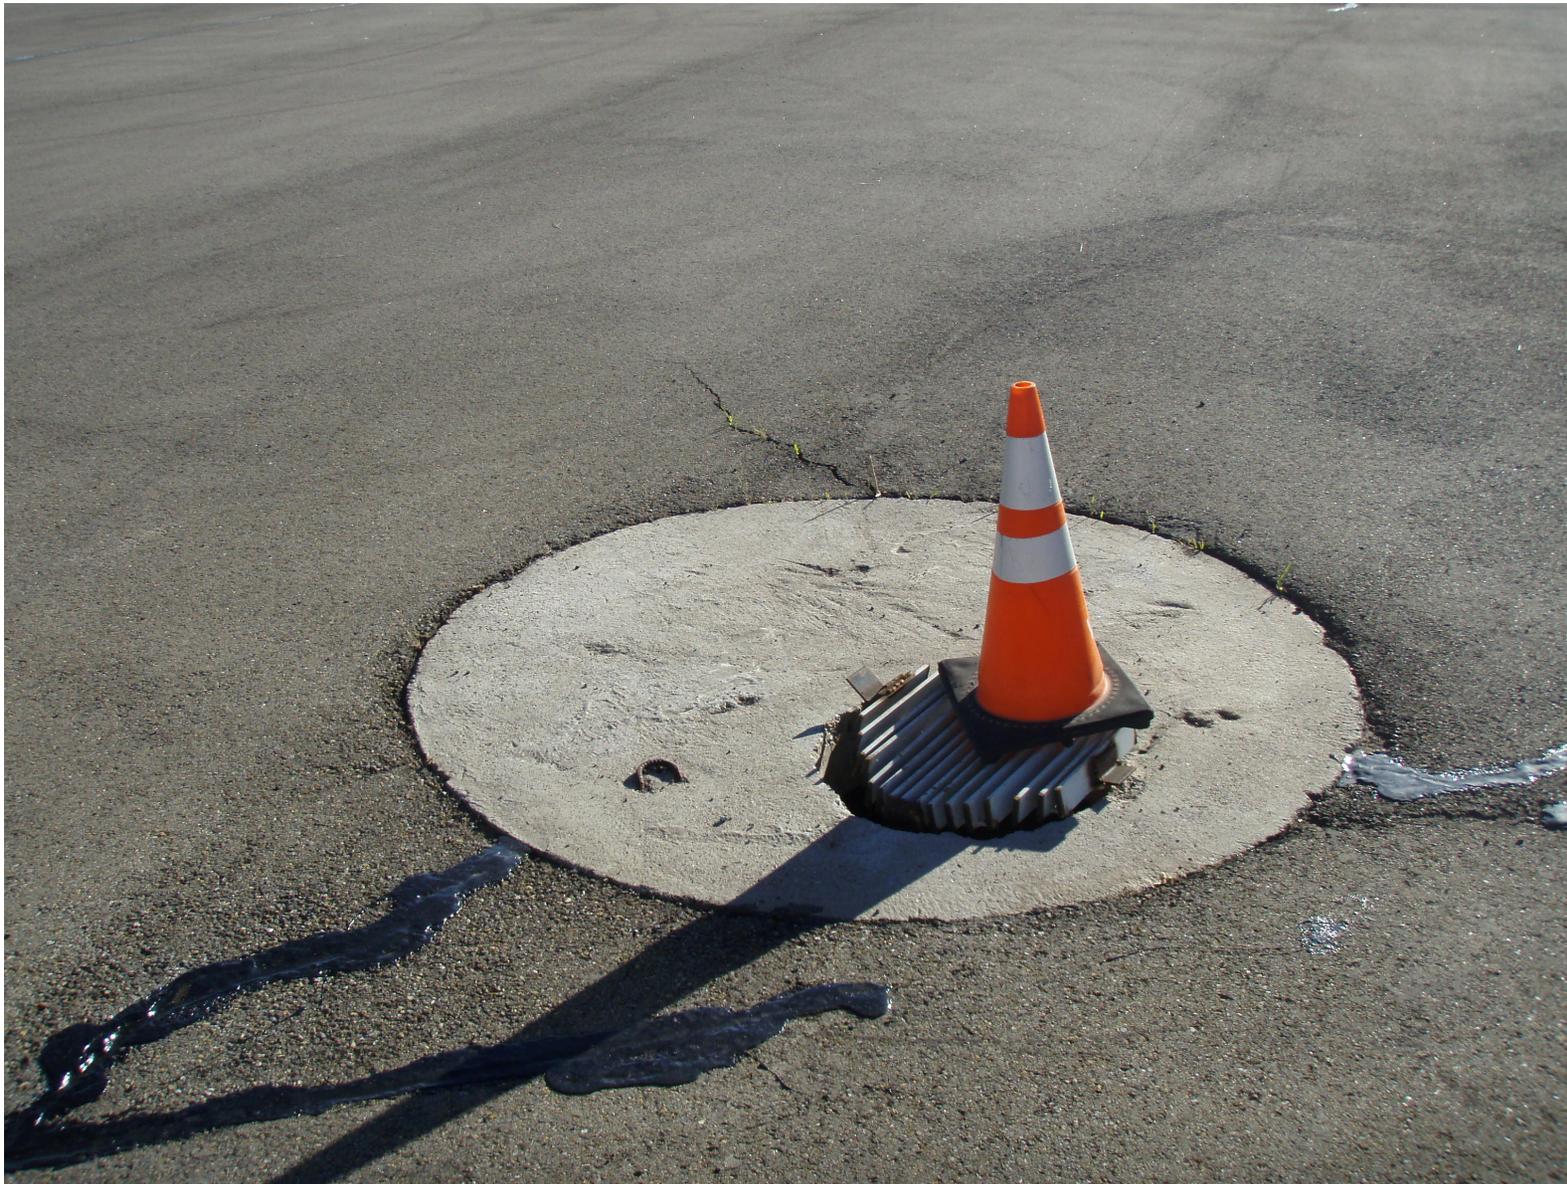
Photo 12: Area around drop inlet was not sealed, note crack that was not sealed.

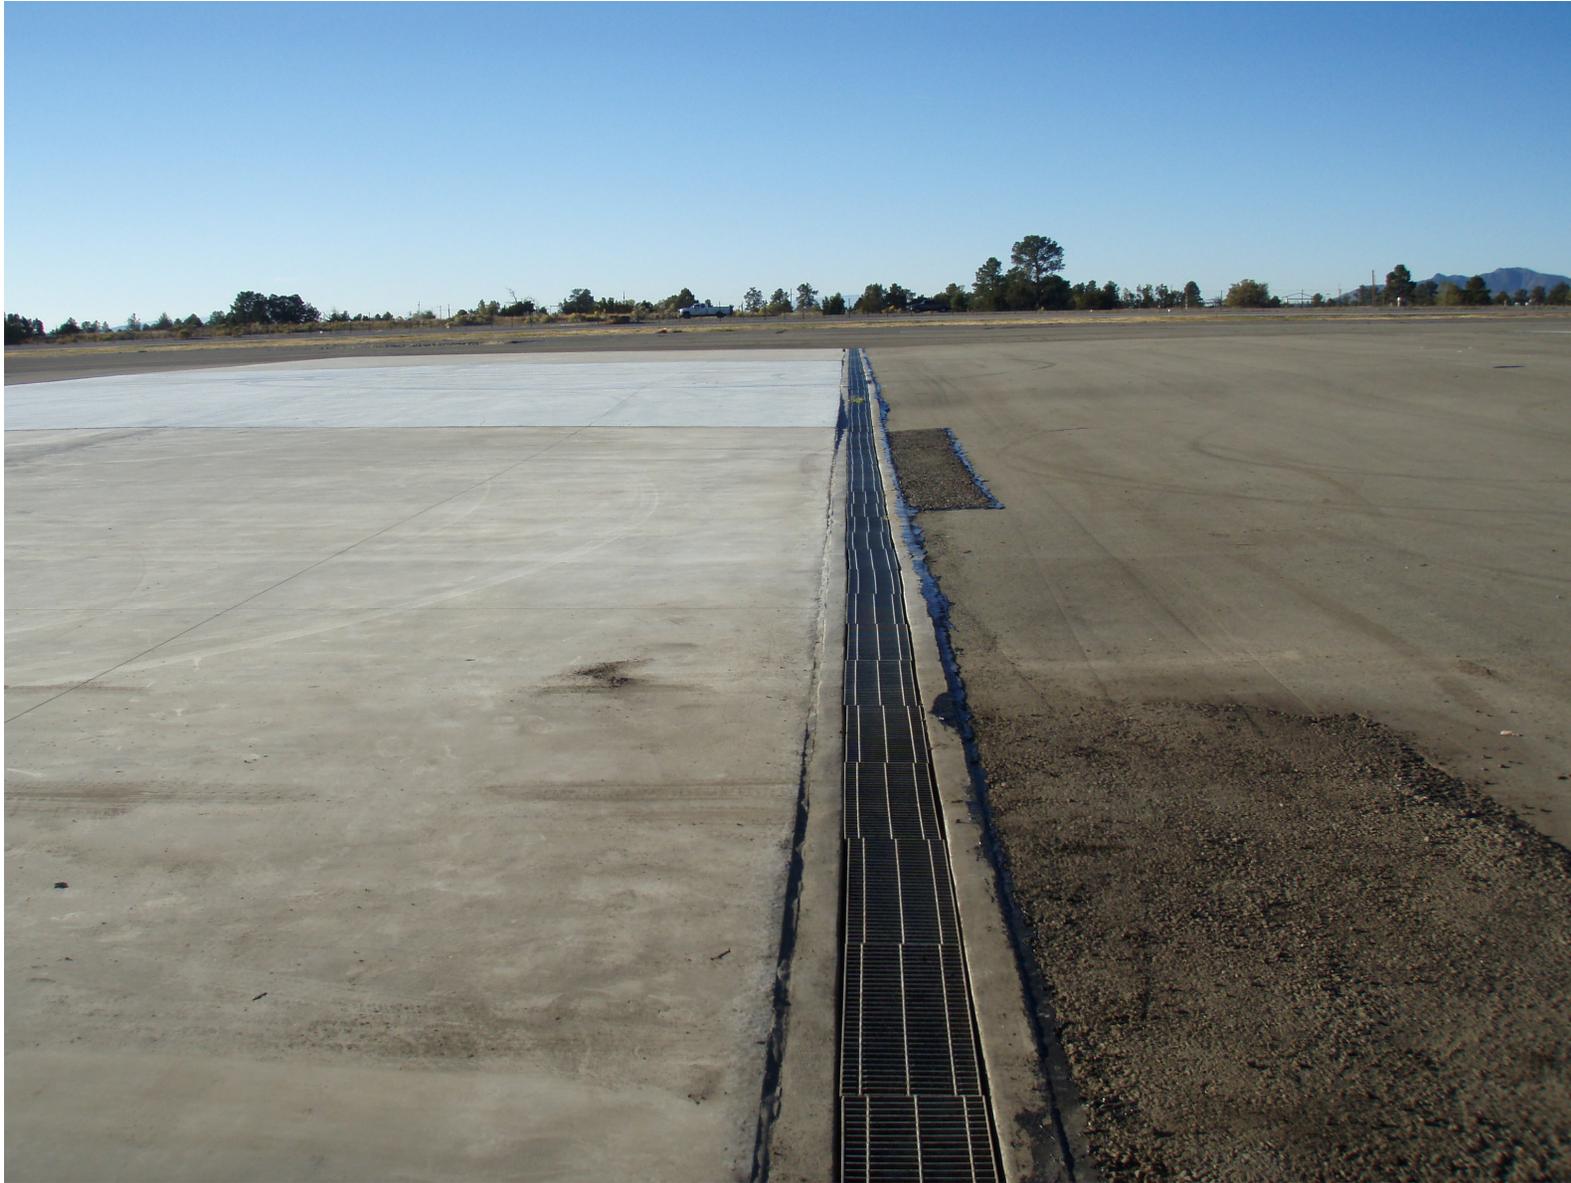
Photo 13: Seal between trench drain and MatCon is visible. Note asphalt patches, one sealed one not.

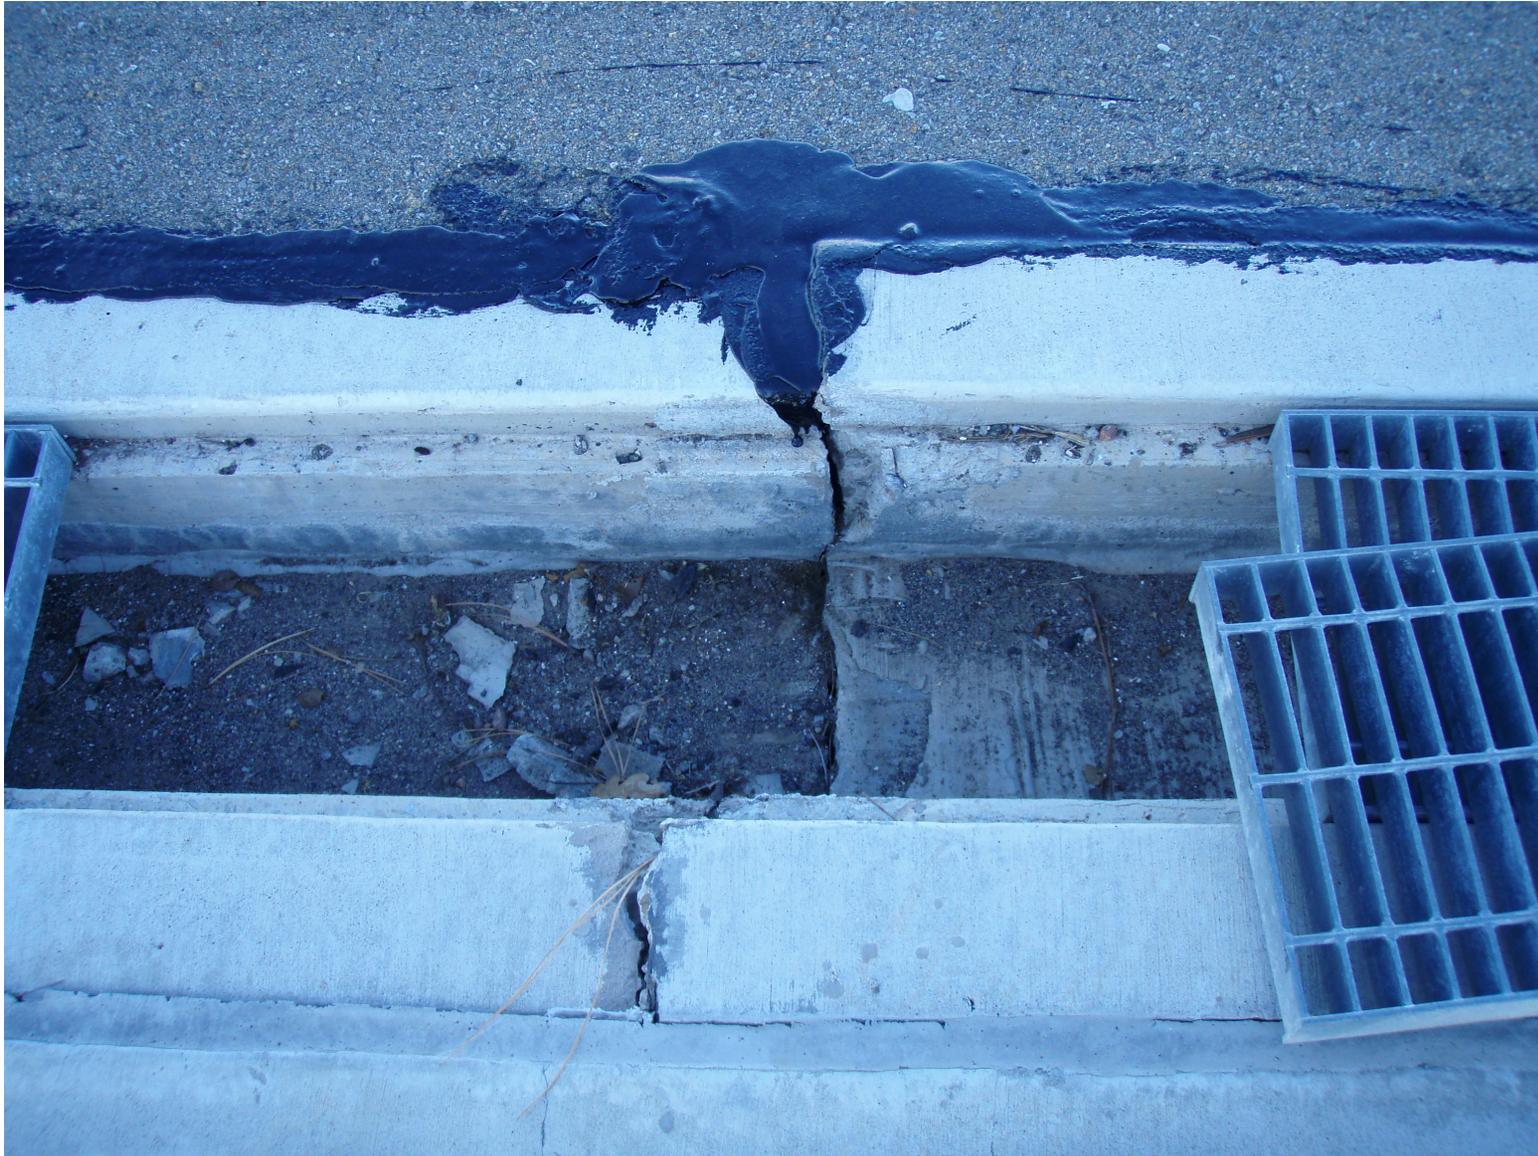
Photo 16: Seal between trench drain, note crack runs completely through drain and is not sealed.

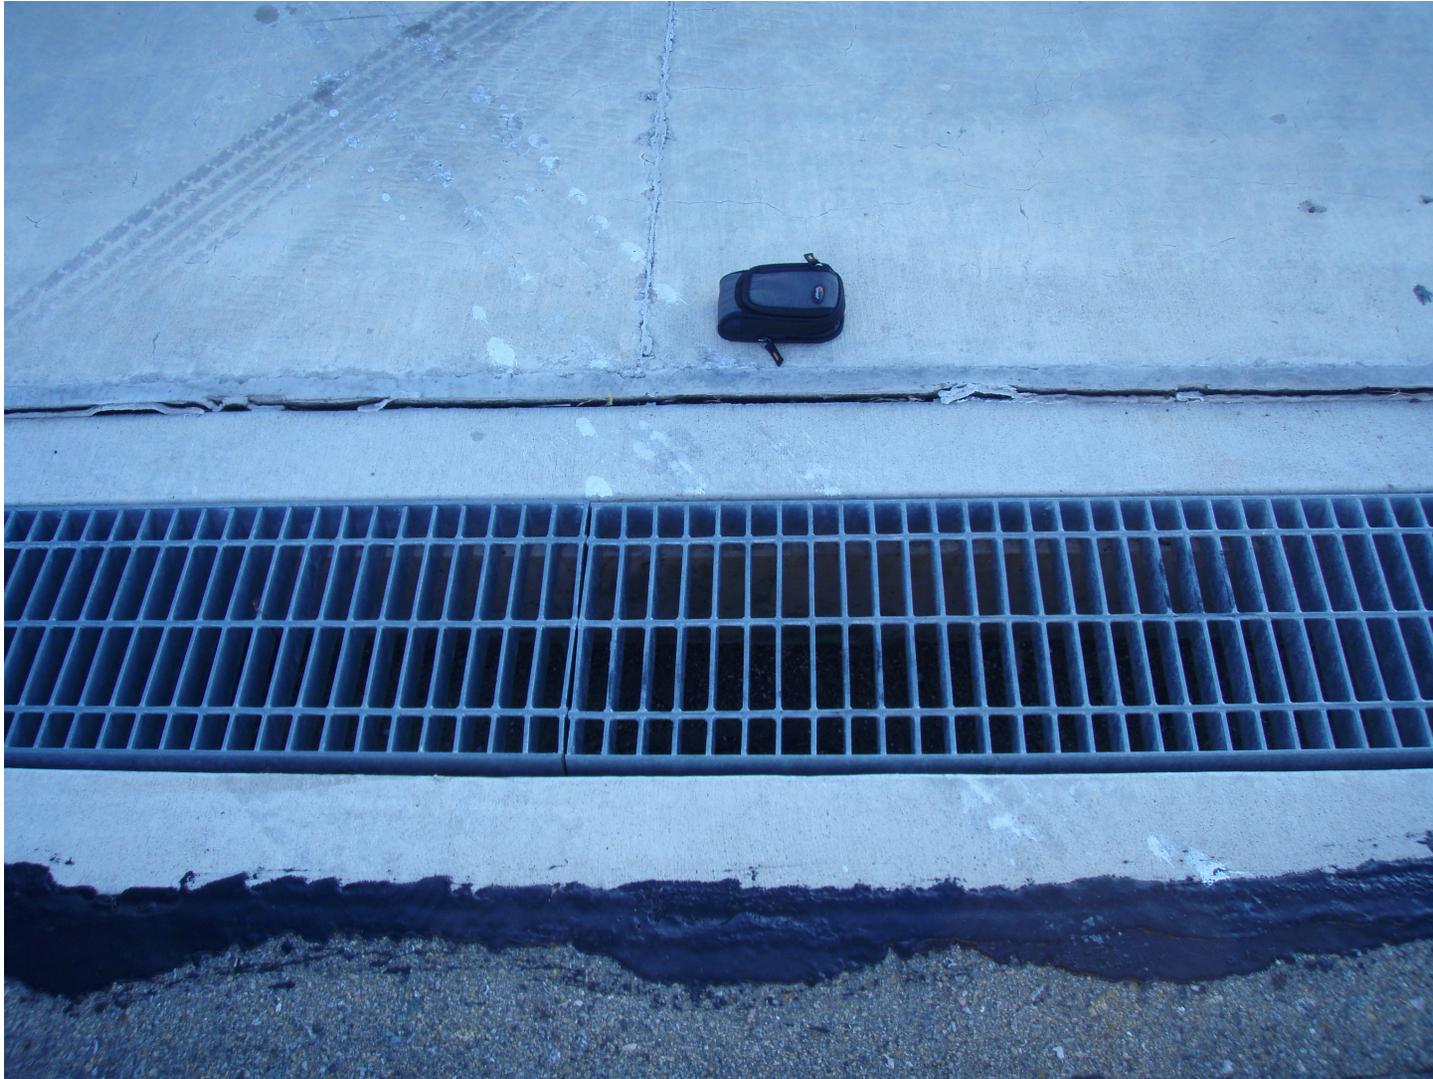
Photo 17: Seal between MatCon and trench drain. Note separation of trench drain and pad #1.

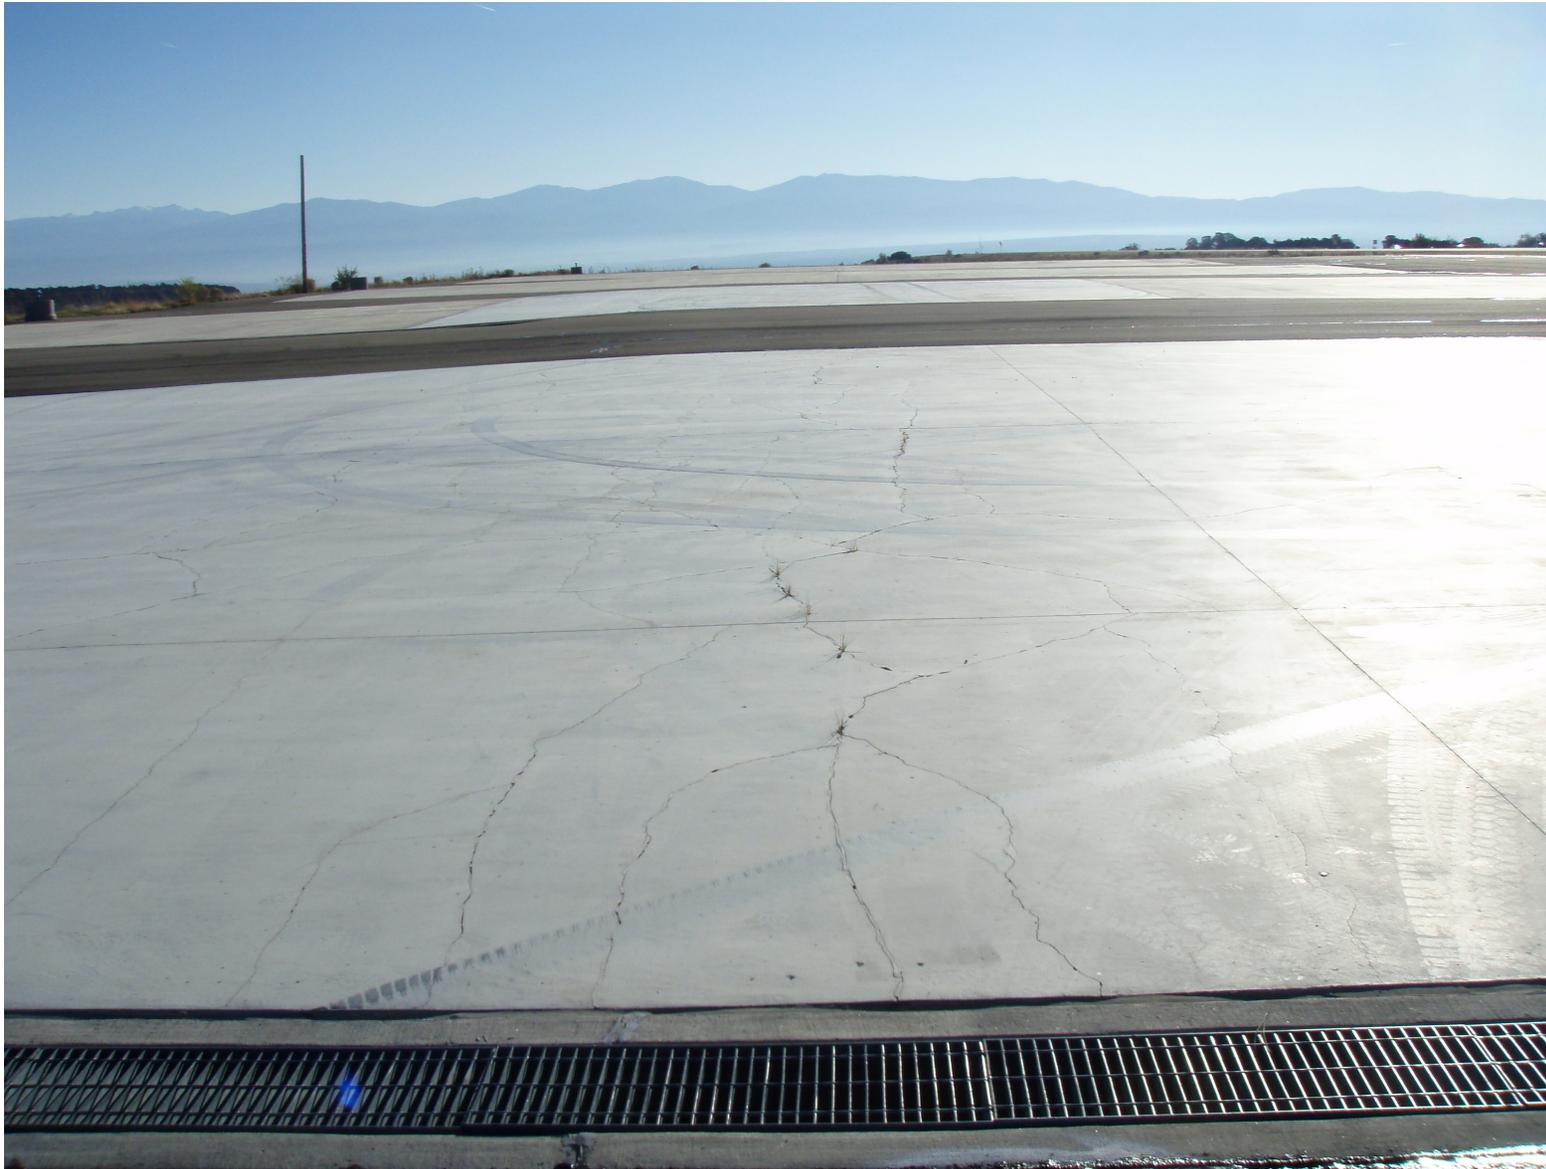
Photo 18: Cracking in pad 2 with an east-west orientation. Similar cracking in pads 1-4.

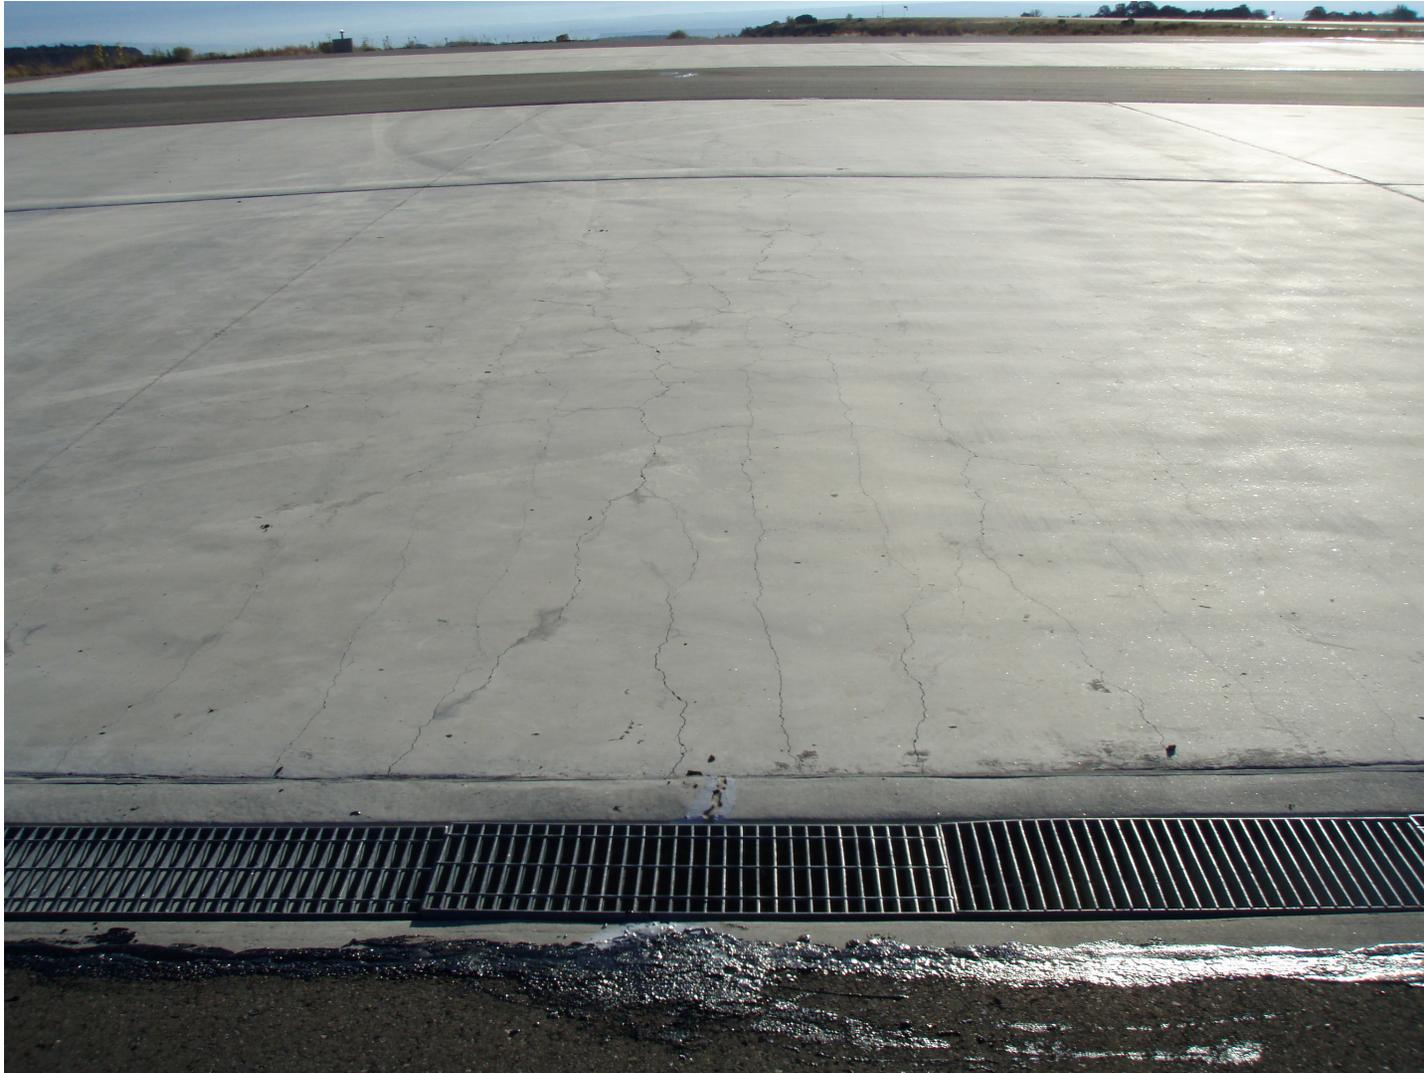
Photo 19: Cracking in pad #4.

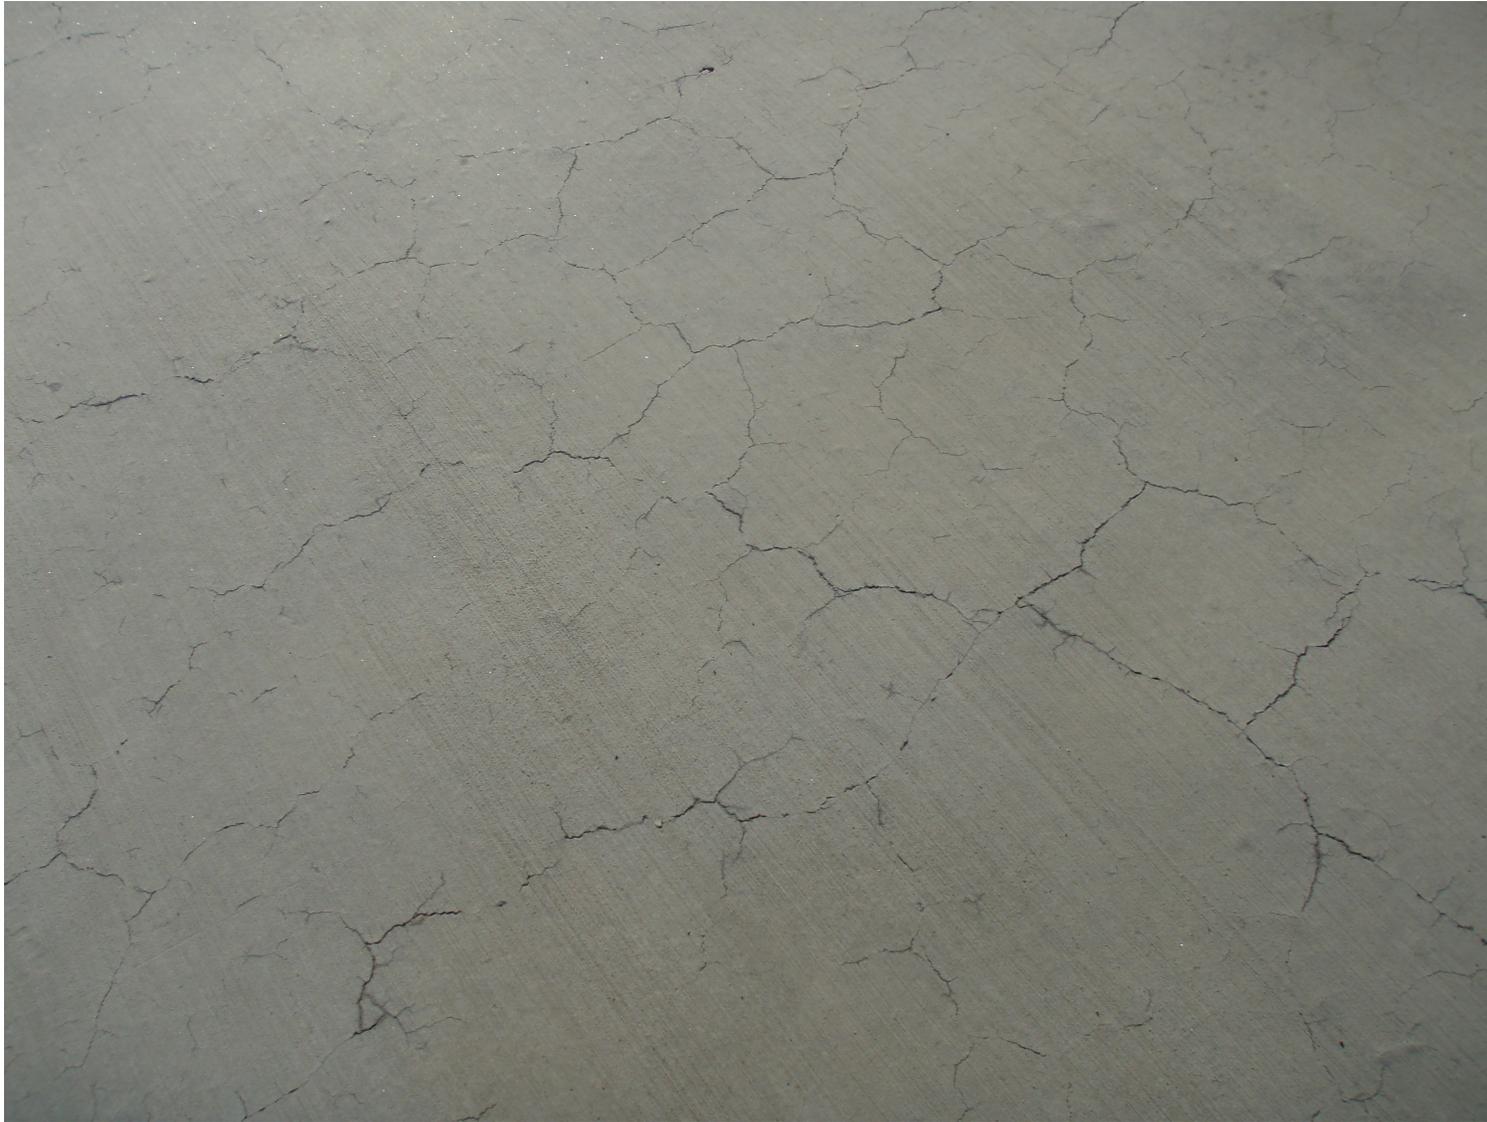
Photo 20: spider web type cracking is visible in all pads.

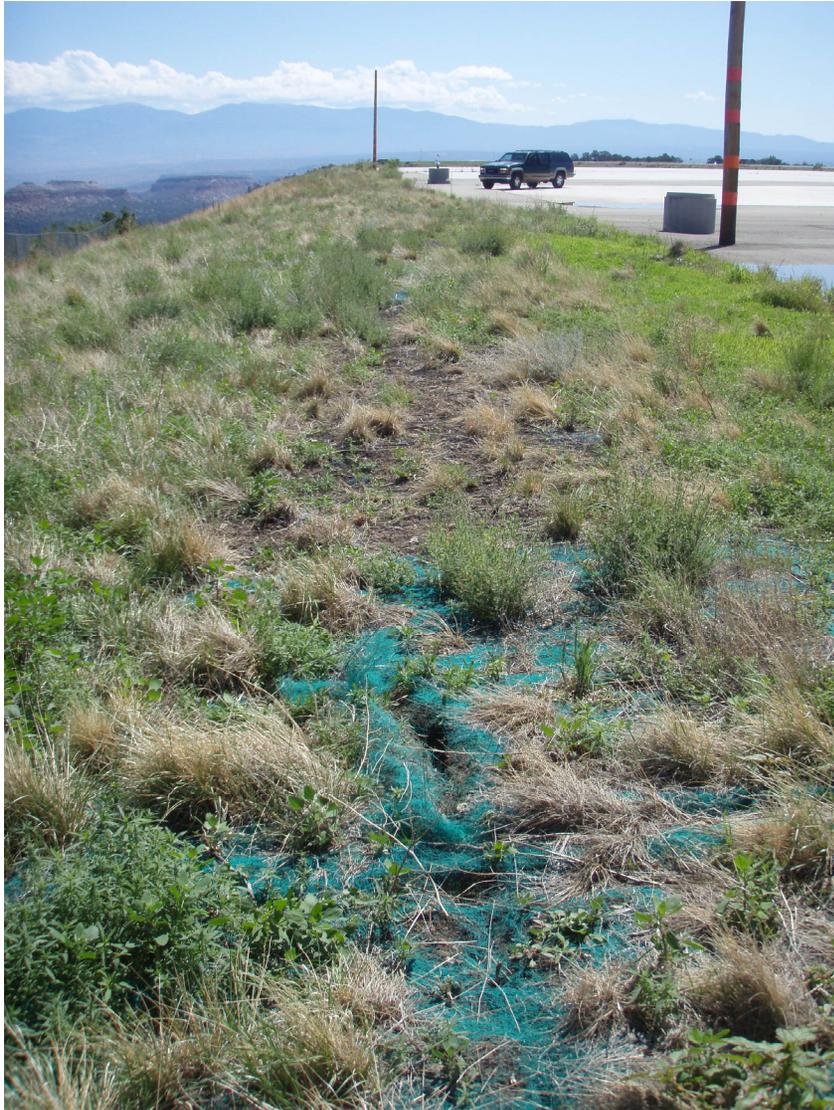
Photo 3: Trace of soil crack is visible down center of photo.

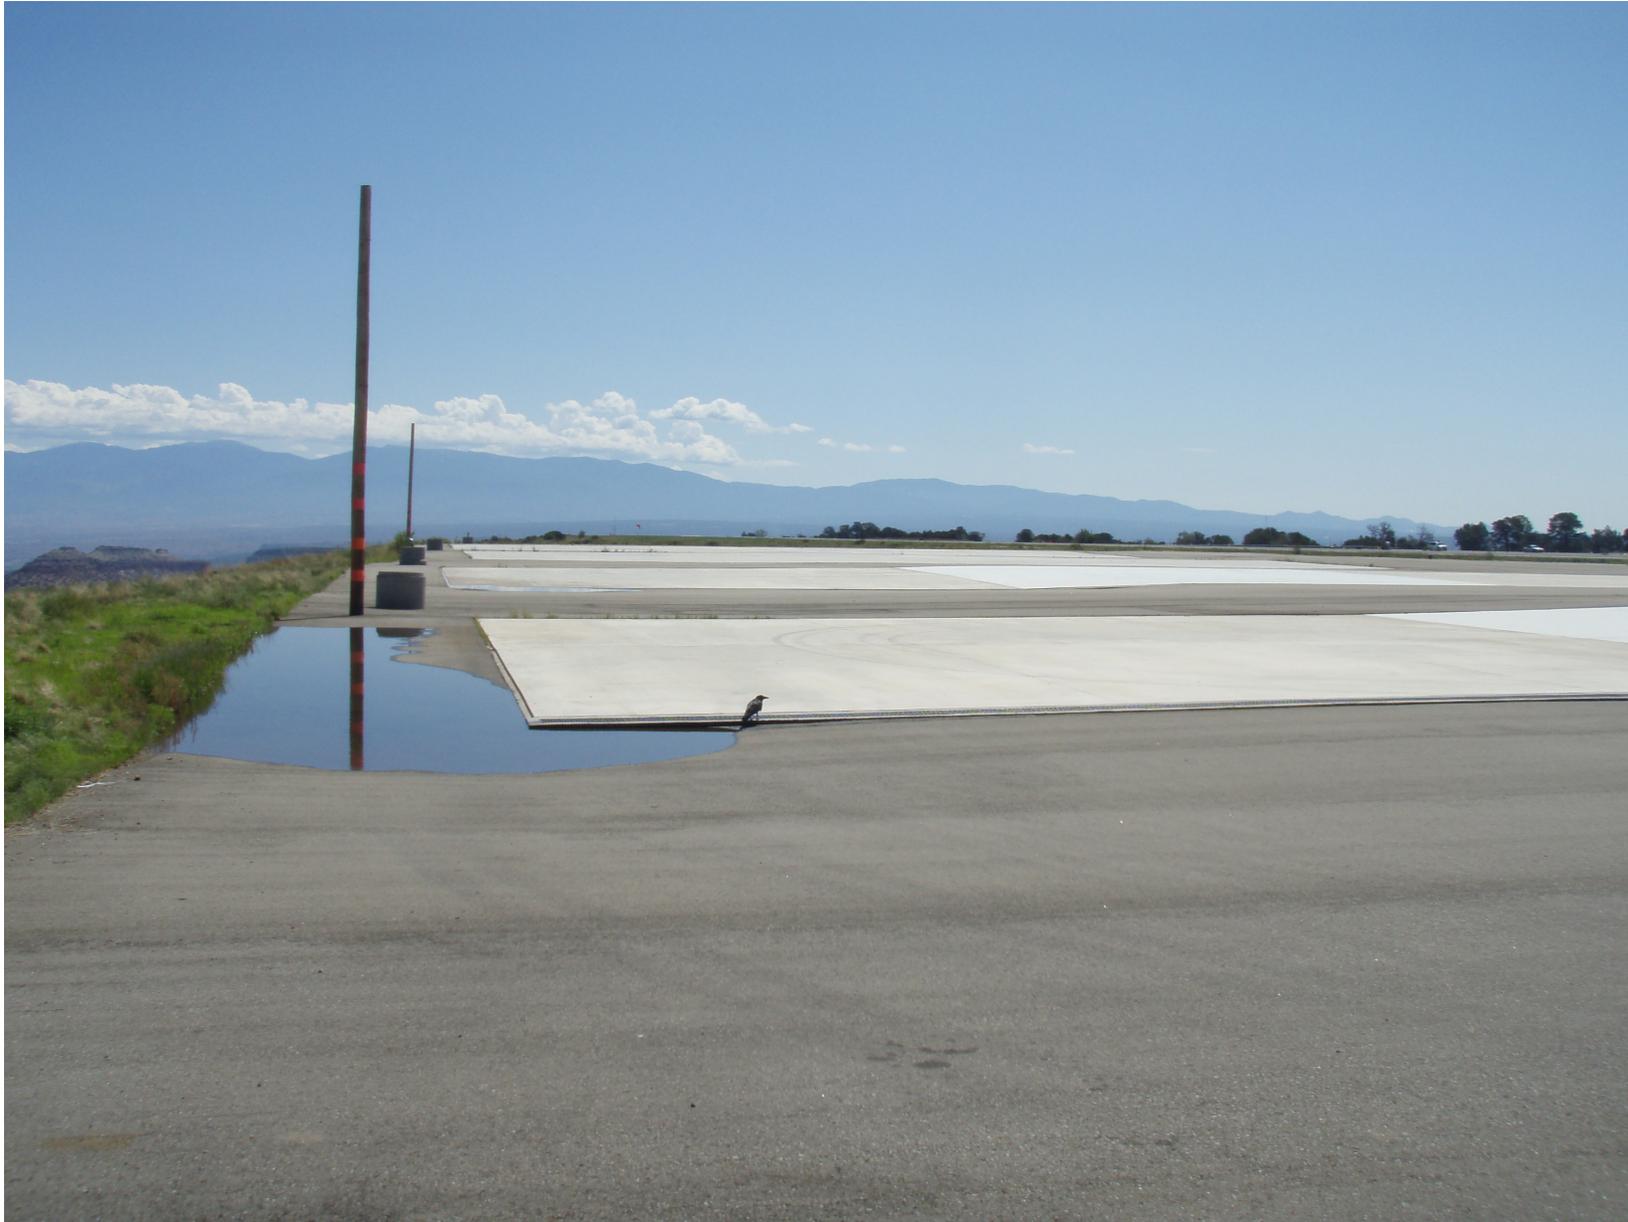
Photo 4: Looking east note puddles at north end of pads 2 & 3. Subsidence of pad and Matcon is visible along pad 3.
