Subject: Submittal of the 2013 Annual Inspection Report for Los Alamos County Airport Landfill, Solid Waste Management Units 73-001(a) and 73-001(d), Technical Area 73

**2013 Annual Inspection Report for
Los Alamos Country Airport Landfill,
Solid Waste Management Units
73-001(a) and 73-001(d),
Technical Area 73**

Prepared by the Los Alamos Field Office

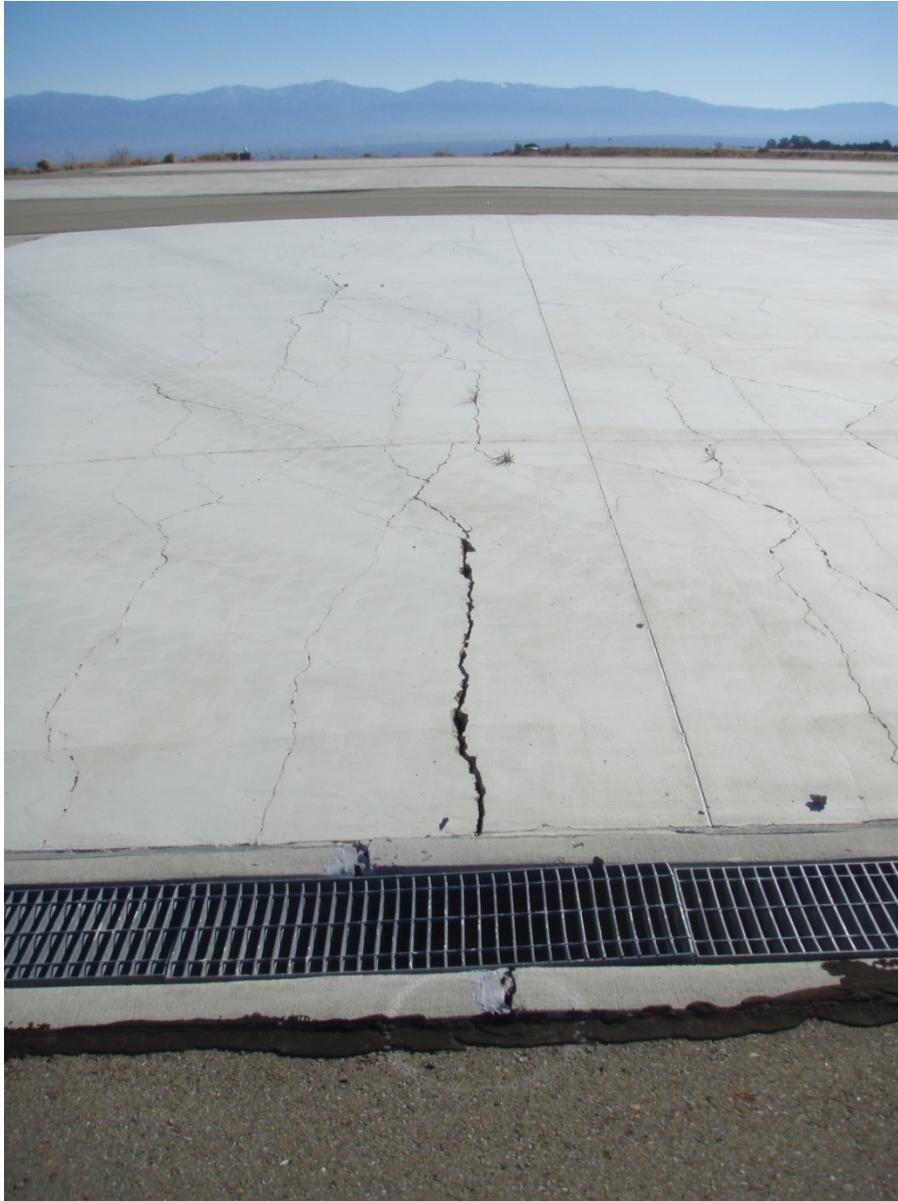
Figure 3.1-2 Subsidence at hangar pad 3

Visual observations at hangar pad 1 indicate that the northern third of the pad has uplifted and tilted slightly to the south. Visible subsidence was observed on the northern half of hangar pads 2, 3, 4, and 5 (Figure 3.1-2). Cracking associated with the subsidence of the pads was also observed throughout the central portion of each pad (Figure 3.1-3). Separation of the expansion joints was observed at hangar pads 1, 2, 3, and 4. Separation or subsidence of joints between the hangar pads and the MatCon pavement was noted at pads 1, 2, 3, and 4.

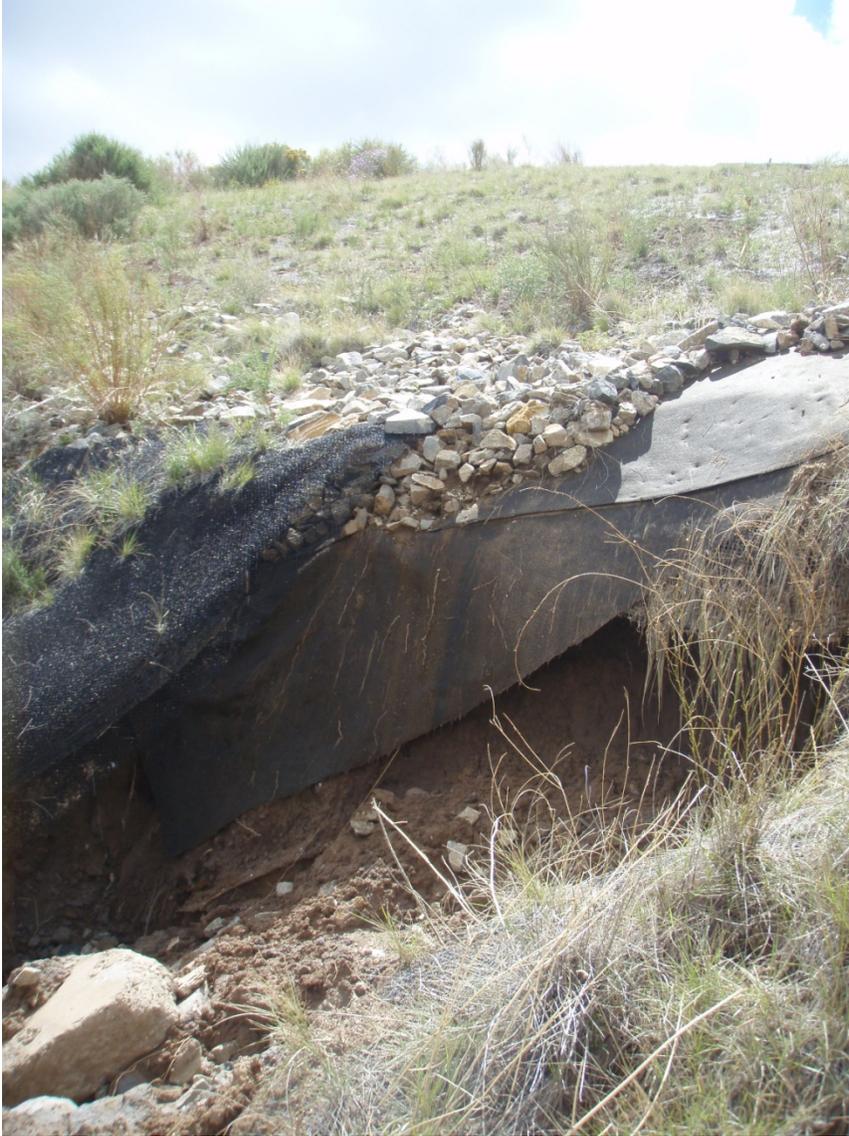
Figure 3.2-2 Erosion channel from runoff from the riprap channel

In September 2013, the airport received over 7 in. of rain. Rill erosion was noted within the vegetated slope area, and a channel cut formed from runoff associated with the mid-slope riprap runoff channel (Figure 3.2-2).

The mid-slope rip-rap channel within the vegetated slope area has some minor sedimentation. The far eastern end of the channel has contributed to the erosion channel cut into the vegetated slope (Figure 3.2-2). The riprap has failed and the liner is exposed (Figure 3.4-1).

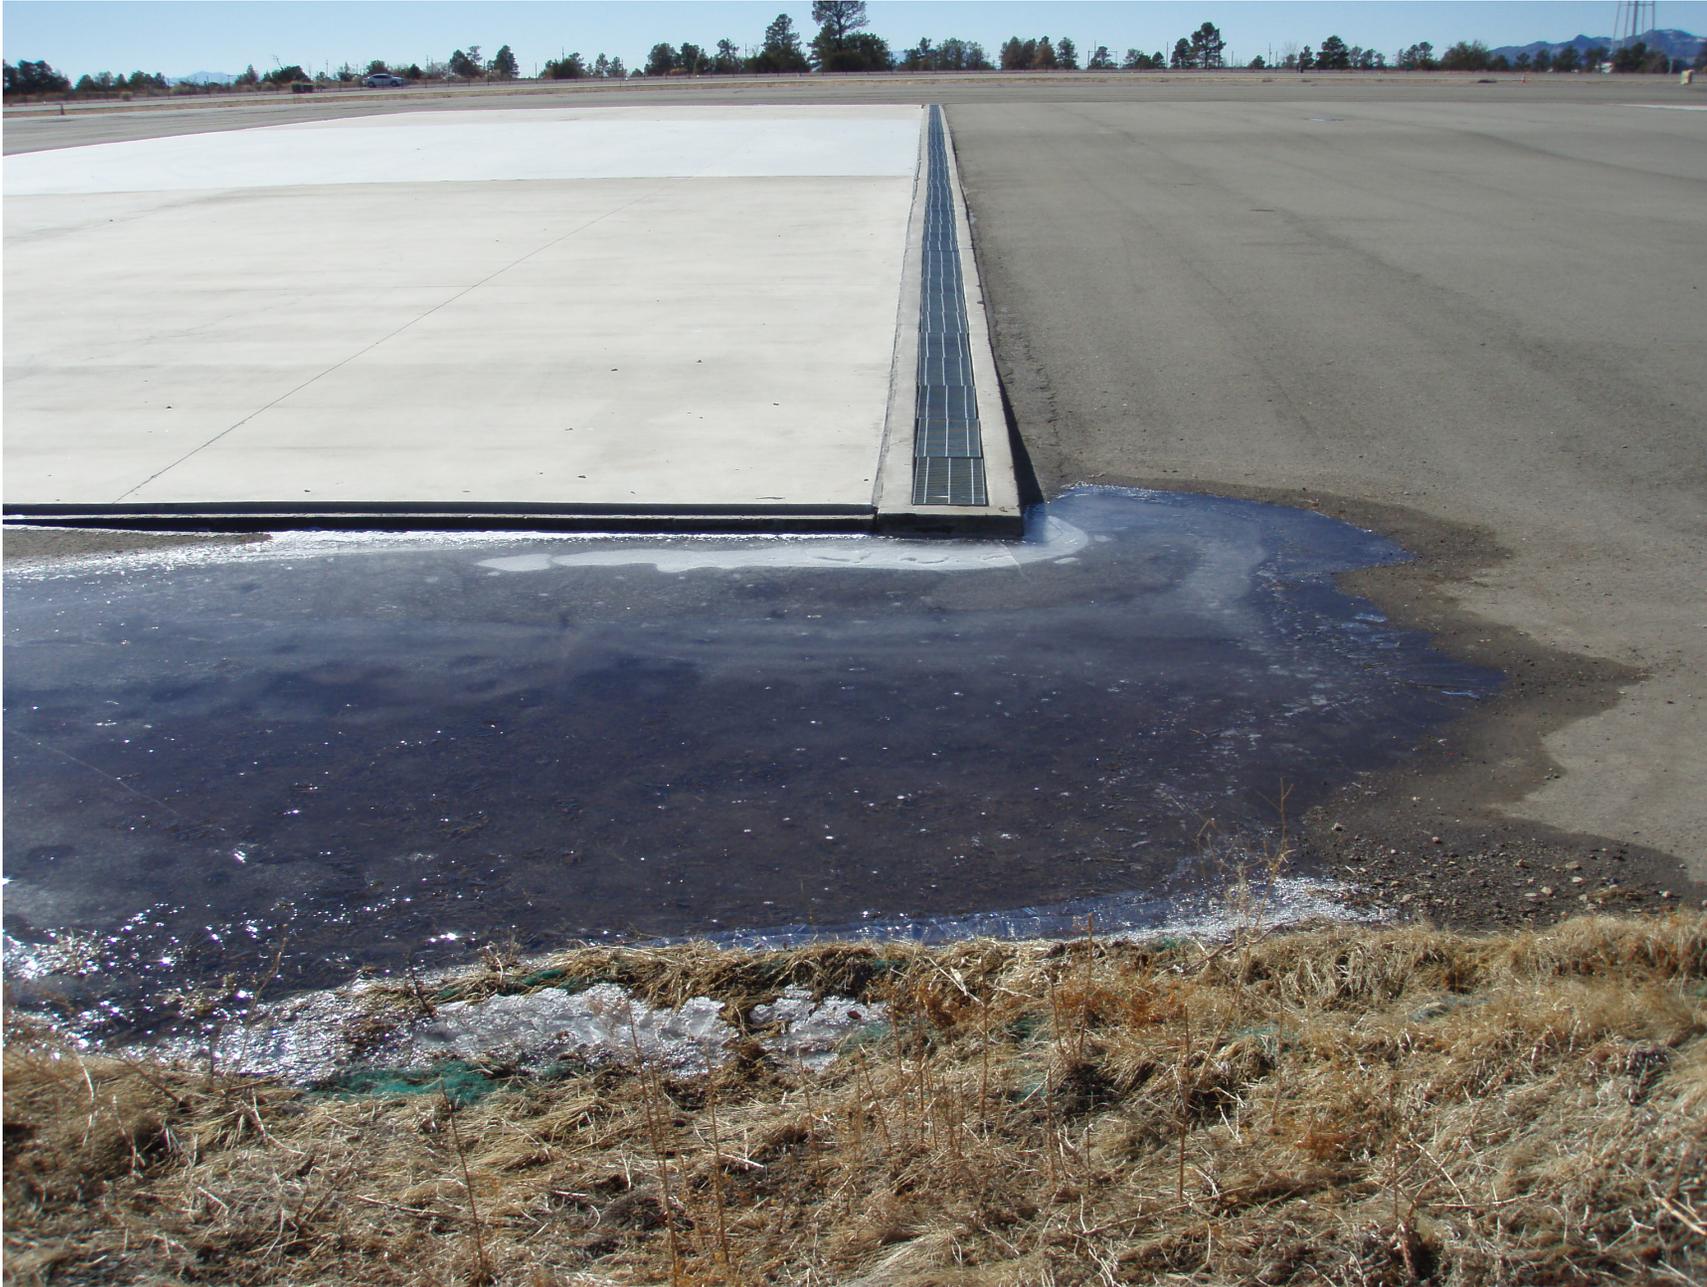
Photo 1: Settlement of Pad 2 has impacted the trench drain for approximately ½ the length of the pad causing water to flow to the north instead of the south forming a pond of water at the NW corner of Pad 2. Note settlement of MatCon pavement 2-3 inches below pad height. Water infiltrates along the vegetated margin of the MatCon.

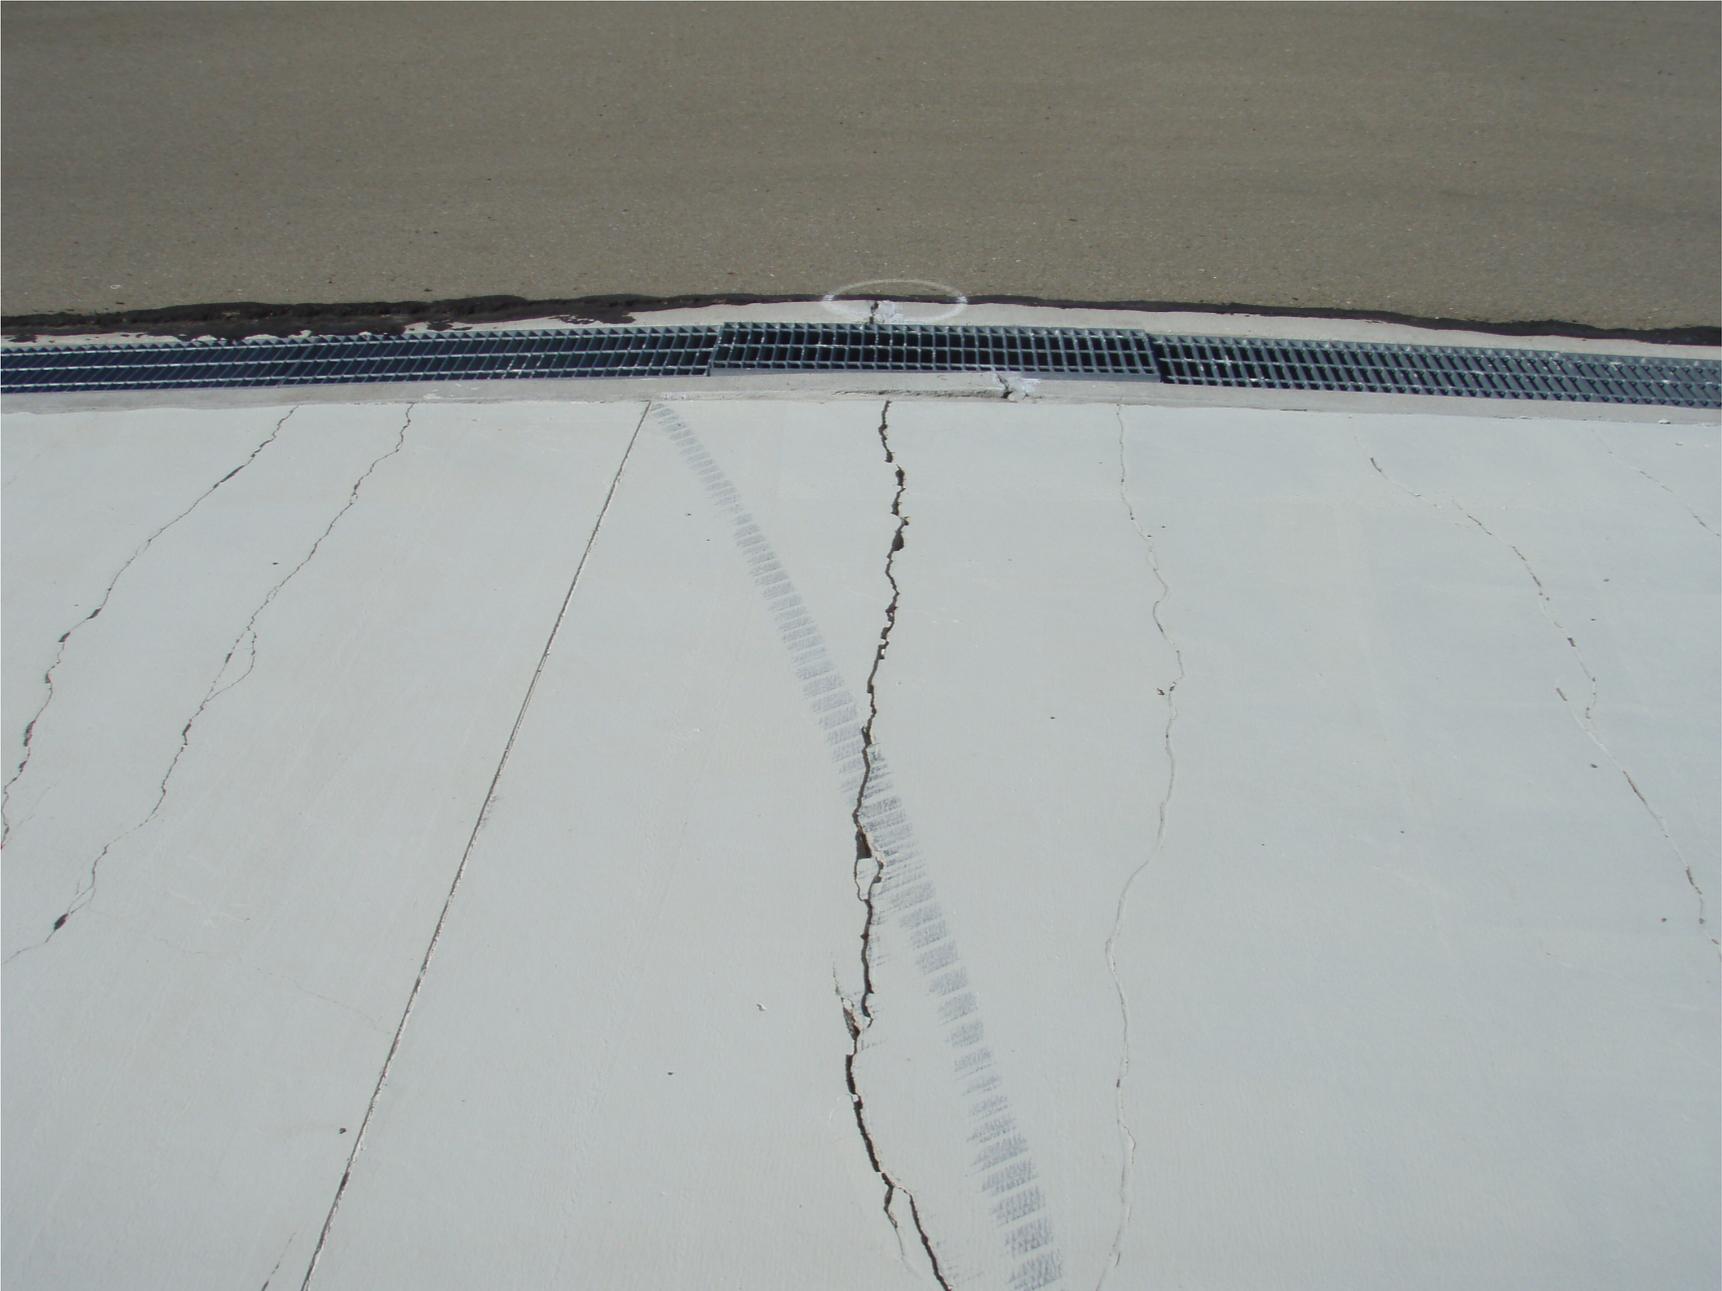
Photo 2: Cracks in Pad 3 and the trench drain. Note the buckling of the pad and drain causing drainage problems to the north.

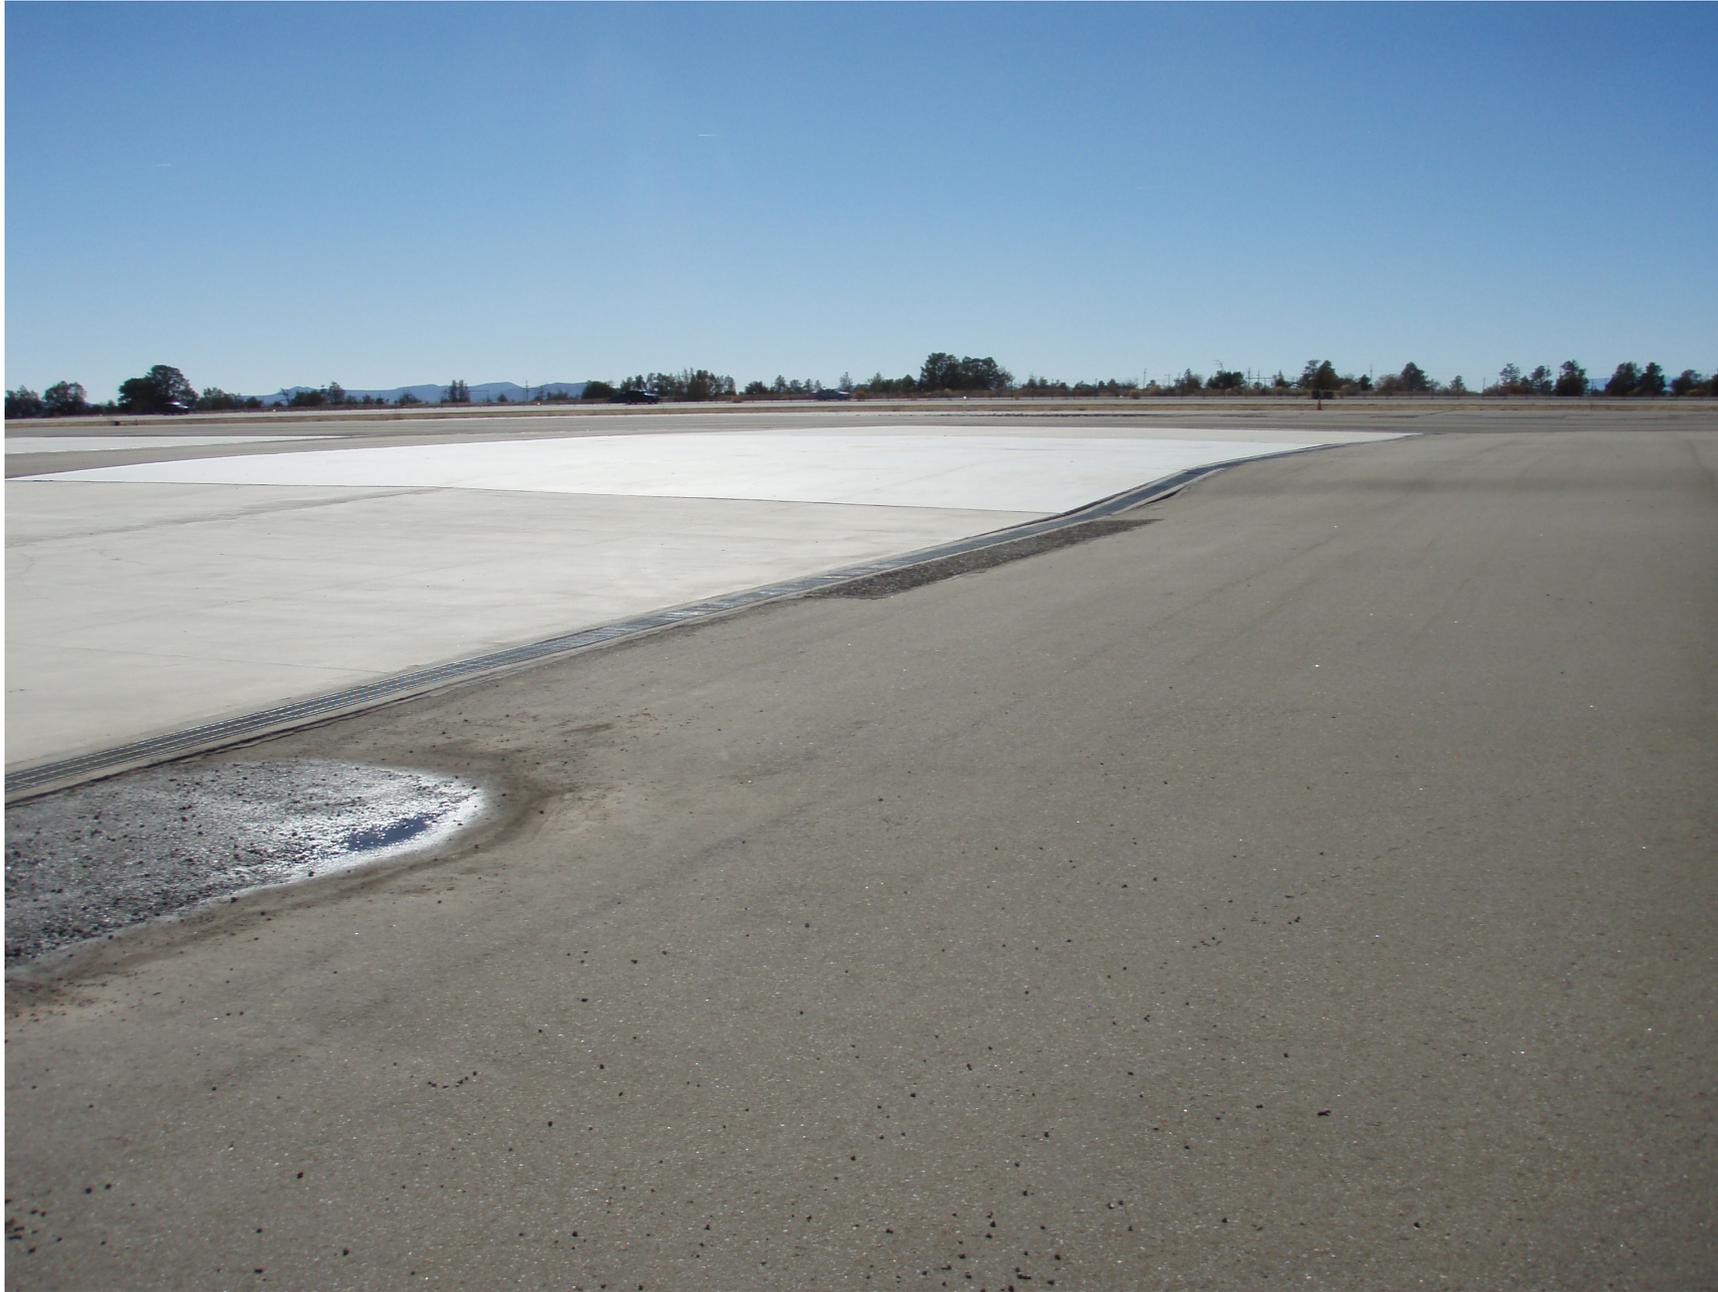
Photo 3: Buckling of Pad 3 is visible near the center line of the pad. Note MatCon repairs along the trench drain.

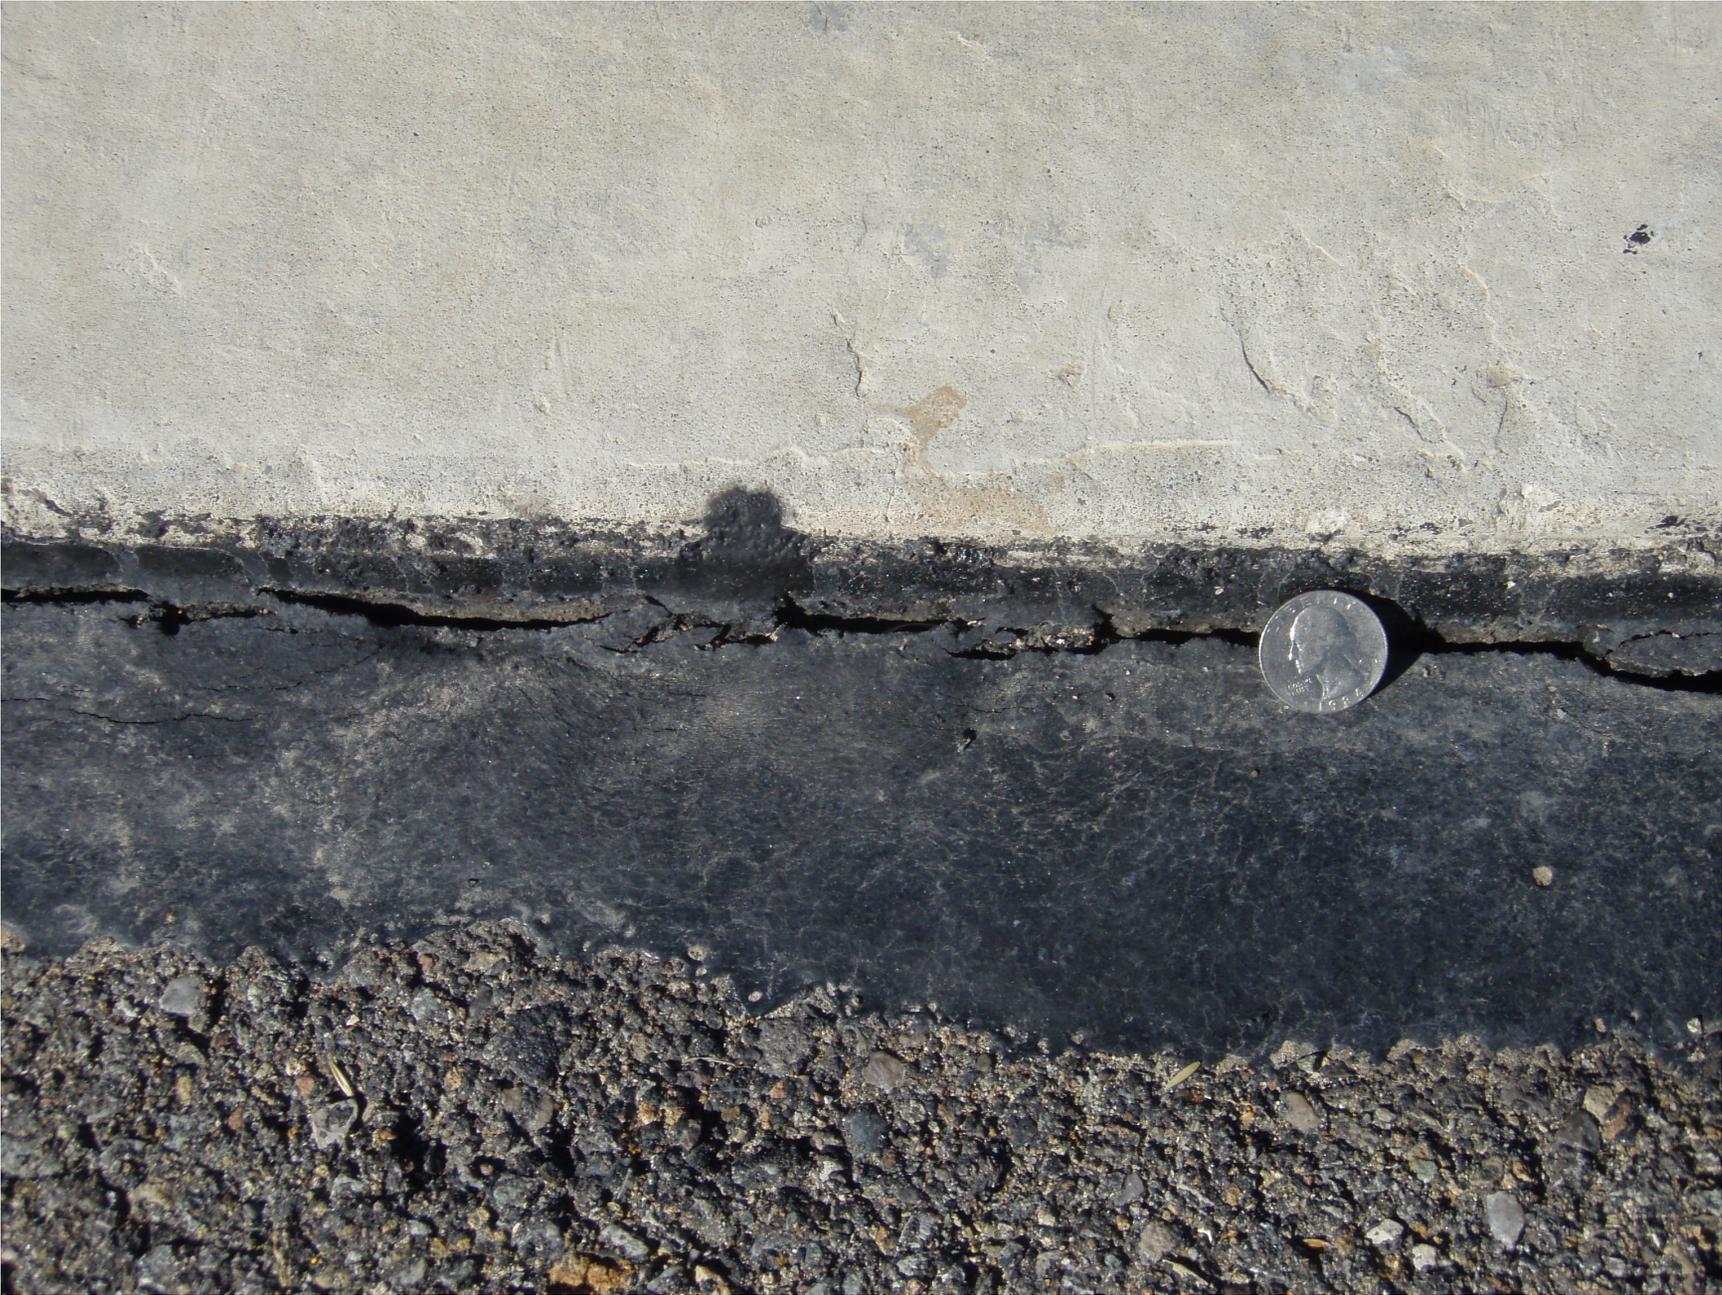
Photo 4: Separation of the concrete pad and MatCon in the hot seal.

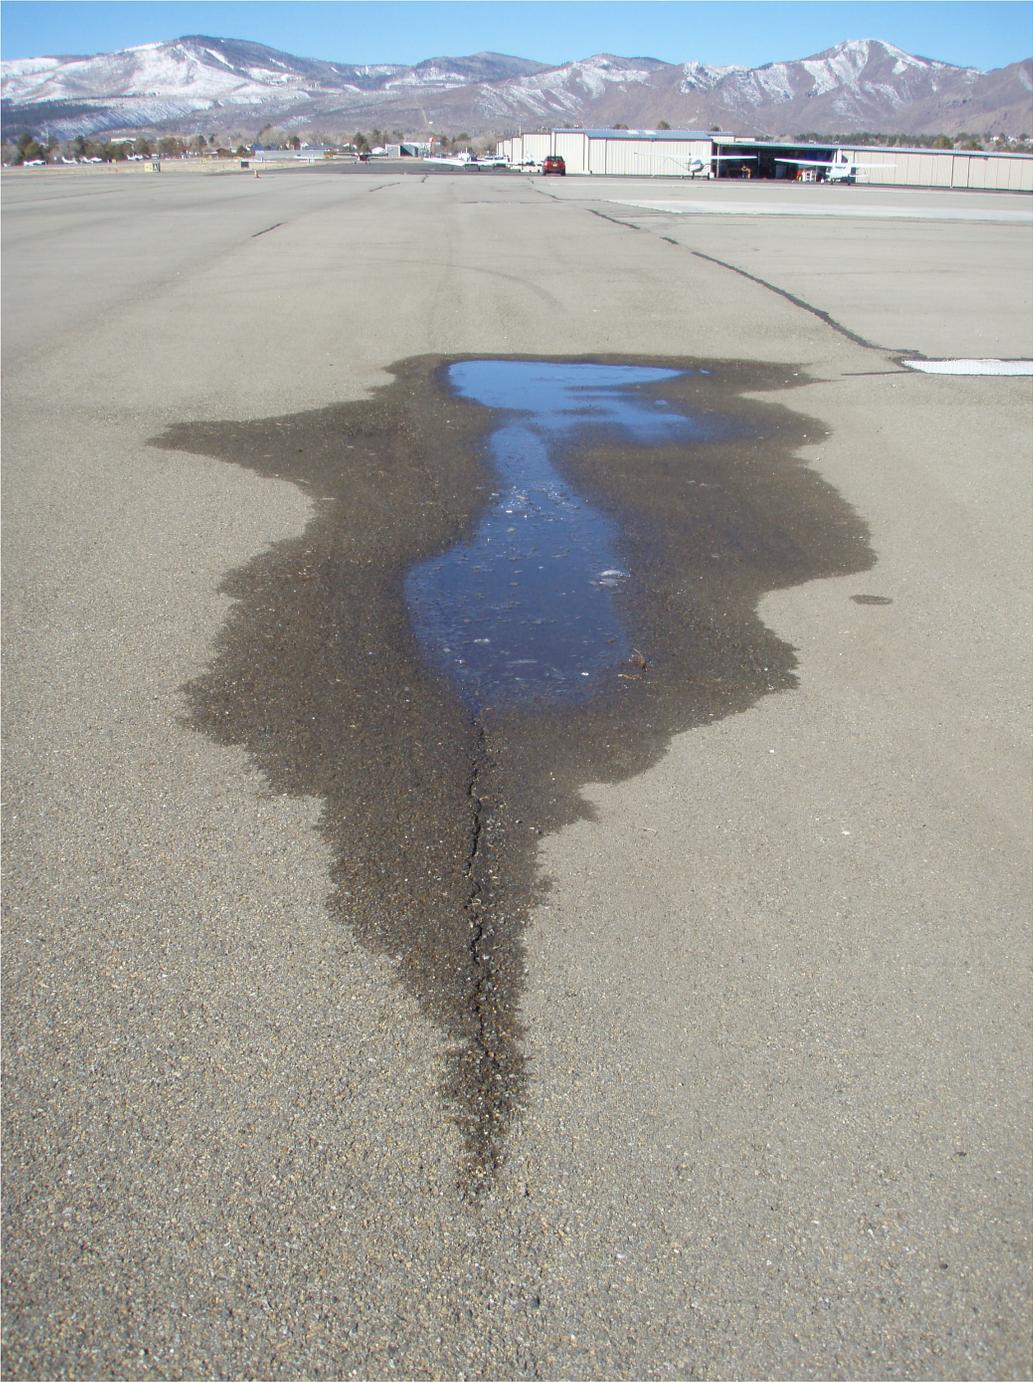
Photo 5: Settlement of MatCon pavement and cracking along the paving lane boundary. Note drop inlet at upper right.

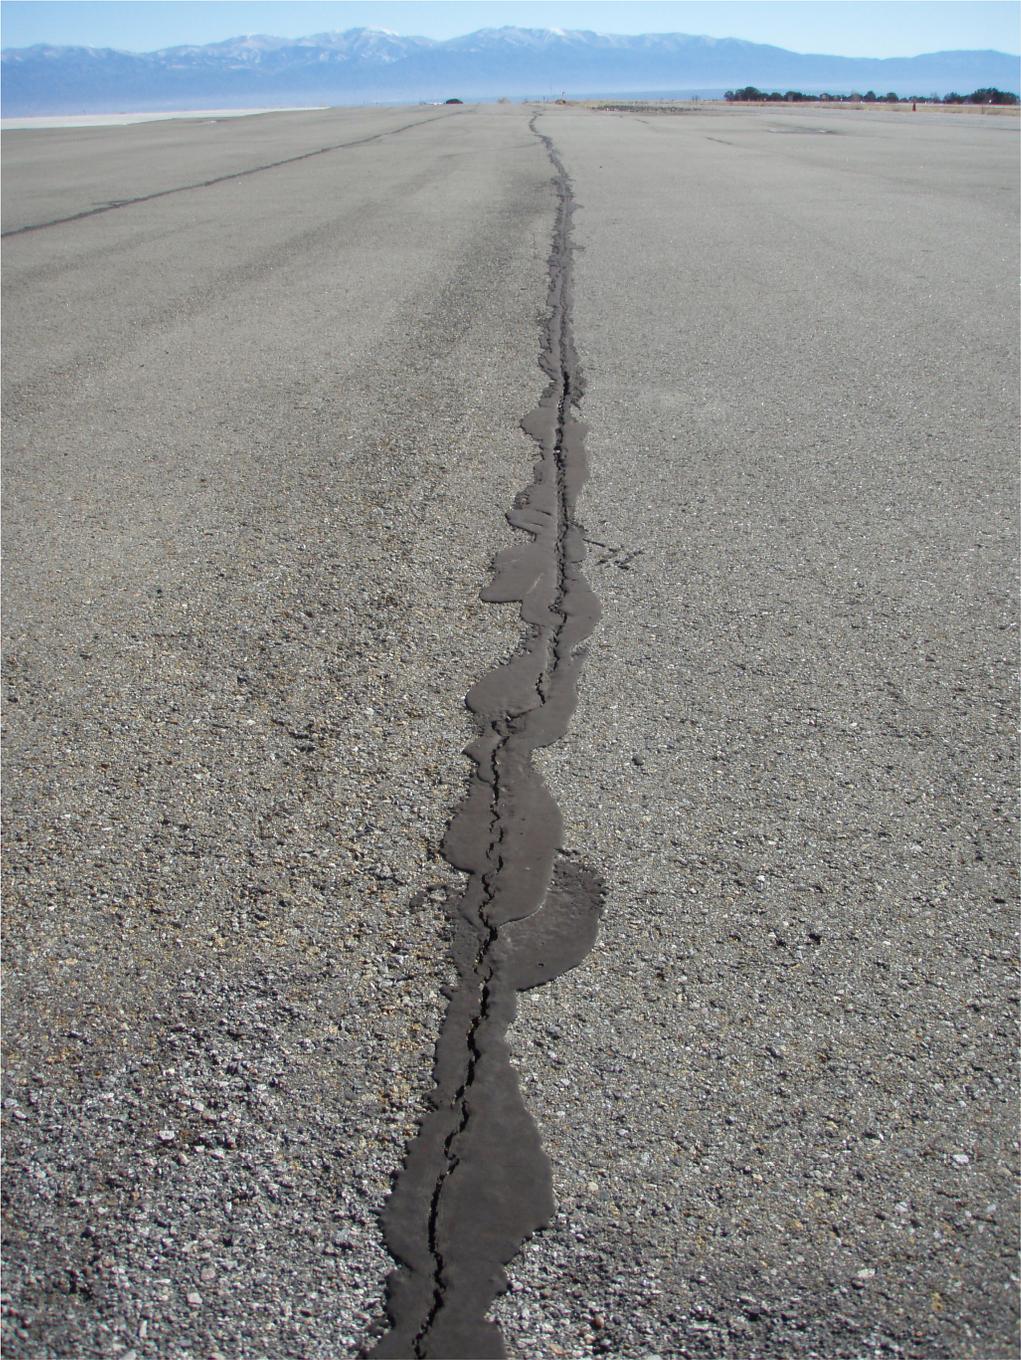
Photo 6: Crack in the hot seal patch.

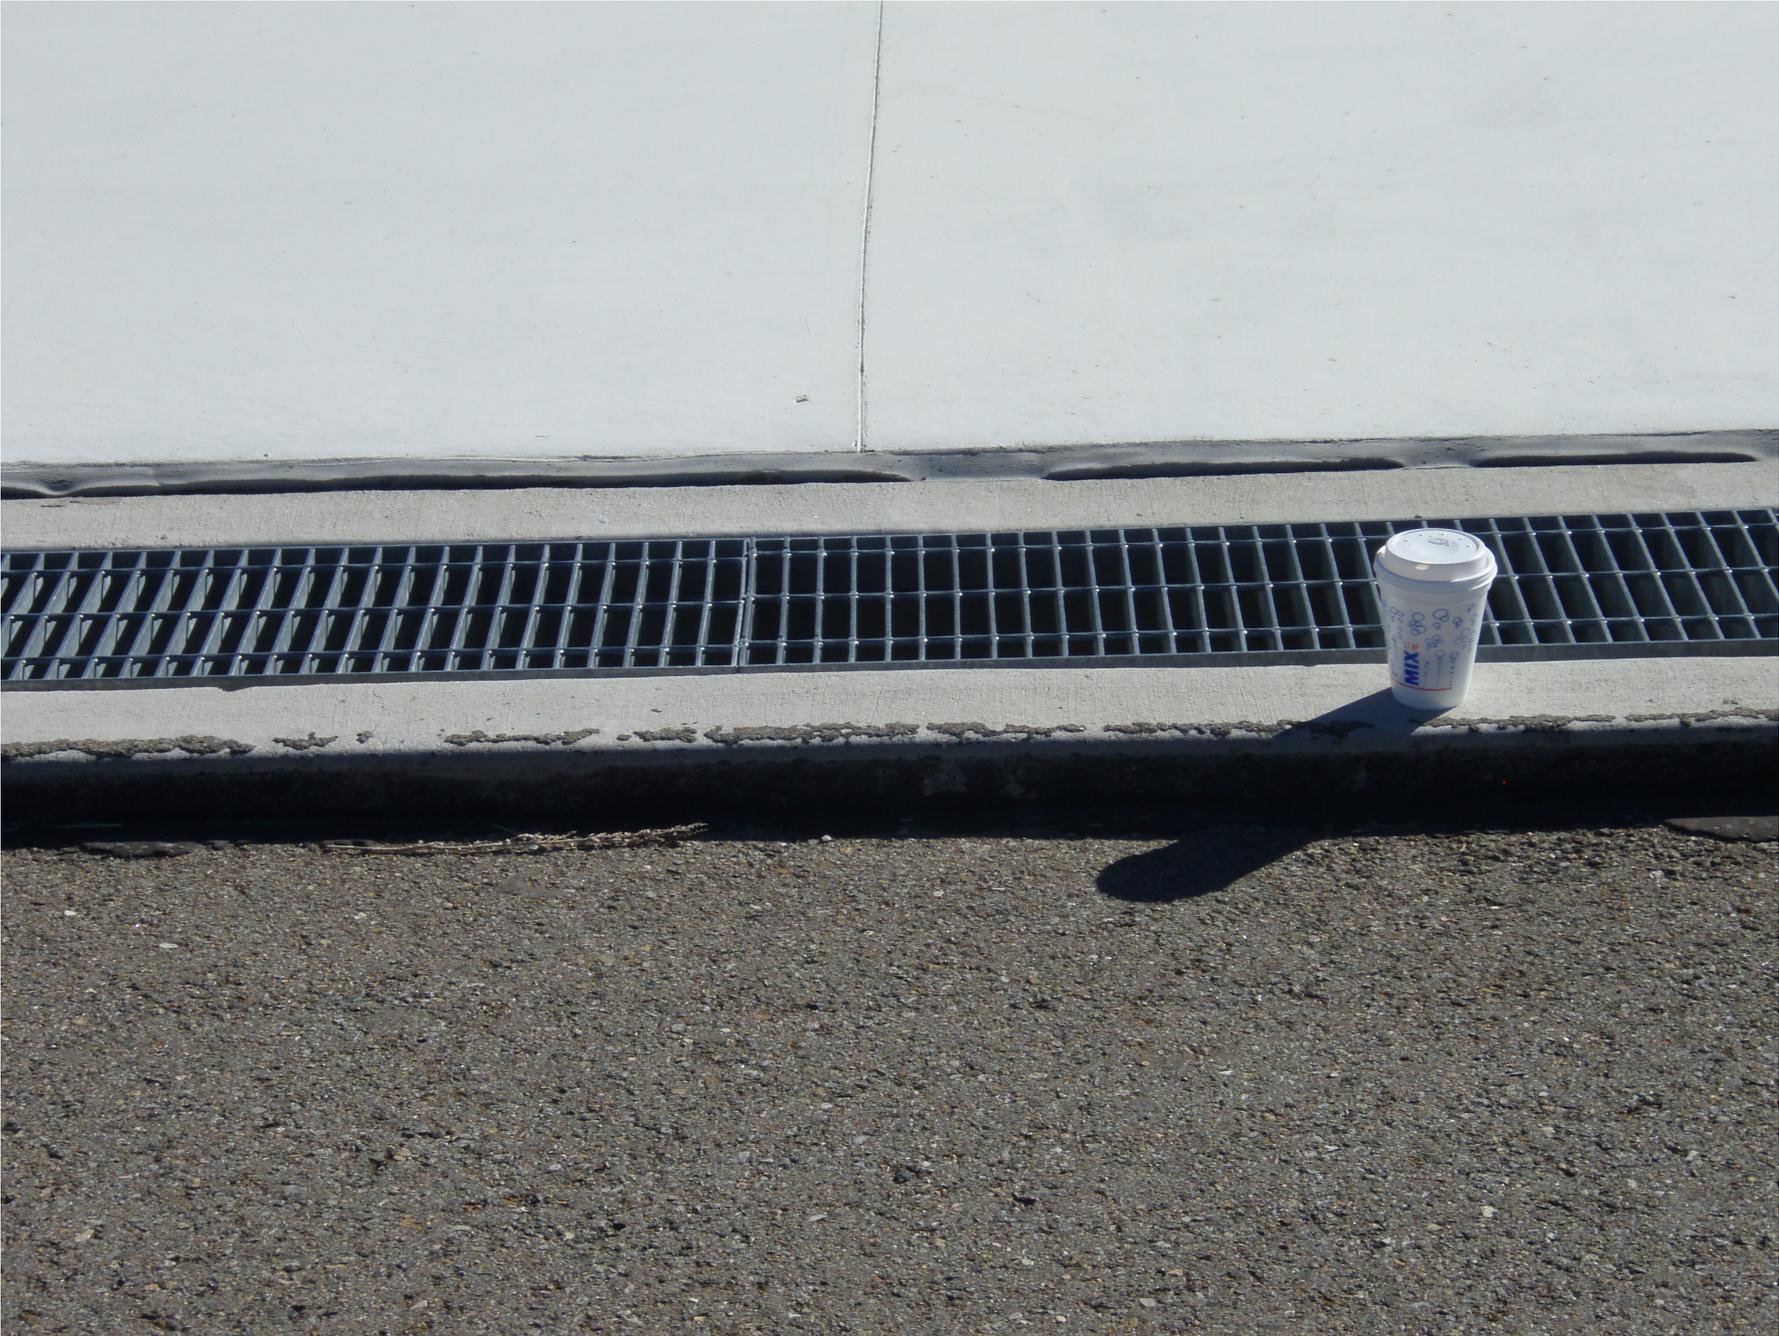
Photo 7: Differential subsidence between the concrete pad, the trench drain, and the MatCon pavement. Note expansion joint seals are separating.

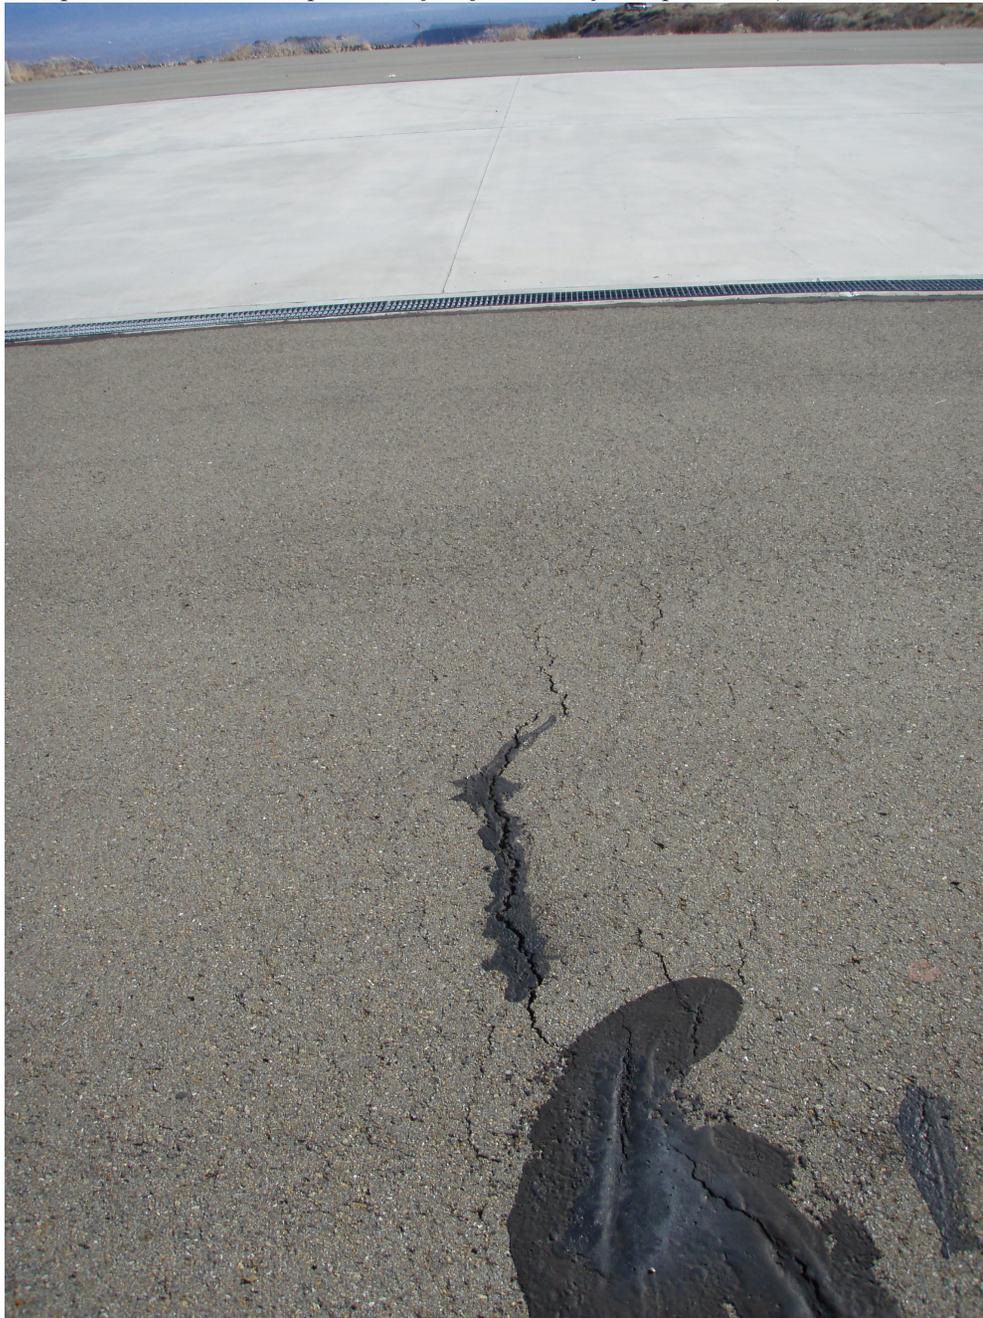
Photo 8: Cracking along the hinge point between Pads 4 & 5.

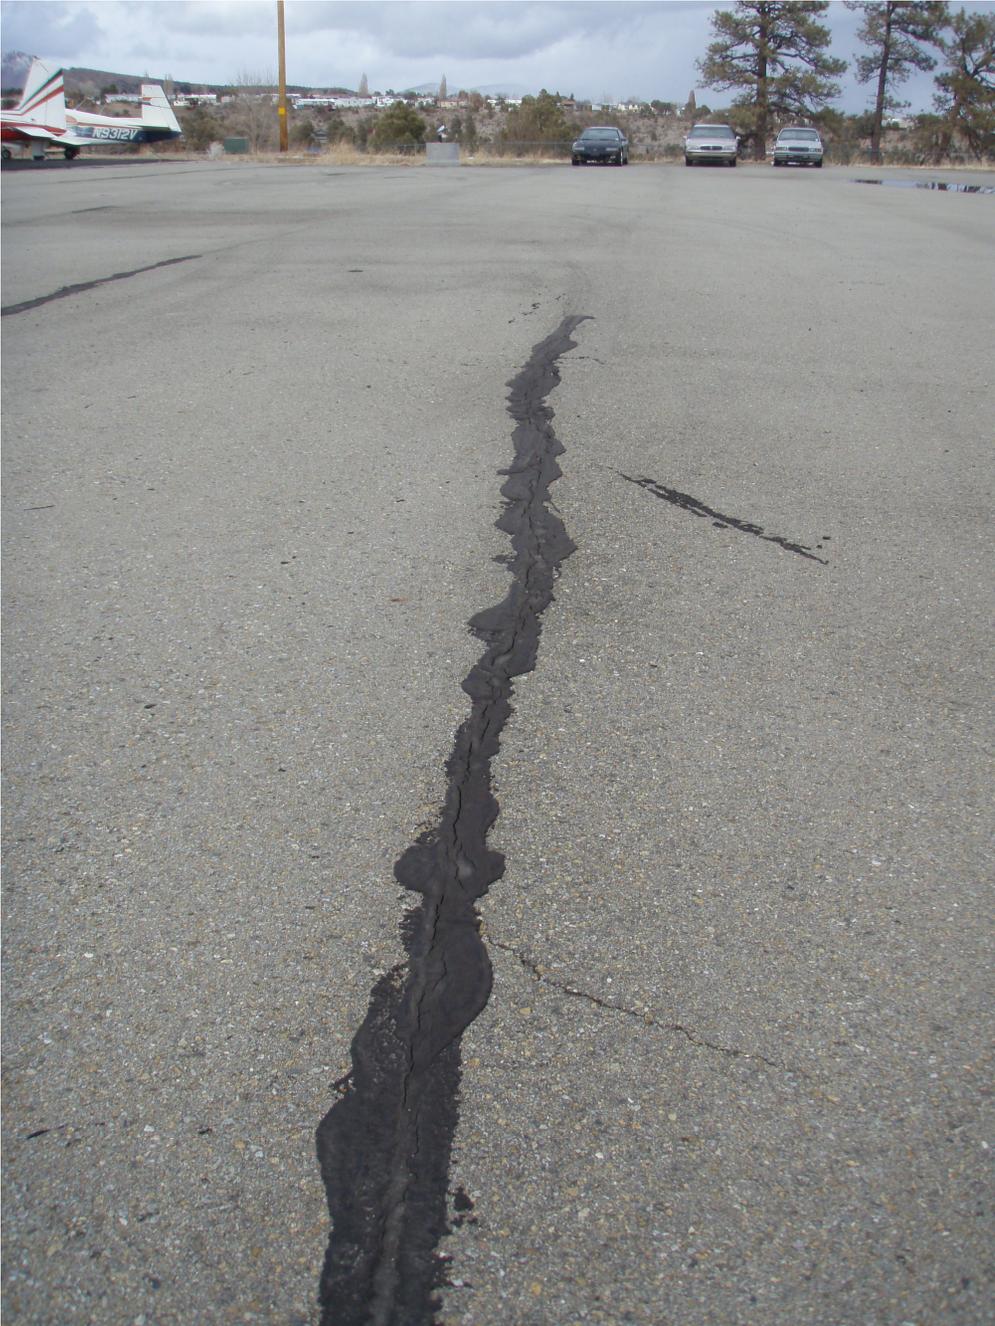
Photo 2: Cracking of hot seal in previously repaired crack, note new crack in MatCon.

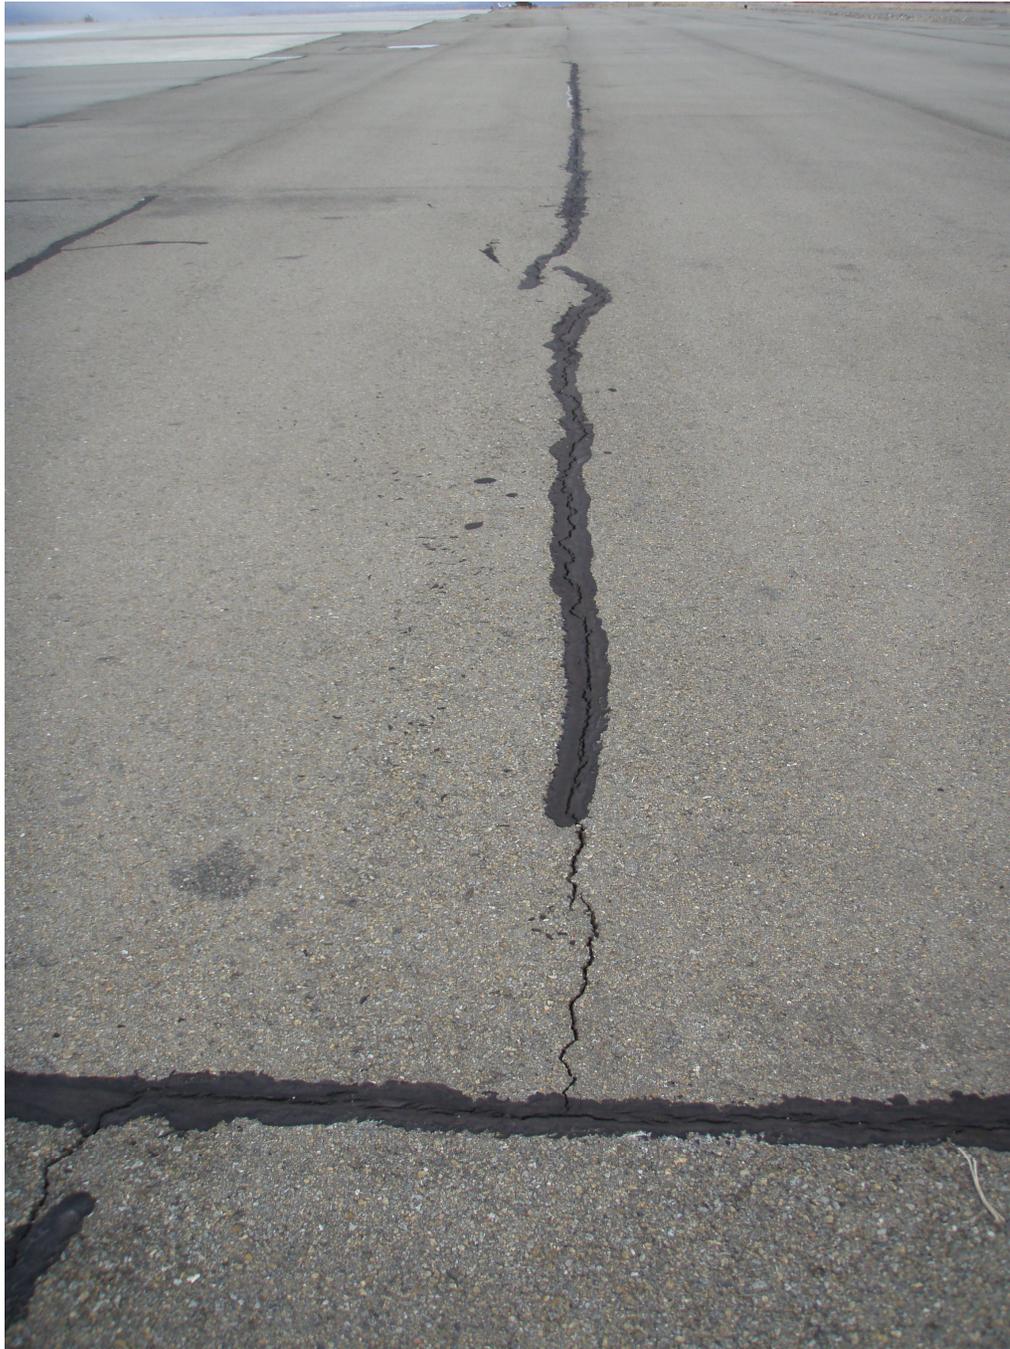
Photo 3: Cracking of hot seal in previously repaired crack, note new crack in MatCon.

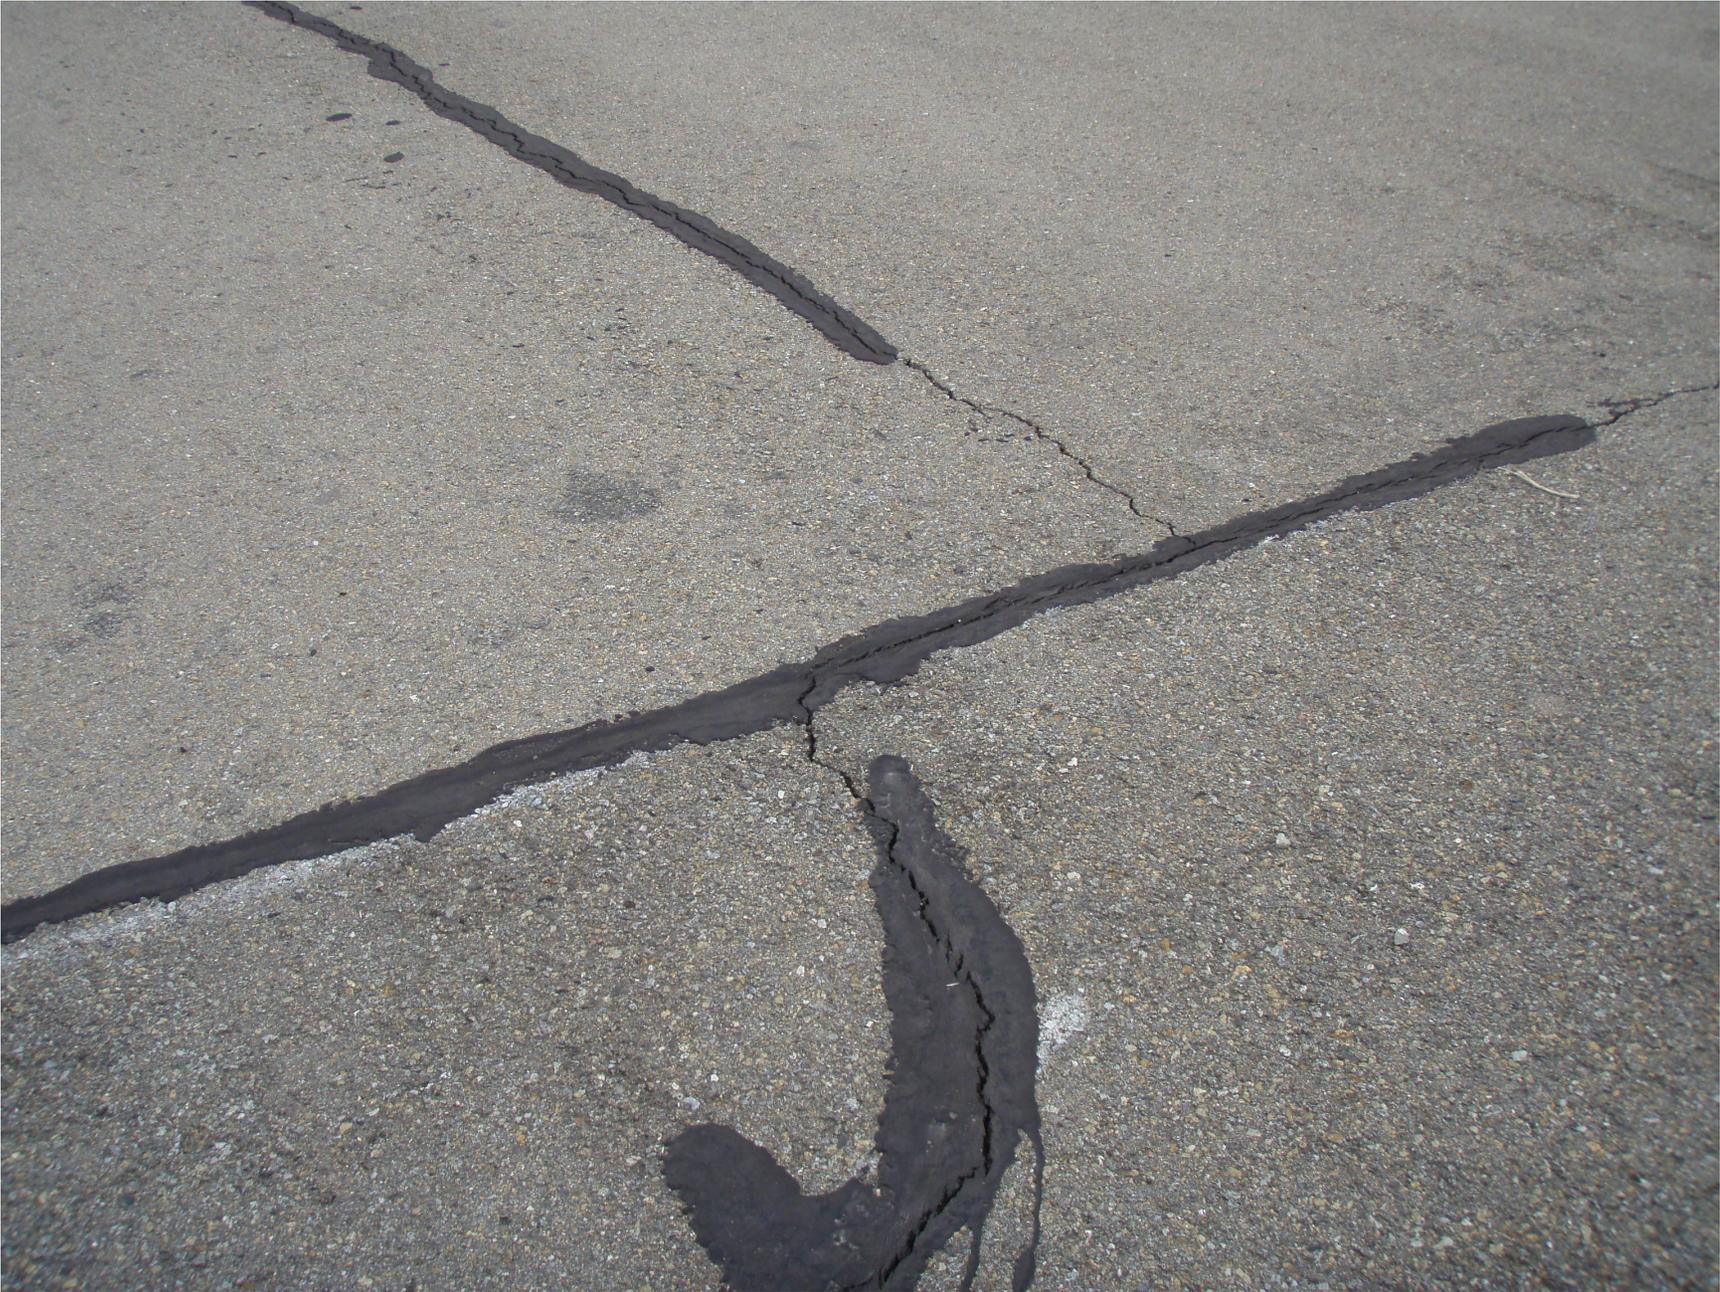
Photo 4: Cracking of hot seal and MatCon.
