Subject: Submittal of the 2013 Annual Inspection Report for Los Alamos County Airport Landfill, Solid Waste Management Units 73-001(a) and 73-001(d), Technical Area 73

**2013 Annual Inspection Report for
Los Alamos Country Airport Landfill,
Solid Waste Management Units
73-001(a) and 73-001(d),
Technical Area 73**

Prepared by the Los Alamos Field Office

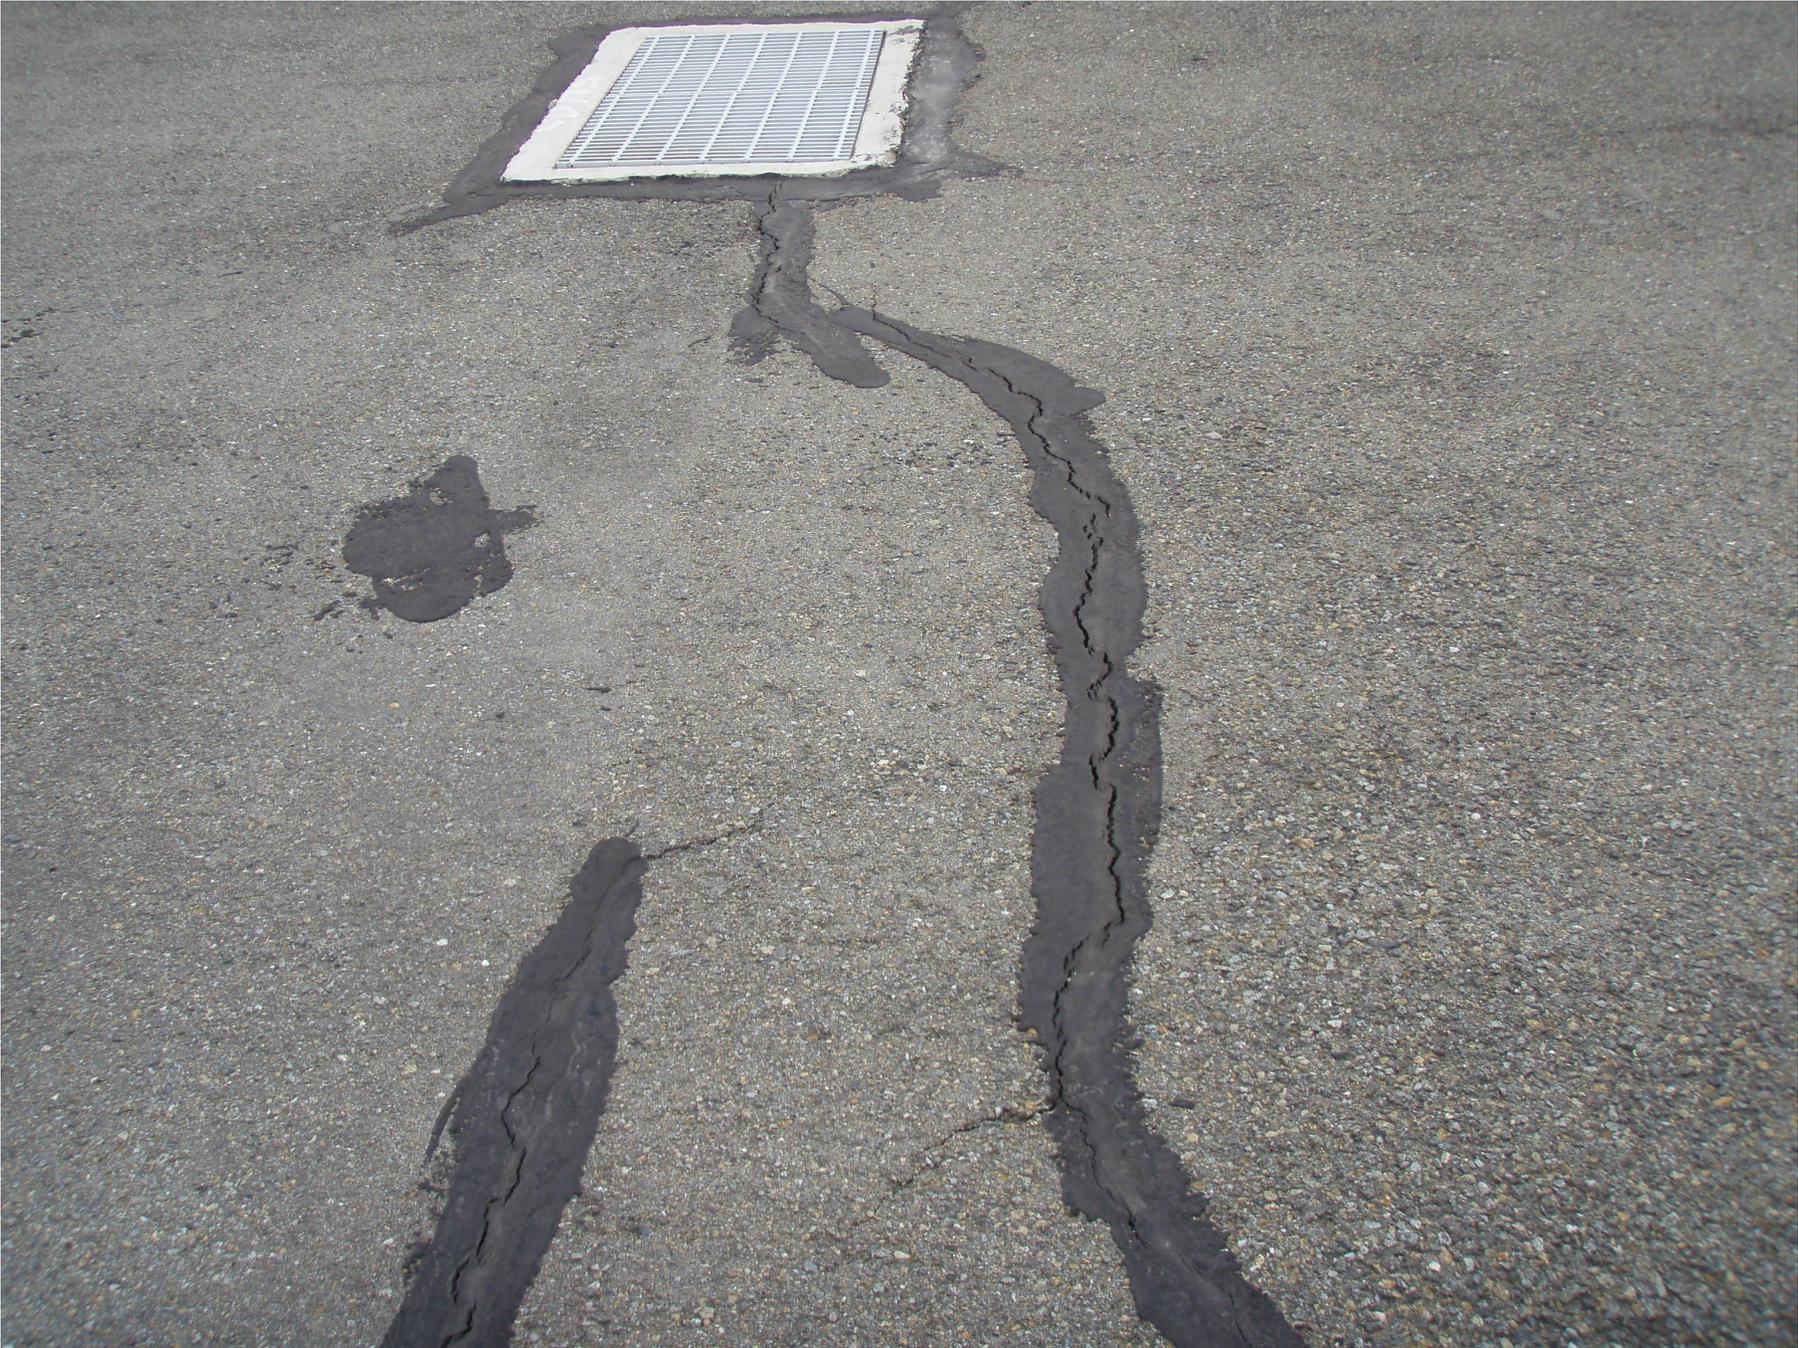
Photo 5: Cracking of hot seal.

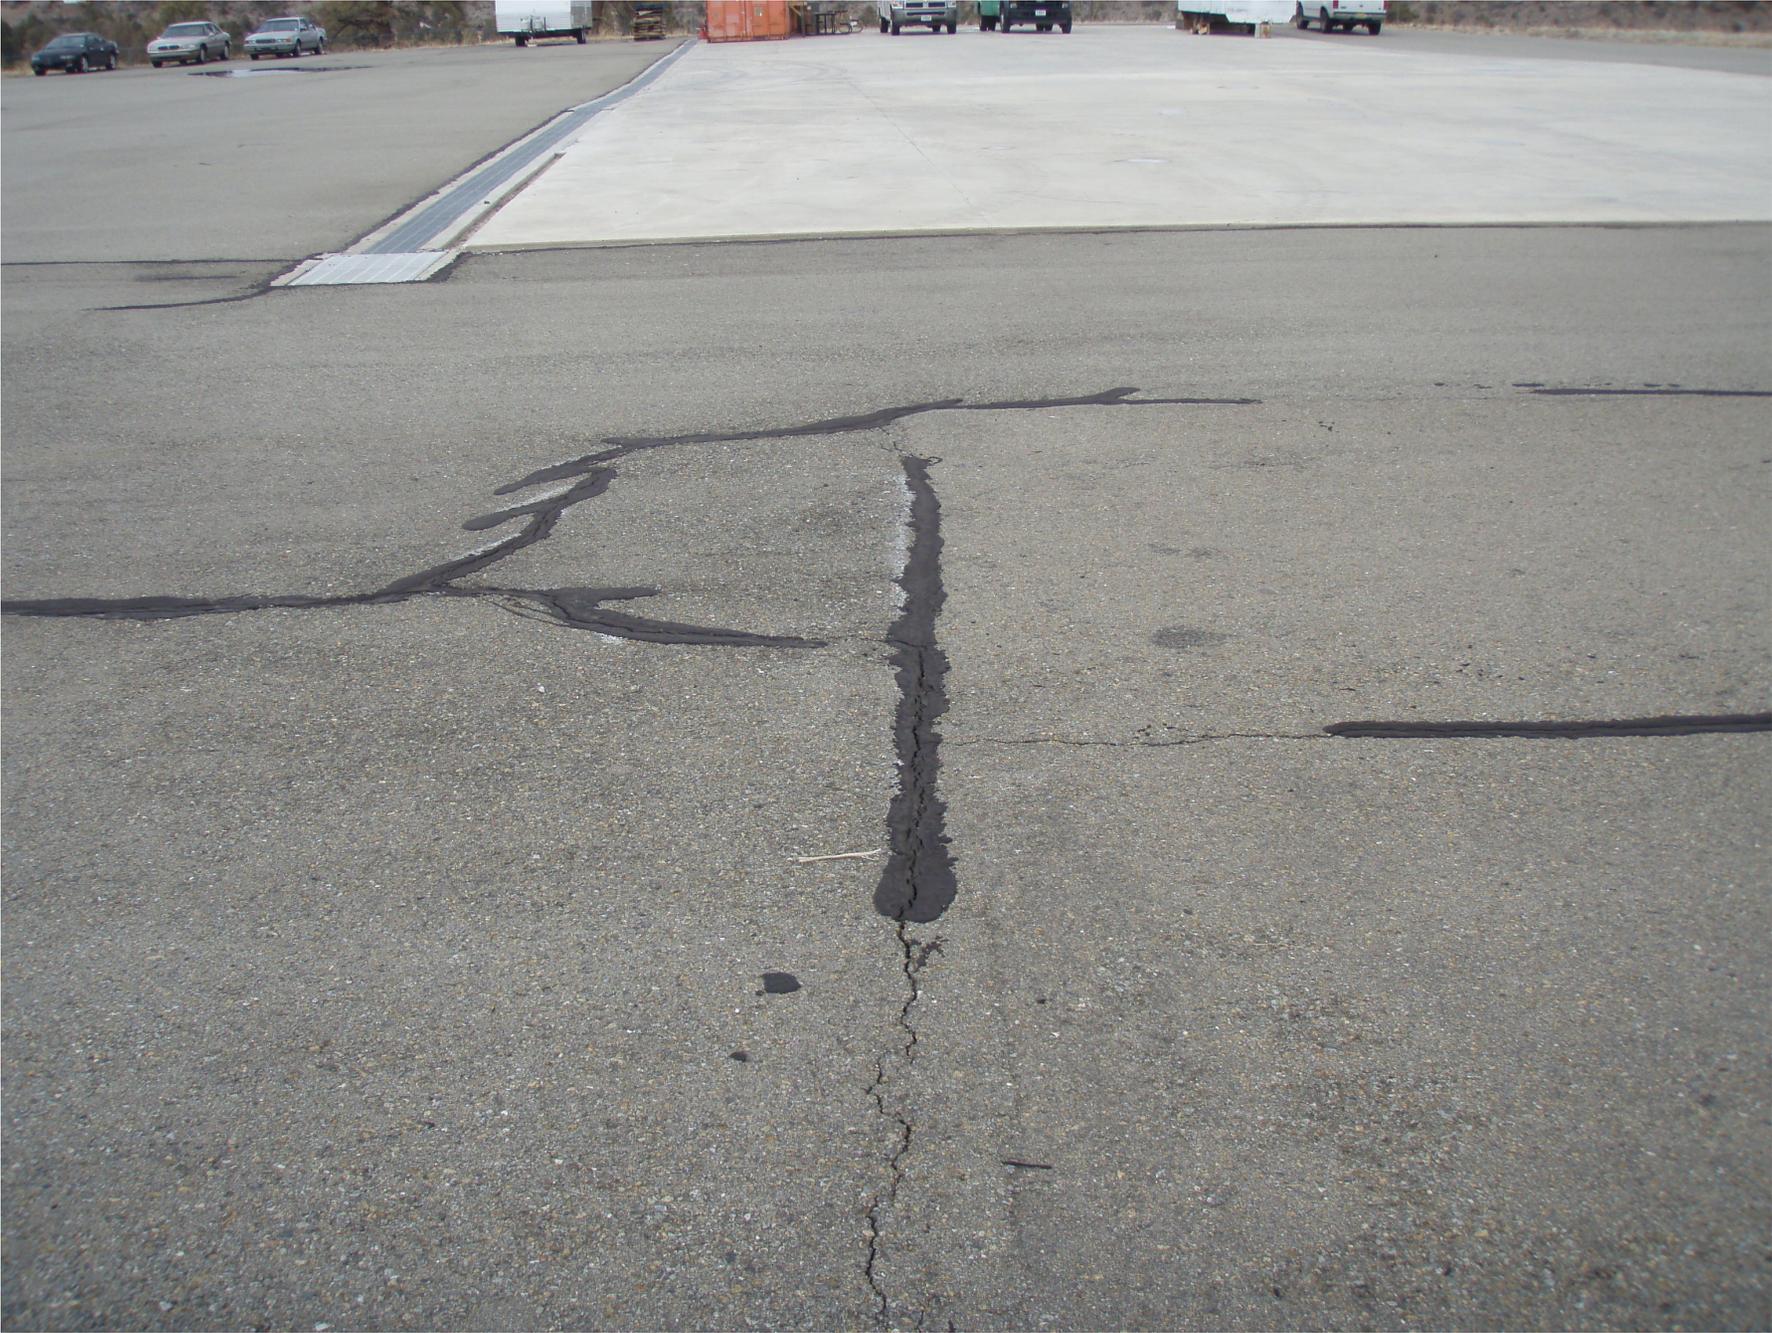
Photo 6: Cracking of hot seal repairs and MatCon.

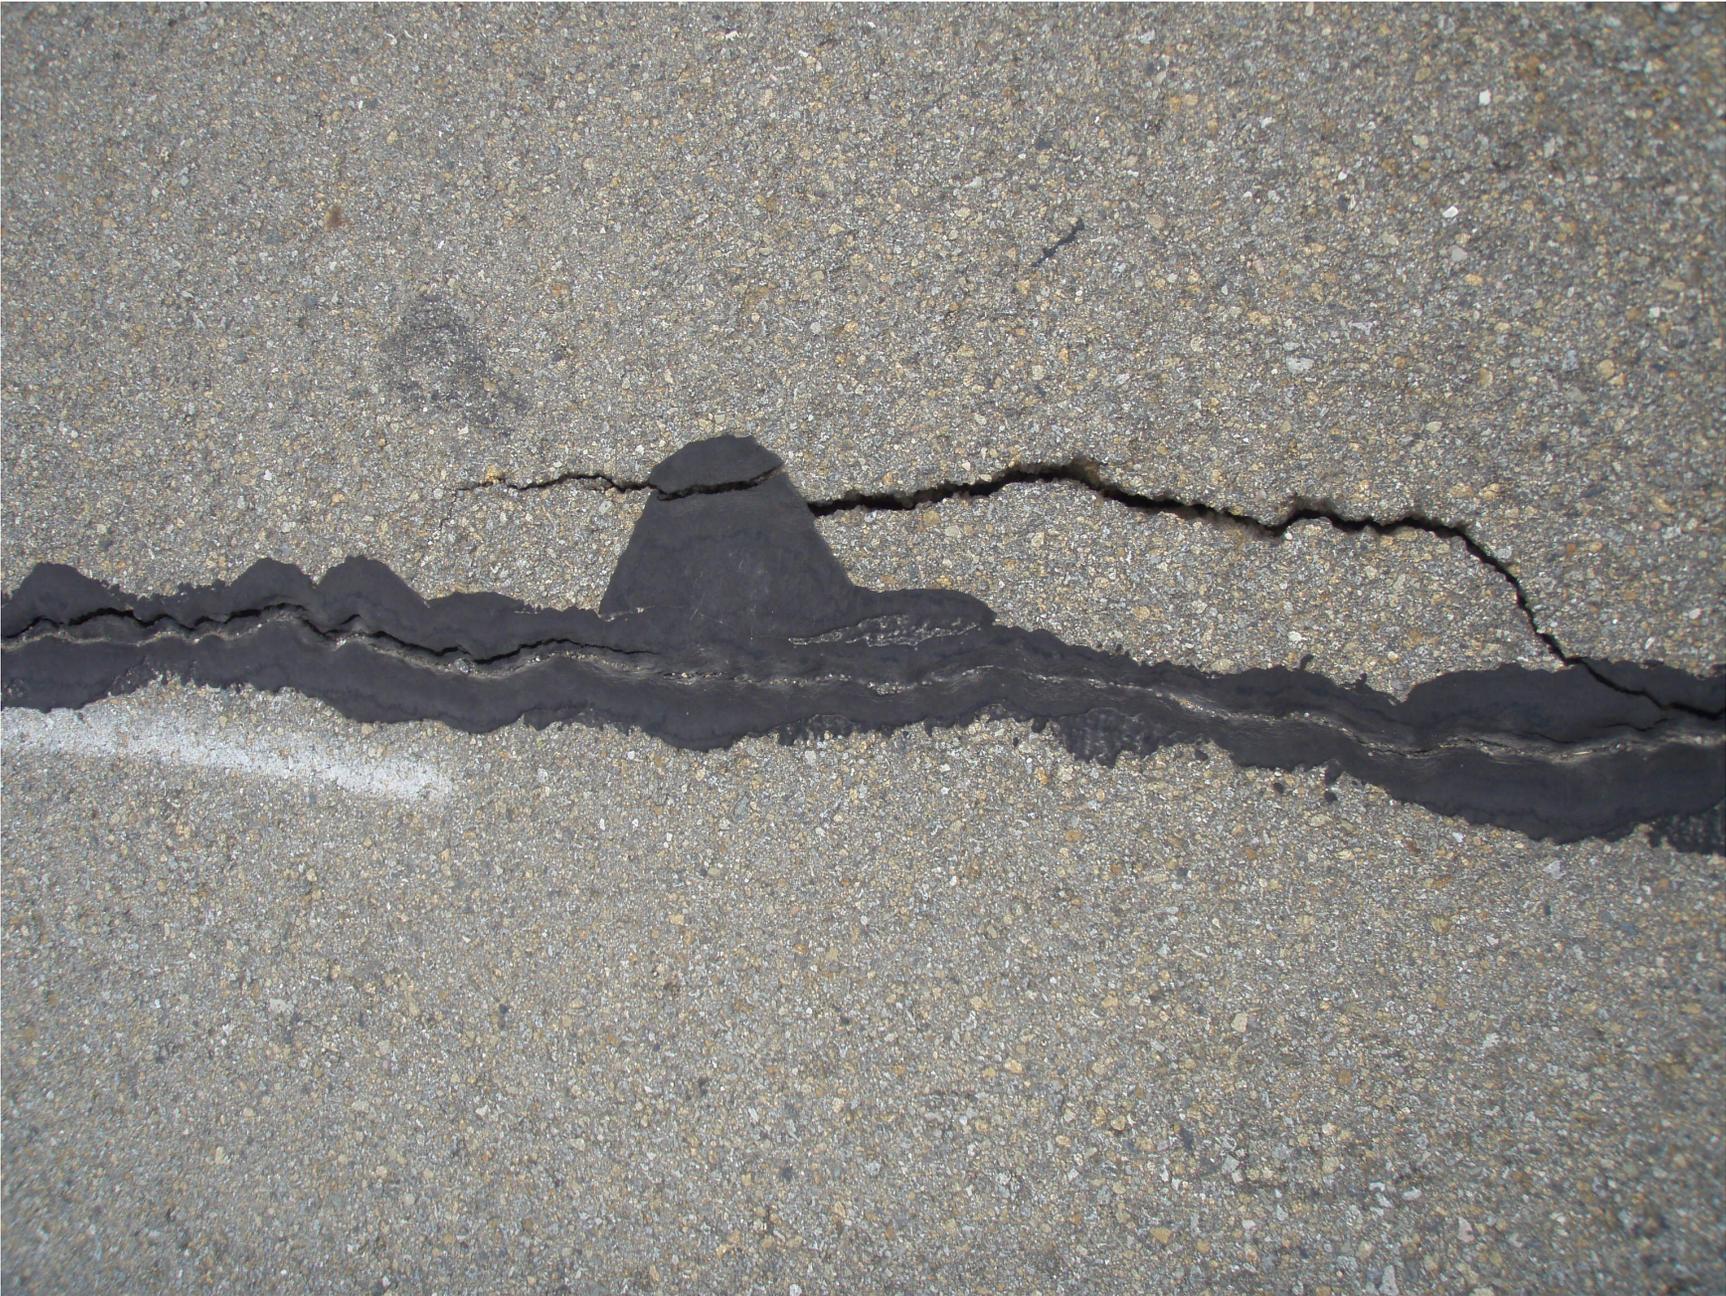
Photo 7: New crack in MatCon.

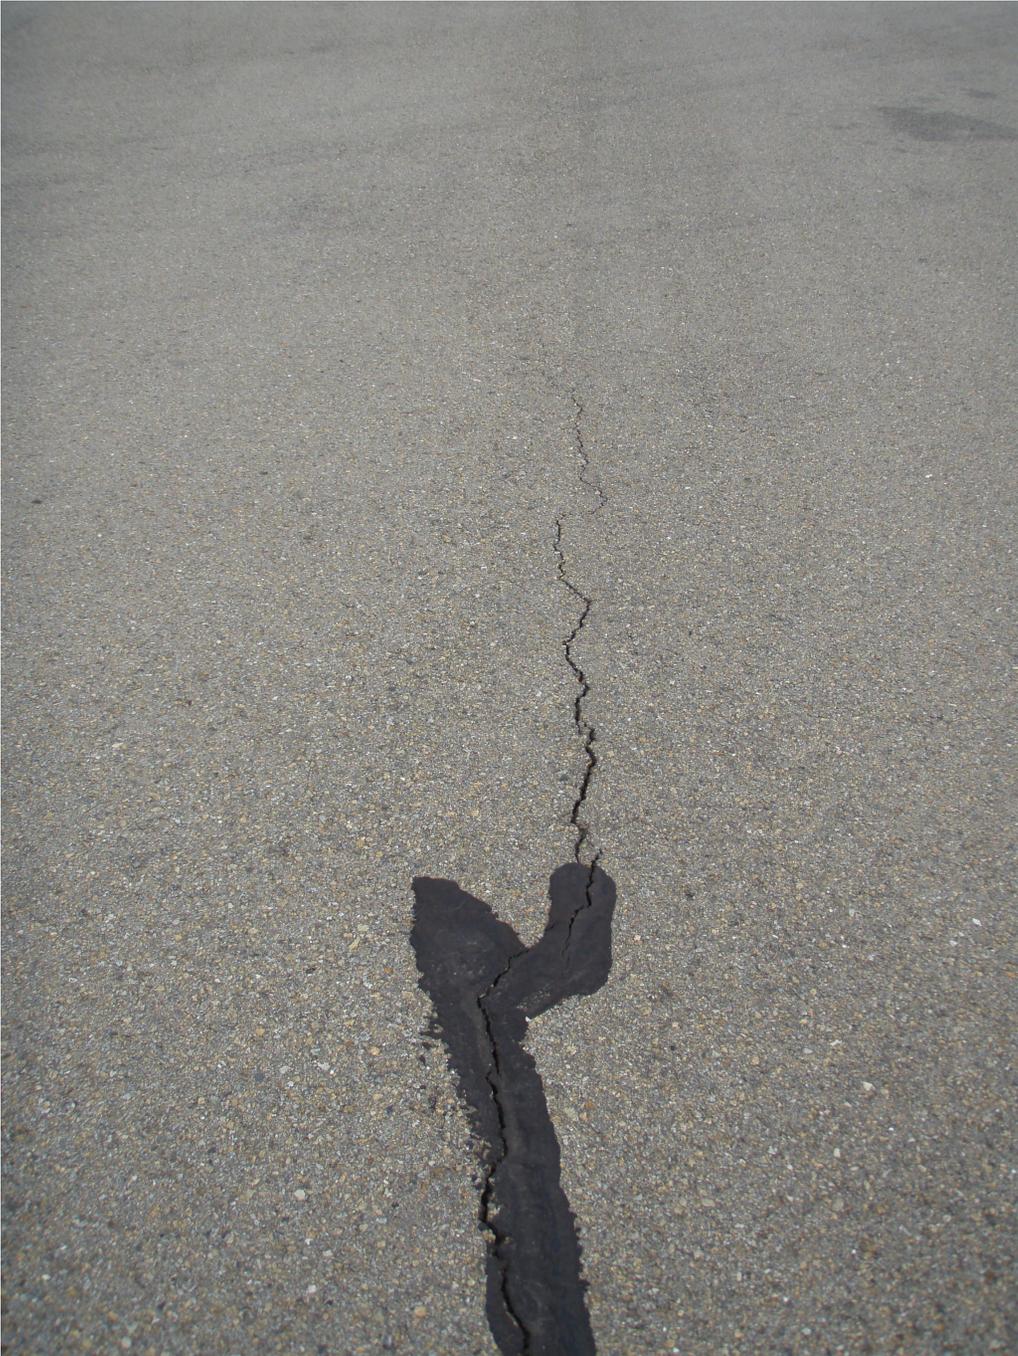
Photo 8: Extension of crack in MatCon.

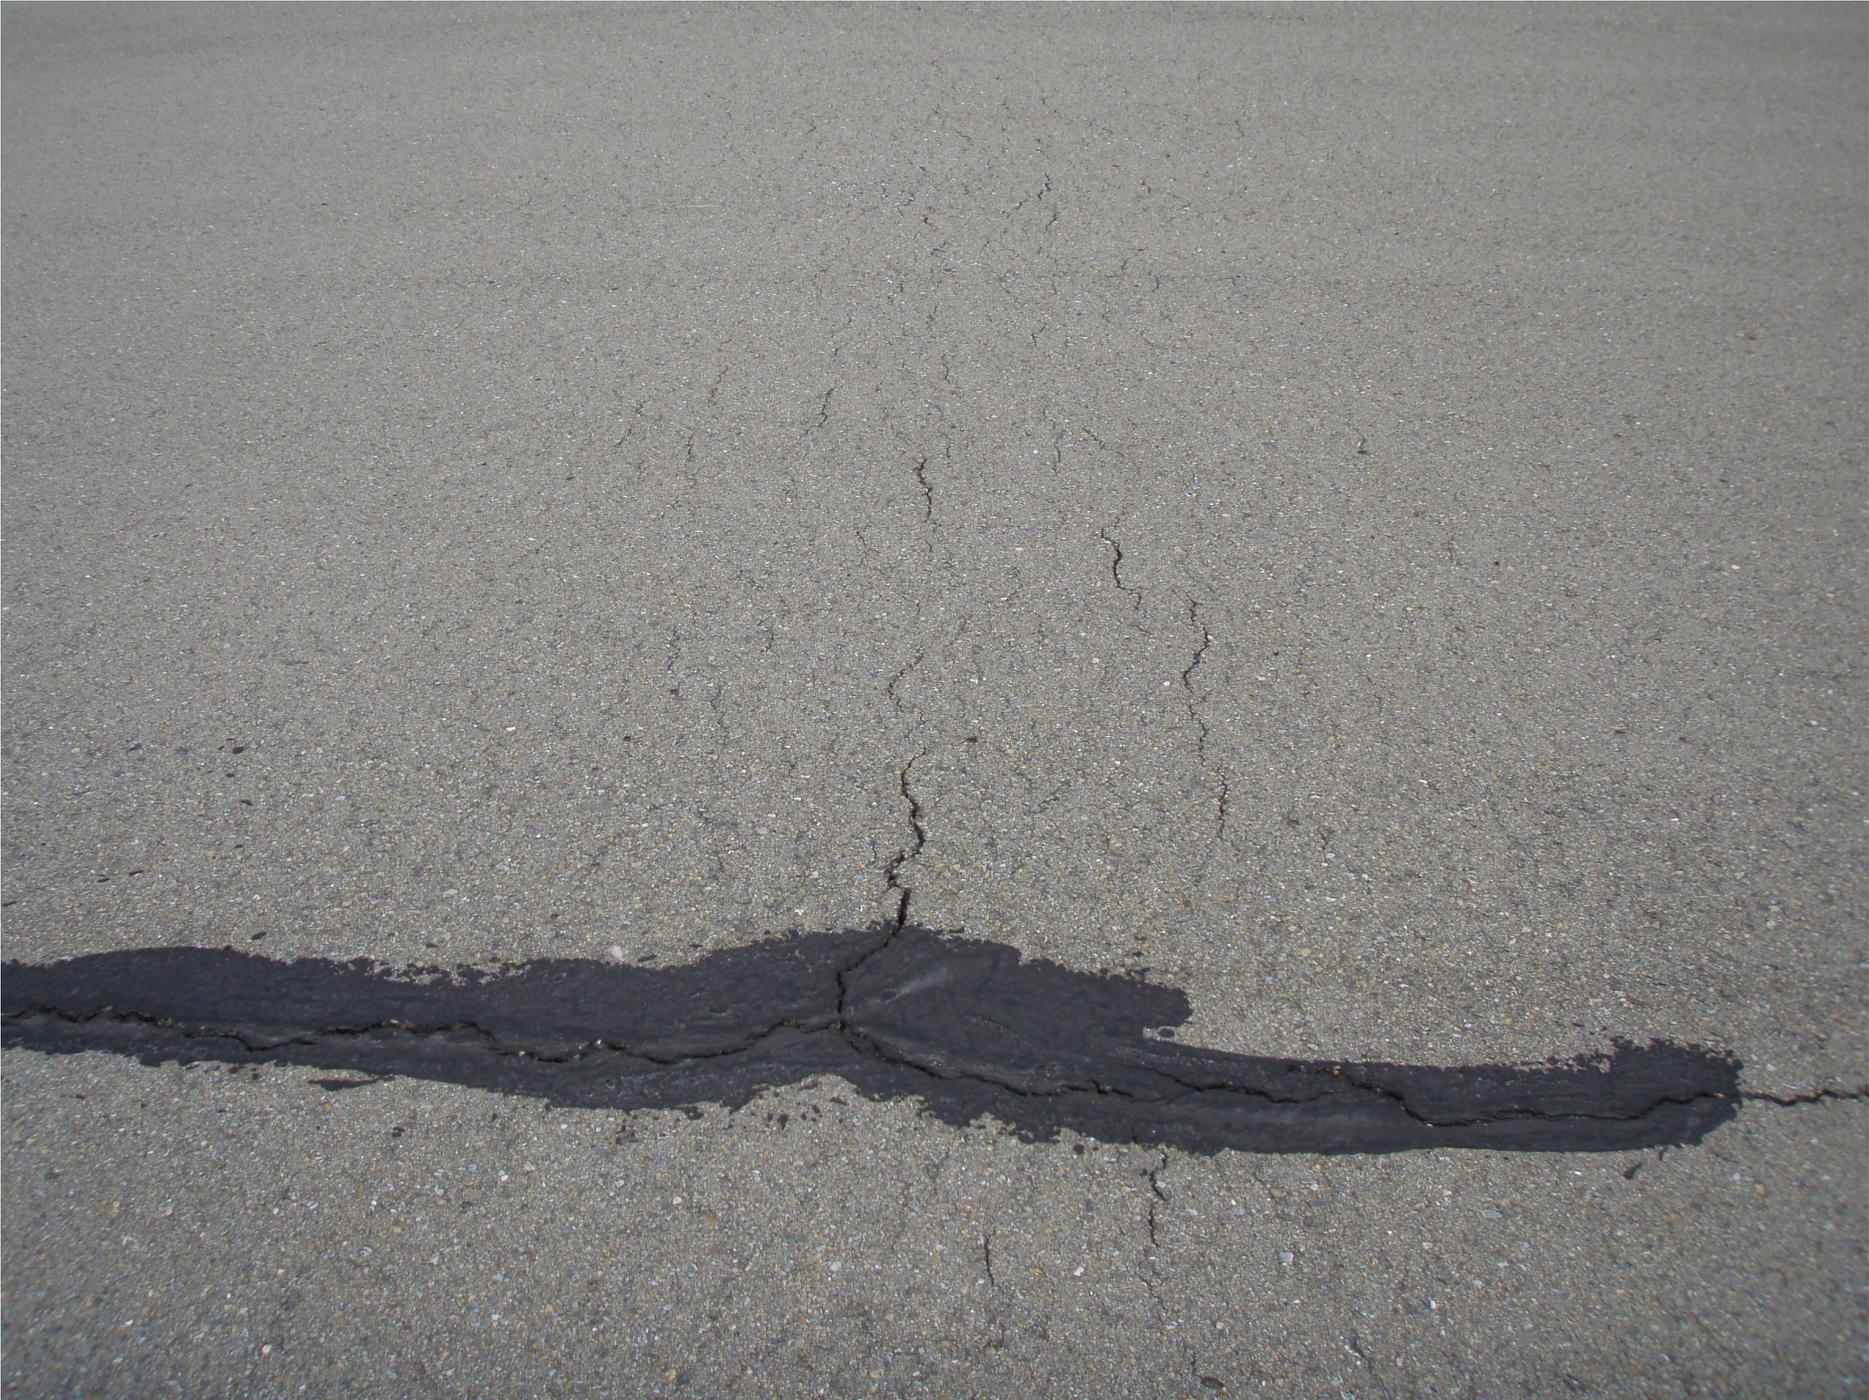
Photo 9: Cracking of MatCon along hinge point.

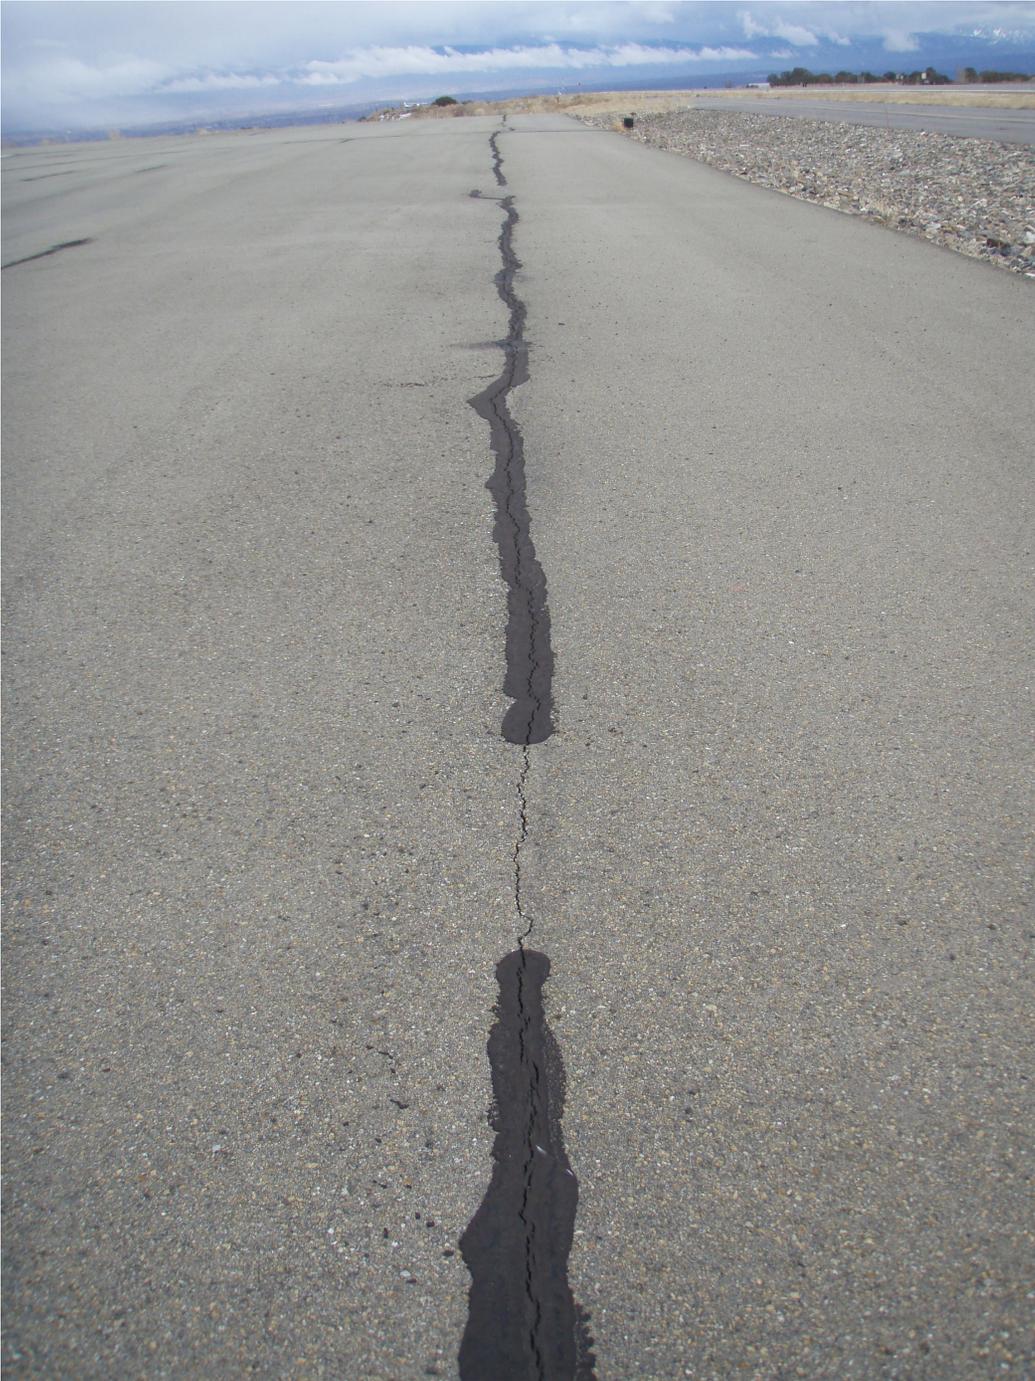
Photo 10: Cracking along paving lane.

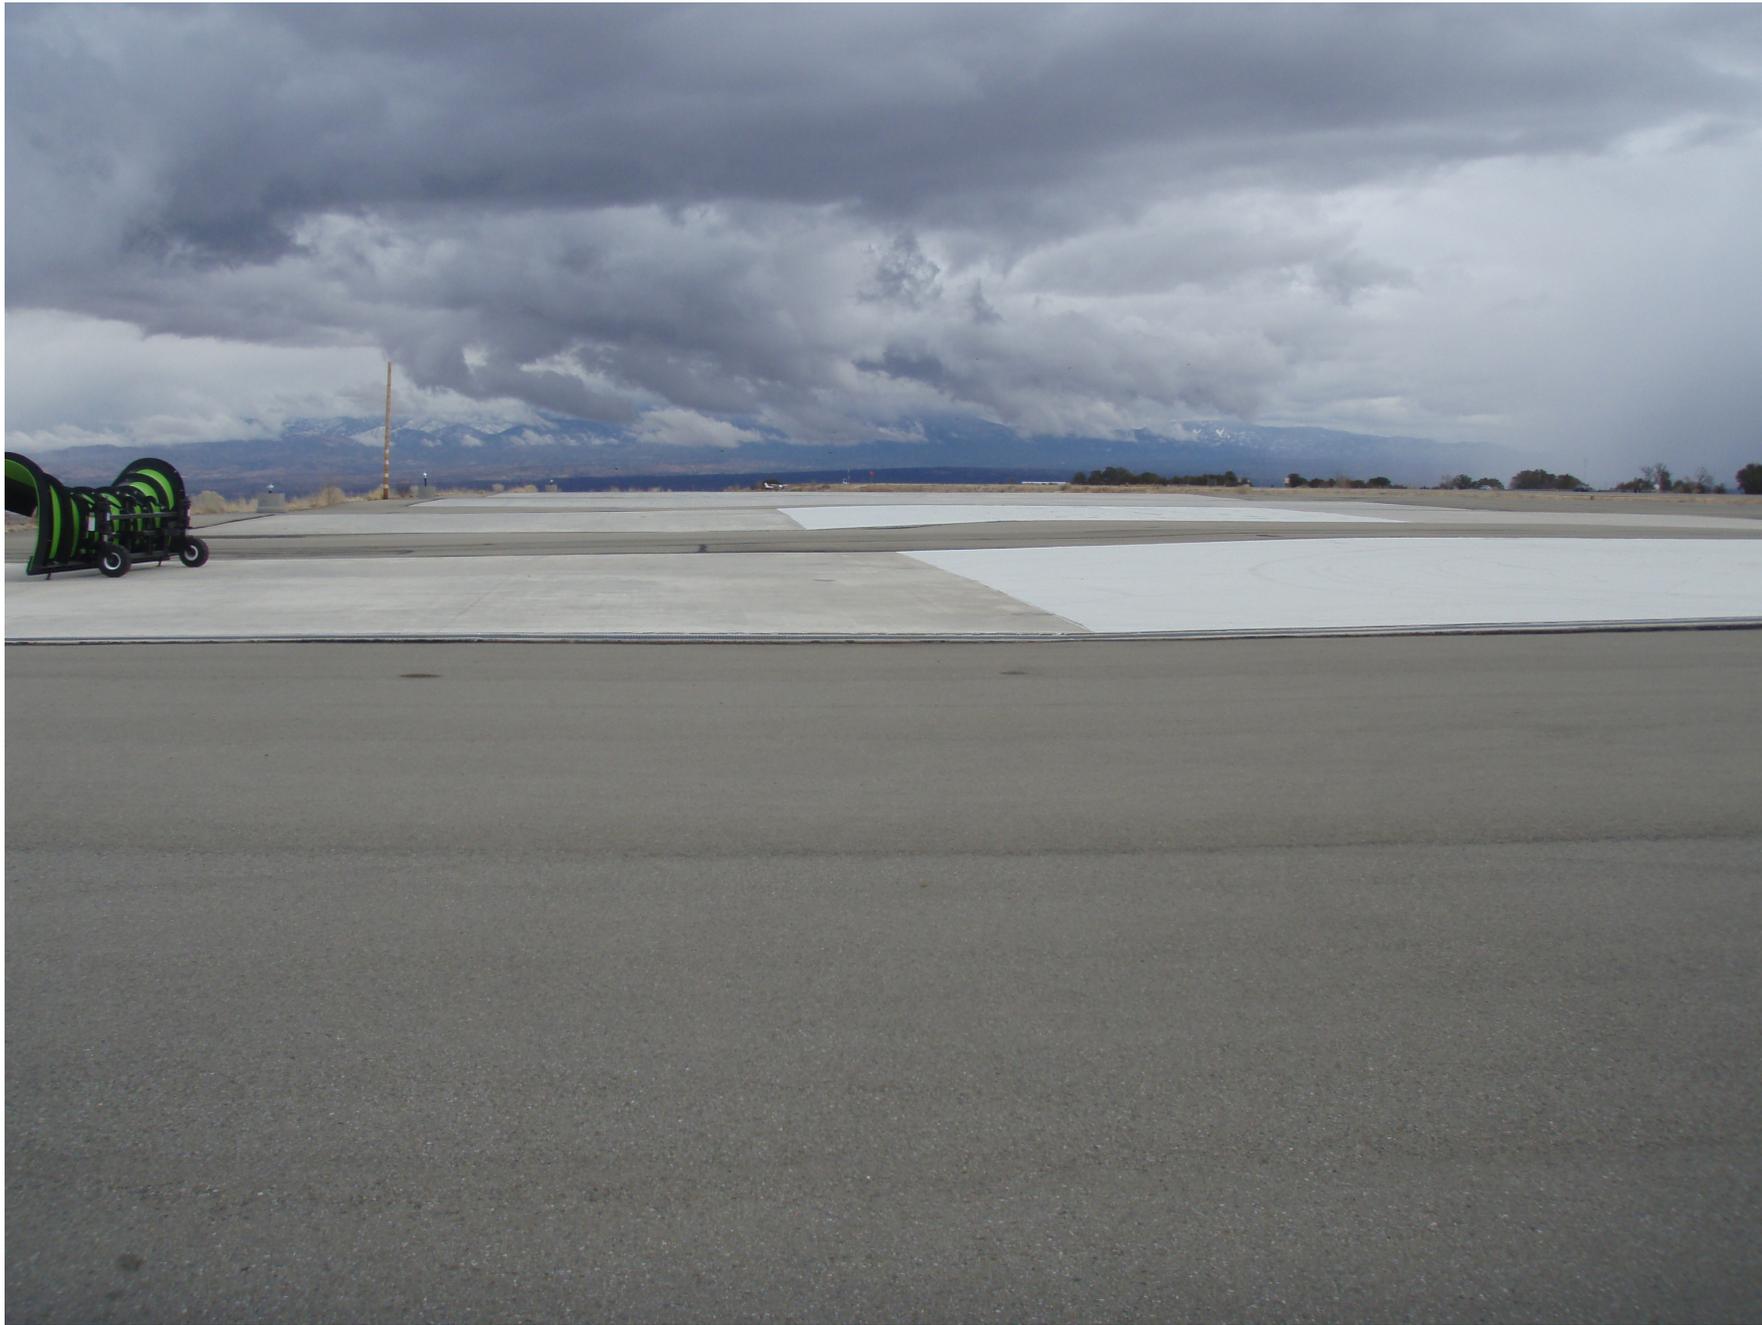
Photo 11: Looking east, note uneven nature and subsidence of pads 2 & 3.

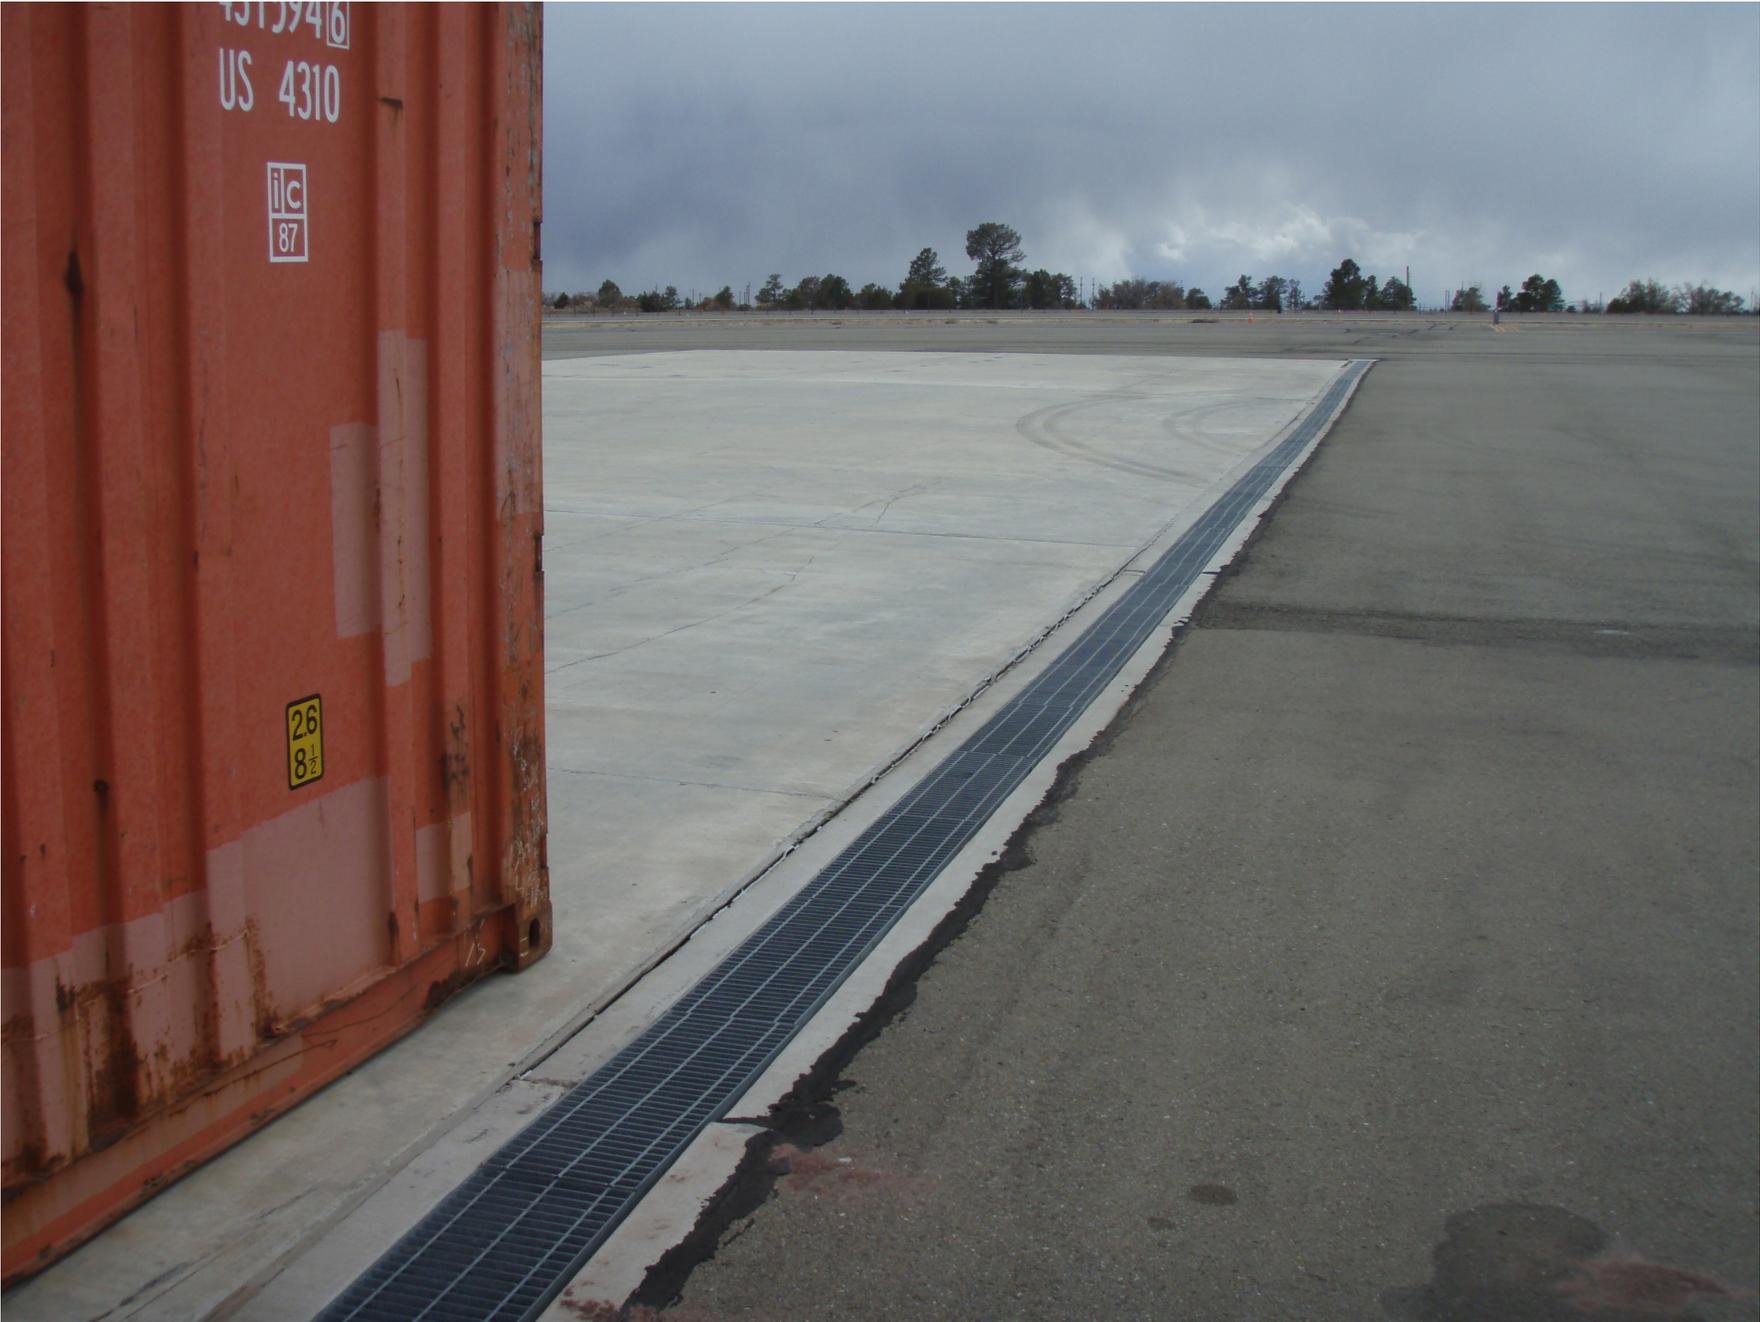
Photo 12: NW corner of Pad 1, note crack across trench drain and separation at of pad / drain.

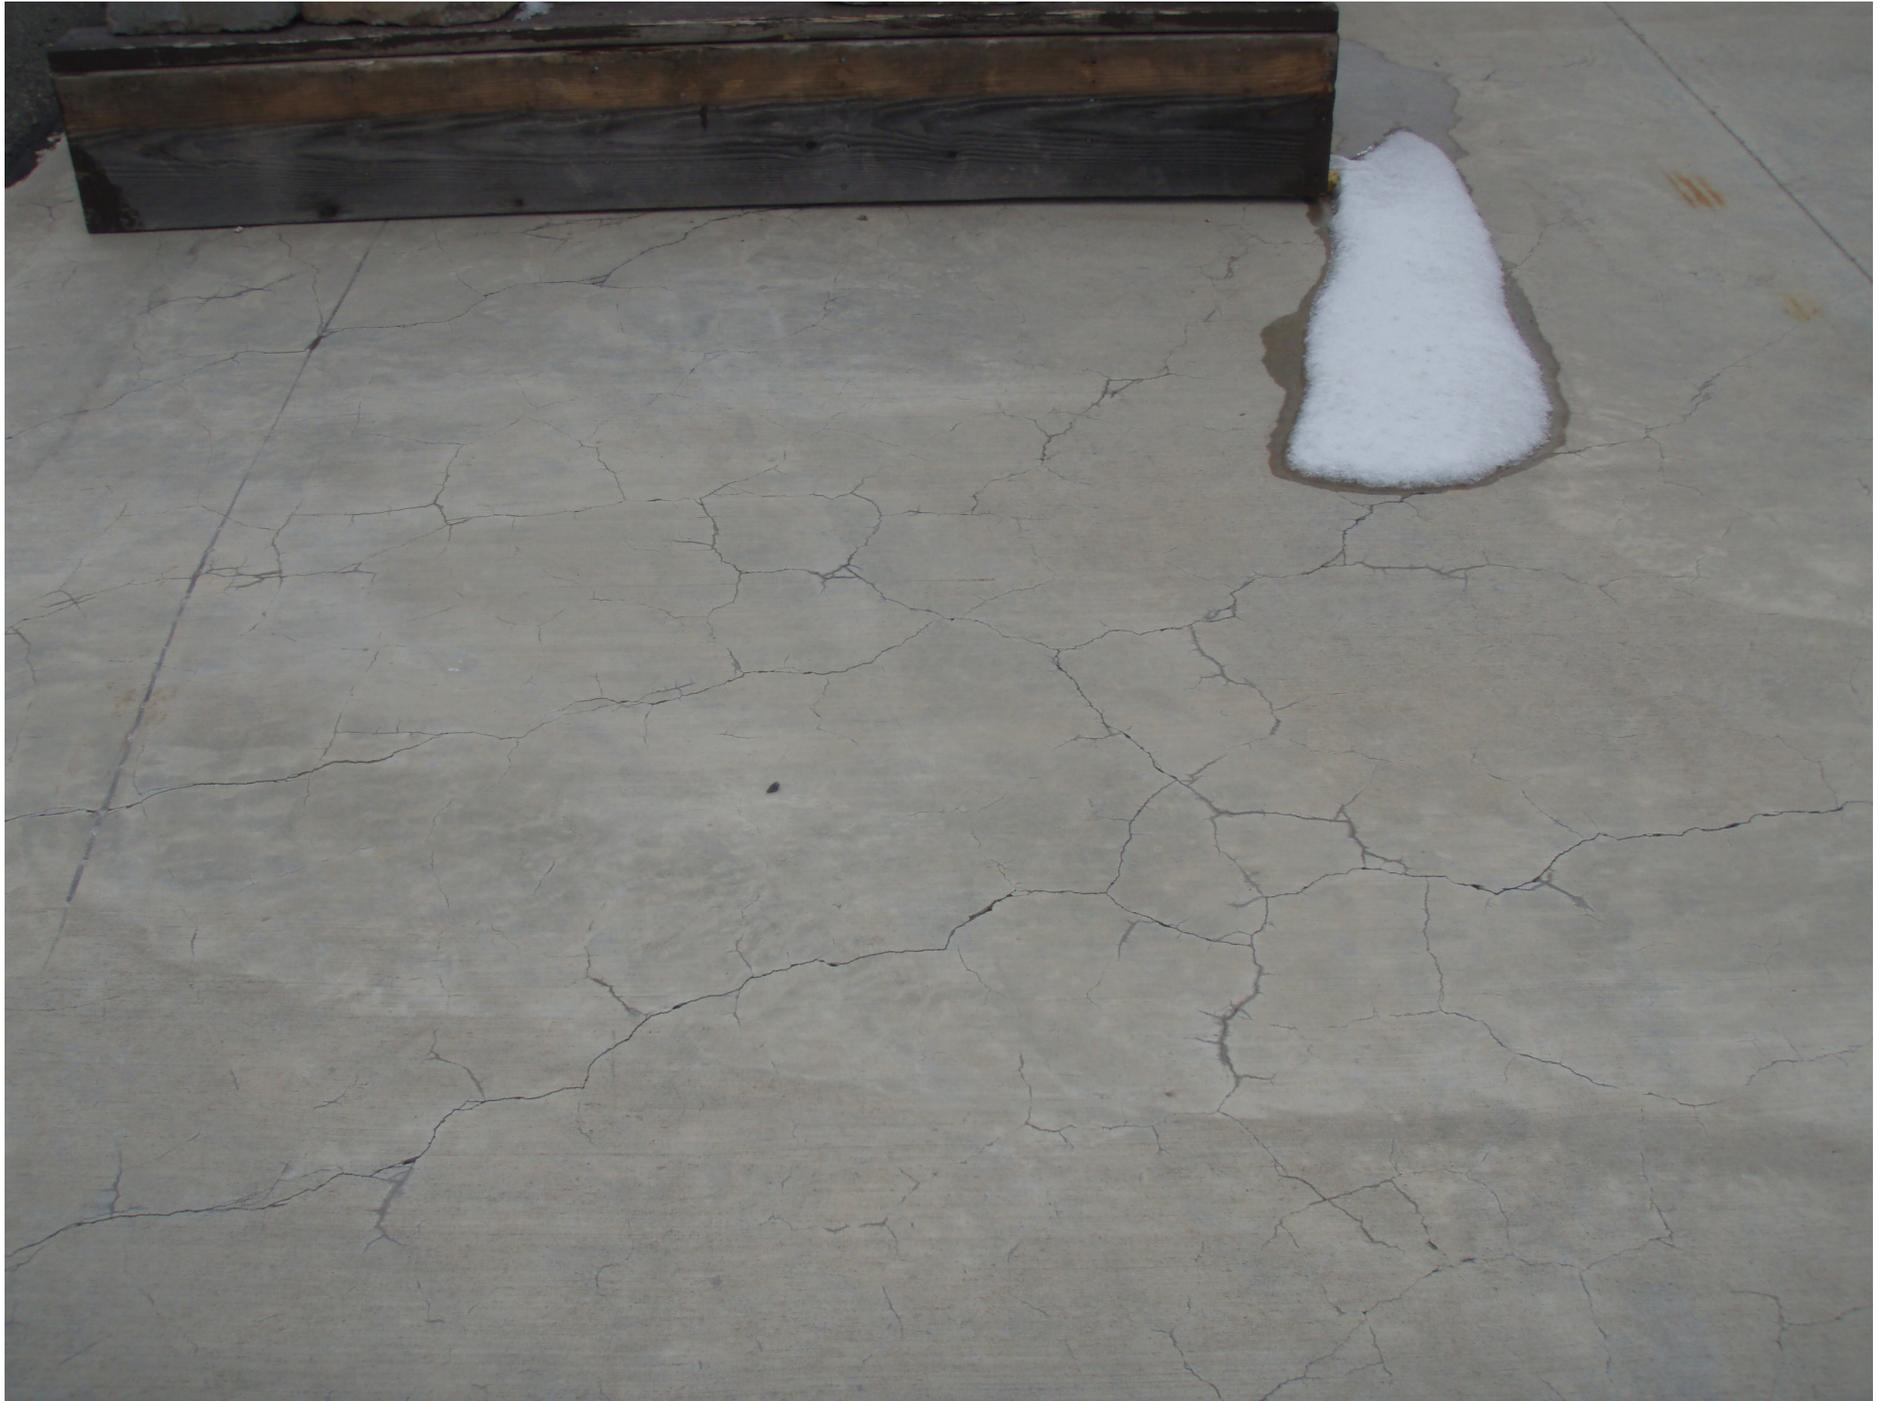
Photo 13: Spider web cracking in Pad 1.

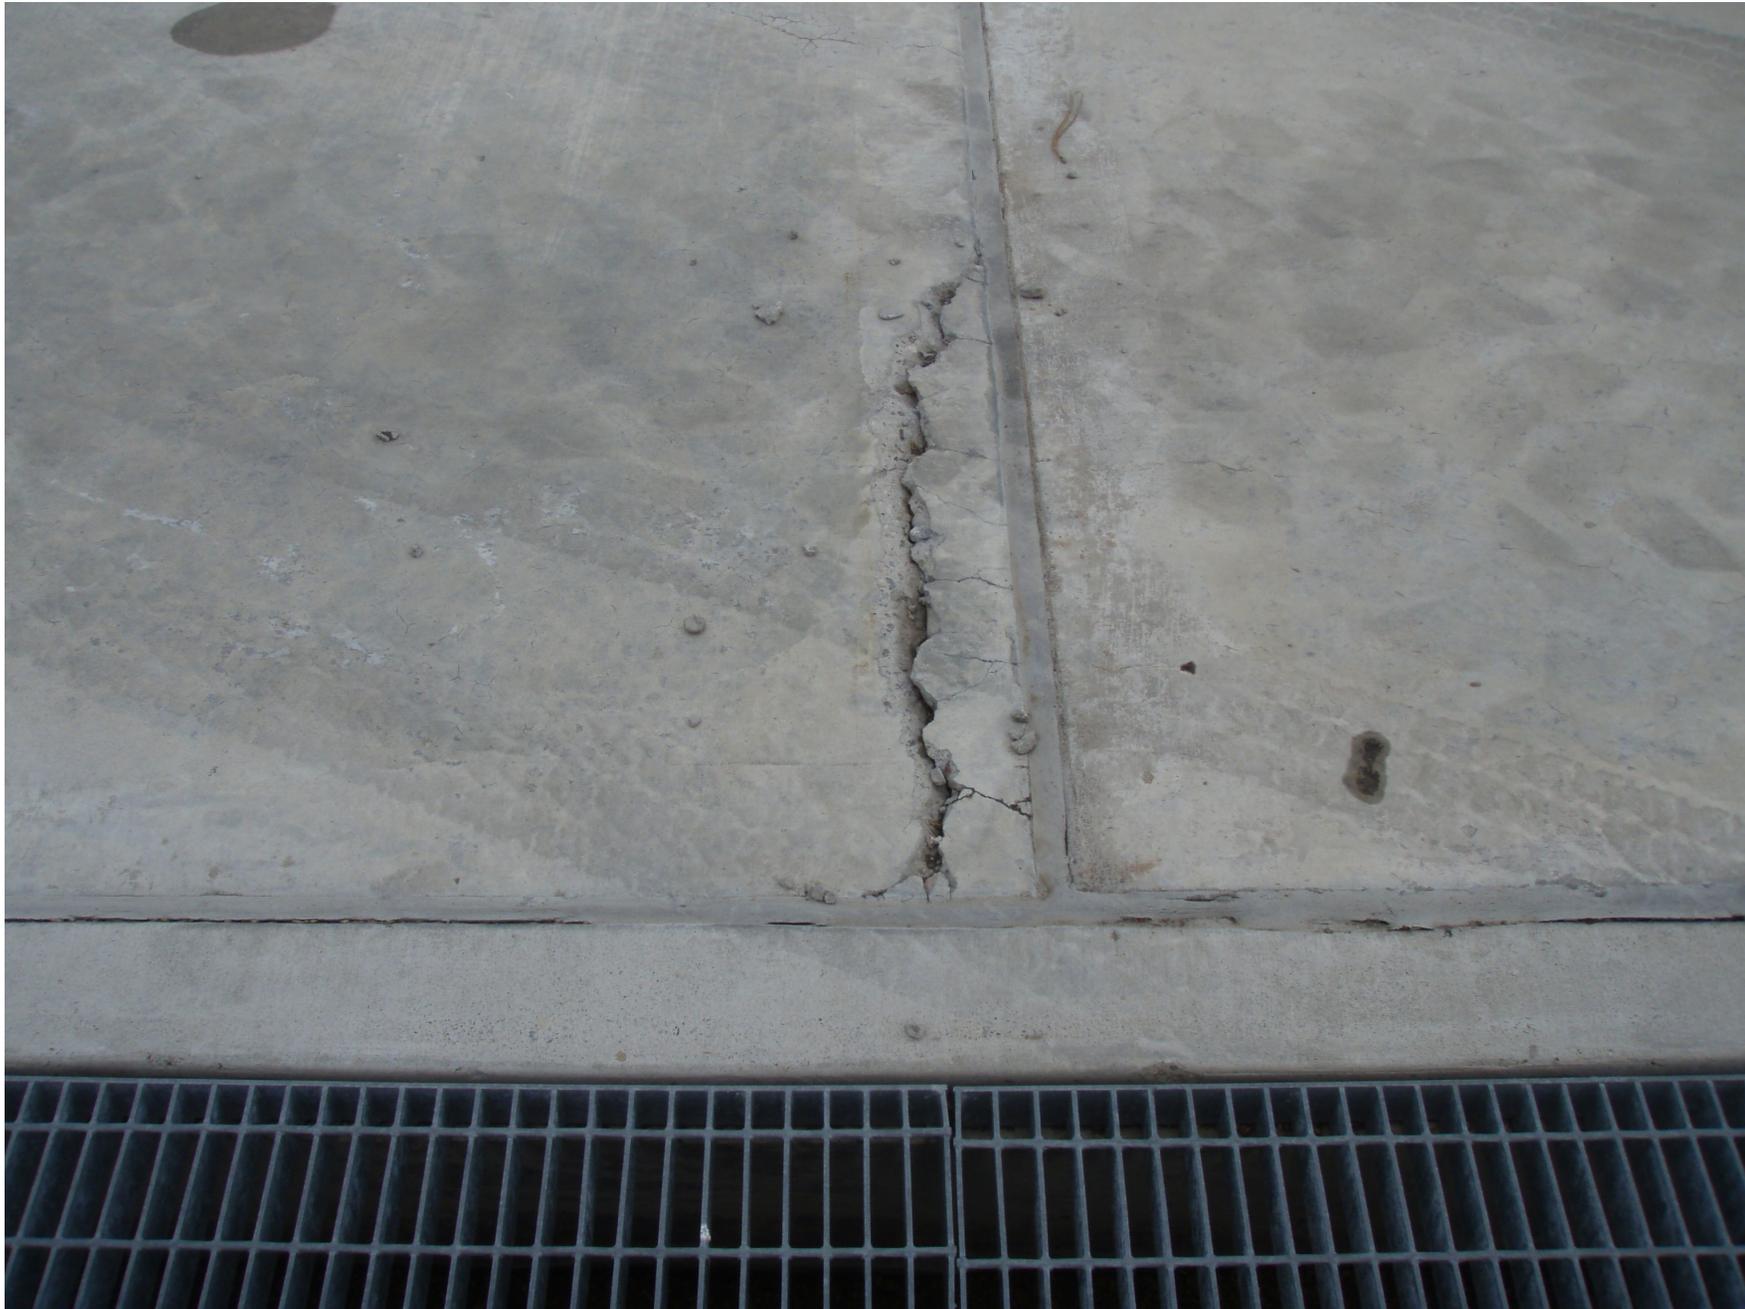
Photo 14: Cracking in Pad 1 along contact joint.
