Subject: Submittal of the 2013 Annual Inspection Report for Los Alamos County Airport Landfill, Solid Waste Management Units 73-001(a) and 73-001(d), Technical Area 73

**2013 Annual Inspection Report for
Los Alamos Country Airport Landfill,
Solid Waste Management Units
73-001(a) and 73-001(d),
Technical Area 73**

Prepared by the Los Alamos Field Office

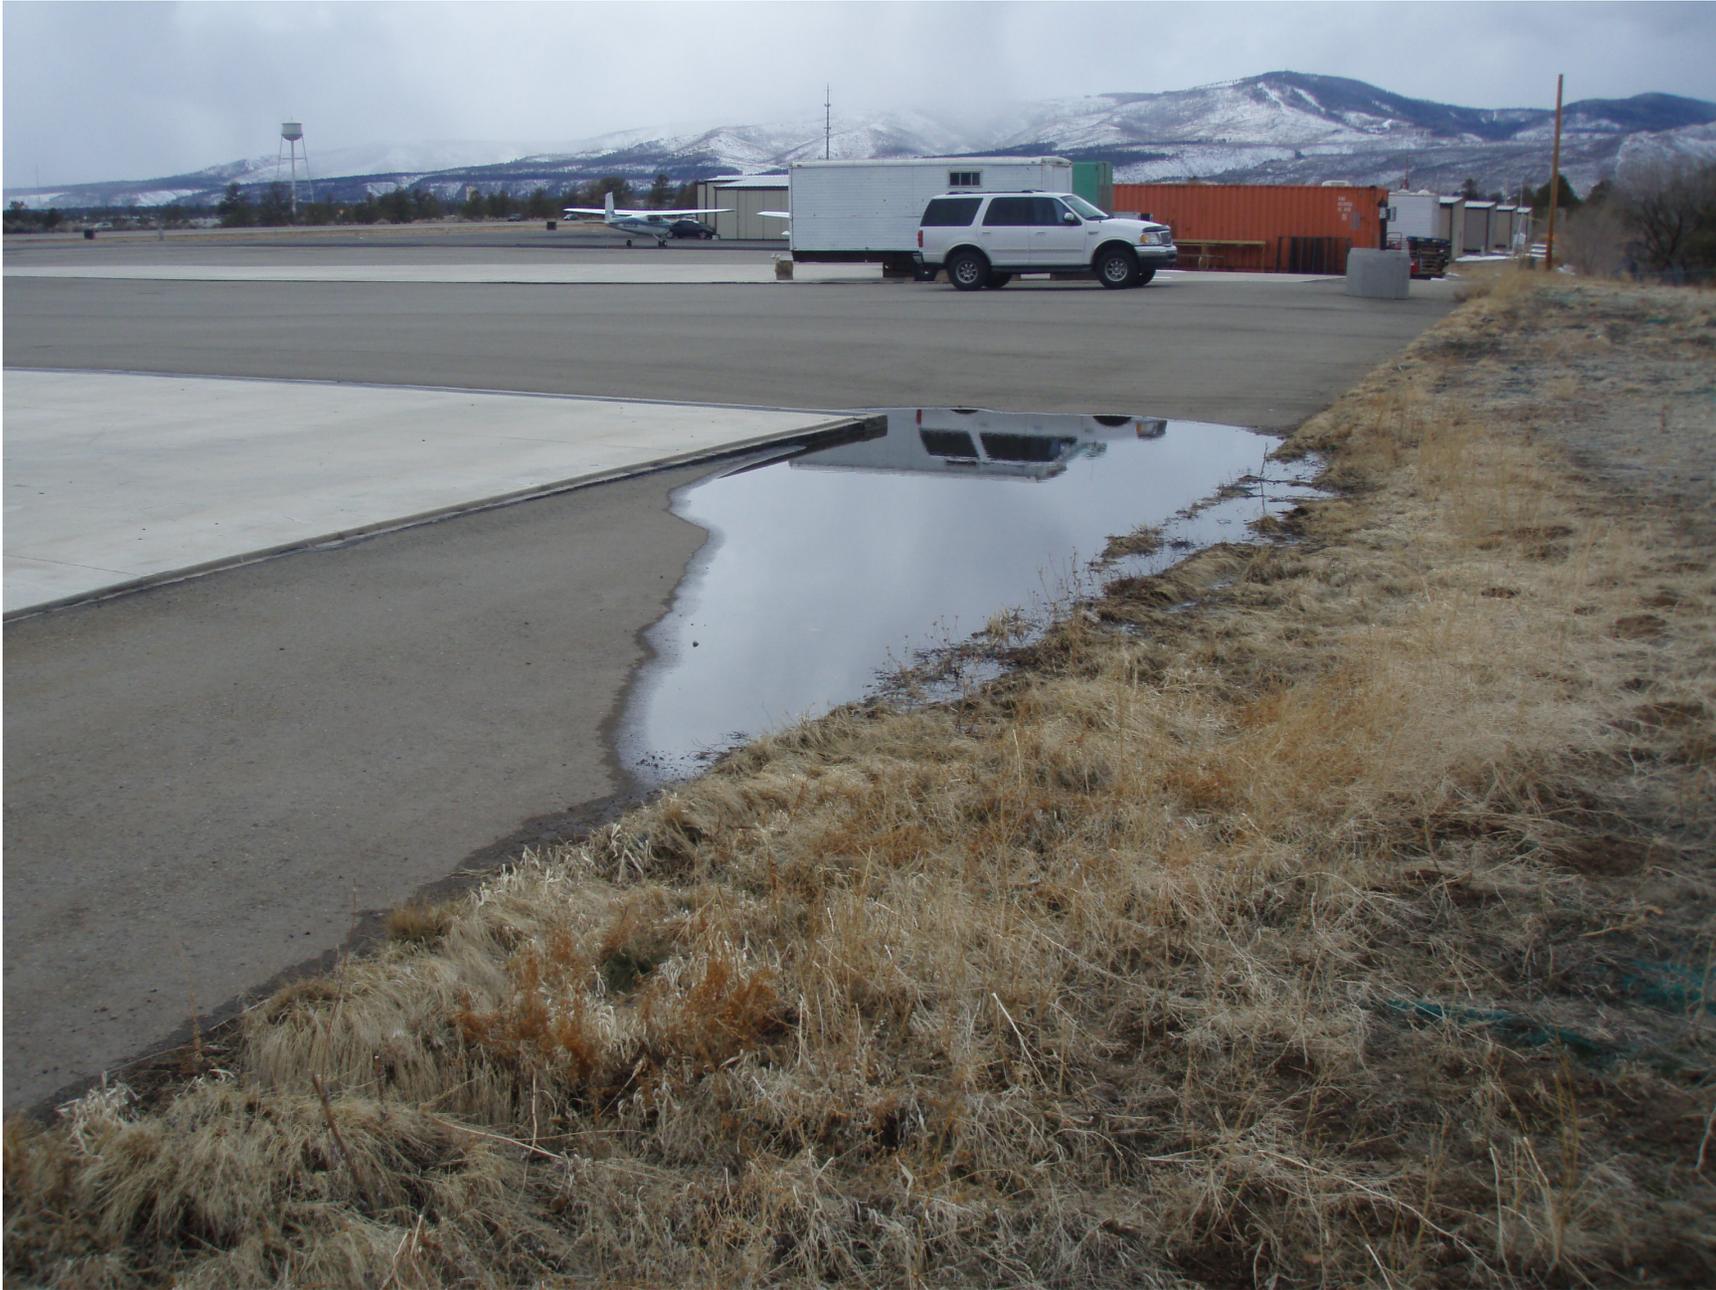
Photo 15: Puddle at NW corner of Pad 2. Note subsidence of MatCon, ineffective trench drain, and infiltration of water along the vegetative edge.

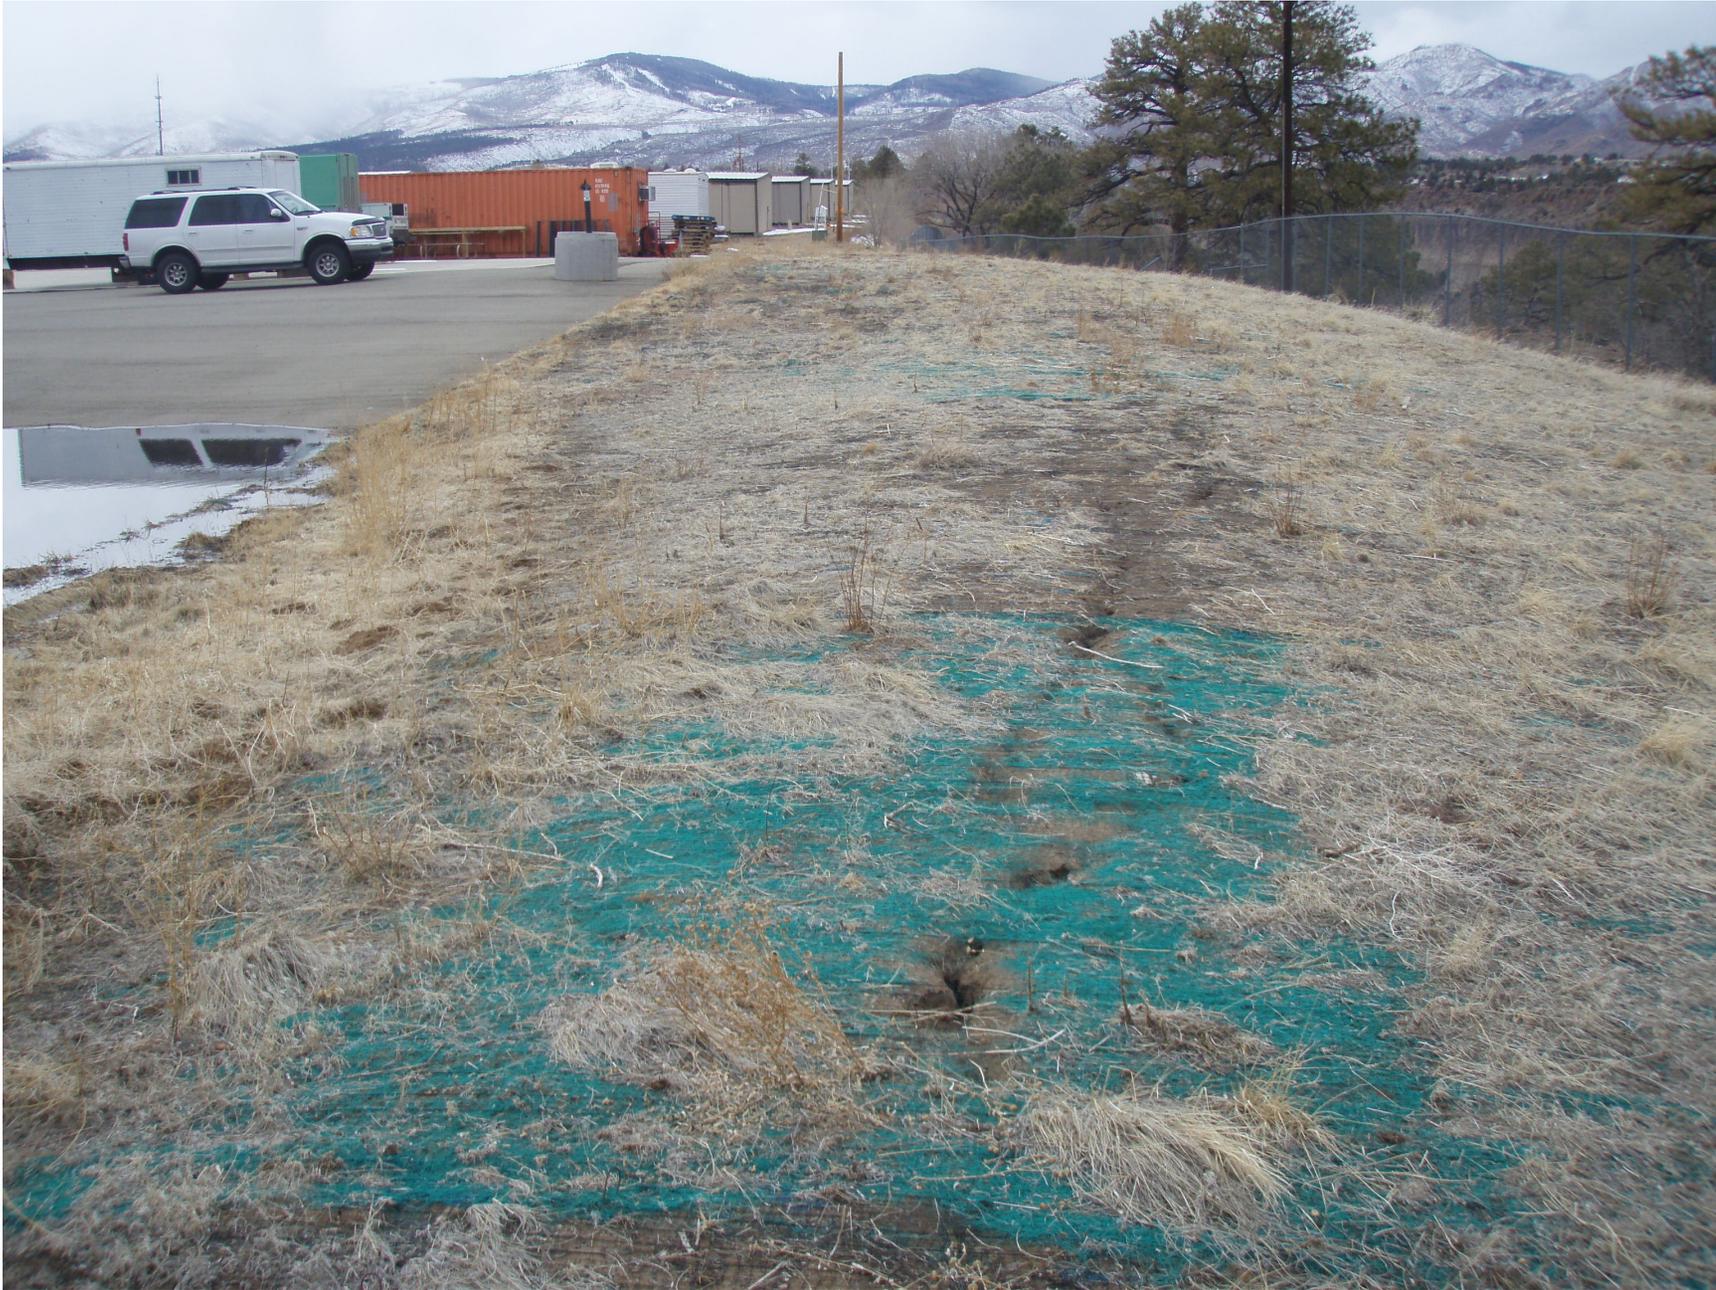
Photo 16: Puddle at NW corner of Pad 2. Note infiltration of water along the vegetative edge and soil fissure along top of earth berm.

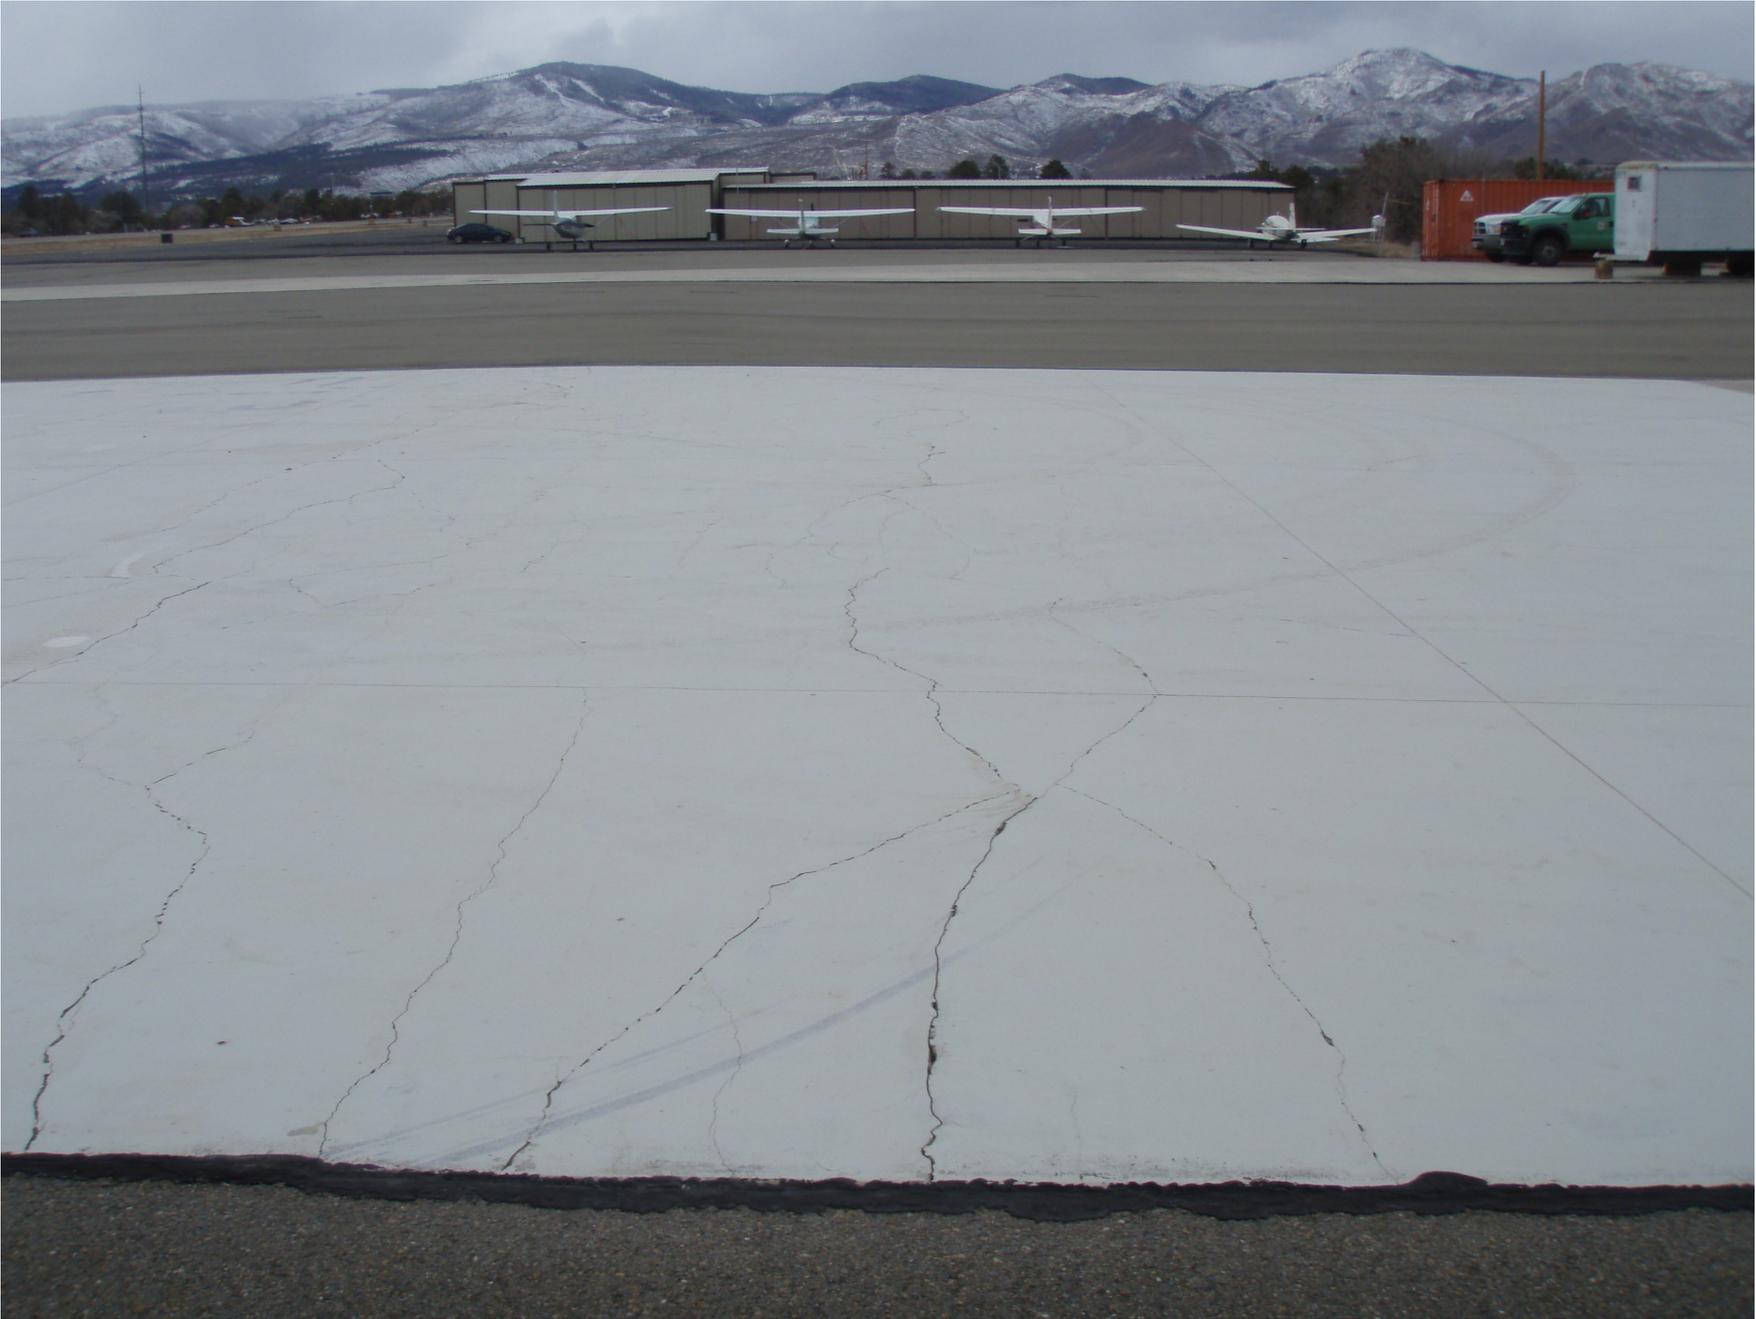
Photo 17: Looking West at cracking in Pad 2.

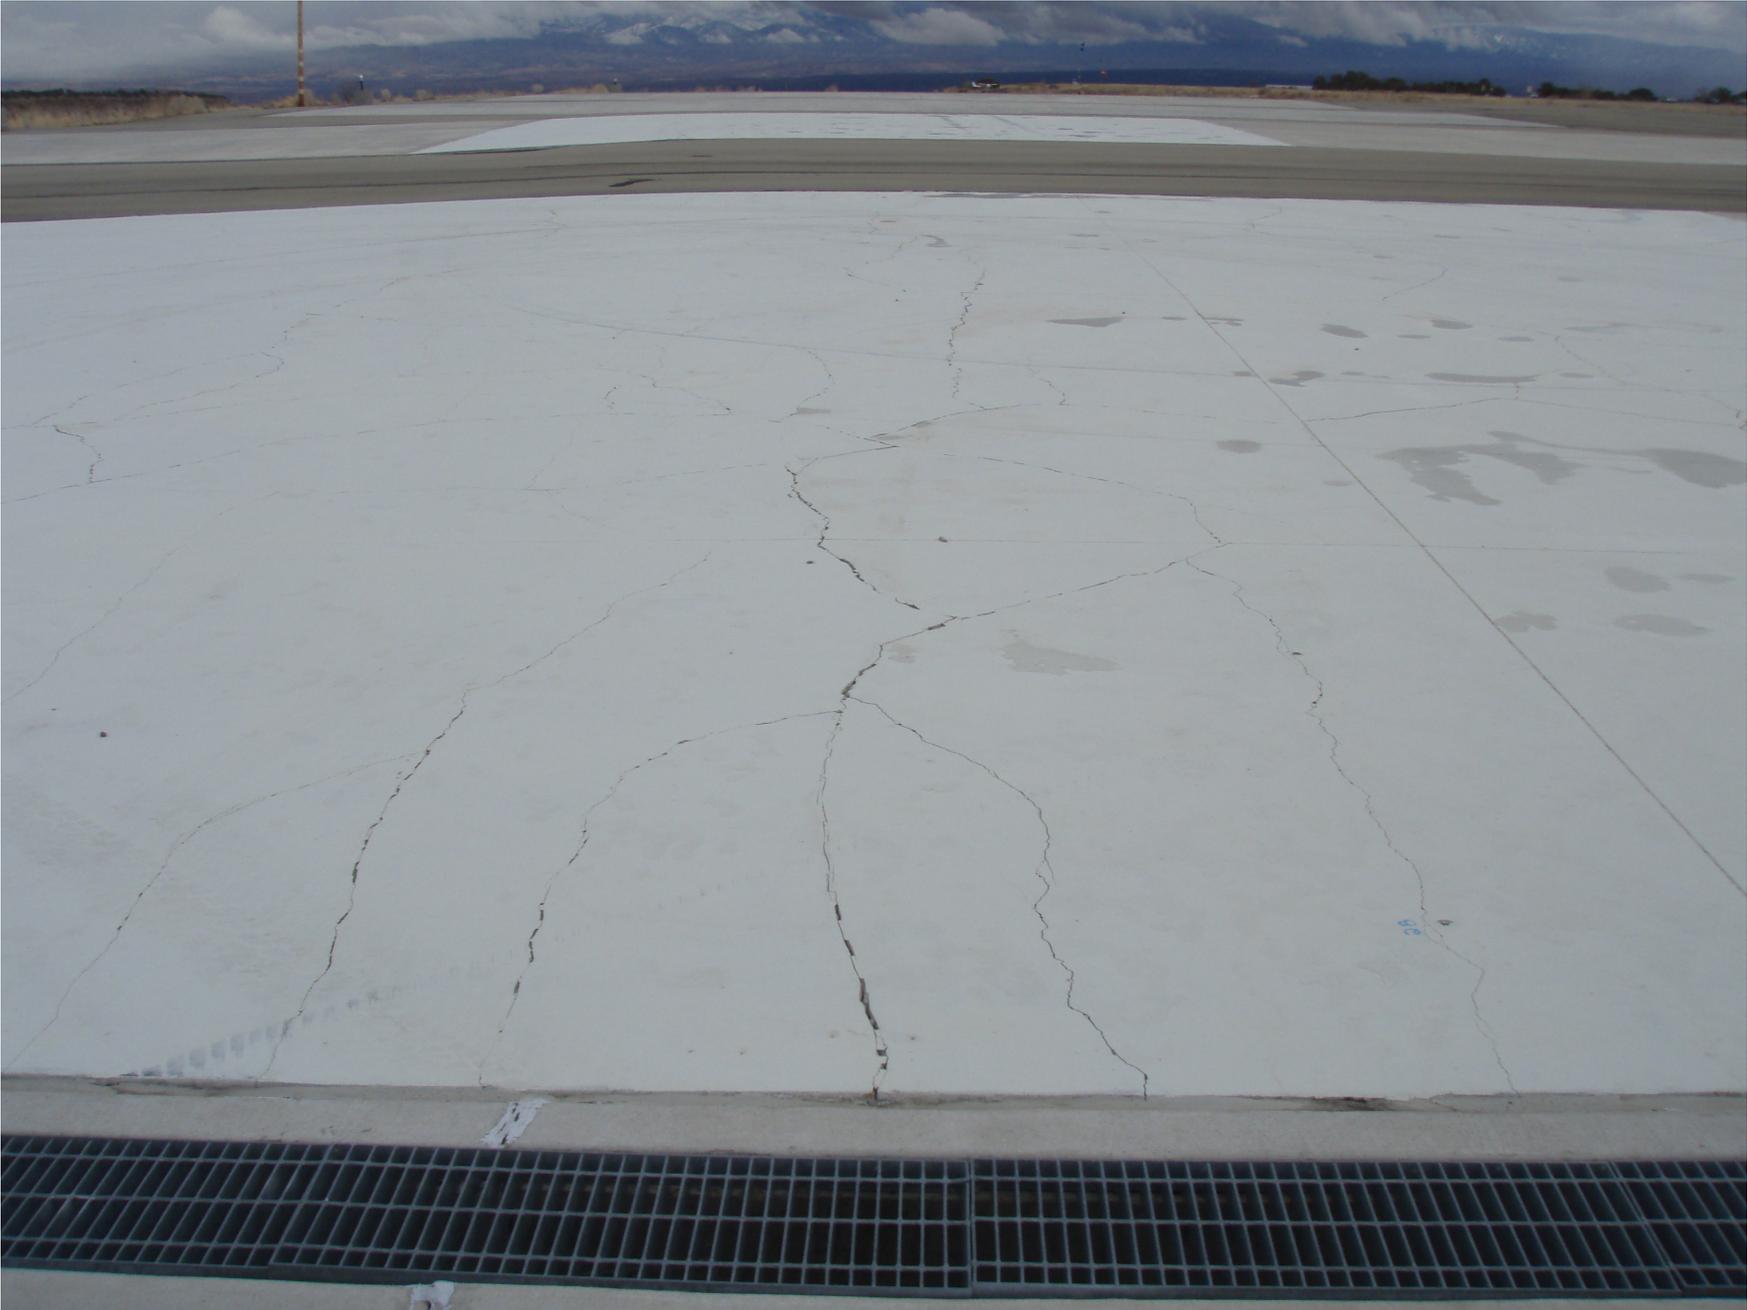
Photo 18: Looking East at cracking in Pad 2, note crack across trench drain.

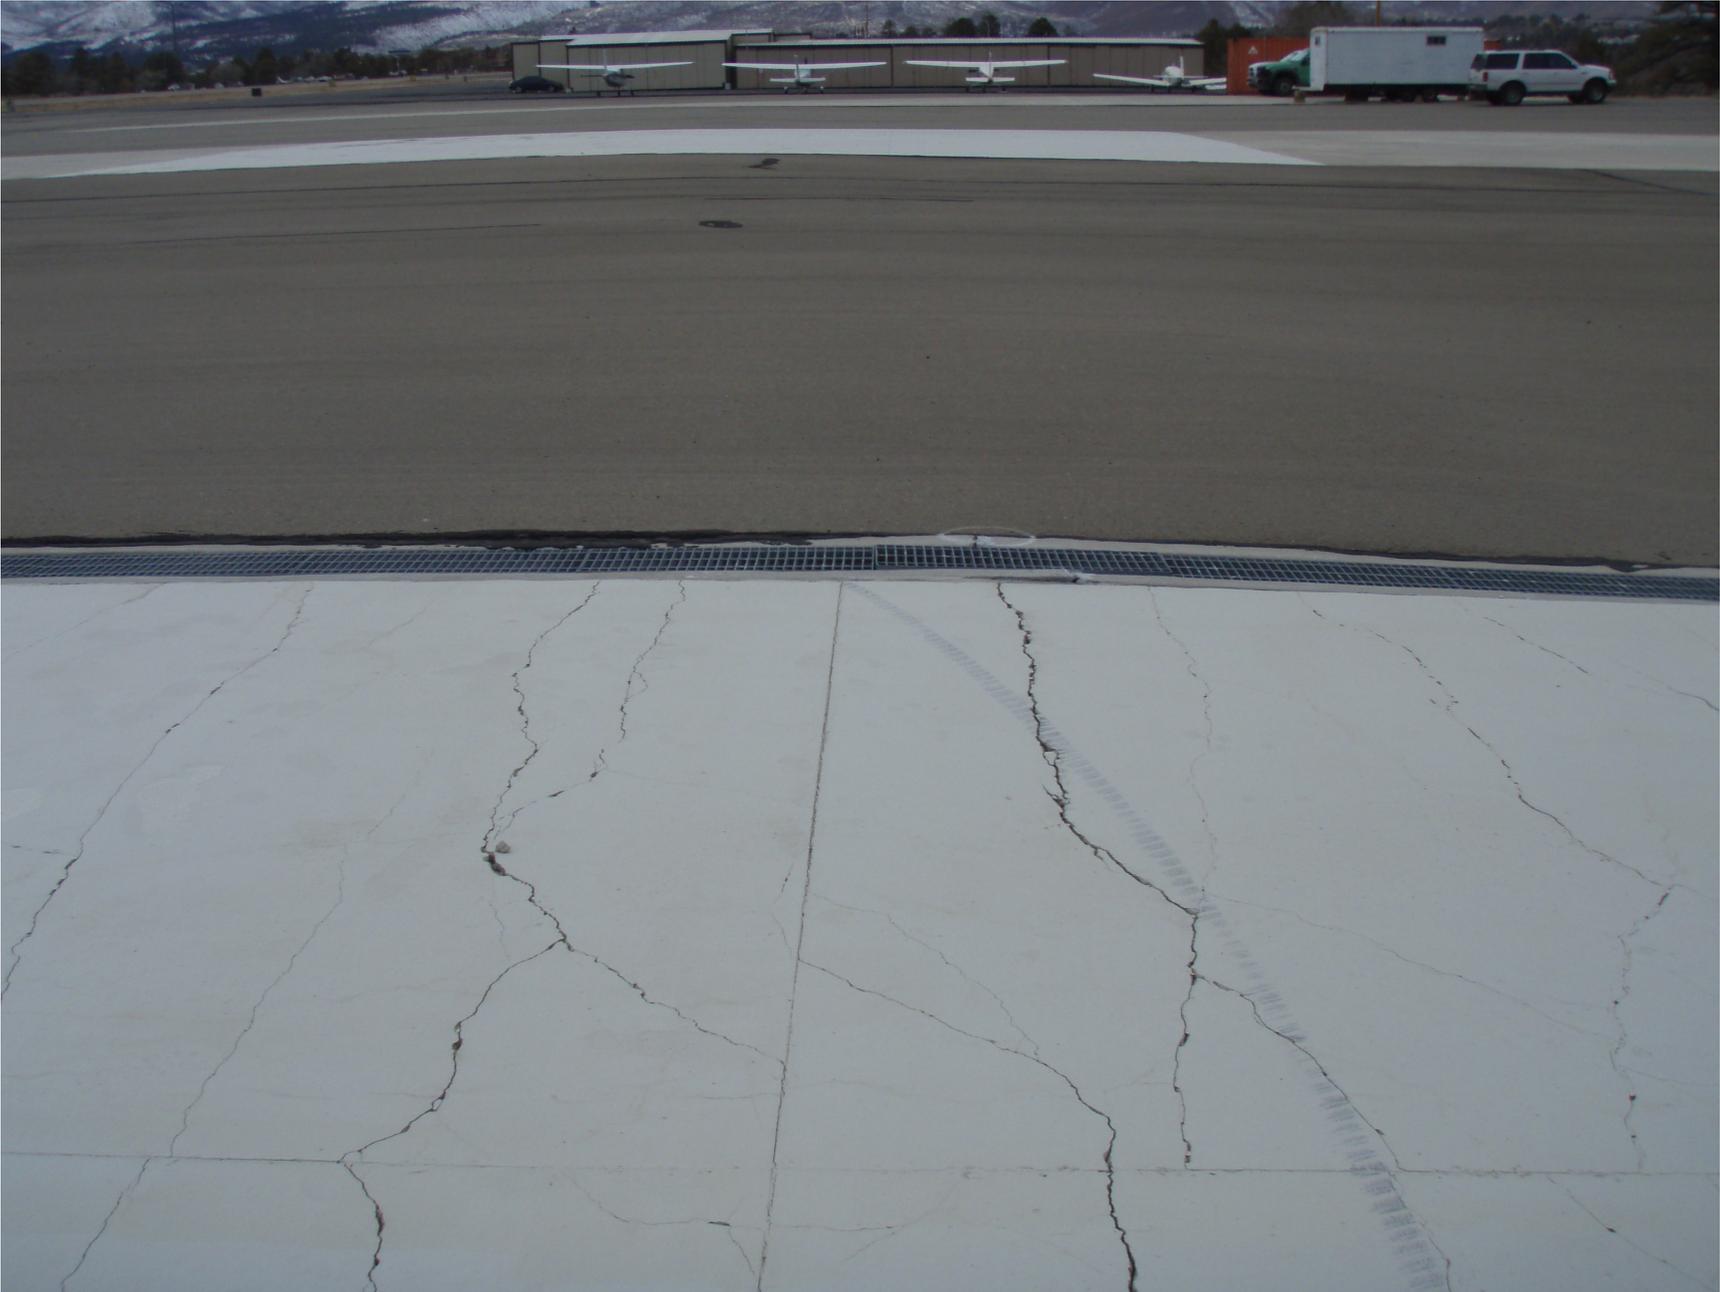
Photo 19: Looking west at cracking in Pad 3 along hinge point. Note cracking and subsidence along trench drain.

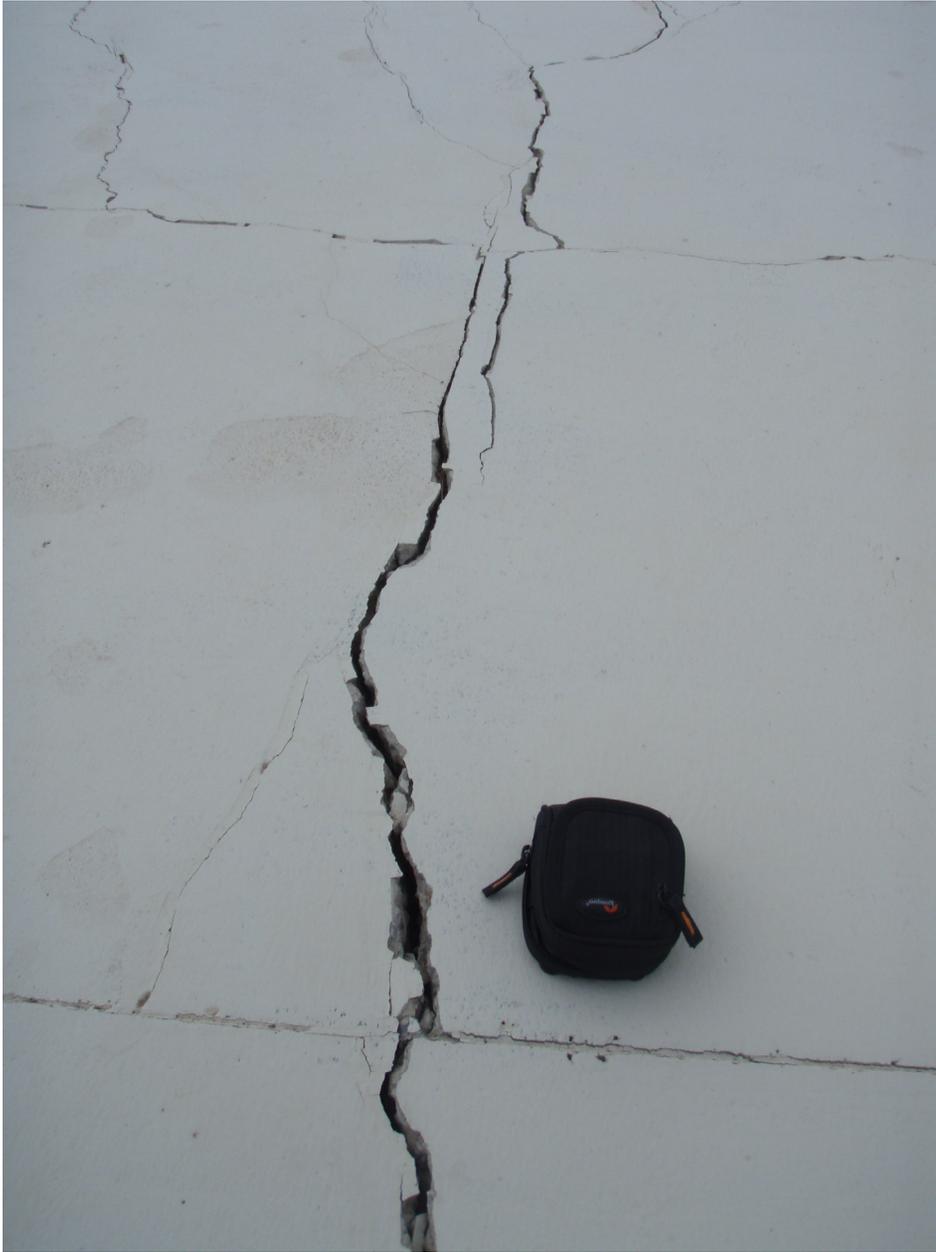
Photo 20: Crack in Pad 3, camera case used for scale.

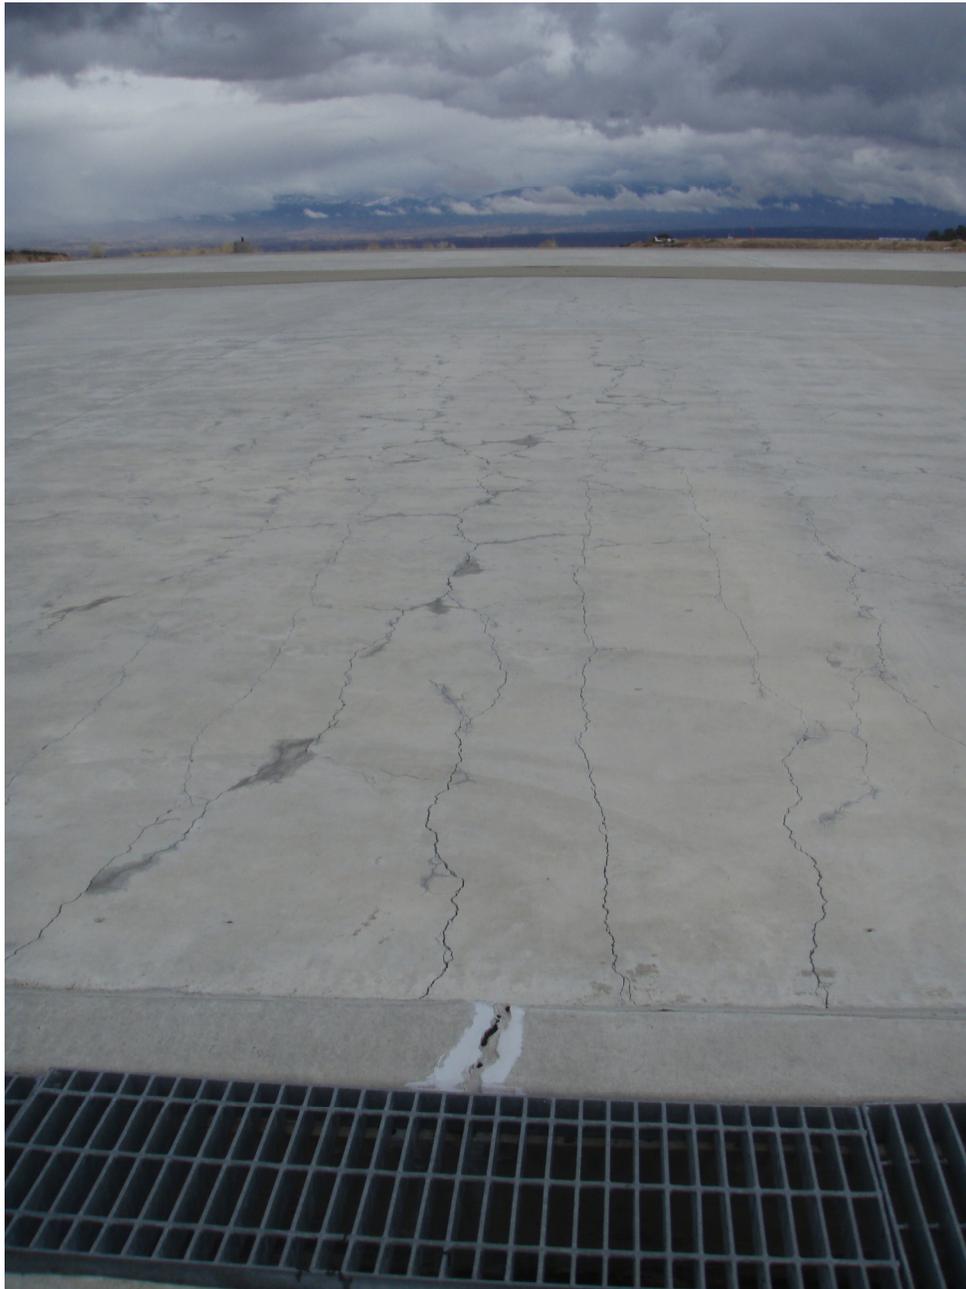
Photo 21: Looking East from Pad 4, note cracking in pad and trench drain.

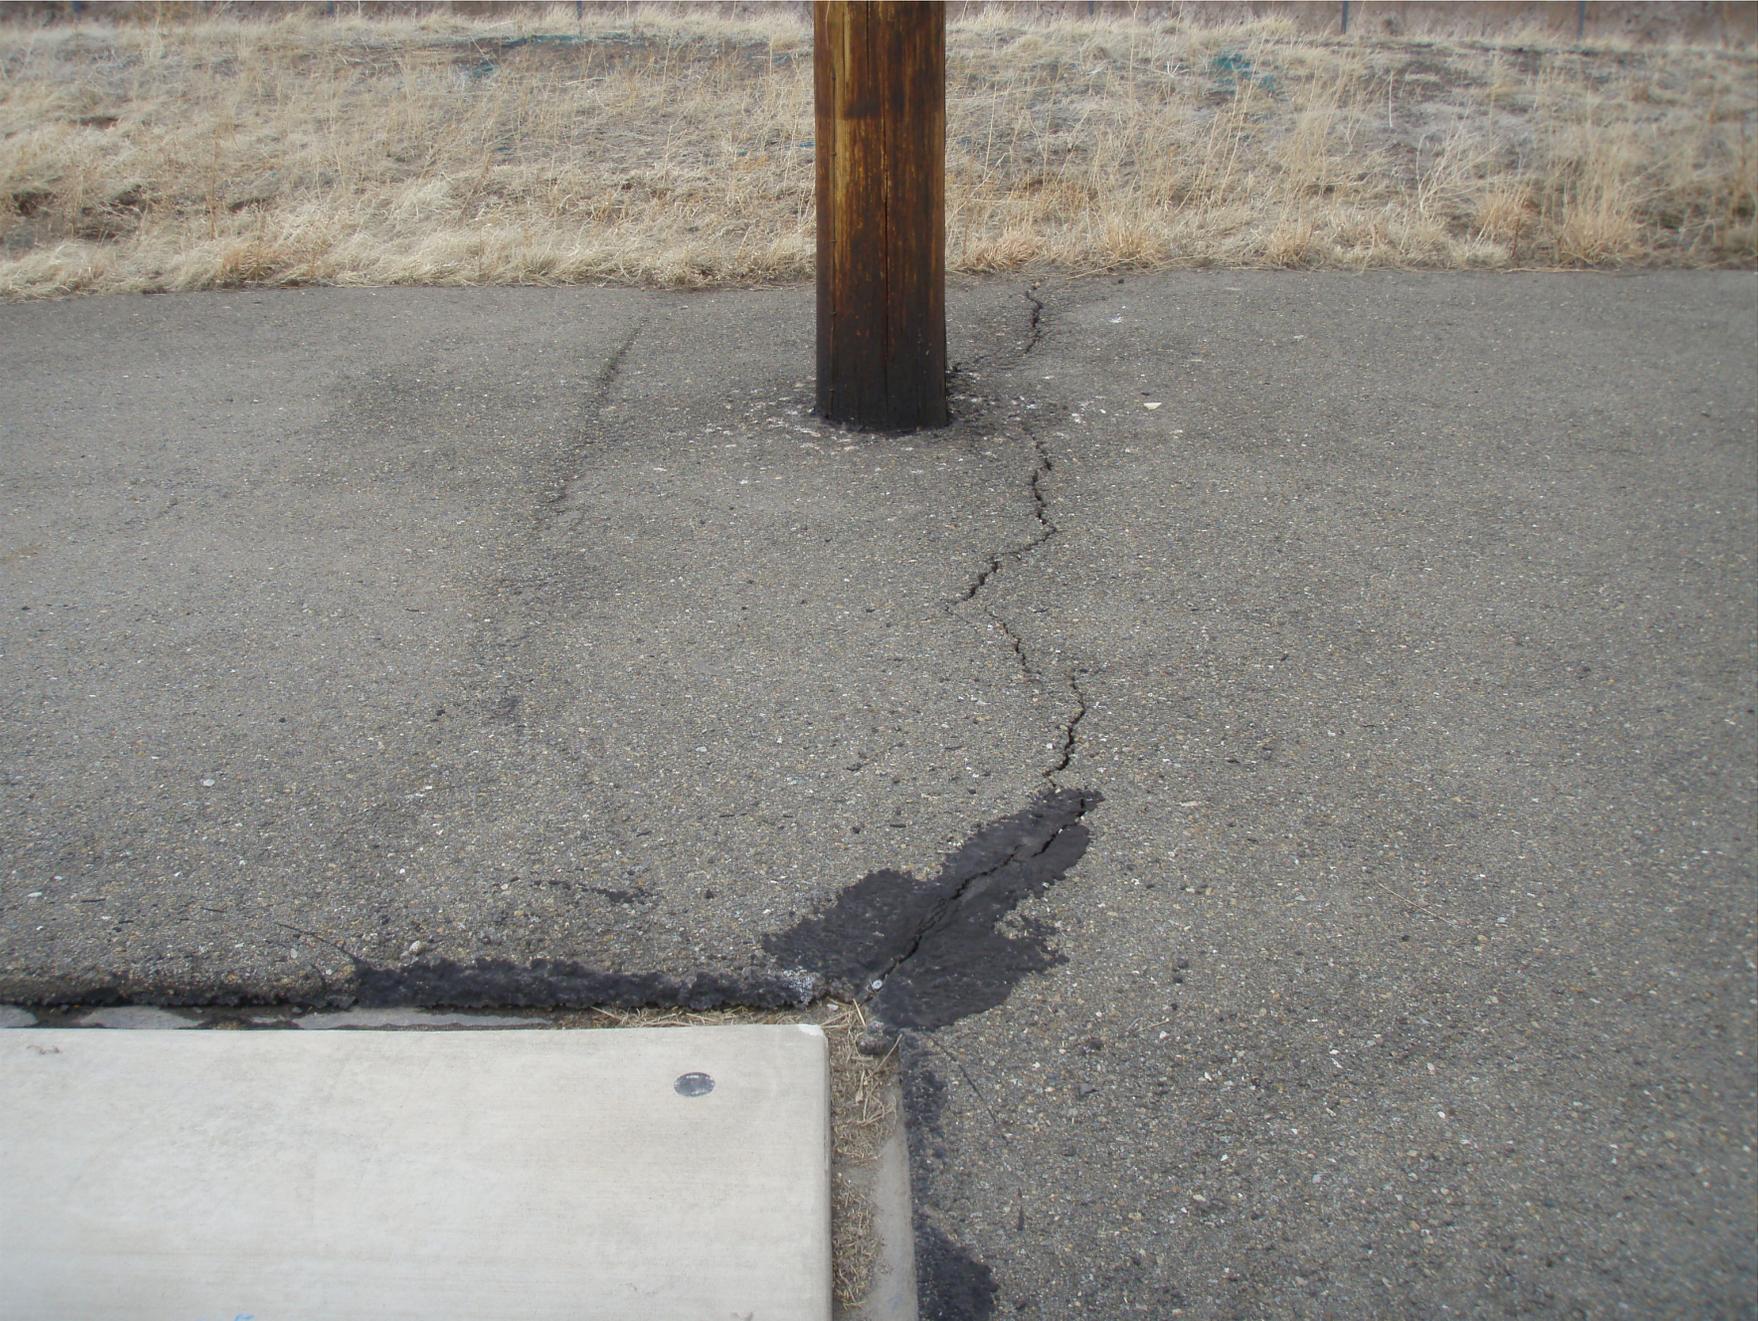
Photo 27: Crack extending from pad to NE edge.

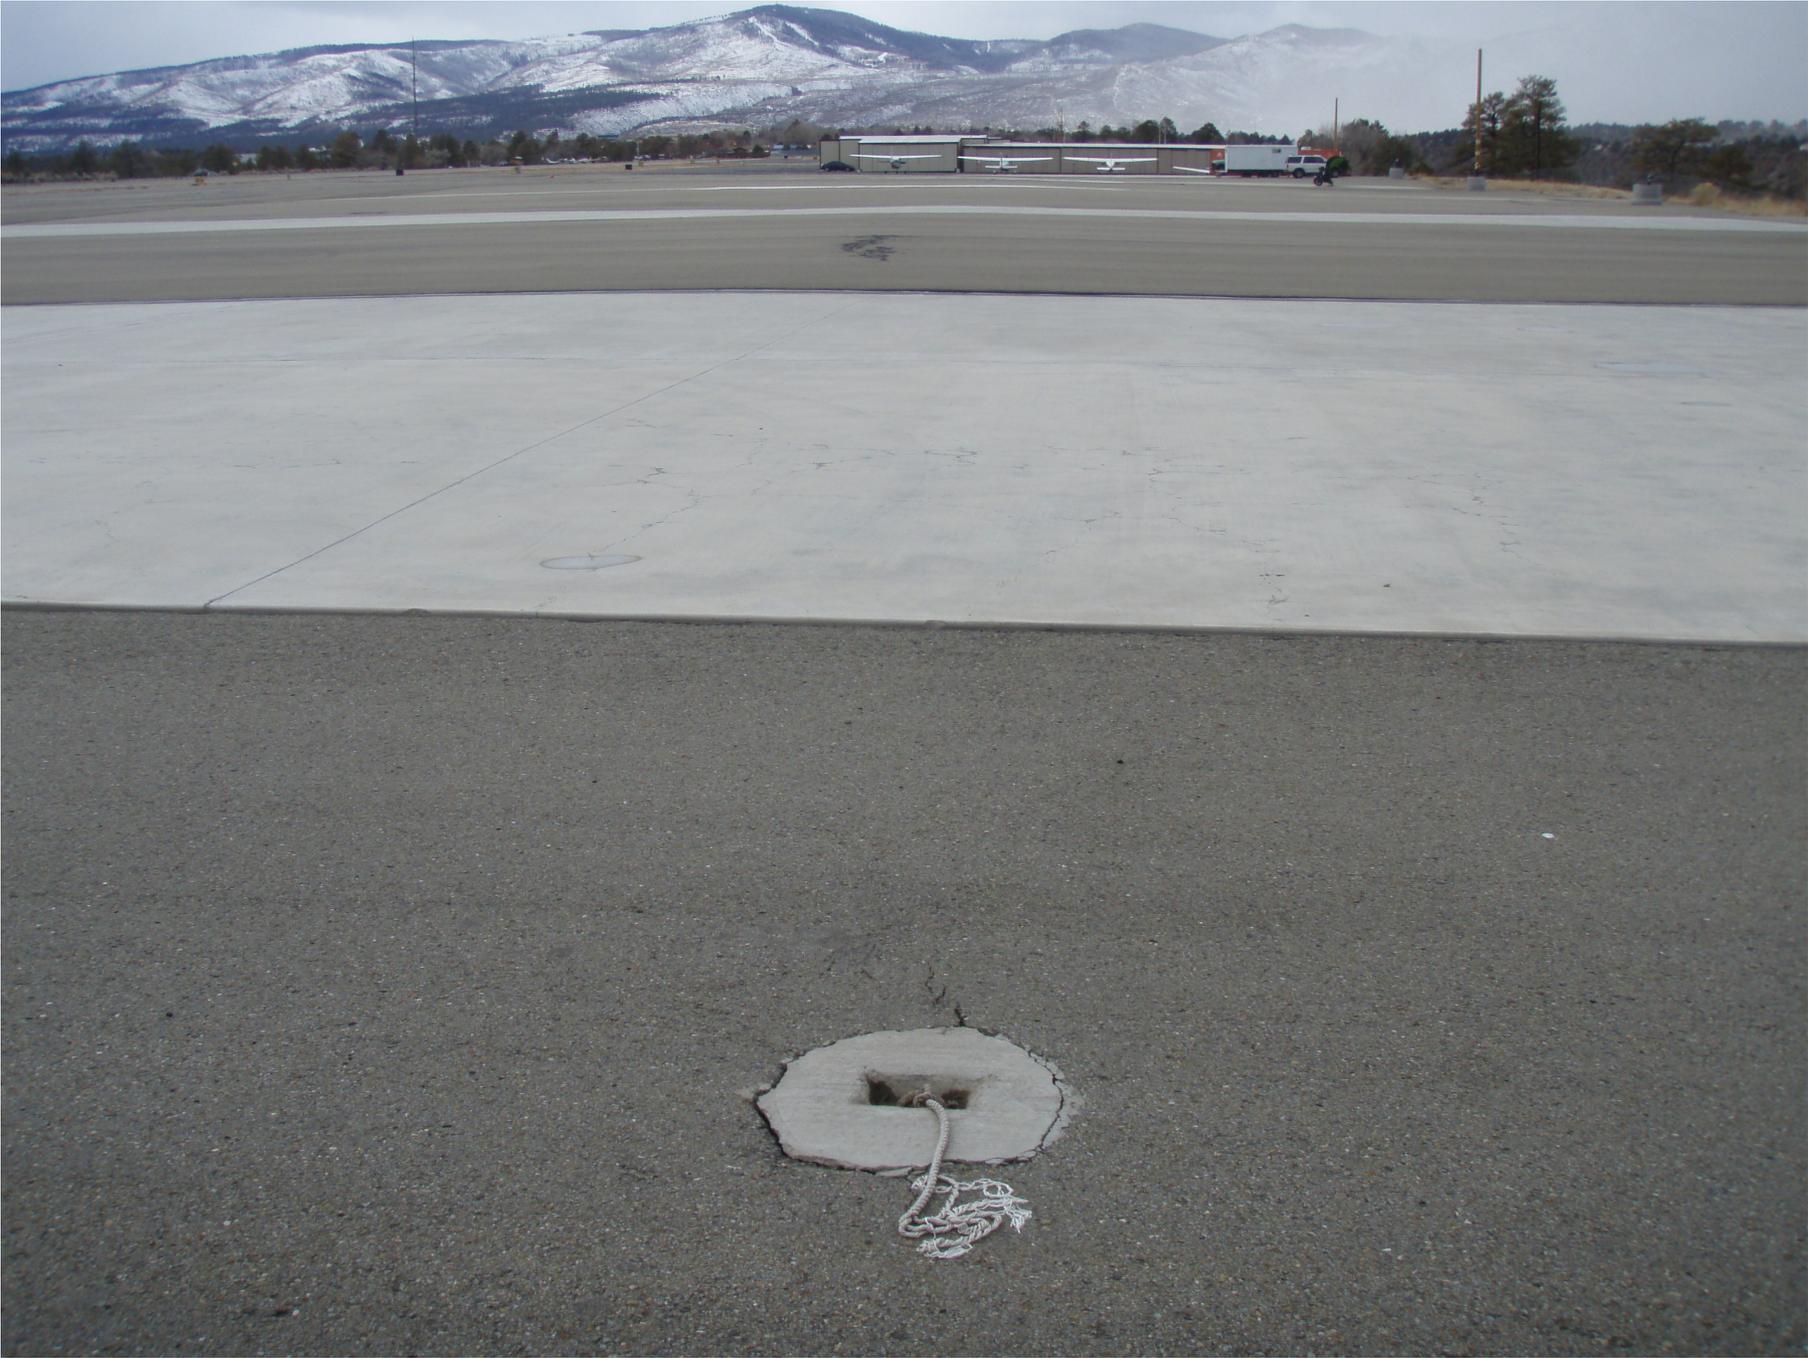
Photo 28: Looking West from Pad 5 along hinge line. Note cracking around tie down.

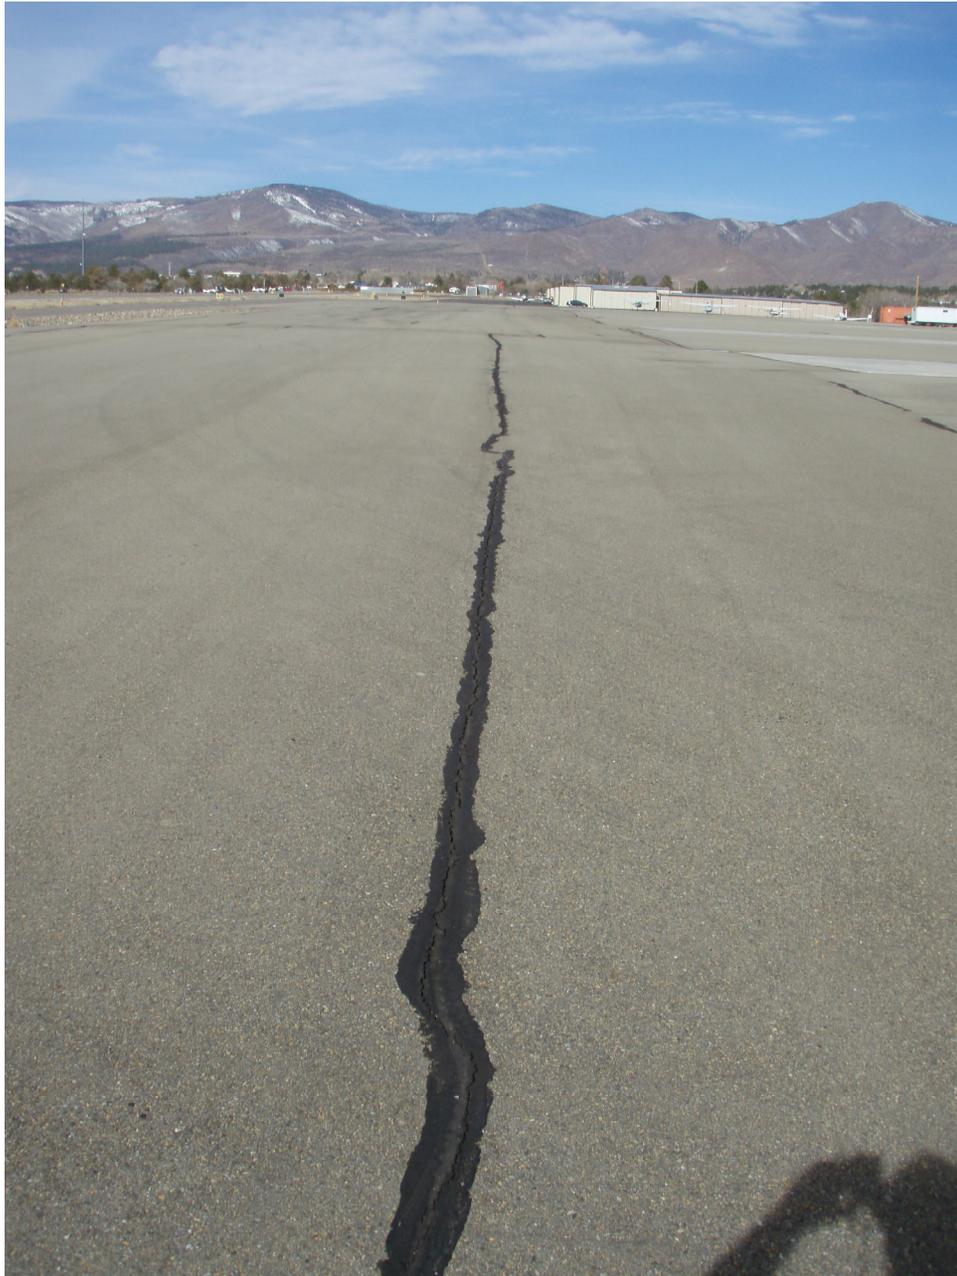
Photo 2: Hot seal repair of crack in MatCon pavement. New cracks within the hot seal and MatCon are evident throughout the cap.

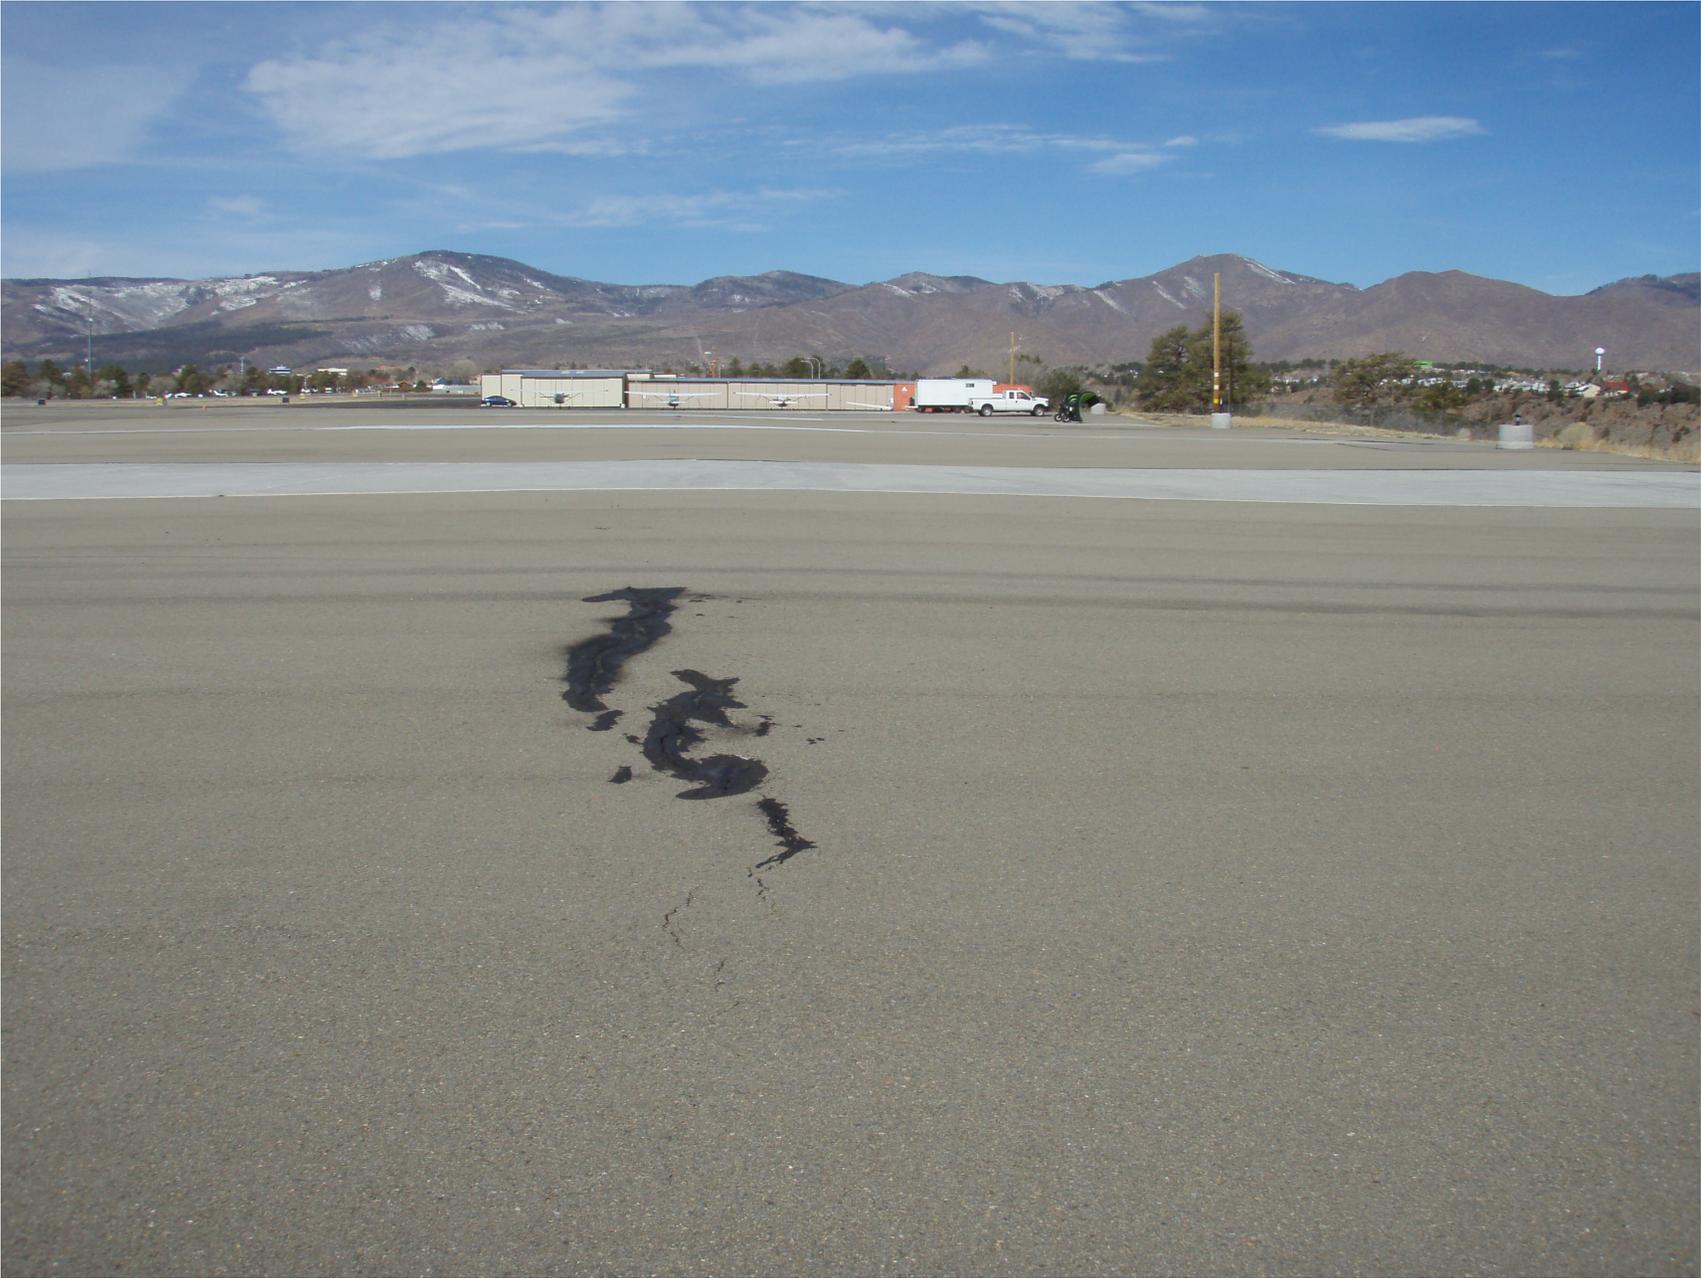
Photo 3: Looking west at new cracks in the MatCon pavement visible along the hinge line. Note subsidence of pads left (south) and right (north) of hinge line.
