Subject: Submittal of the 2013 Annual Inspection Report for Los Alamos County Airport Landfill, Solid Waste Management Units 73-001(a) and 73-001(d), Technical Area 73

**2013 Annual Inspection Report for
Los Alamos Country Airport Landfill,
Solid Waste Management Units
73-001(a) and 73-001(d),
Technical Area 73**

Prepared by the Los Alamos Field Office

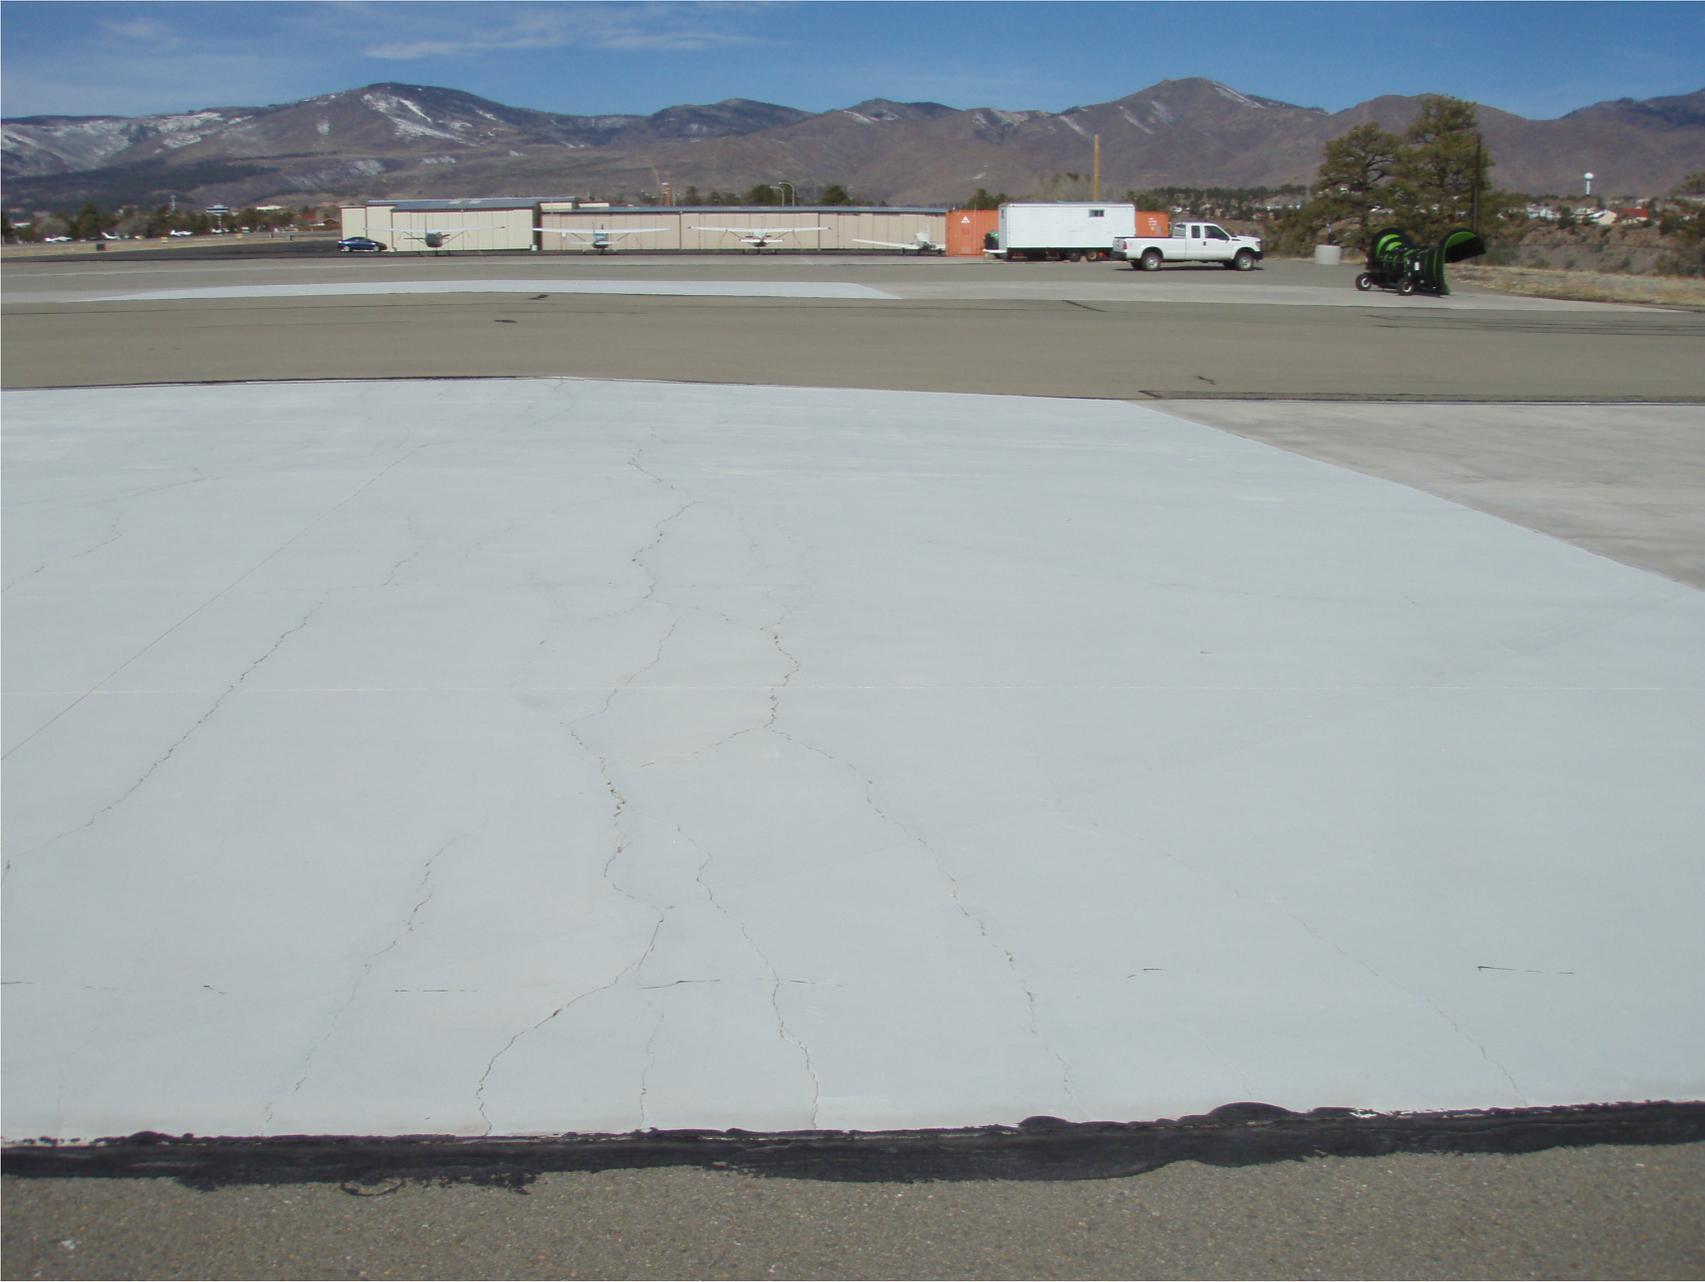
Photo 4: Looking west at cracks in concrete Hangar Pad #3 along the hinge line, note large amount of subsidence to right (north) of the hinge line.

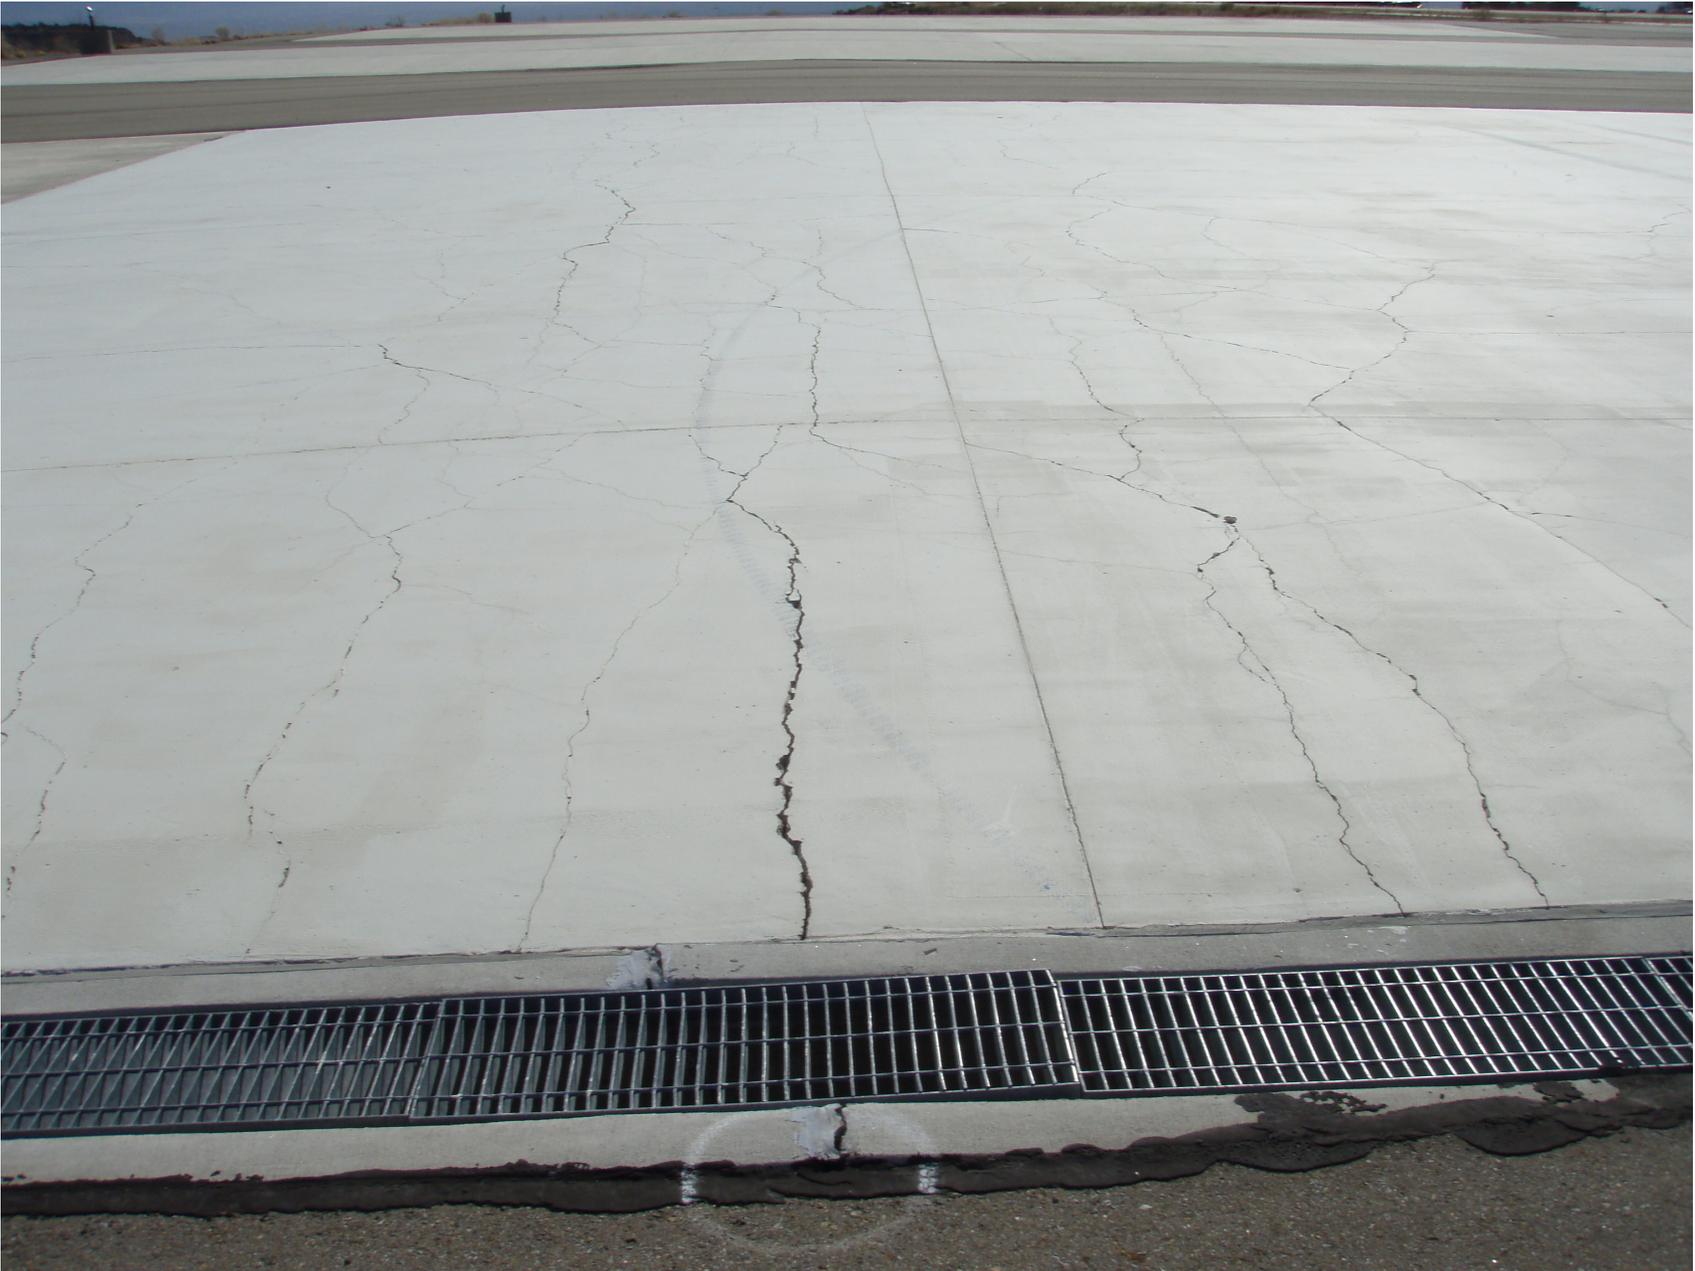
Photo 5: Looking East across Pad #3 along hinge line. Note crack across trench drain and subsidence to the north.

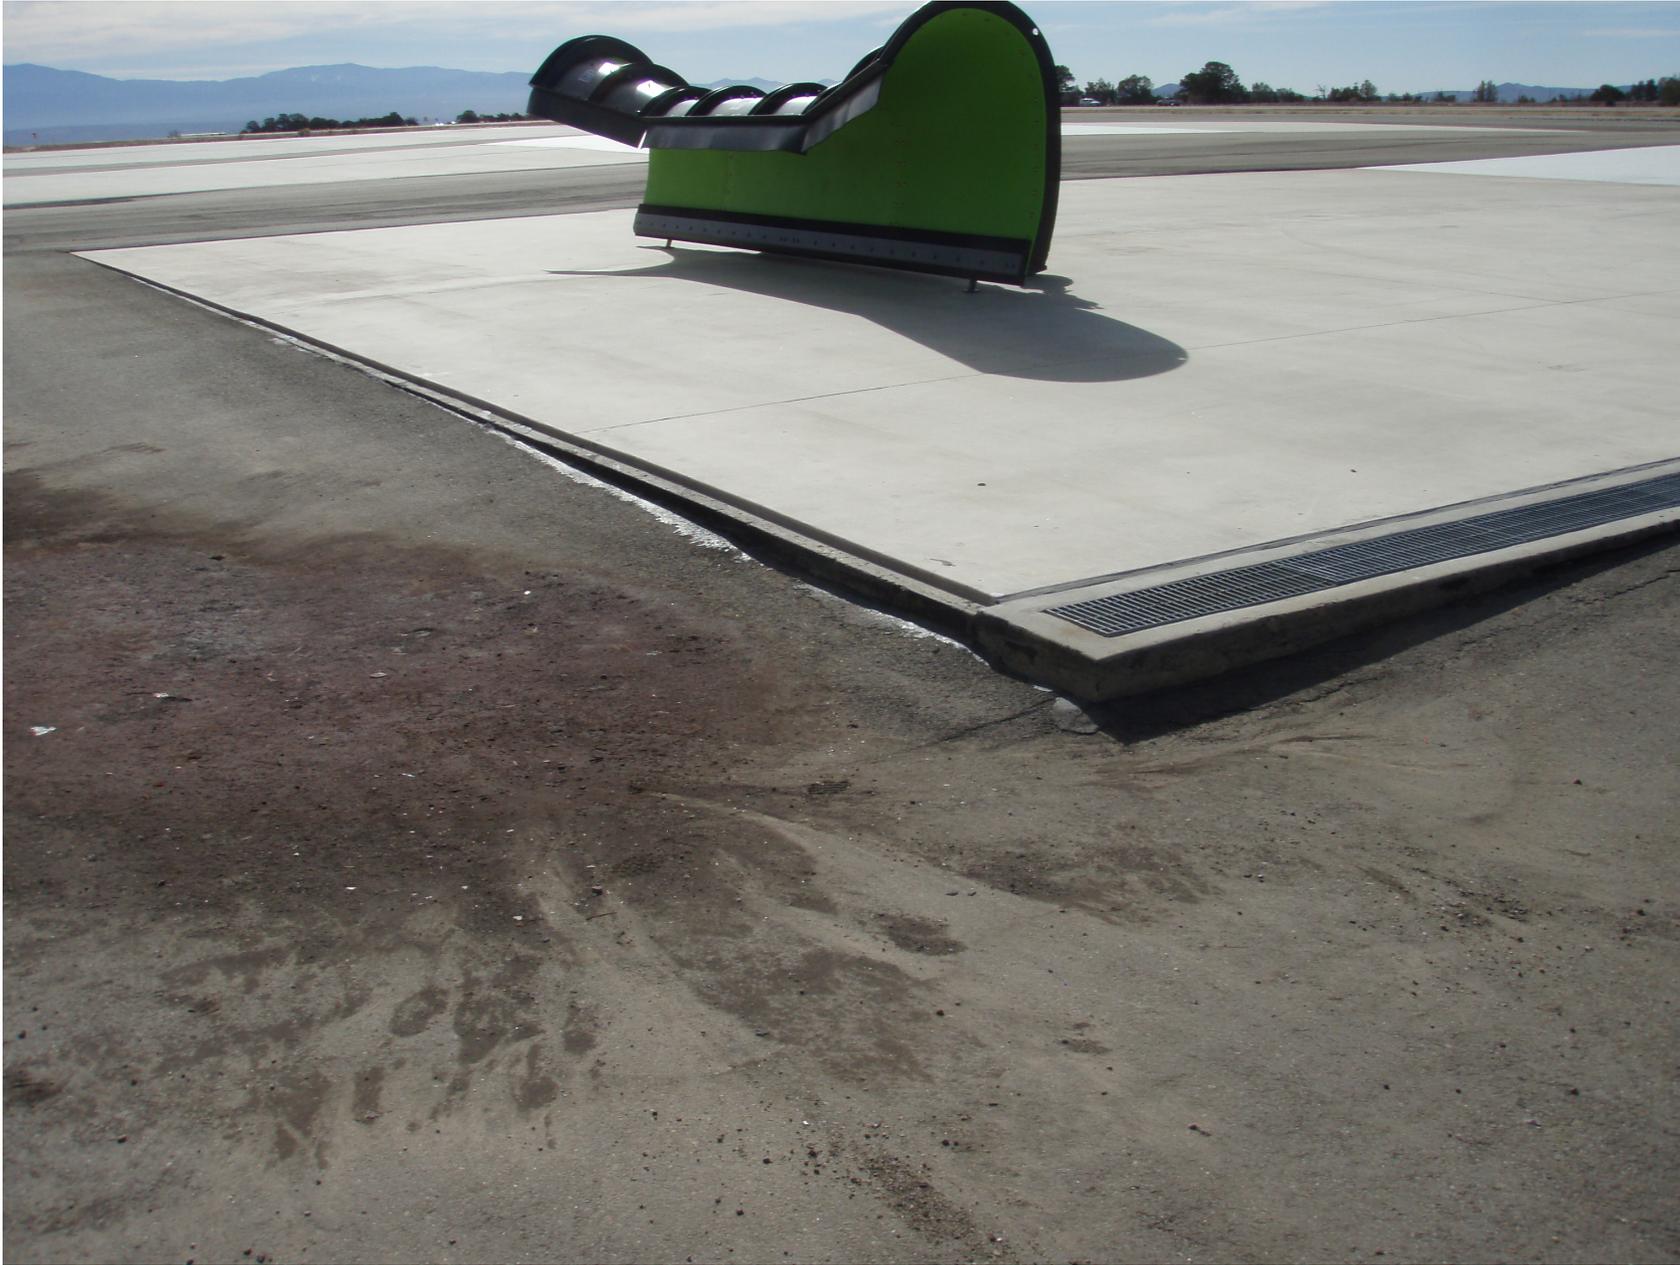
Photo 6: NW corner of Pad #2. Note subsidence of MatCon at contact with pad (3 inches) and sediment from puddle, trench drain is ineffective.

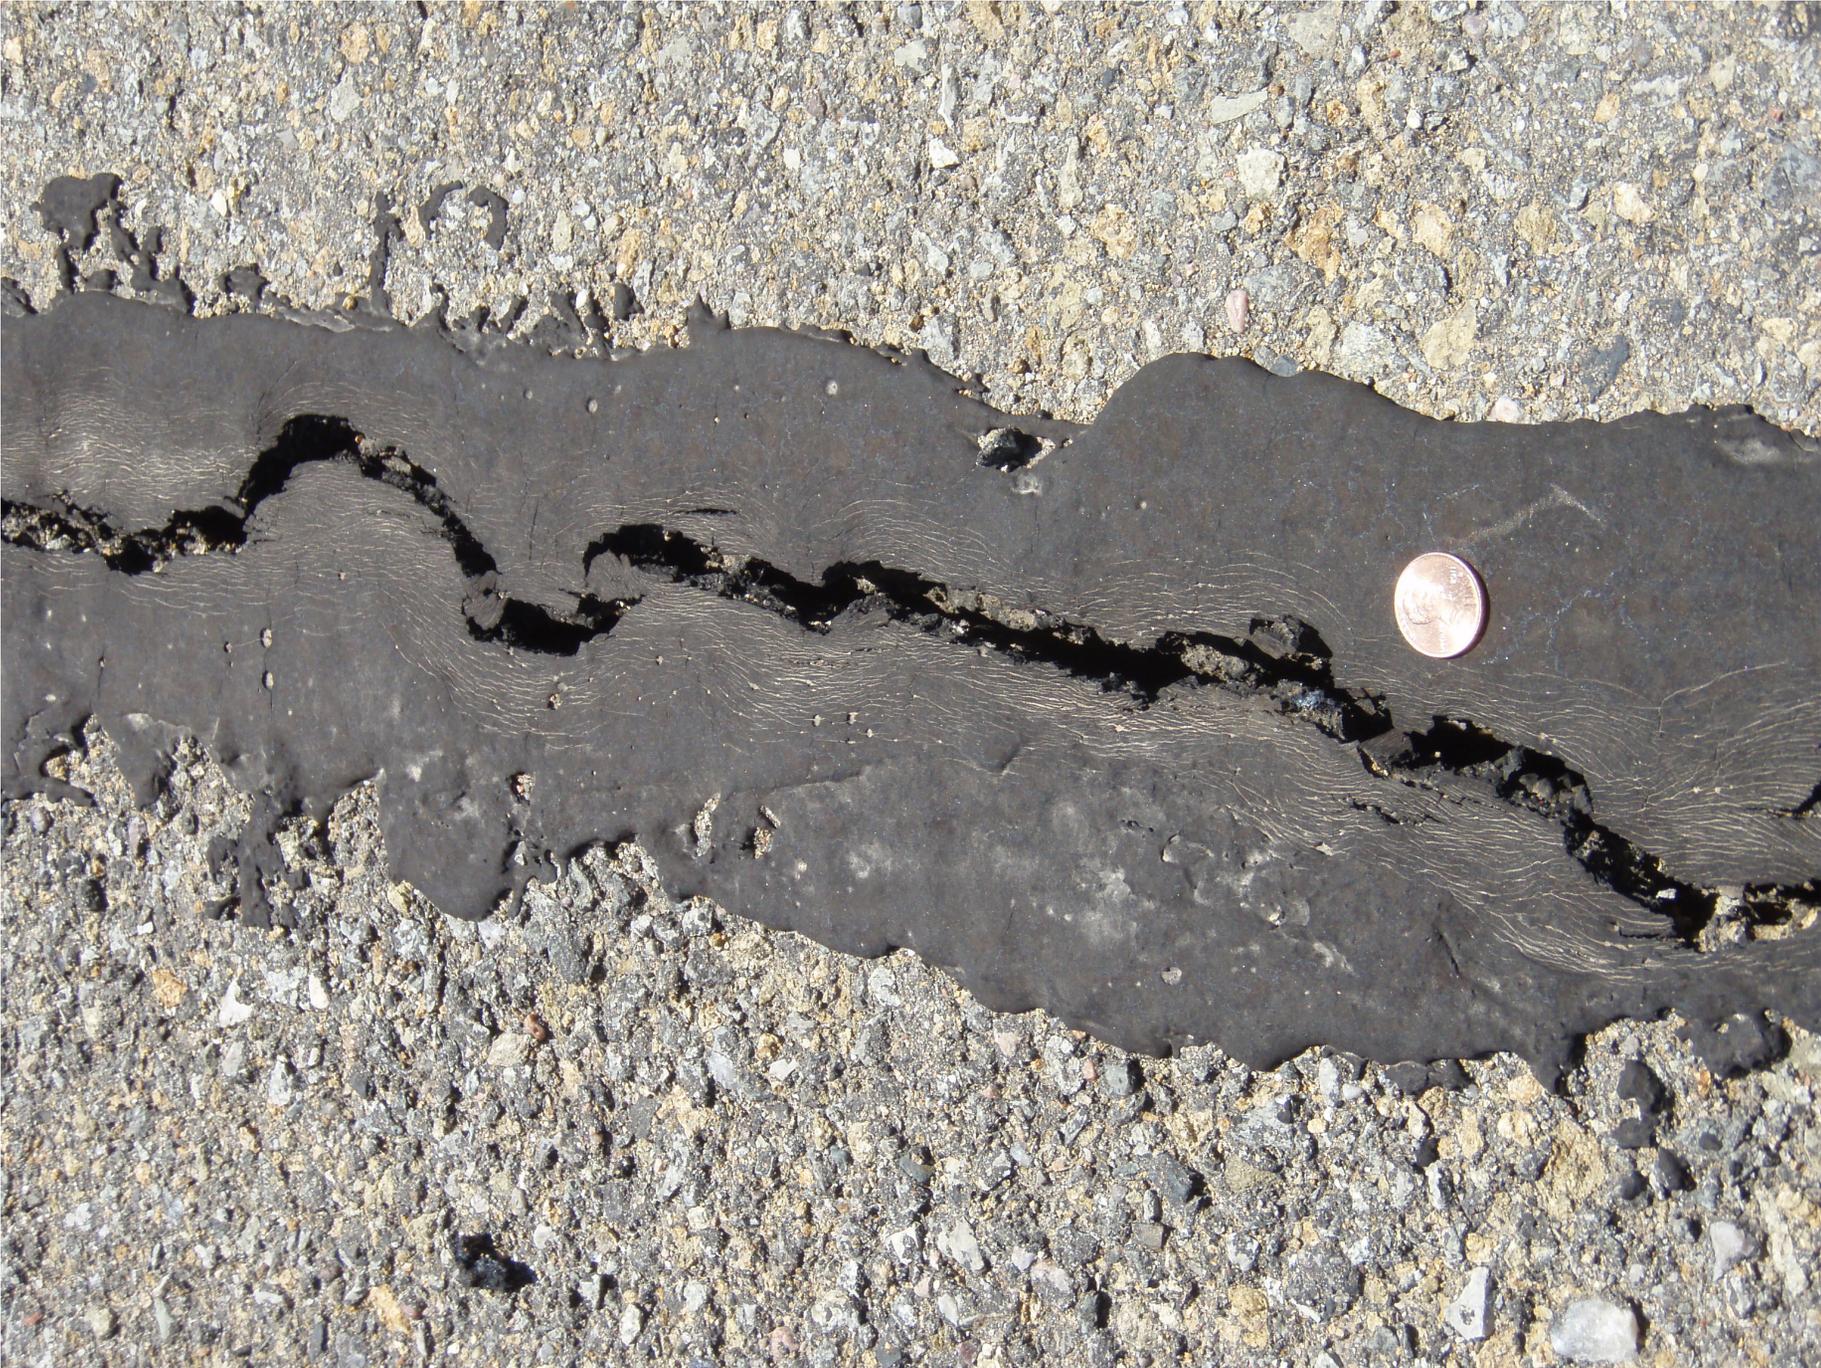
Photo 3: Hot seal repair of crack in MatCon pavement. New cracks within the hot seal and MatCon are evident throughout the cap.

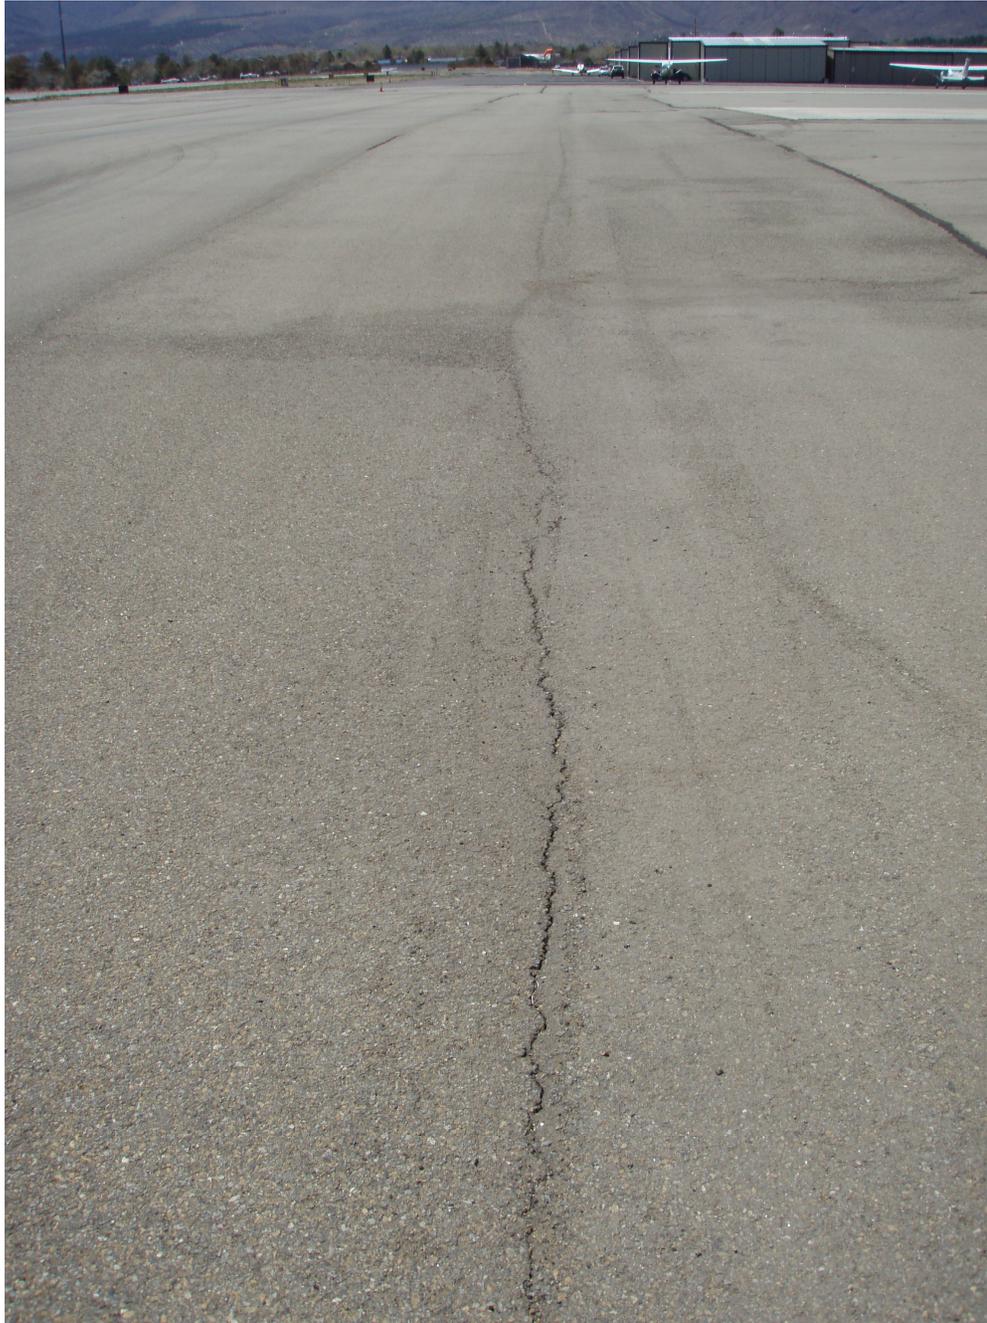
Photo 4: Looking West at new crack in MatCon pavement.

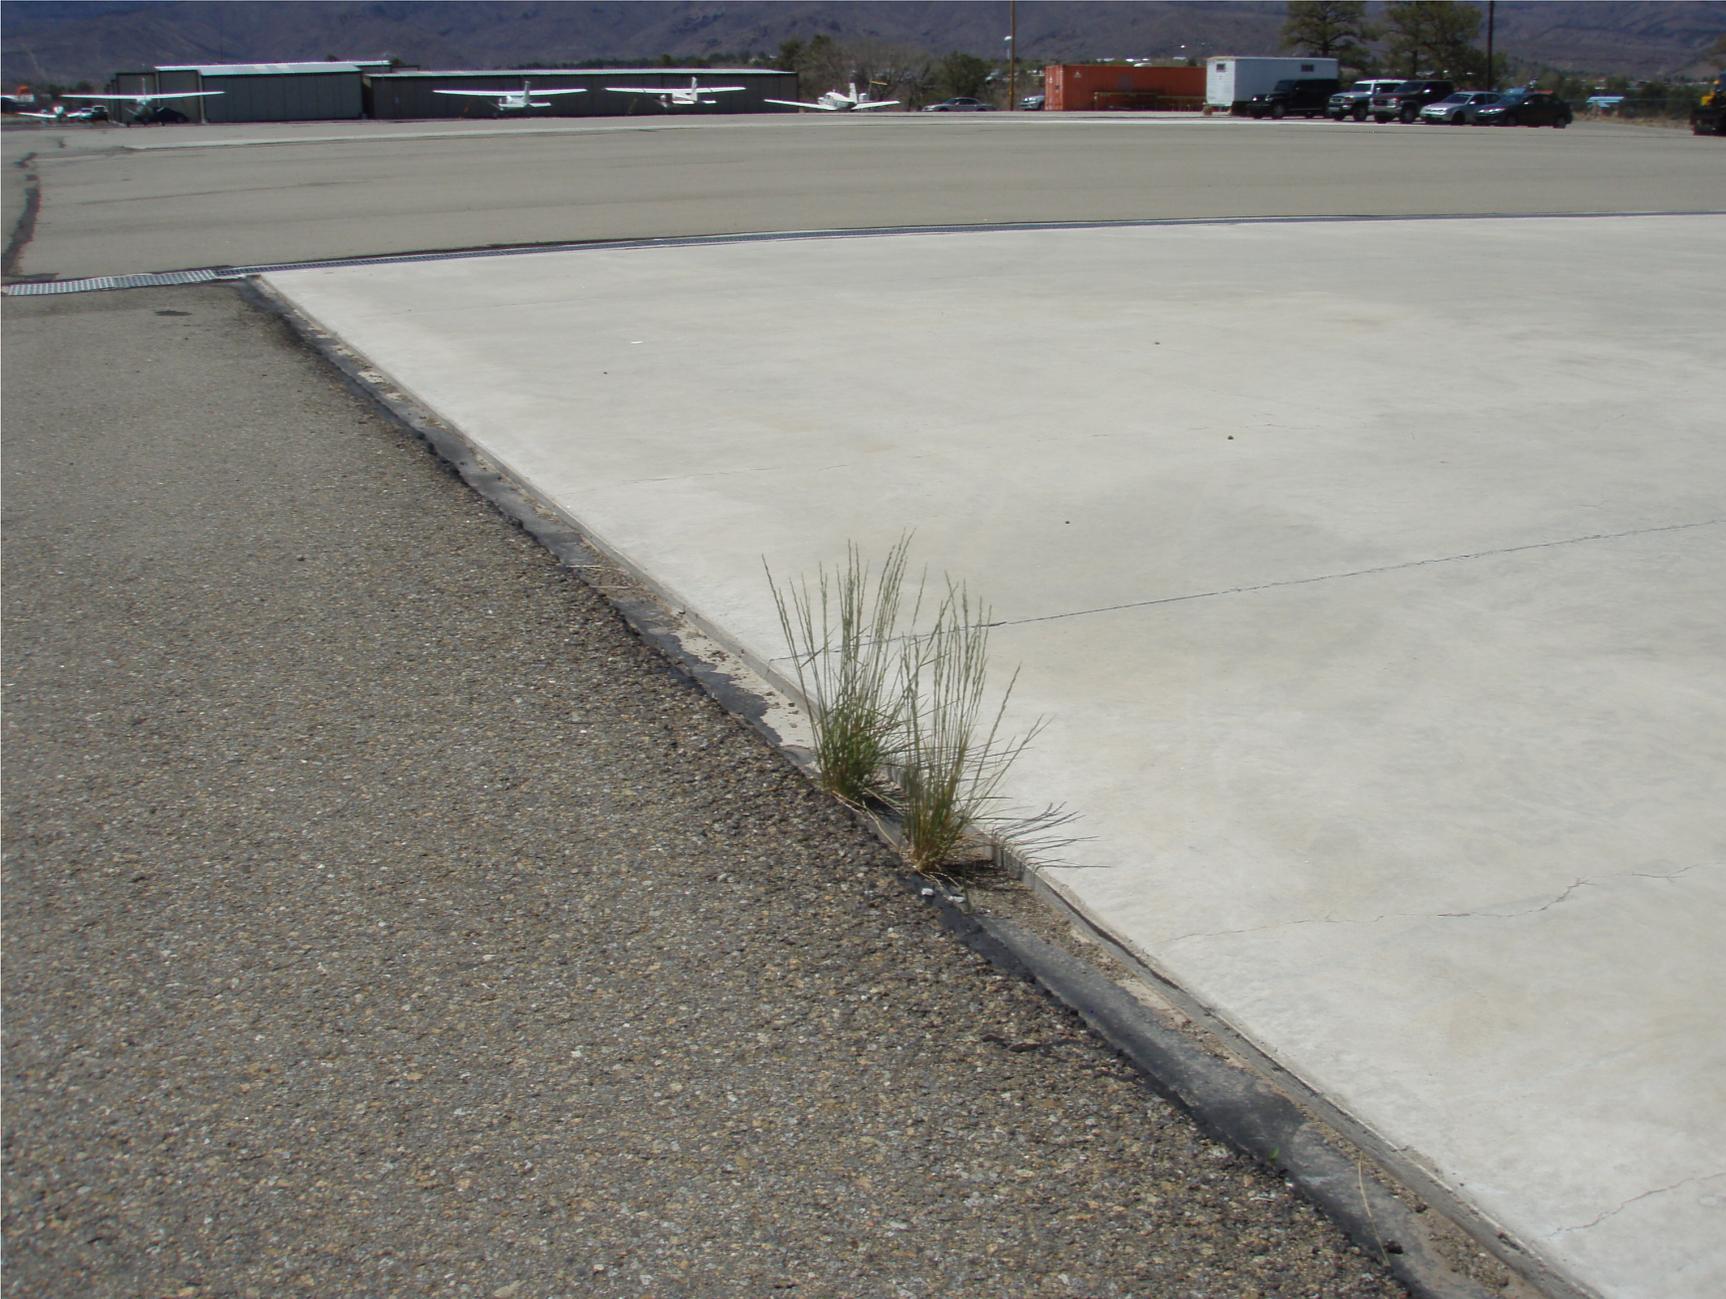
Photo 5: Plant growth between MatCon and Pad #2.

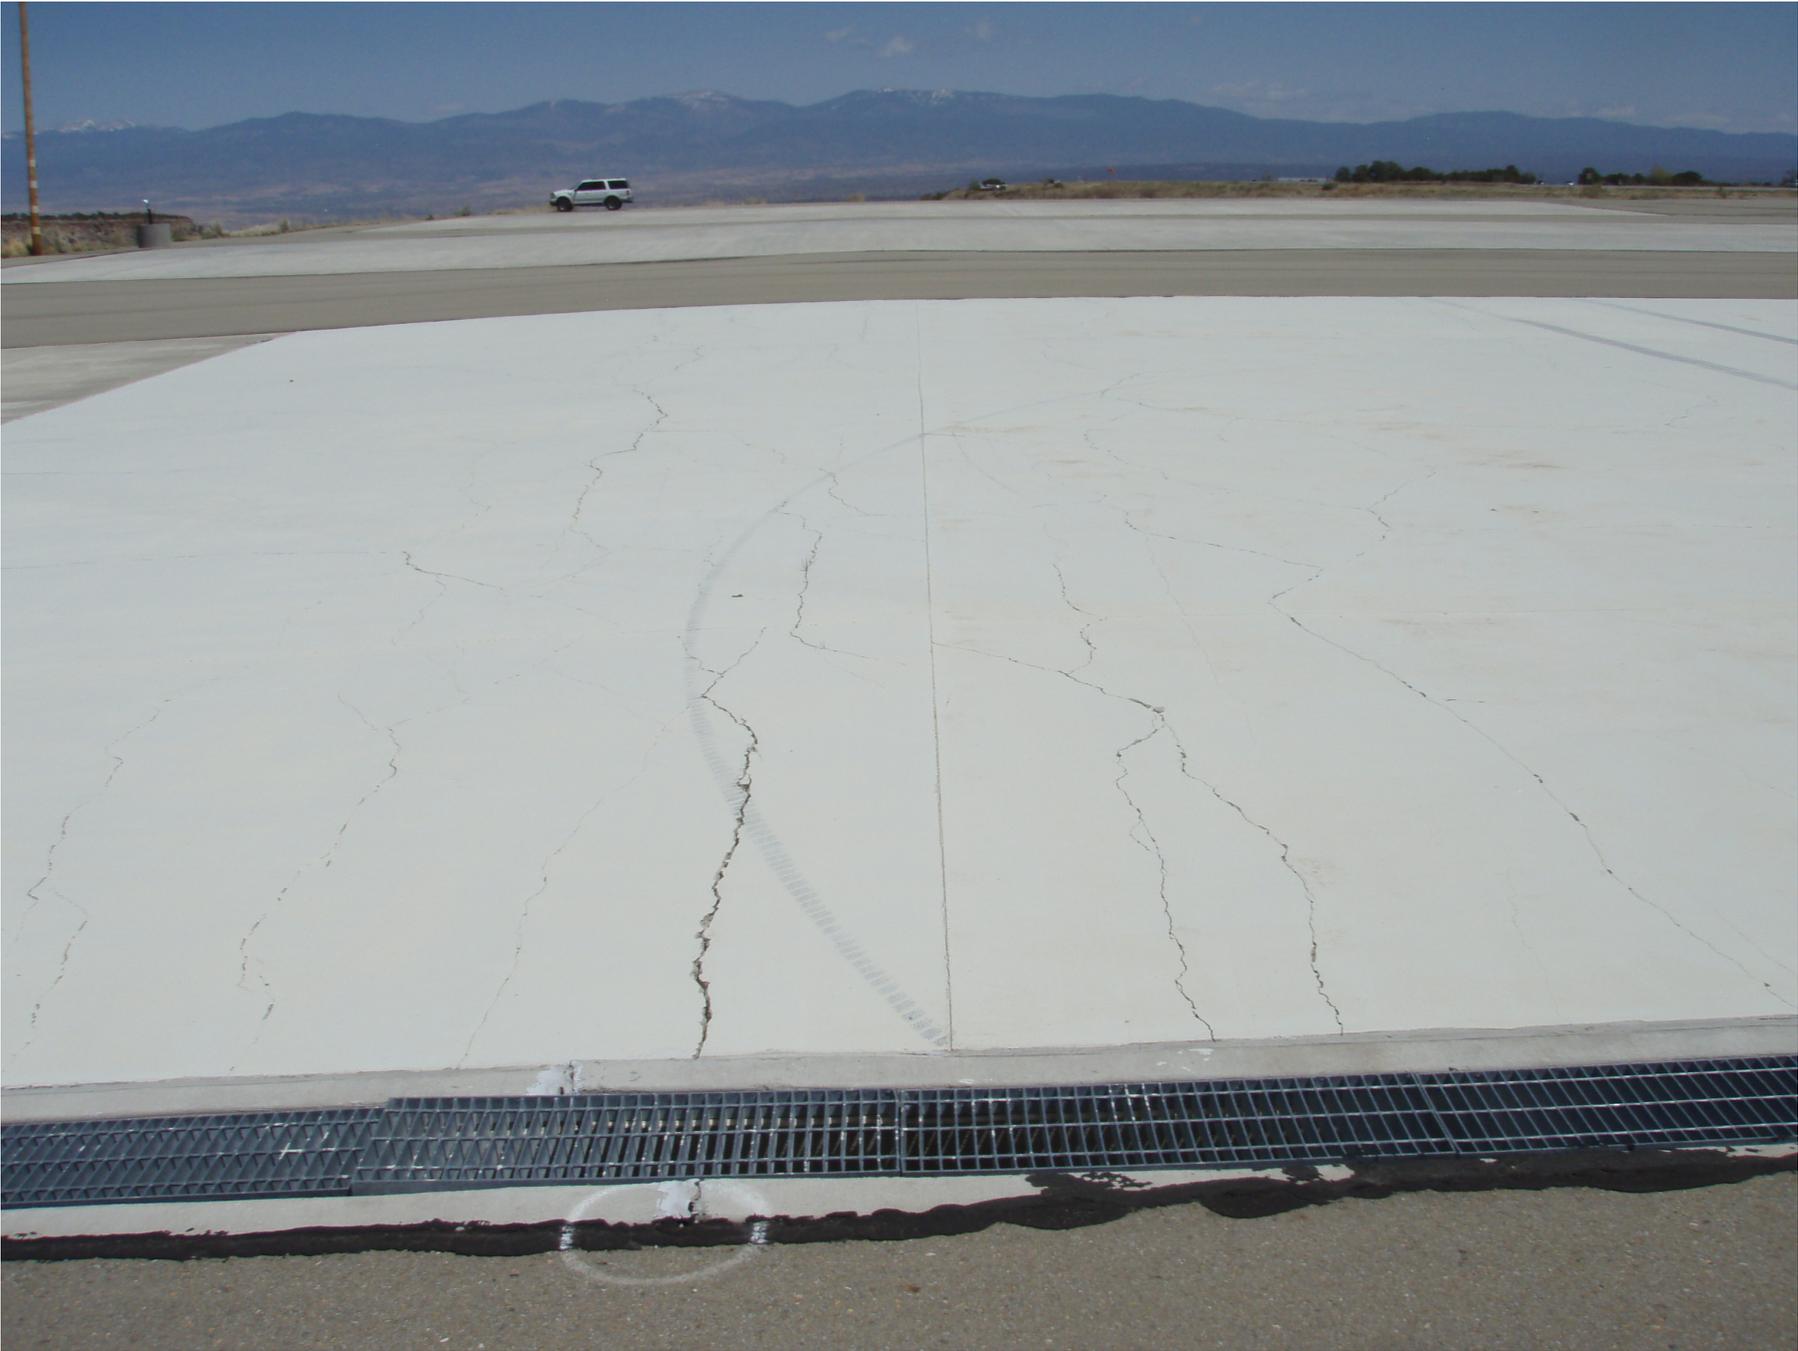
Photo 6: Looking east at cracks in concrete Hangar Pad #3 along the hinge line, note crack across trench drain.

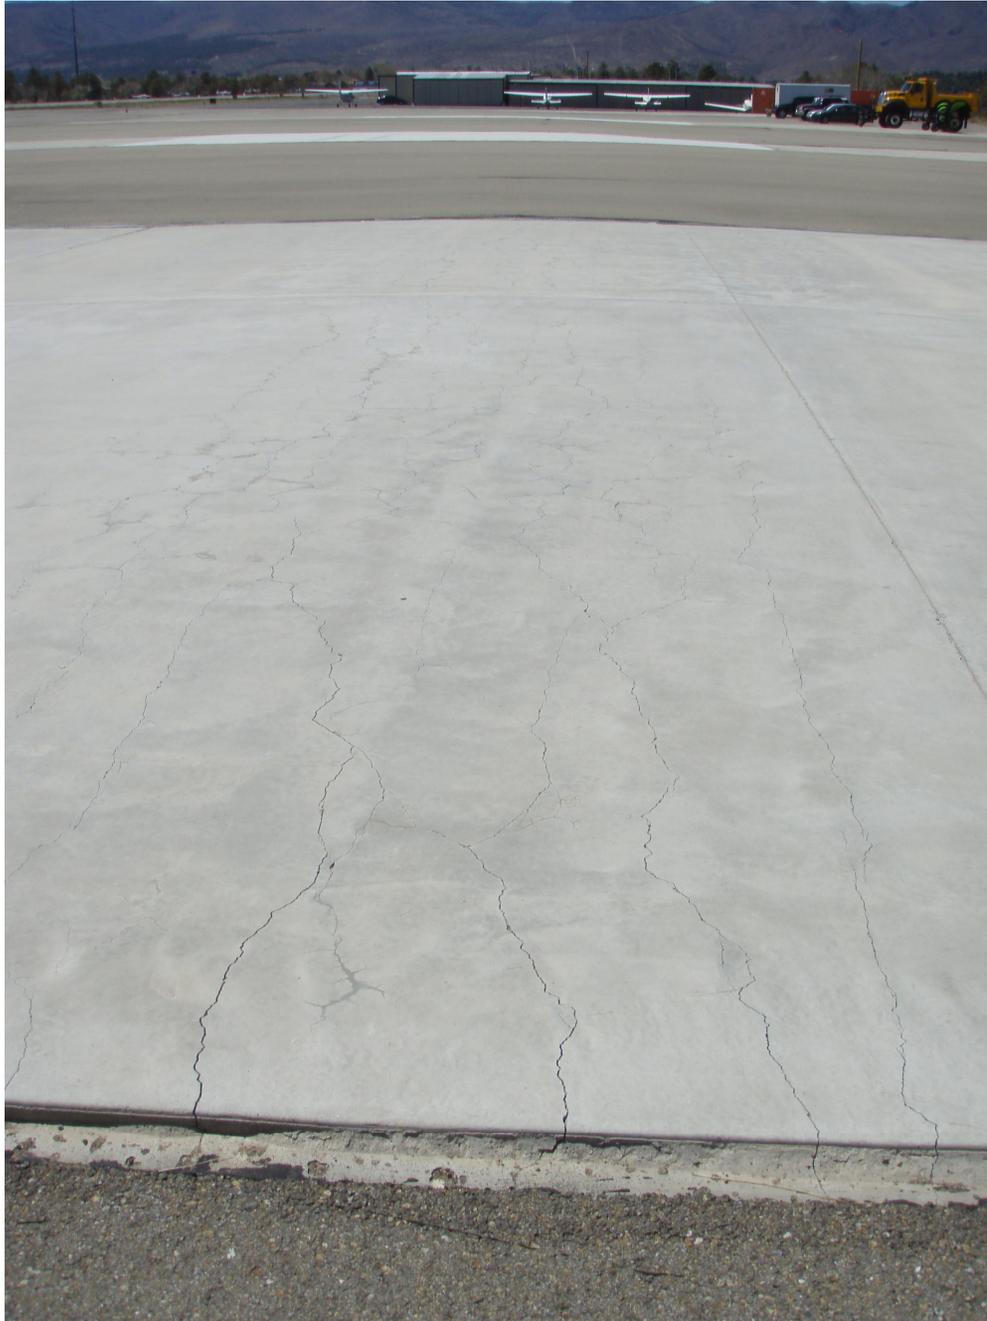
Photo 7: Looking West at new cracking in concrete Hangar Pad #4 along the hinge line.

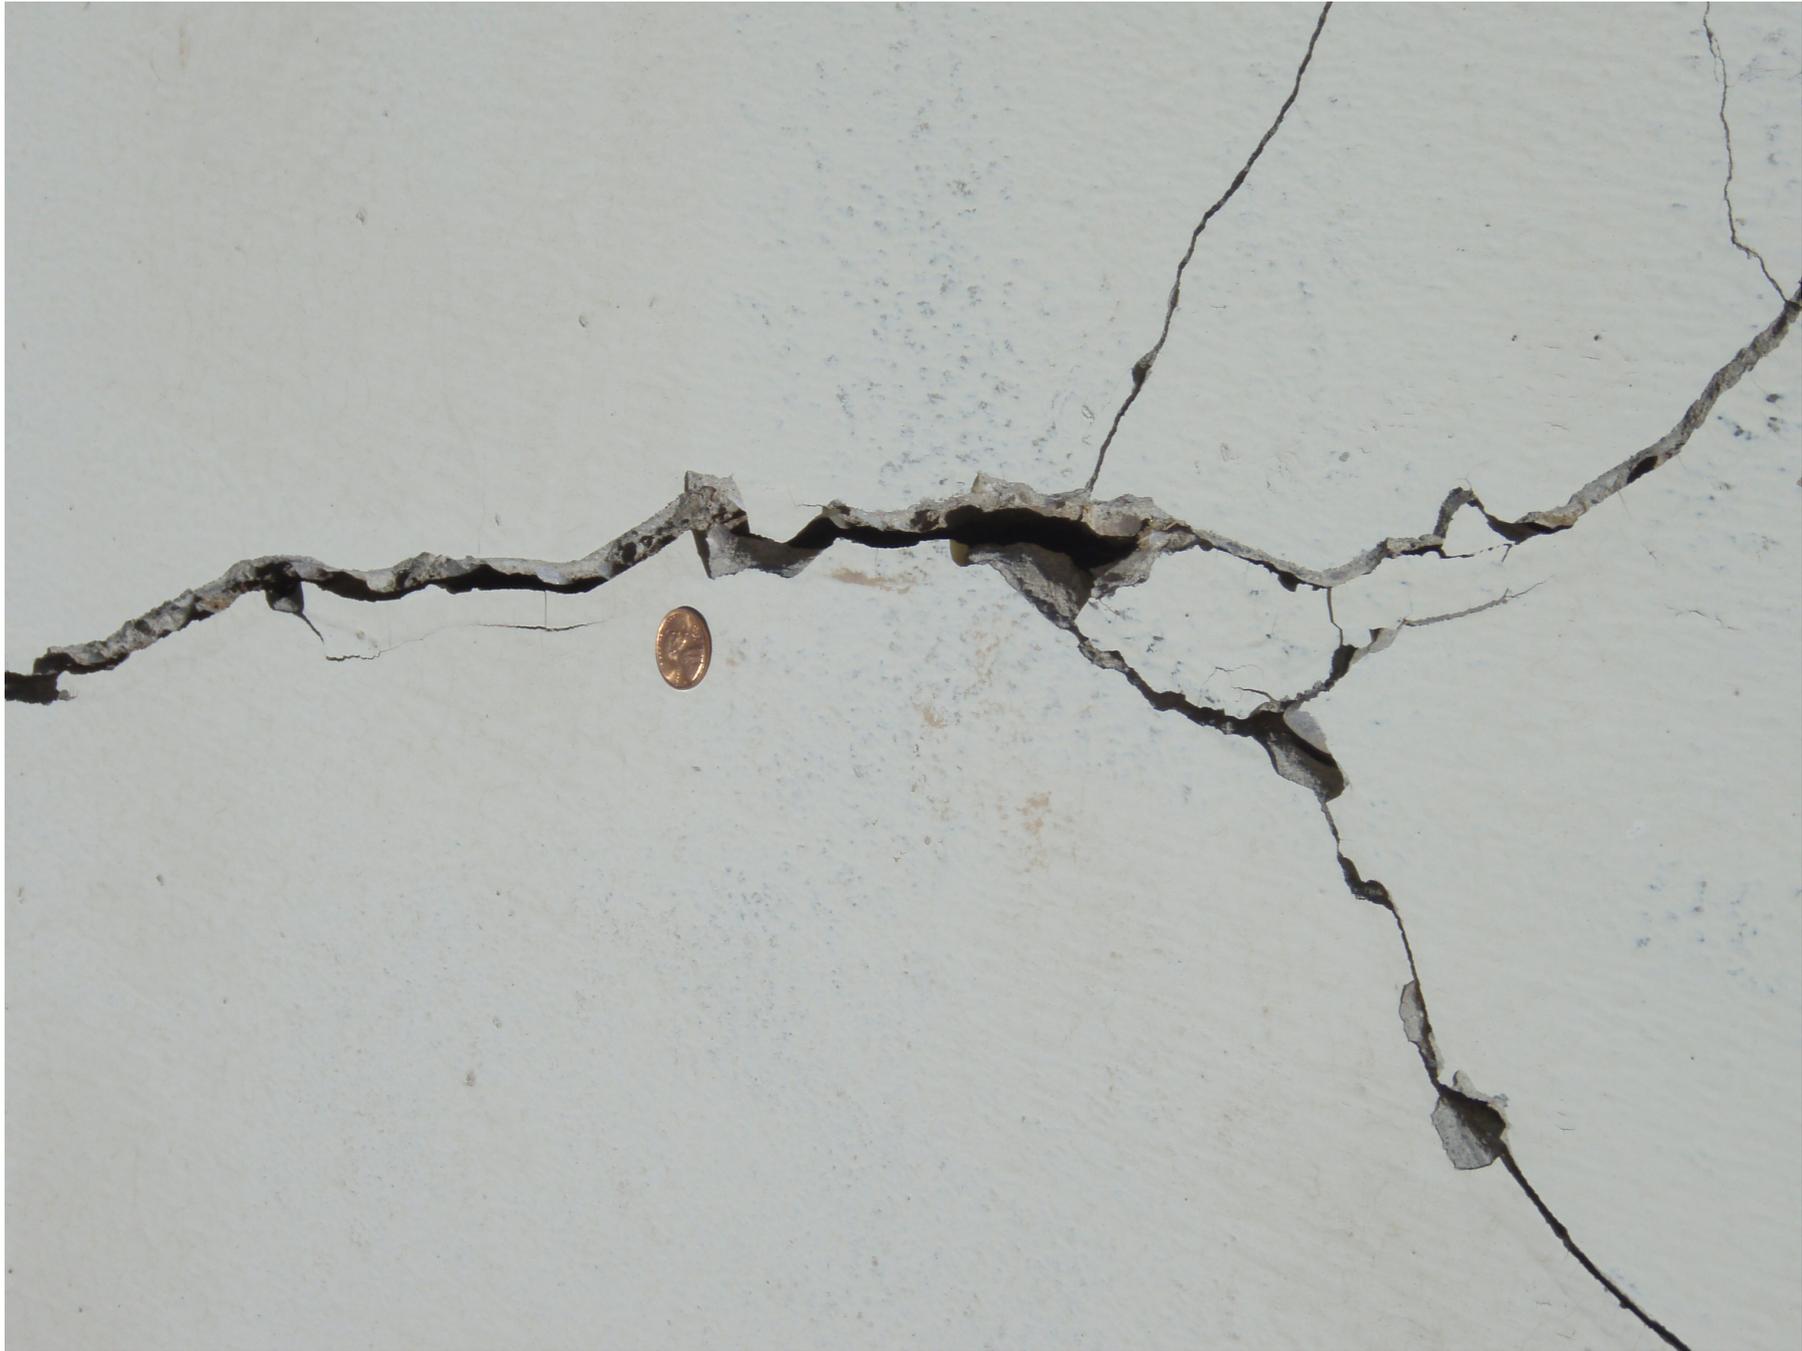
Photo 8: Crack in Pad #3.

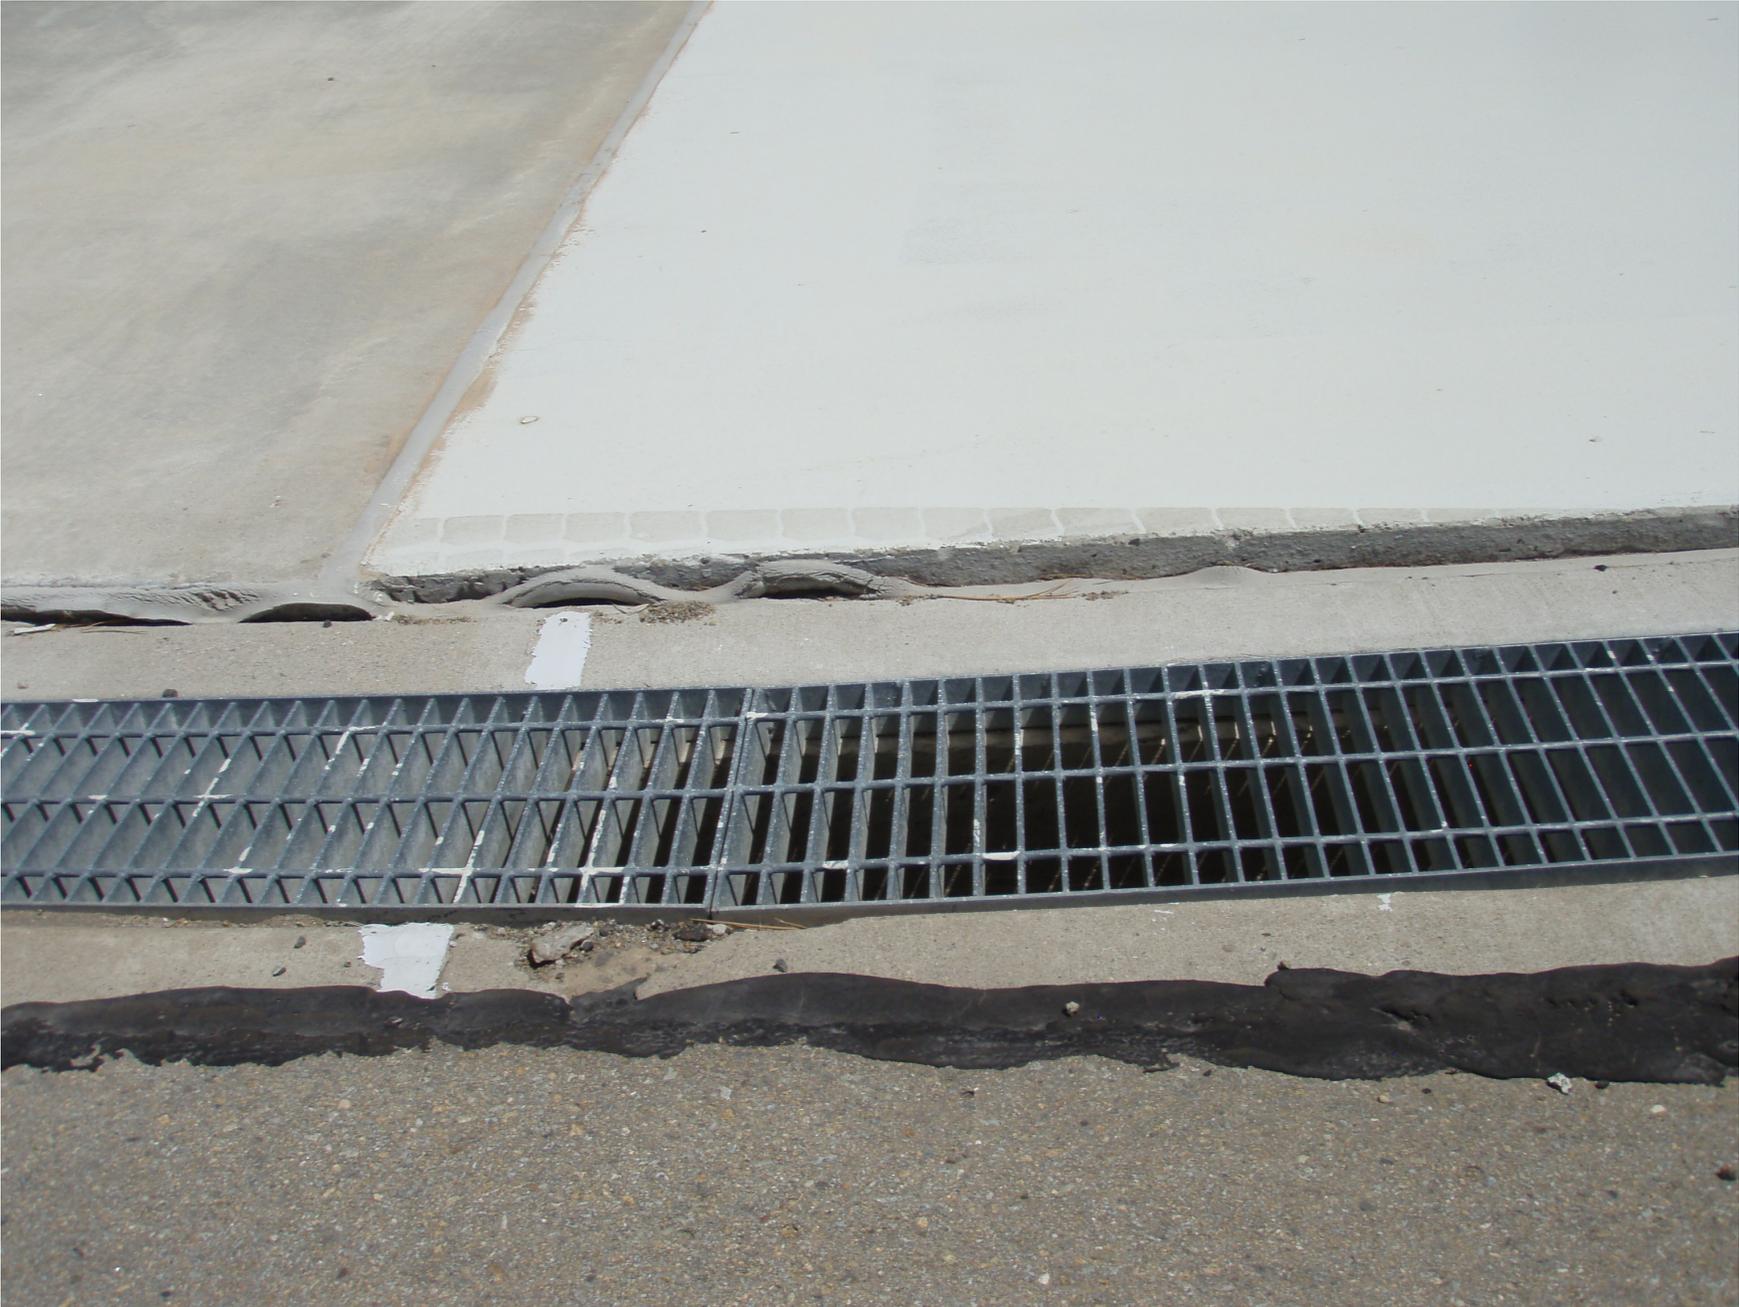
Photo 9: Separation between pad and trench drain at Pad #2.
