Subject: Submittal of the 2013 Annual Inspection Report for Los Alamos County Airport Landfill, Solid Waste Management Units 73-001(a) and 73-001(d), Technical Area 73

**2013 Annual Inspection Report for
Los Alamos Country Airport Landfill,
Solid Waste Management Units
73-001(a) and 73-001(d),
Technical Area 73**

Prepared by the Los Alamos Field Office

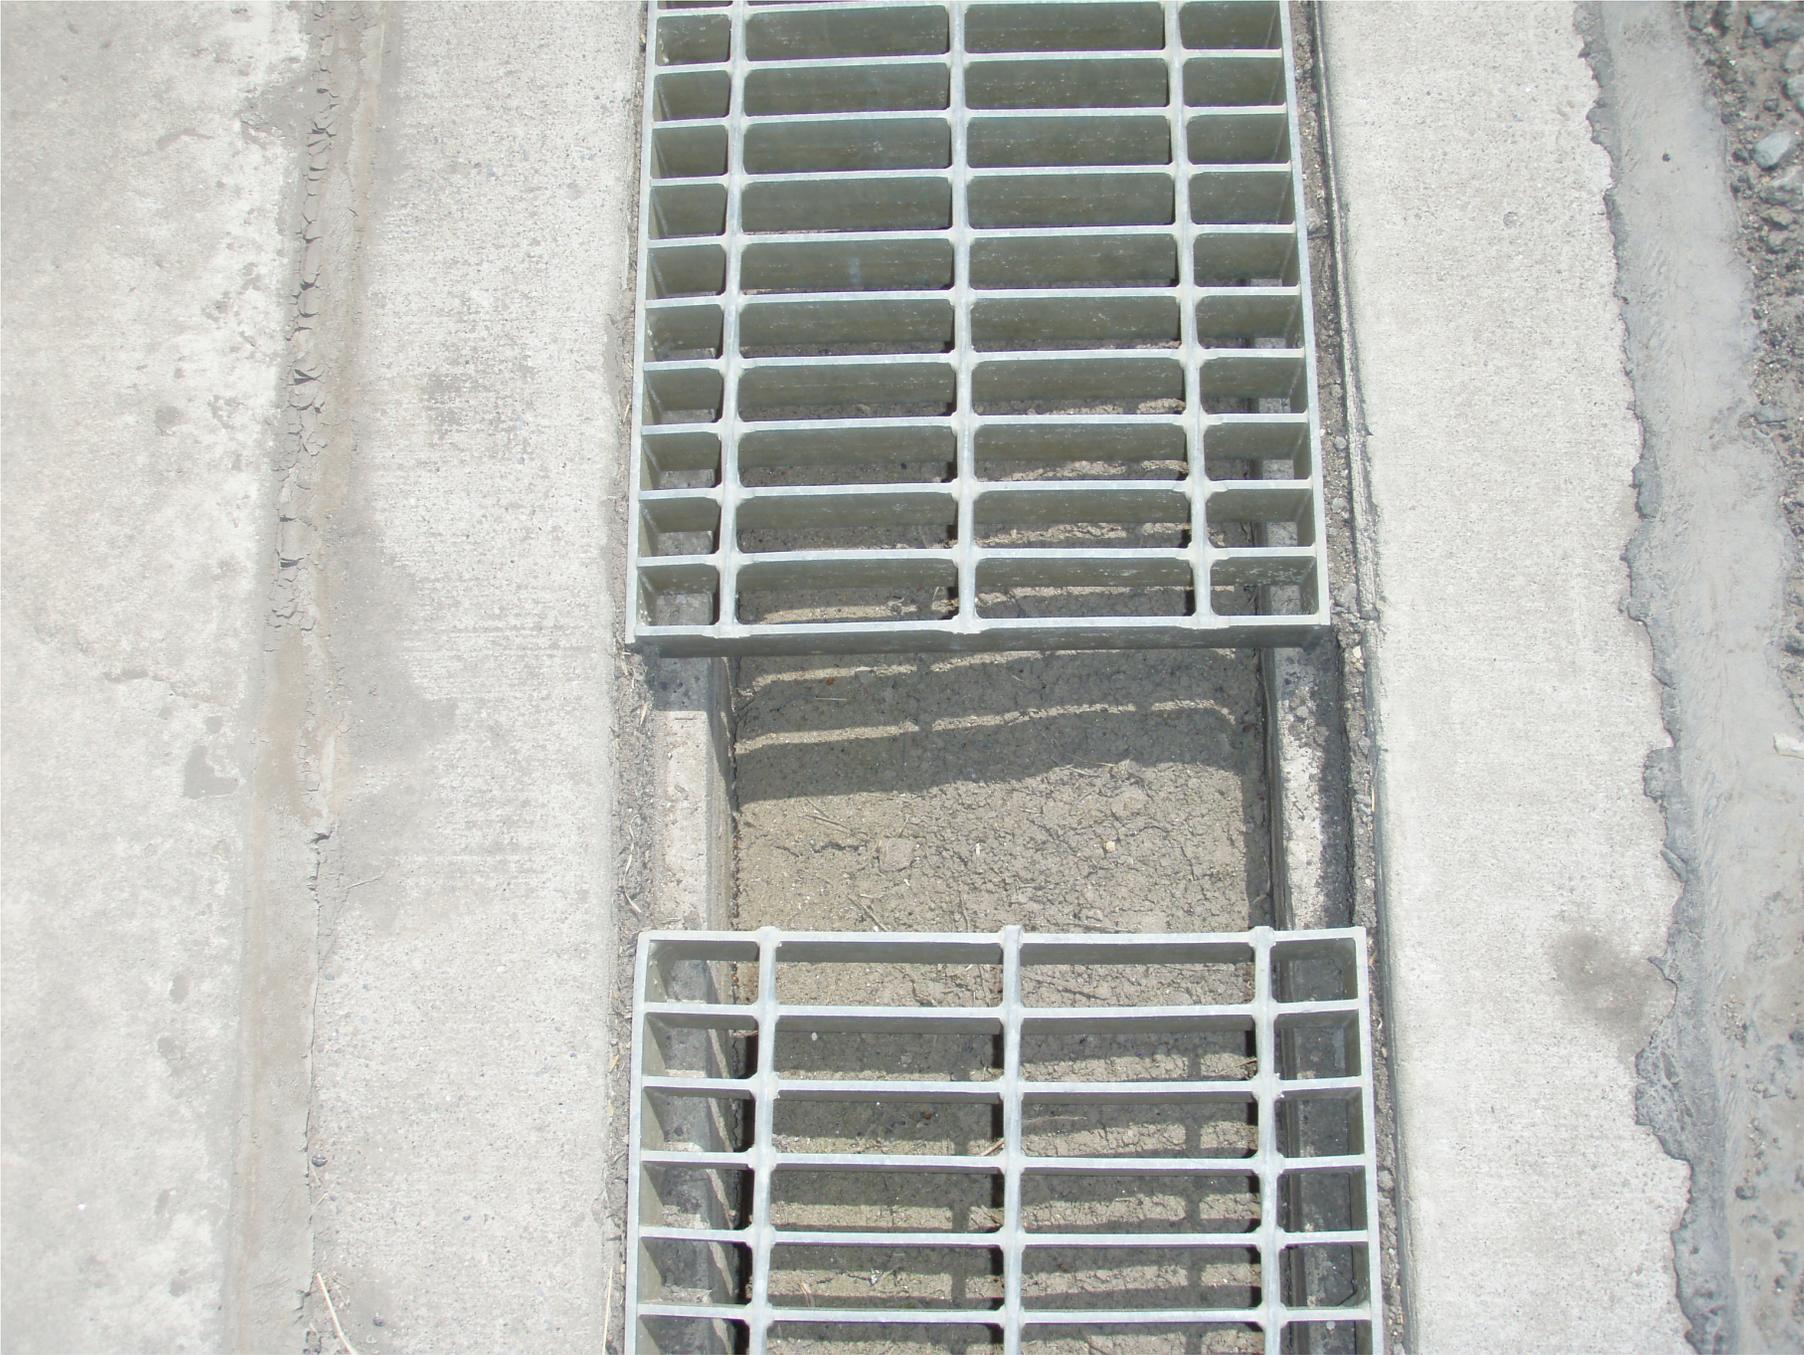
Photo 10: Trench drain filled with sediment due to inadequate drainage from subsidence.

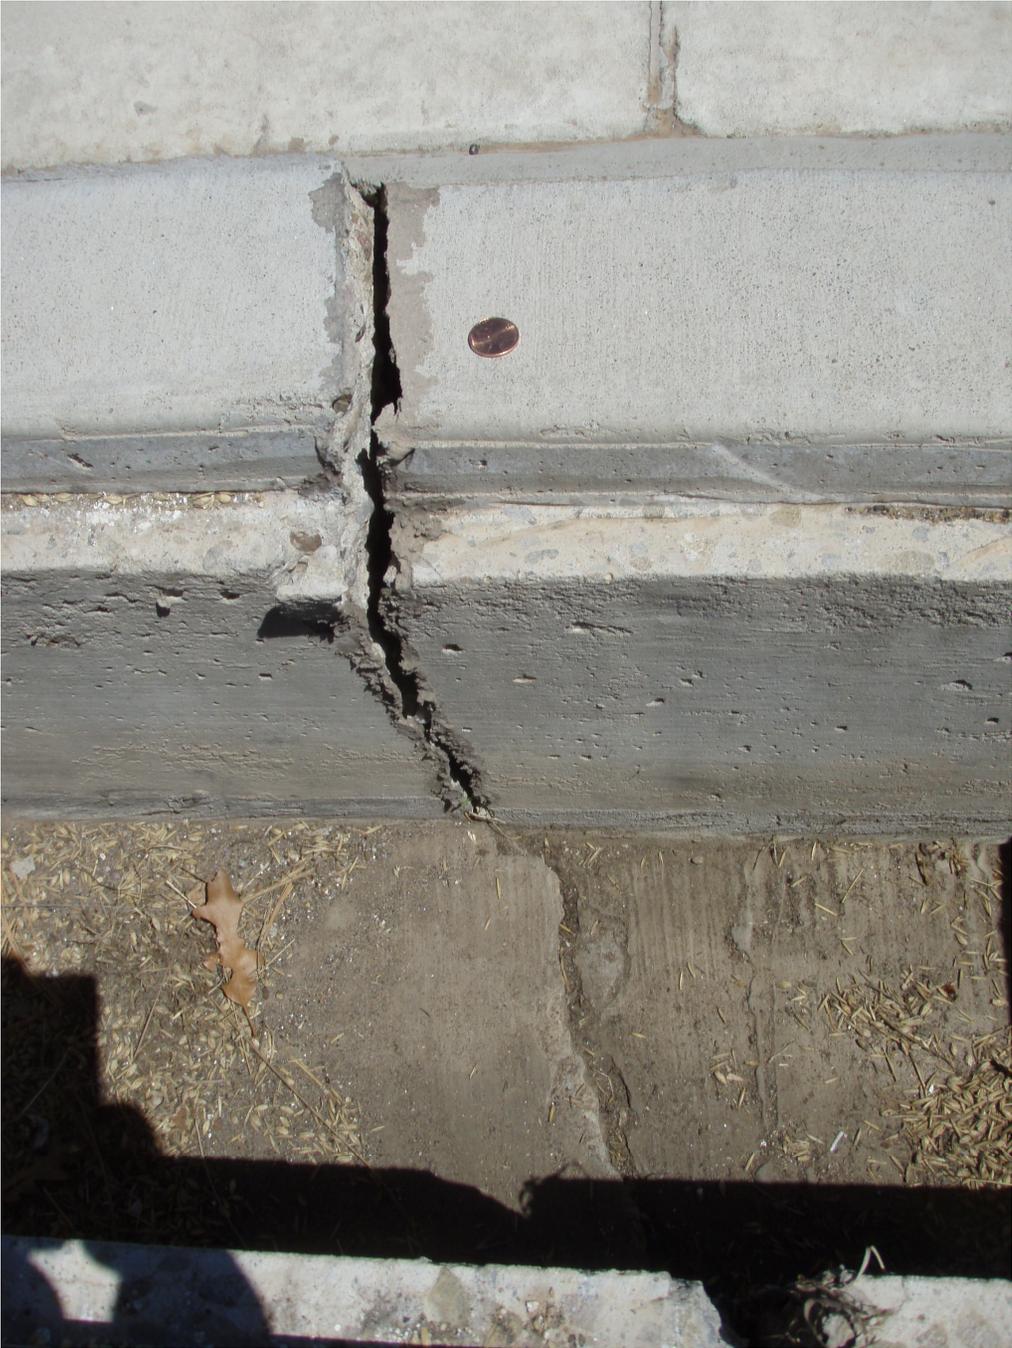
Photo 11: Crack across trench drain.

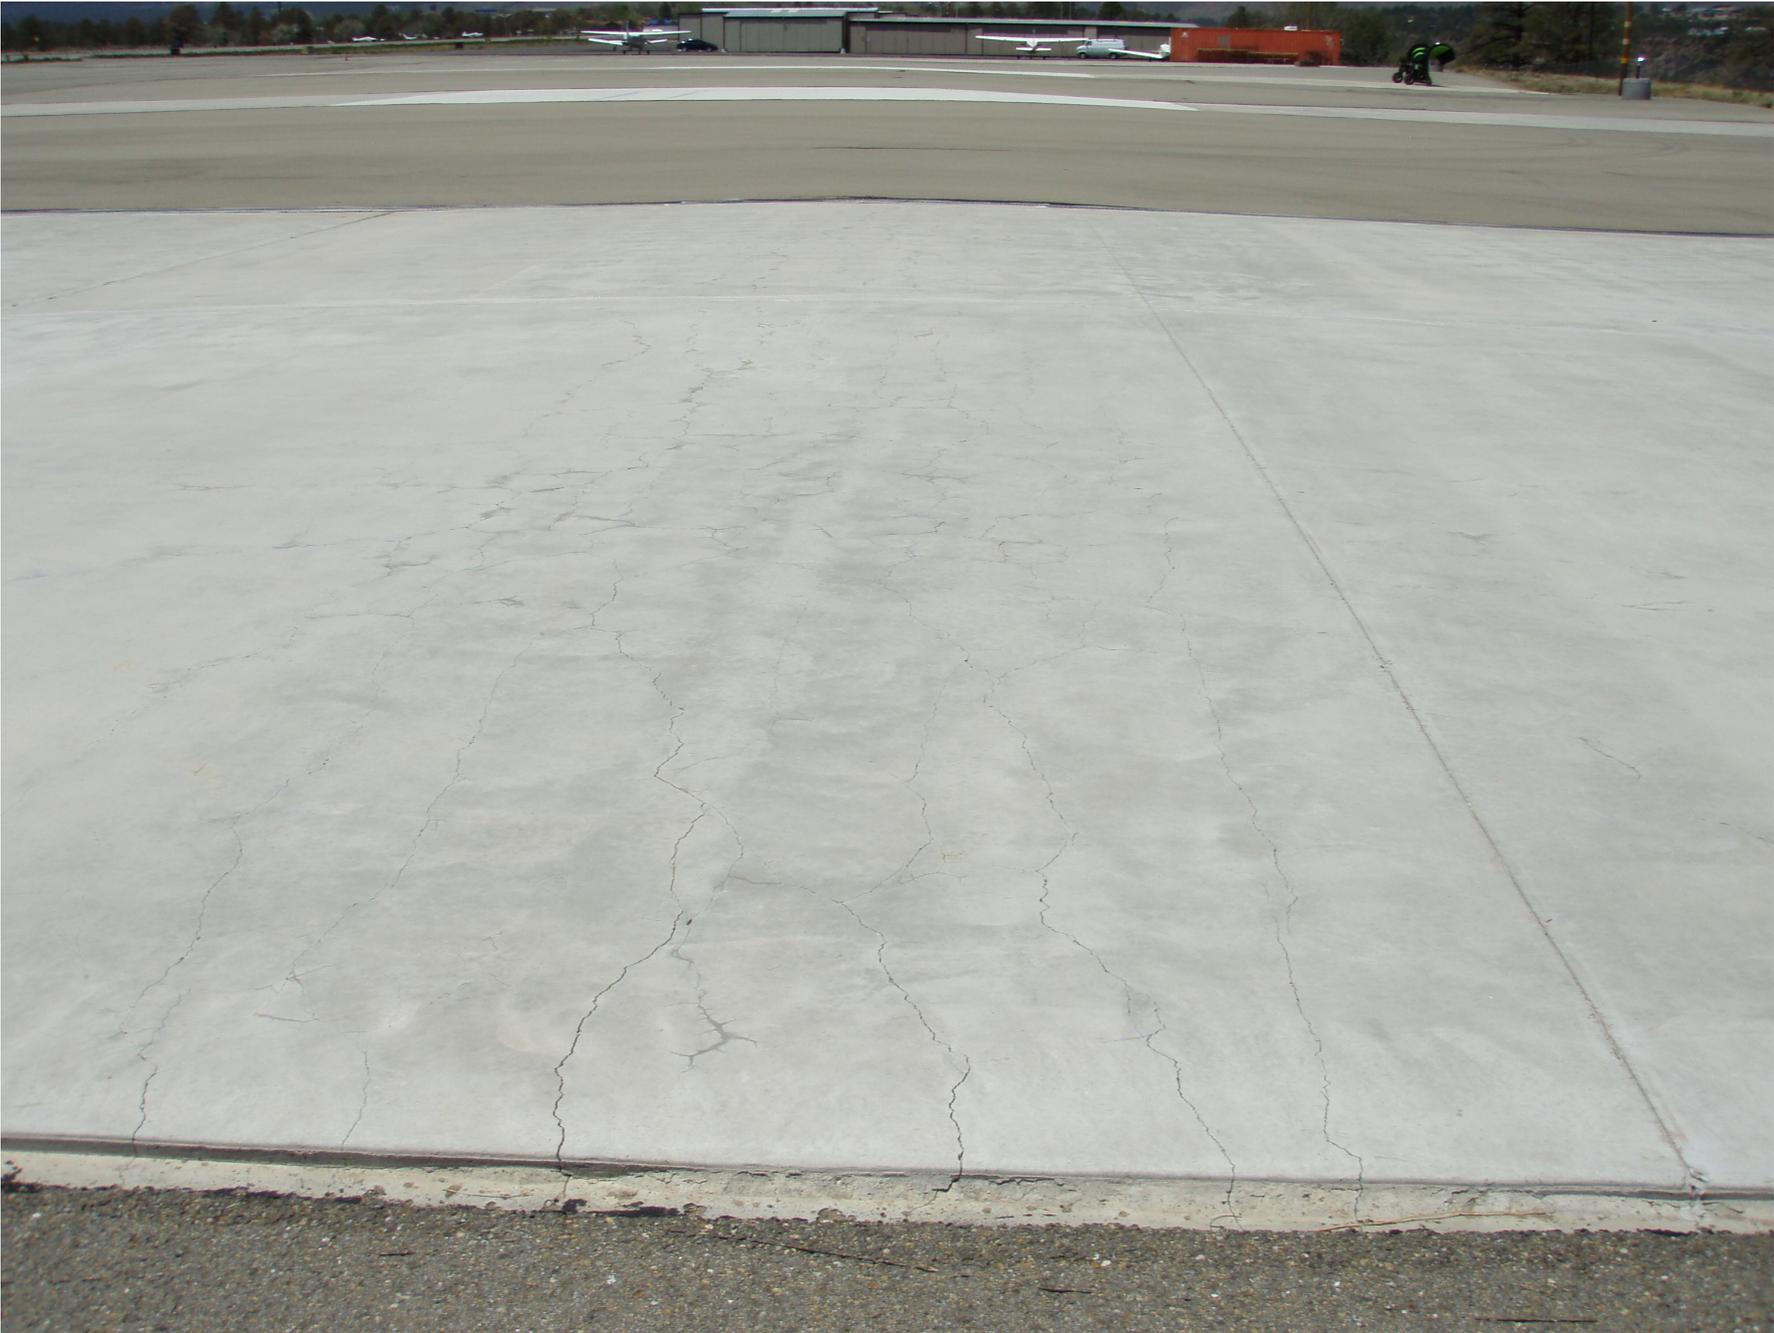
Photo 4: New cracking in Pad #4.

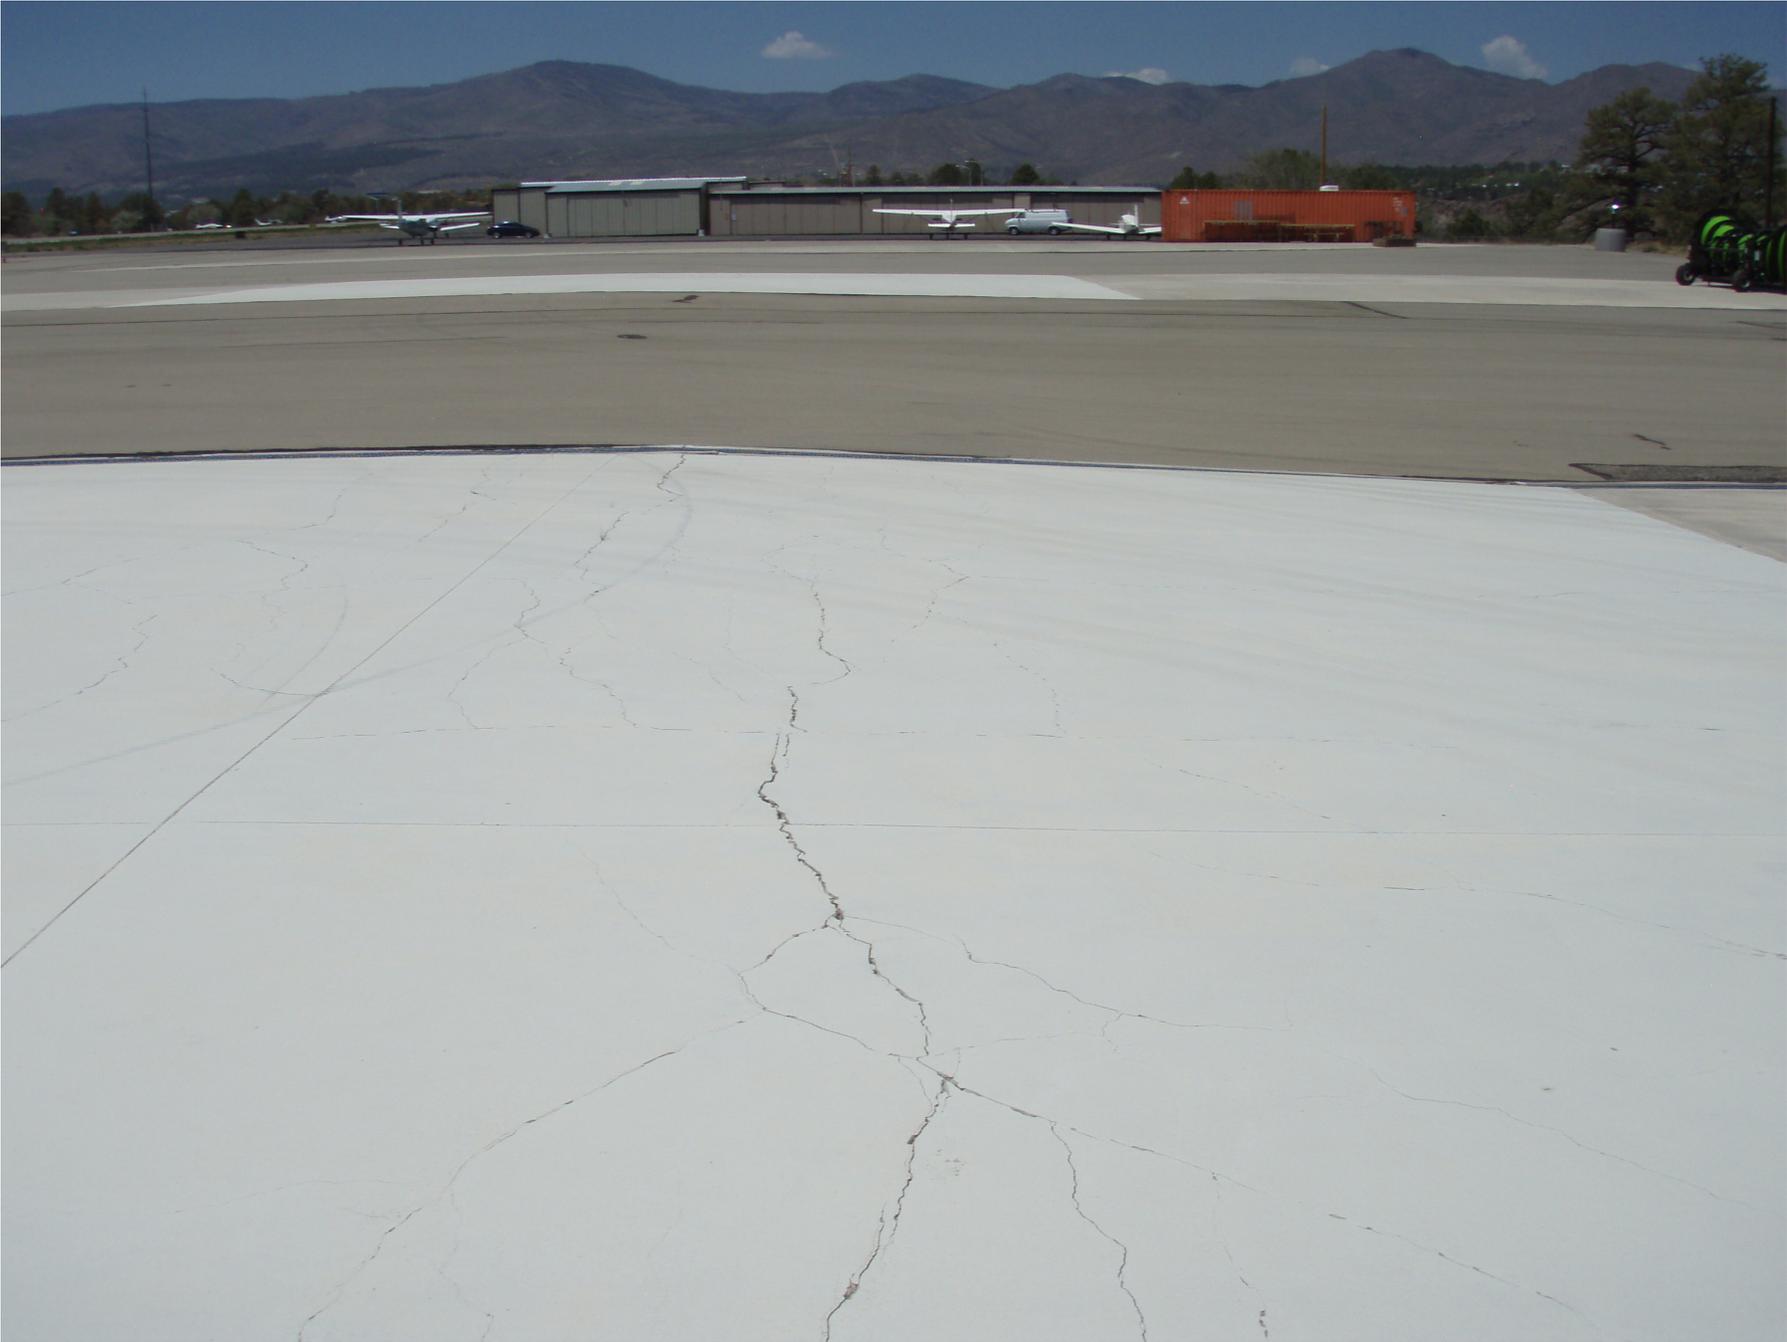
Photo 5: Cracking in Pad #3 along hinge point.

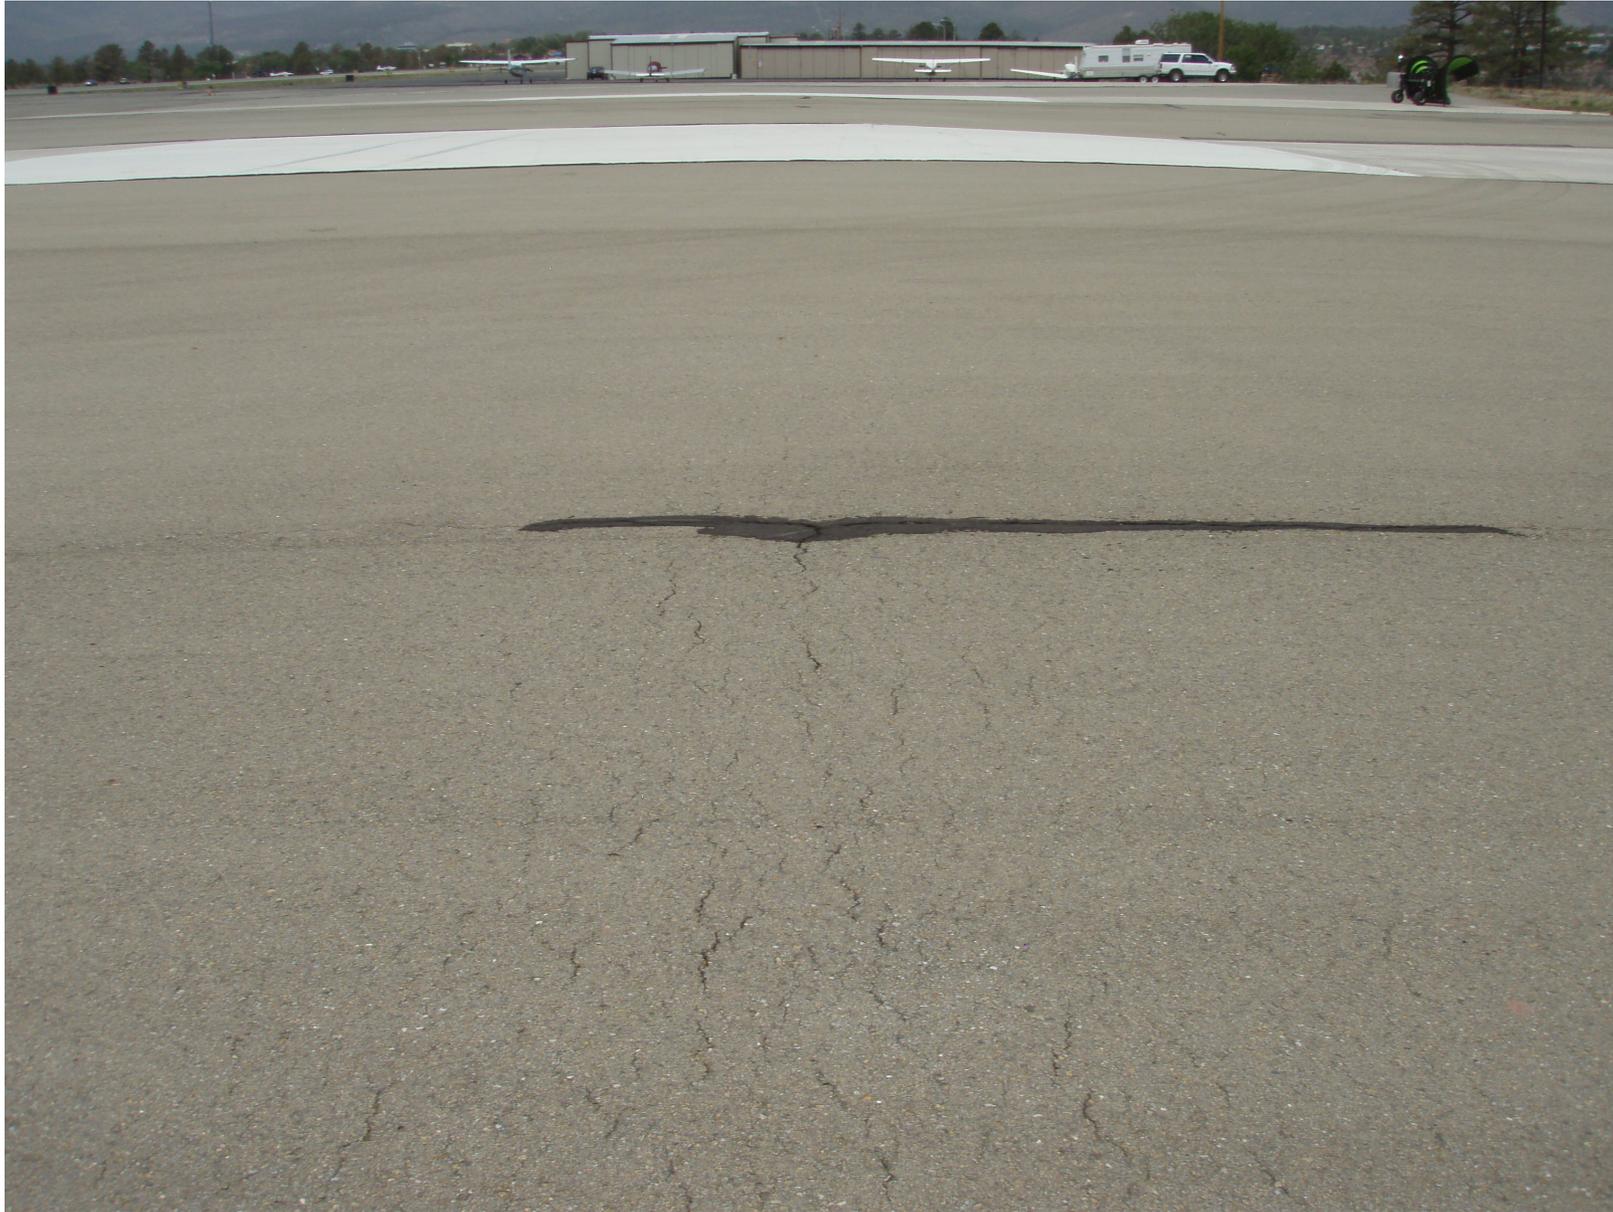
Photo 5: New cracks in MatCon pavement in an east-west orientation between hangar pads 3 and 4 along the hinge point.

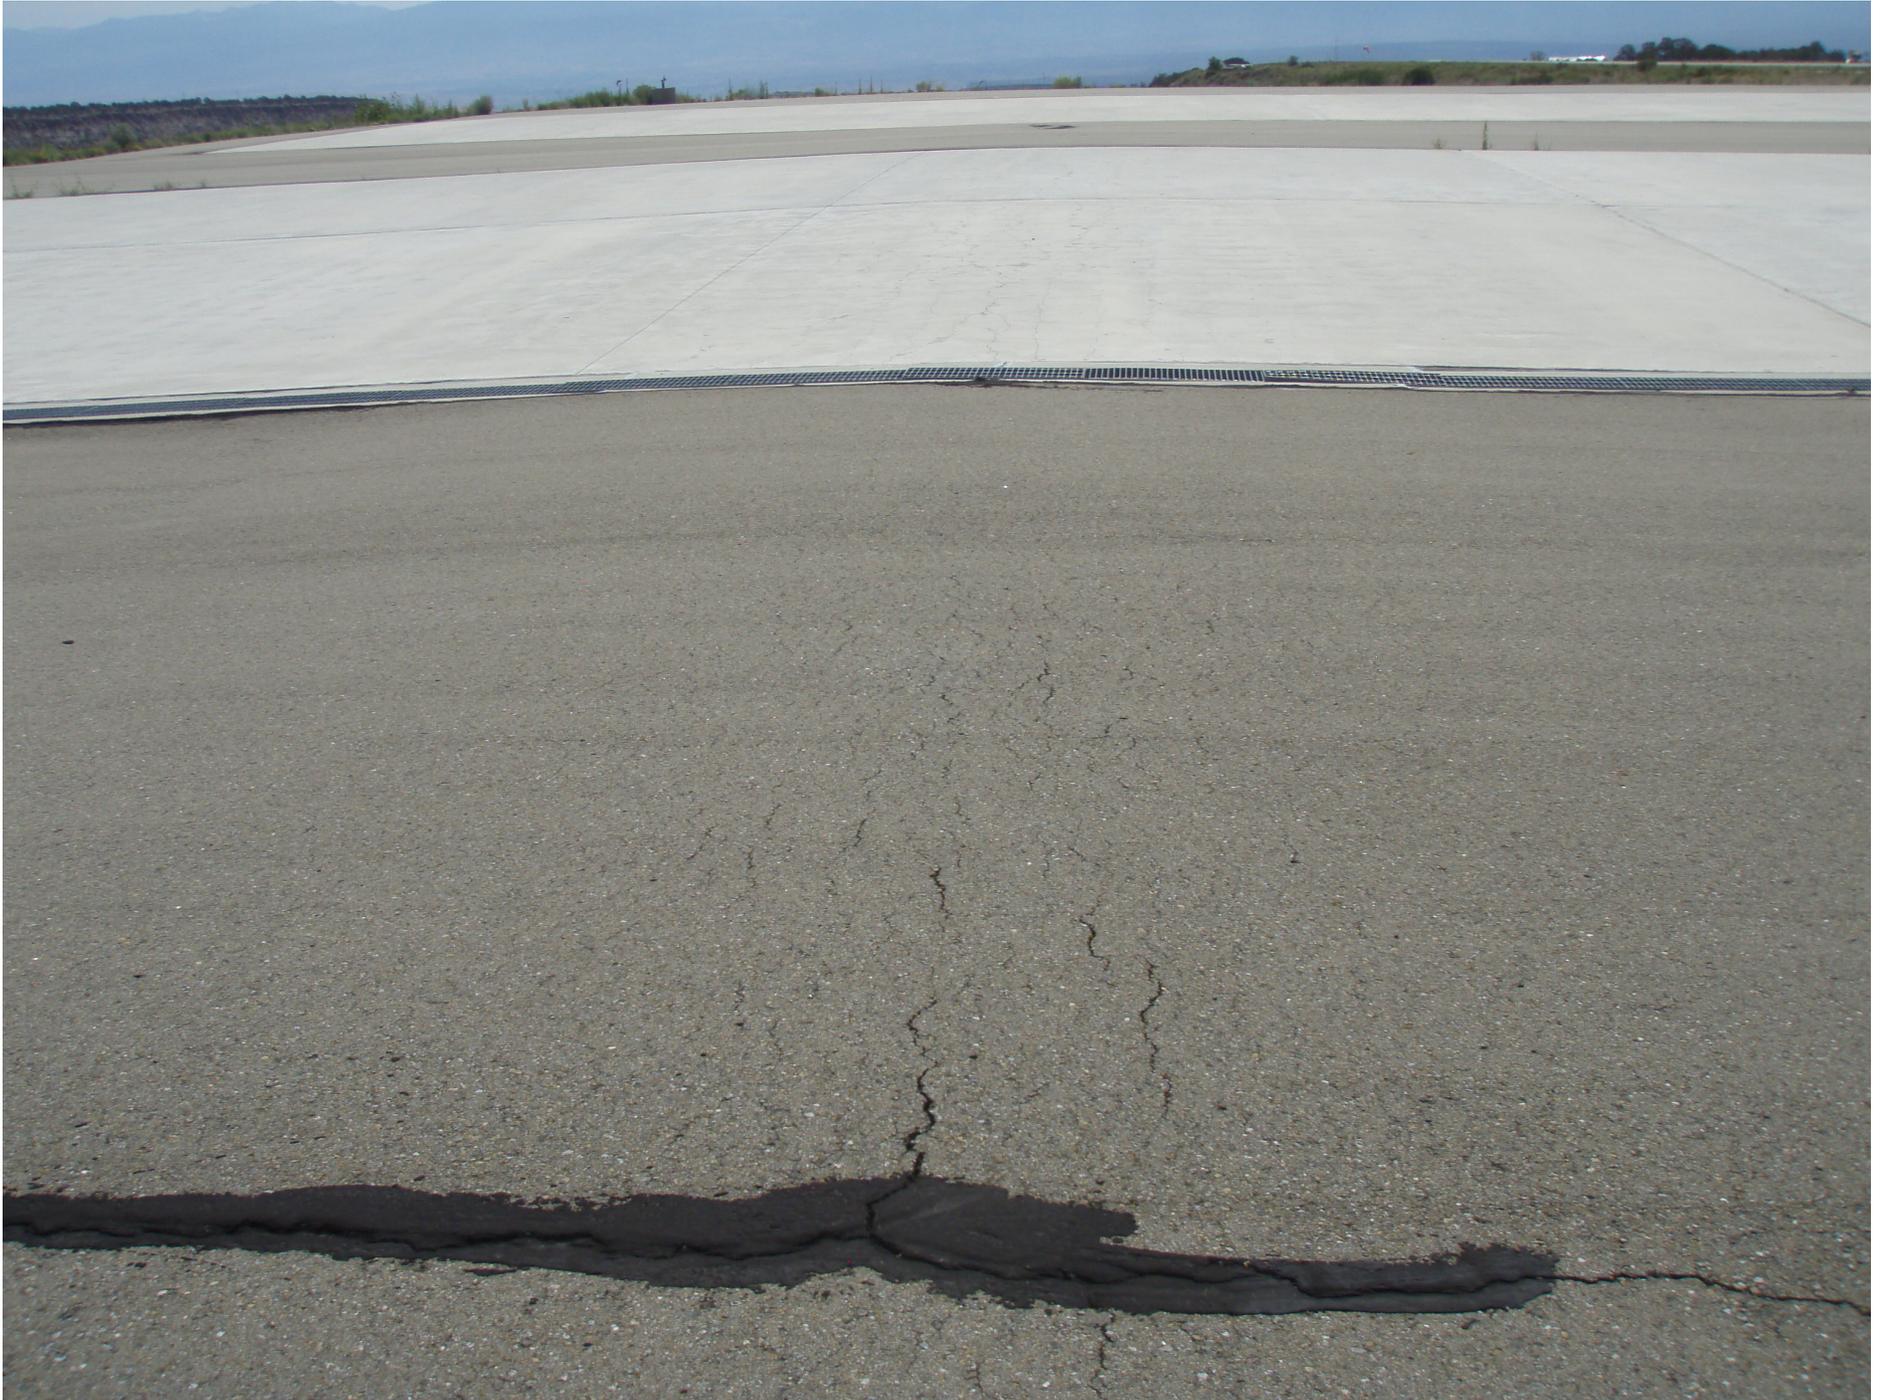
Photo 2: Cracks in MatCon pavement in an east-west orientation between hangar pads 3 and 4 along the hinge point.

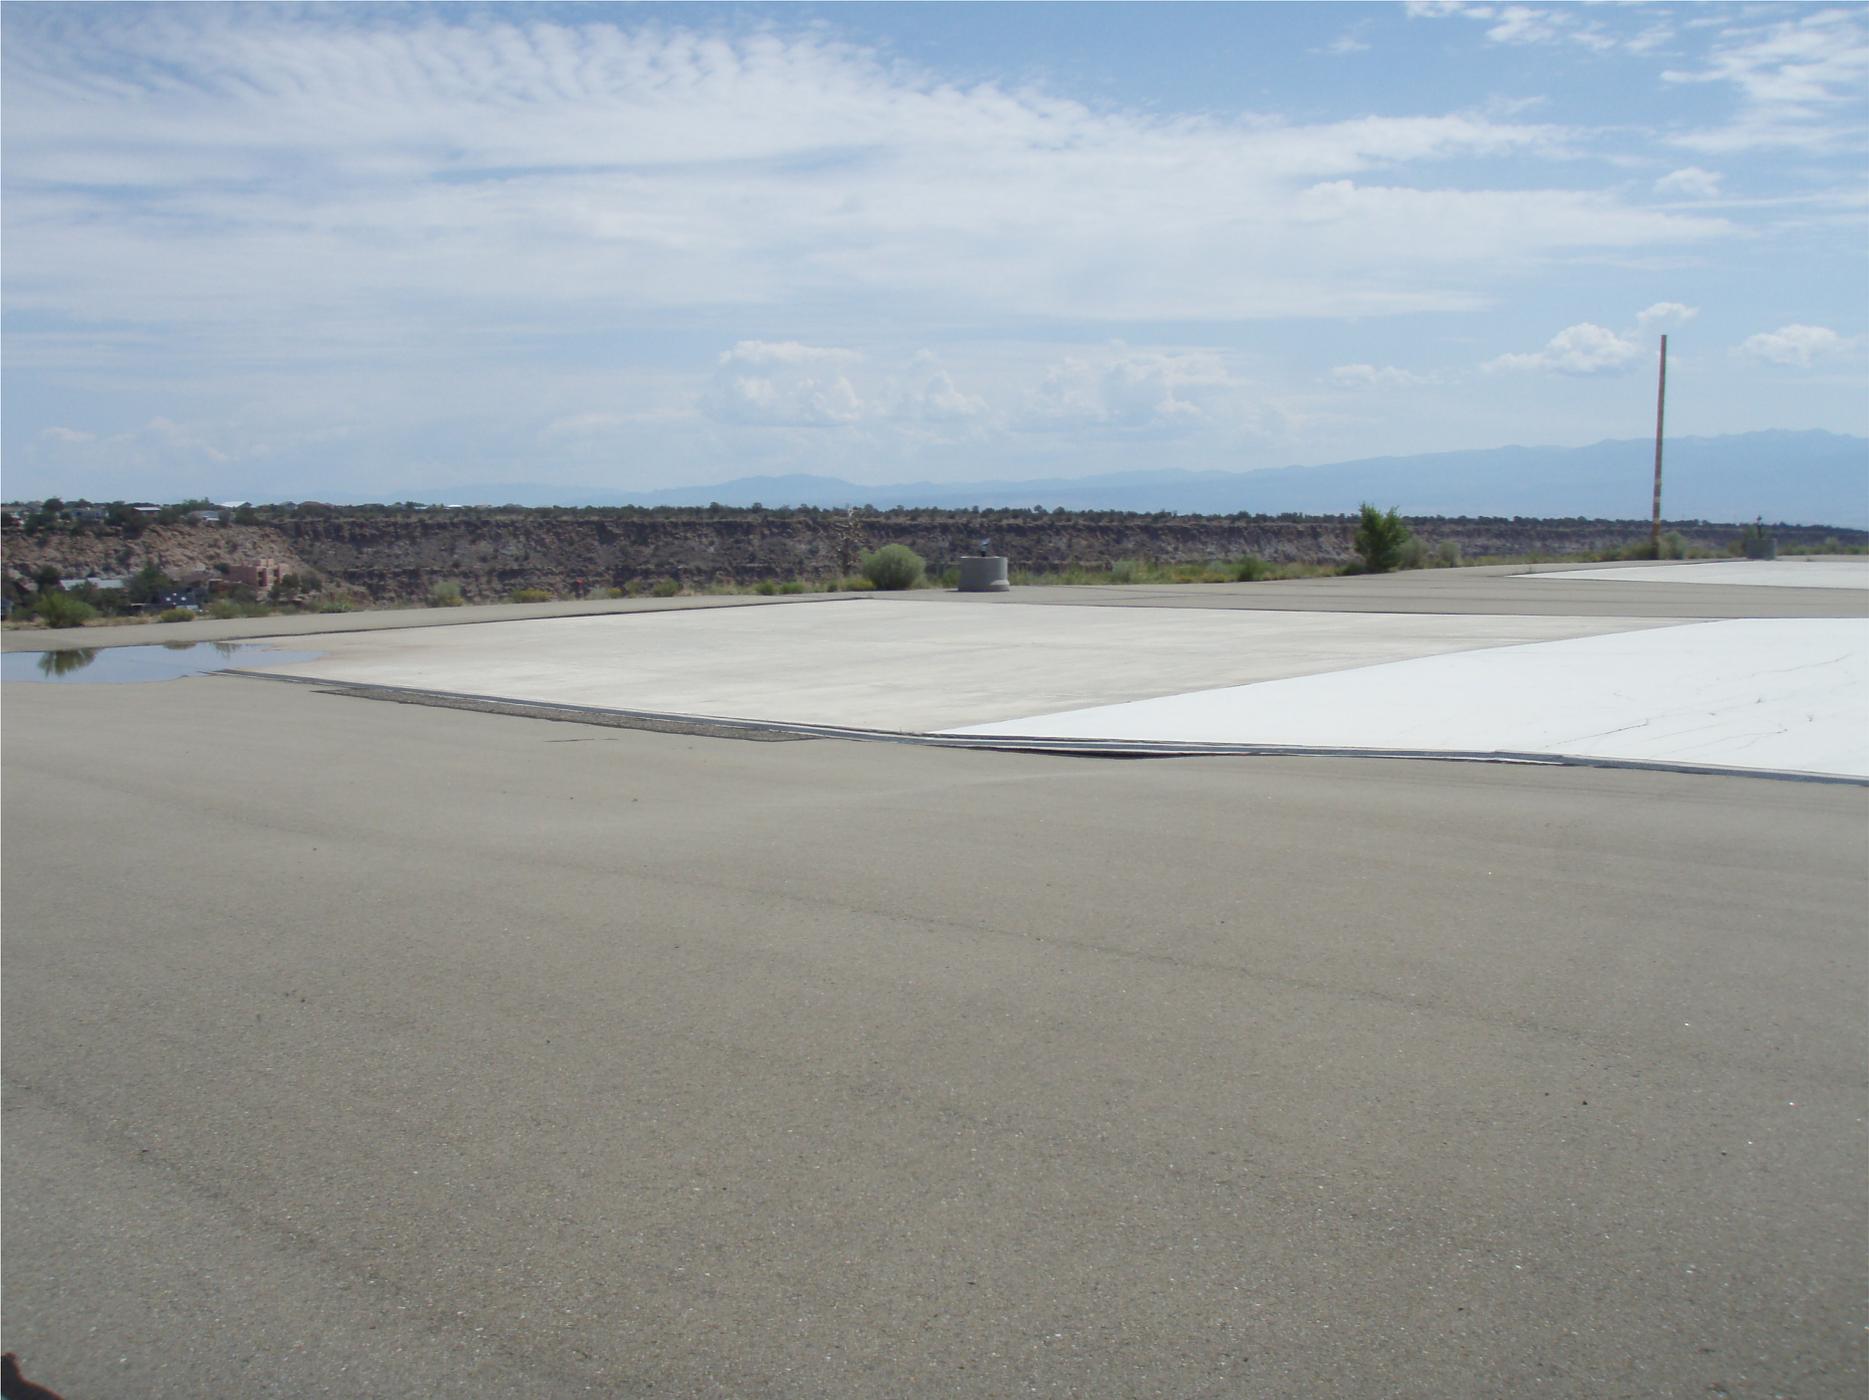
Photo 3: North end of Pad 3. Note improper drainage of trench drain, puddle of water, cracking of pad, separation of MatCon and trench drain, and repair patch in pavement.

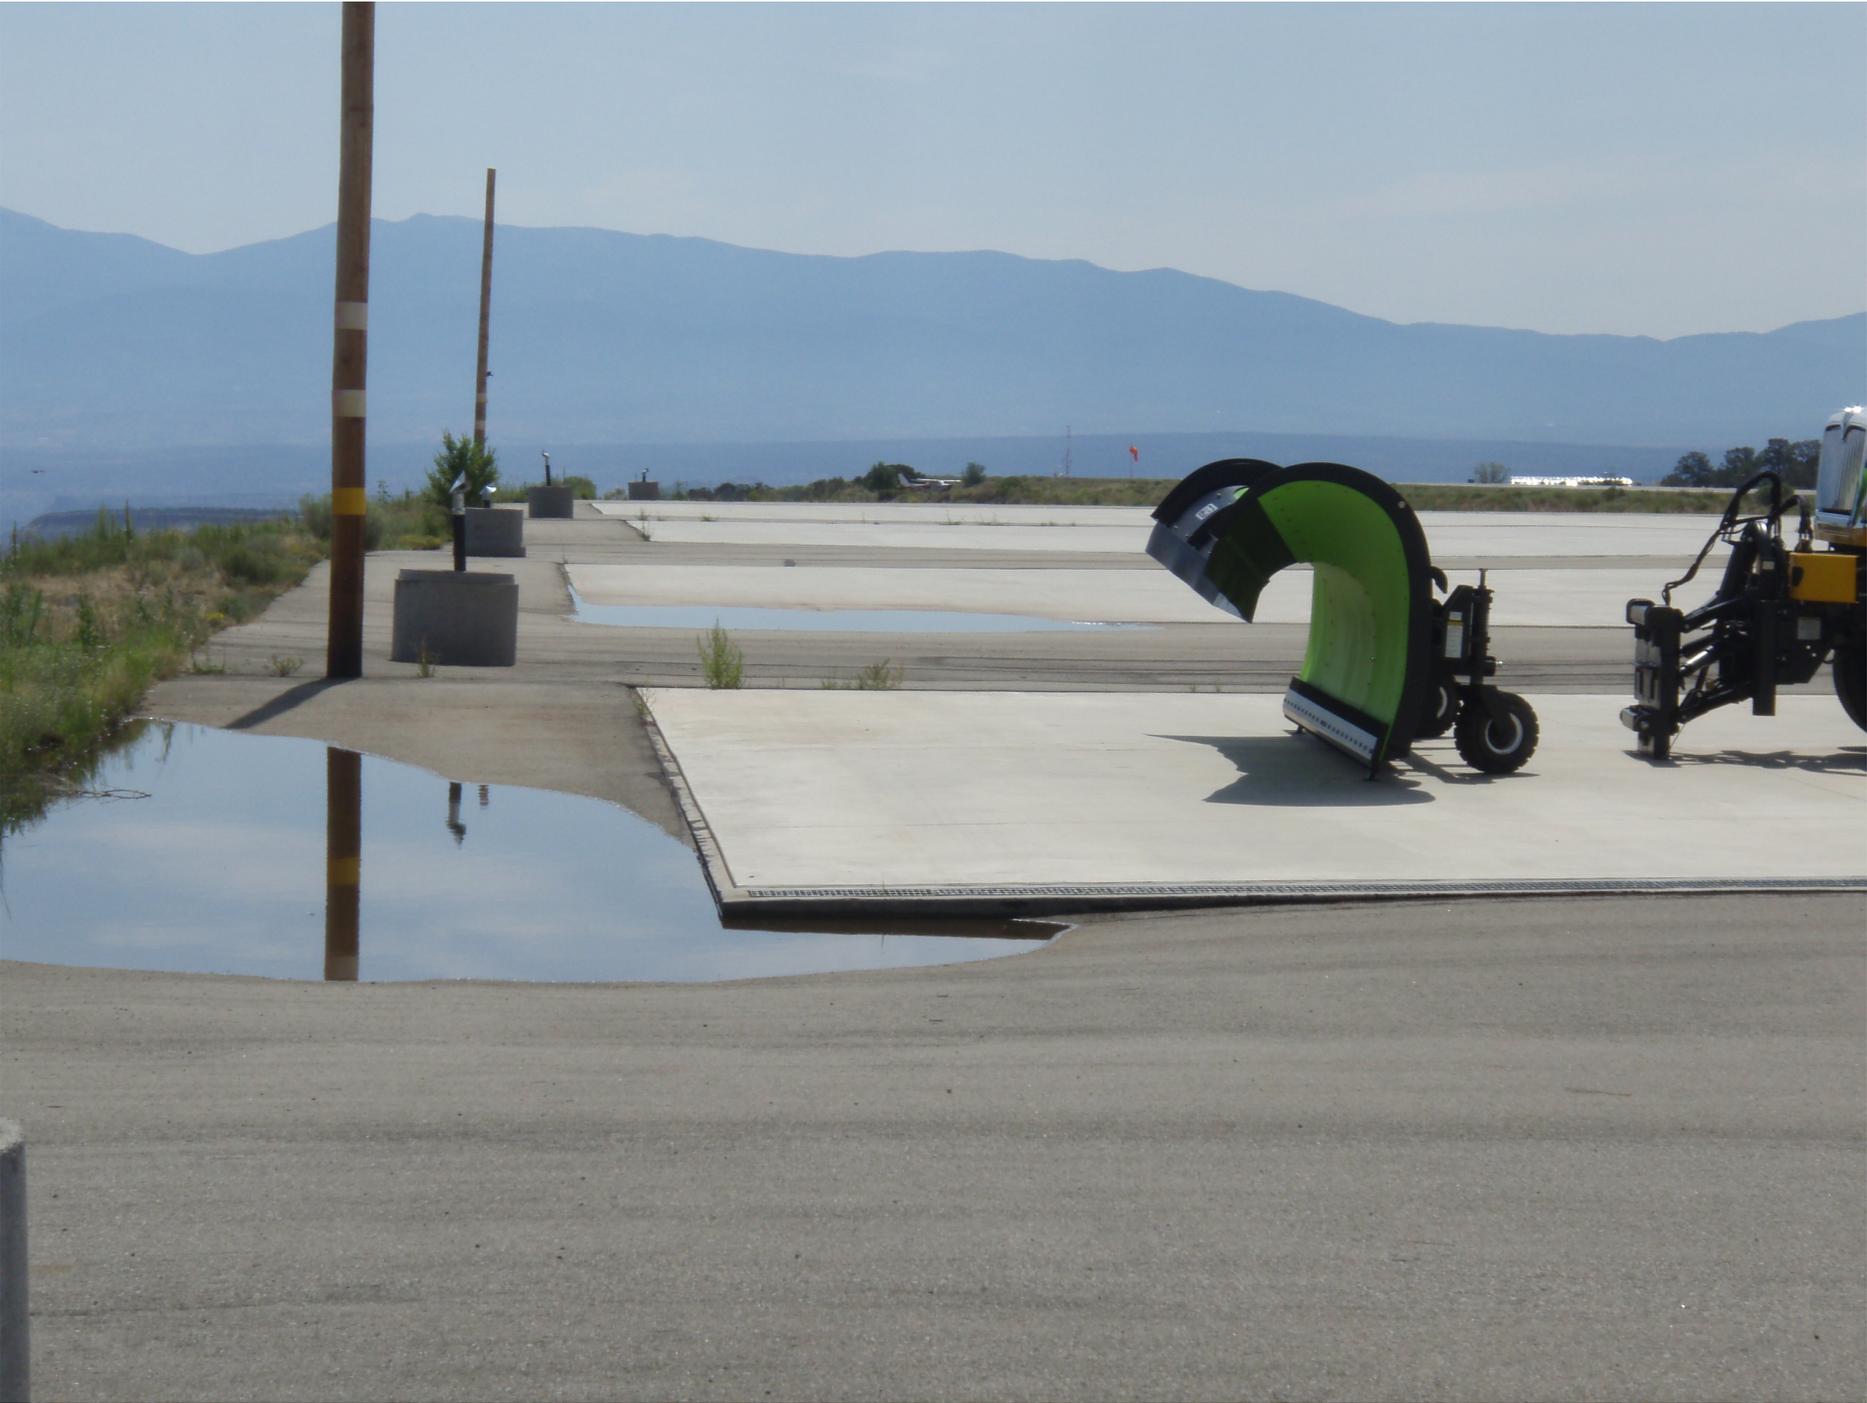
Photo 4: Puddles at Pad 2 and 3 due to subsidence of MatCon, pads and trench drains.

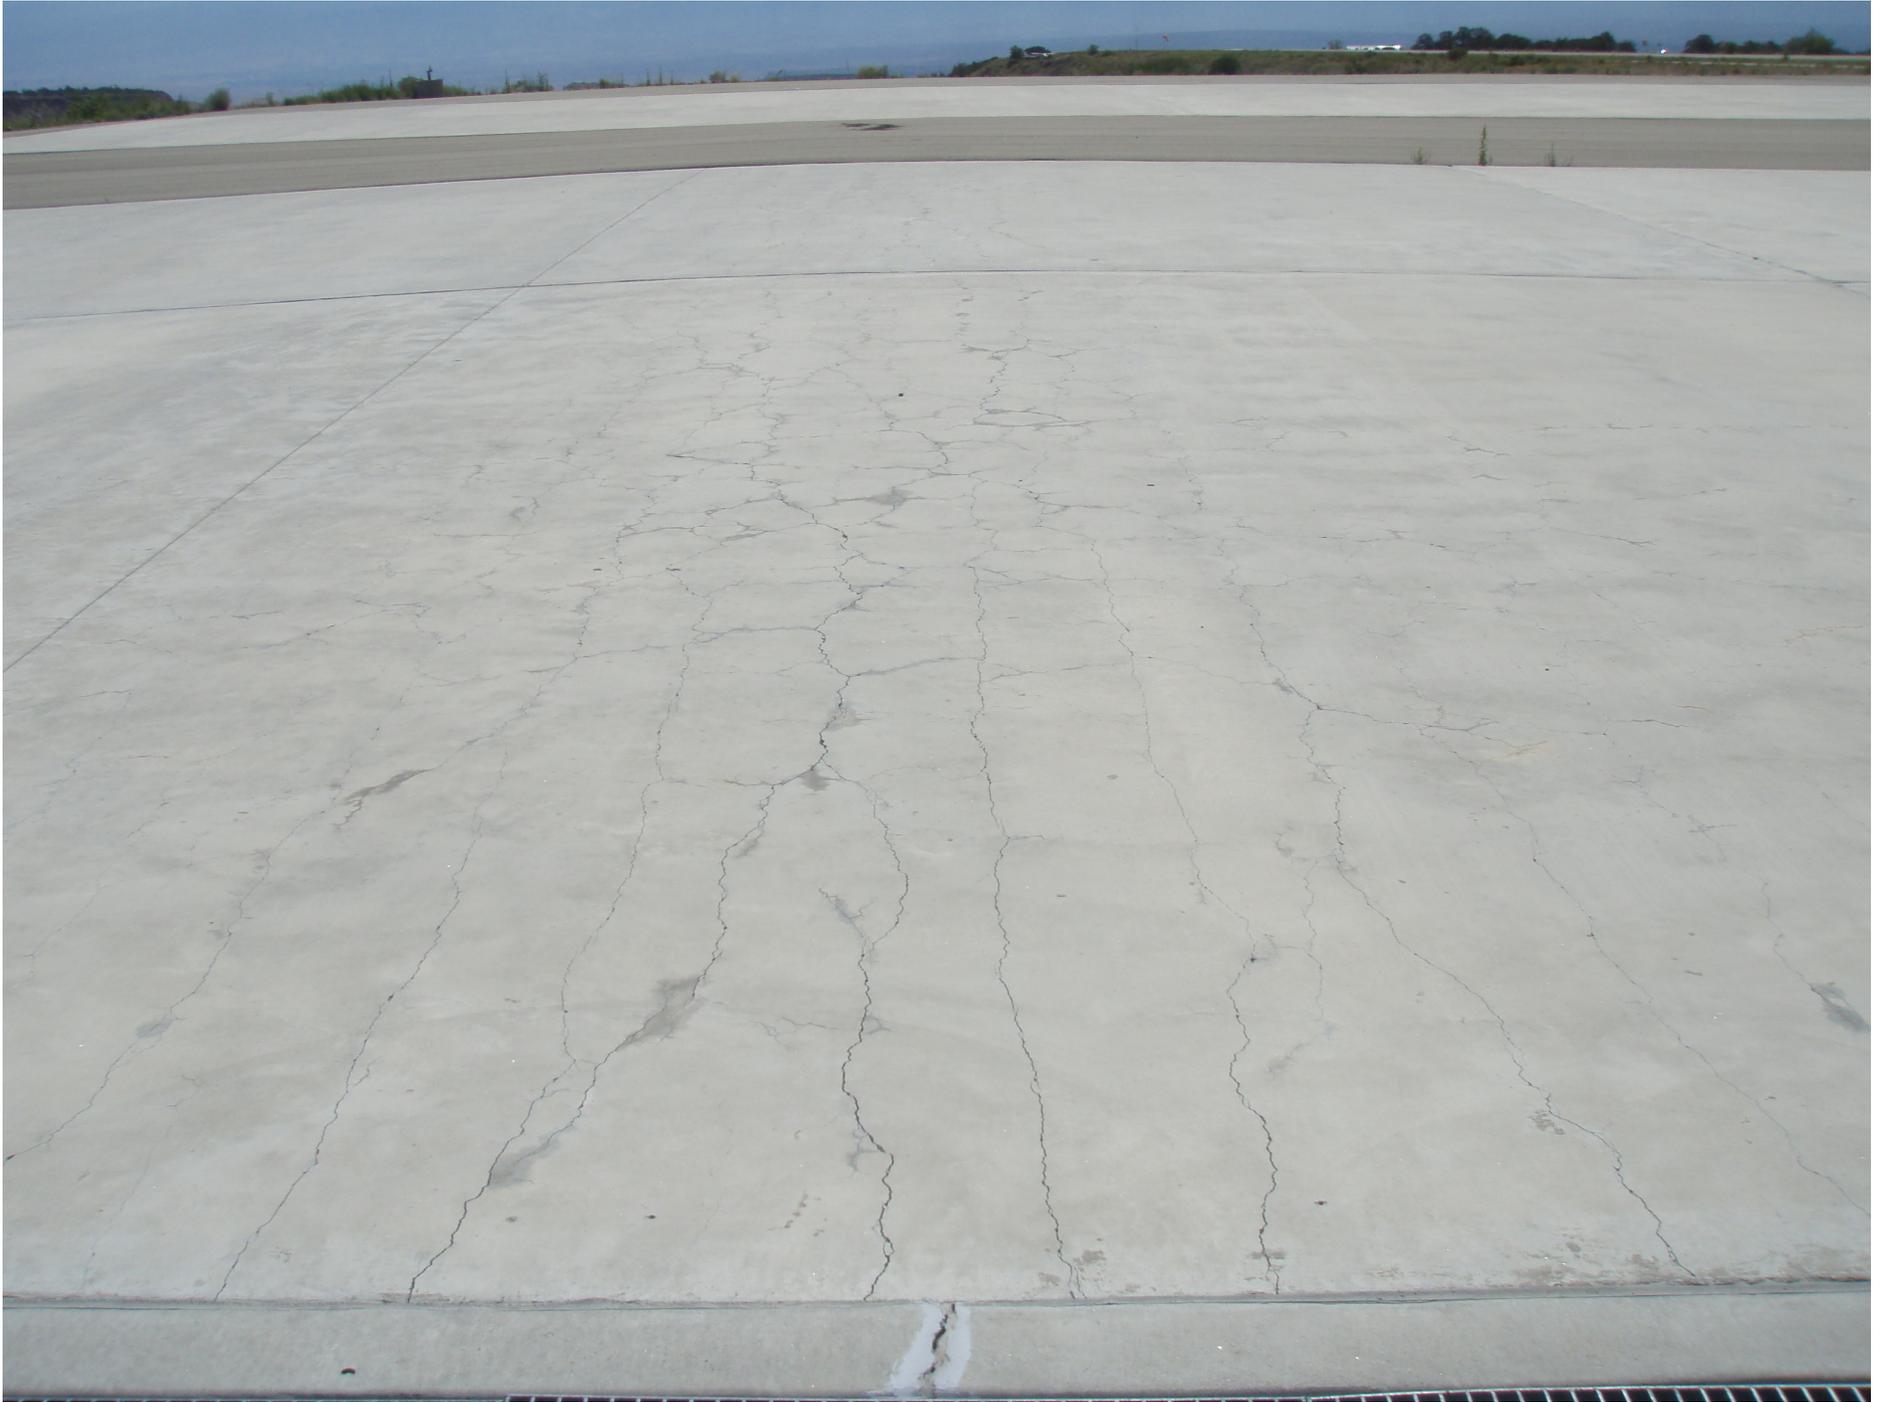
Photo 6: Pad 4, cracks in an east-west orientation along hinge point. Note repaired crack at trench drain has failed.

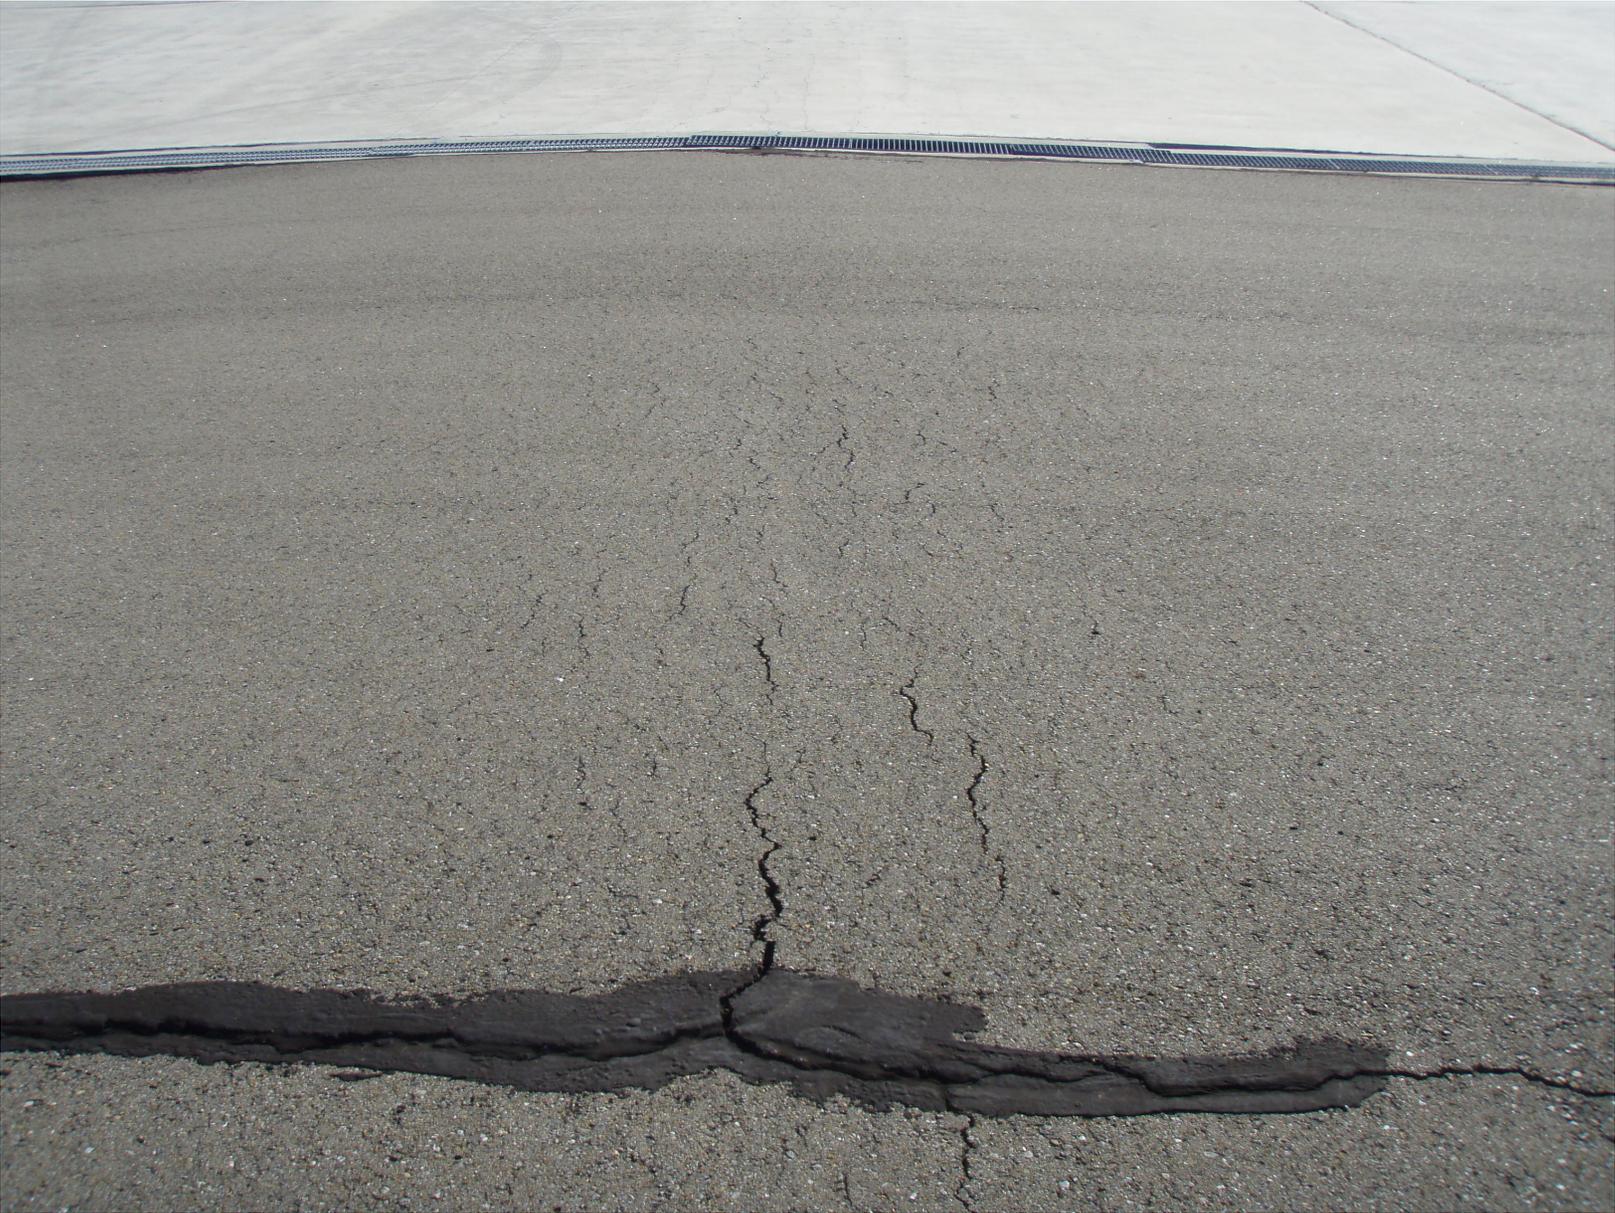
Photo 2: Cracks in MatCon between hangar pads 3 & 4
