Subject: Submittal of the 2013 Annual Inspection Report for Los Alamos County Airport Landfill, Solid Waste Management Units 73-001(a) and 73-001(d), Technical Area 73

**2013 Annual Inspection Report for
Los Alamos Country Airport Landfill,
Solid Waste Management Units
73-001(a) and 73-001(d),
Technical Area 73**

Prepared by the Los Alamos Field Office

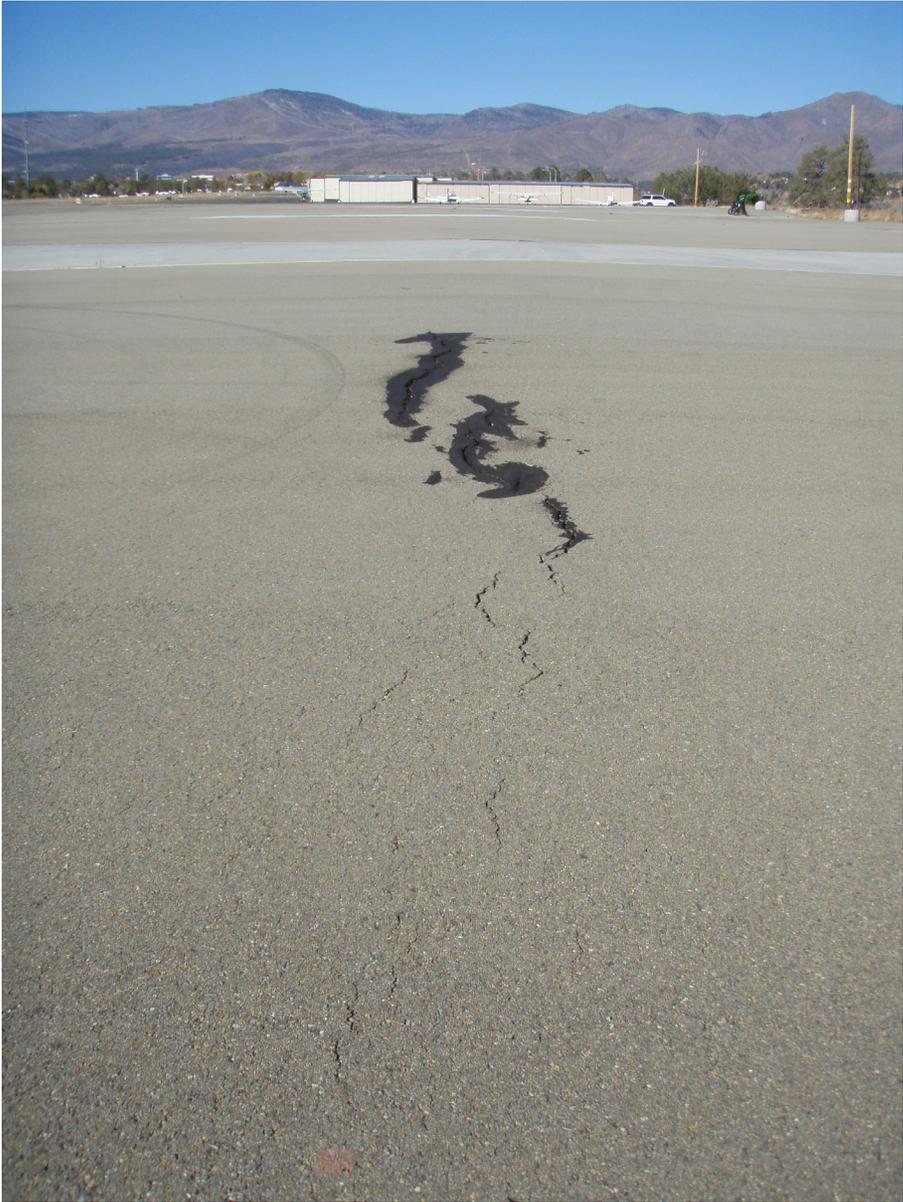
Photo 3: Cracks in MatCon between hangar pads 4 & 5

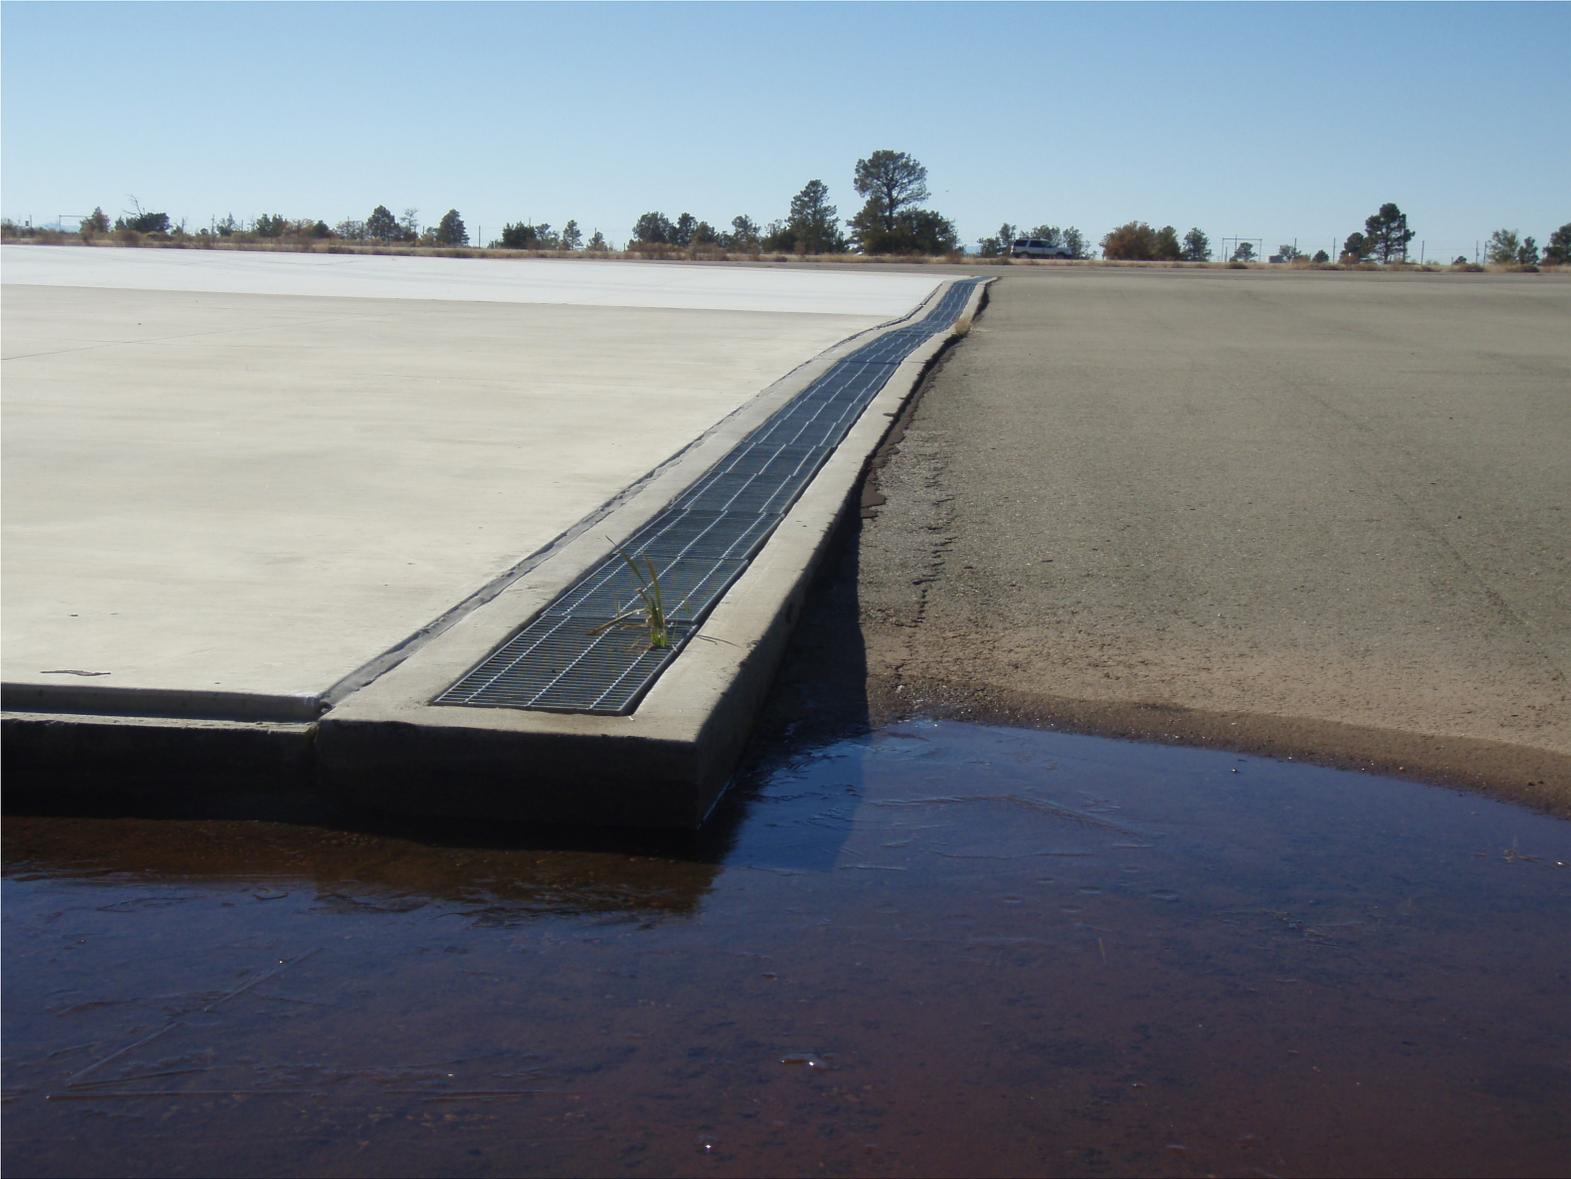
Photo4: Subsidence of MatCon at NW corner of hangar pad 3

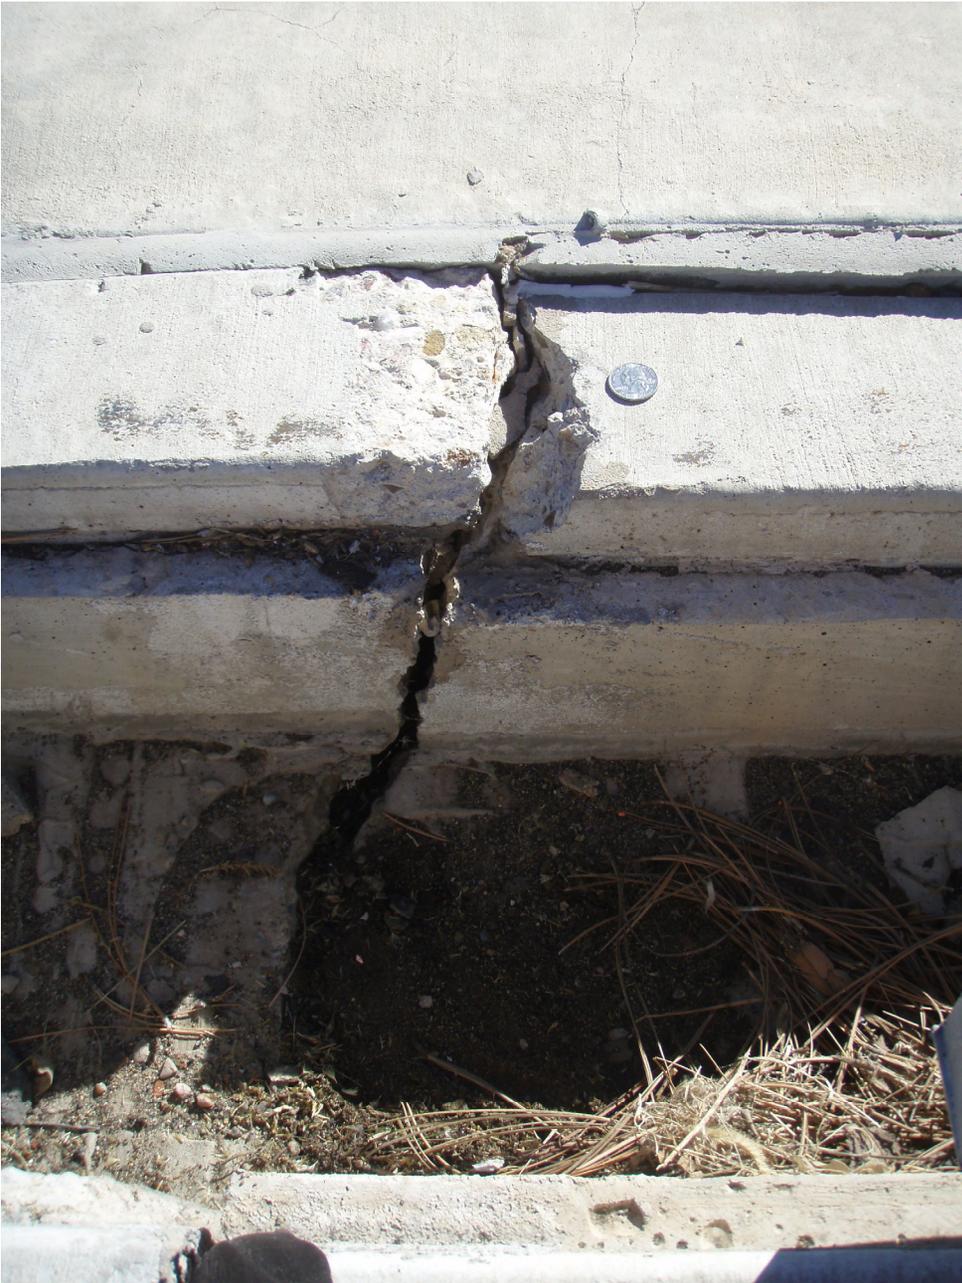
Photo 6: Crack across trench drain

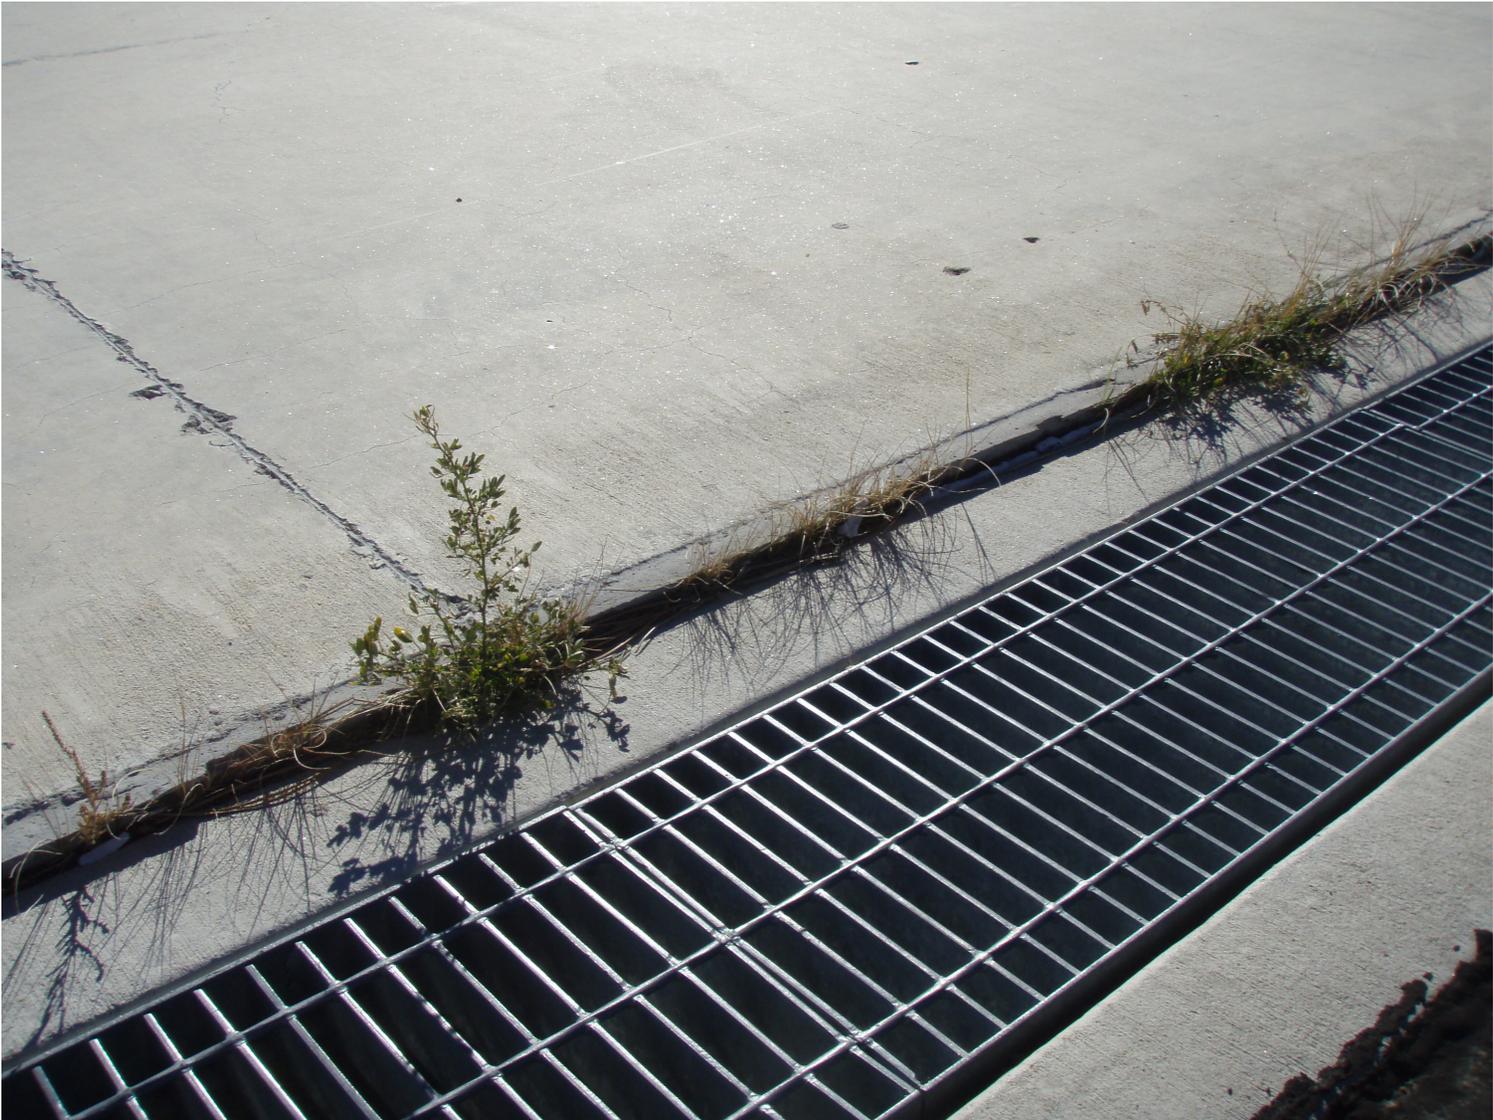
Photo 7: Separation of hangar pad and trench drain

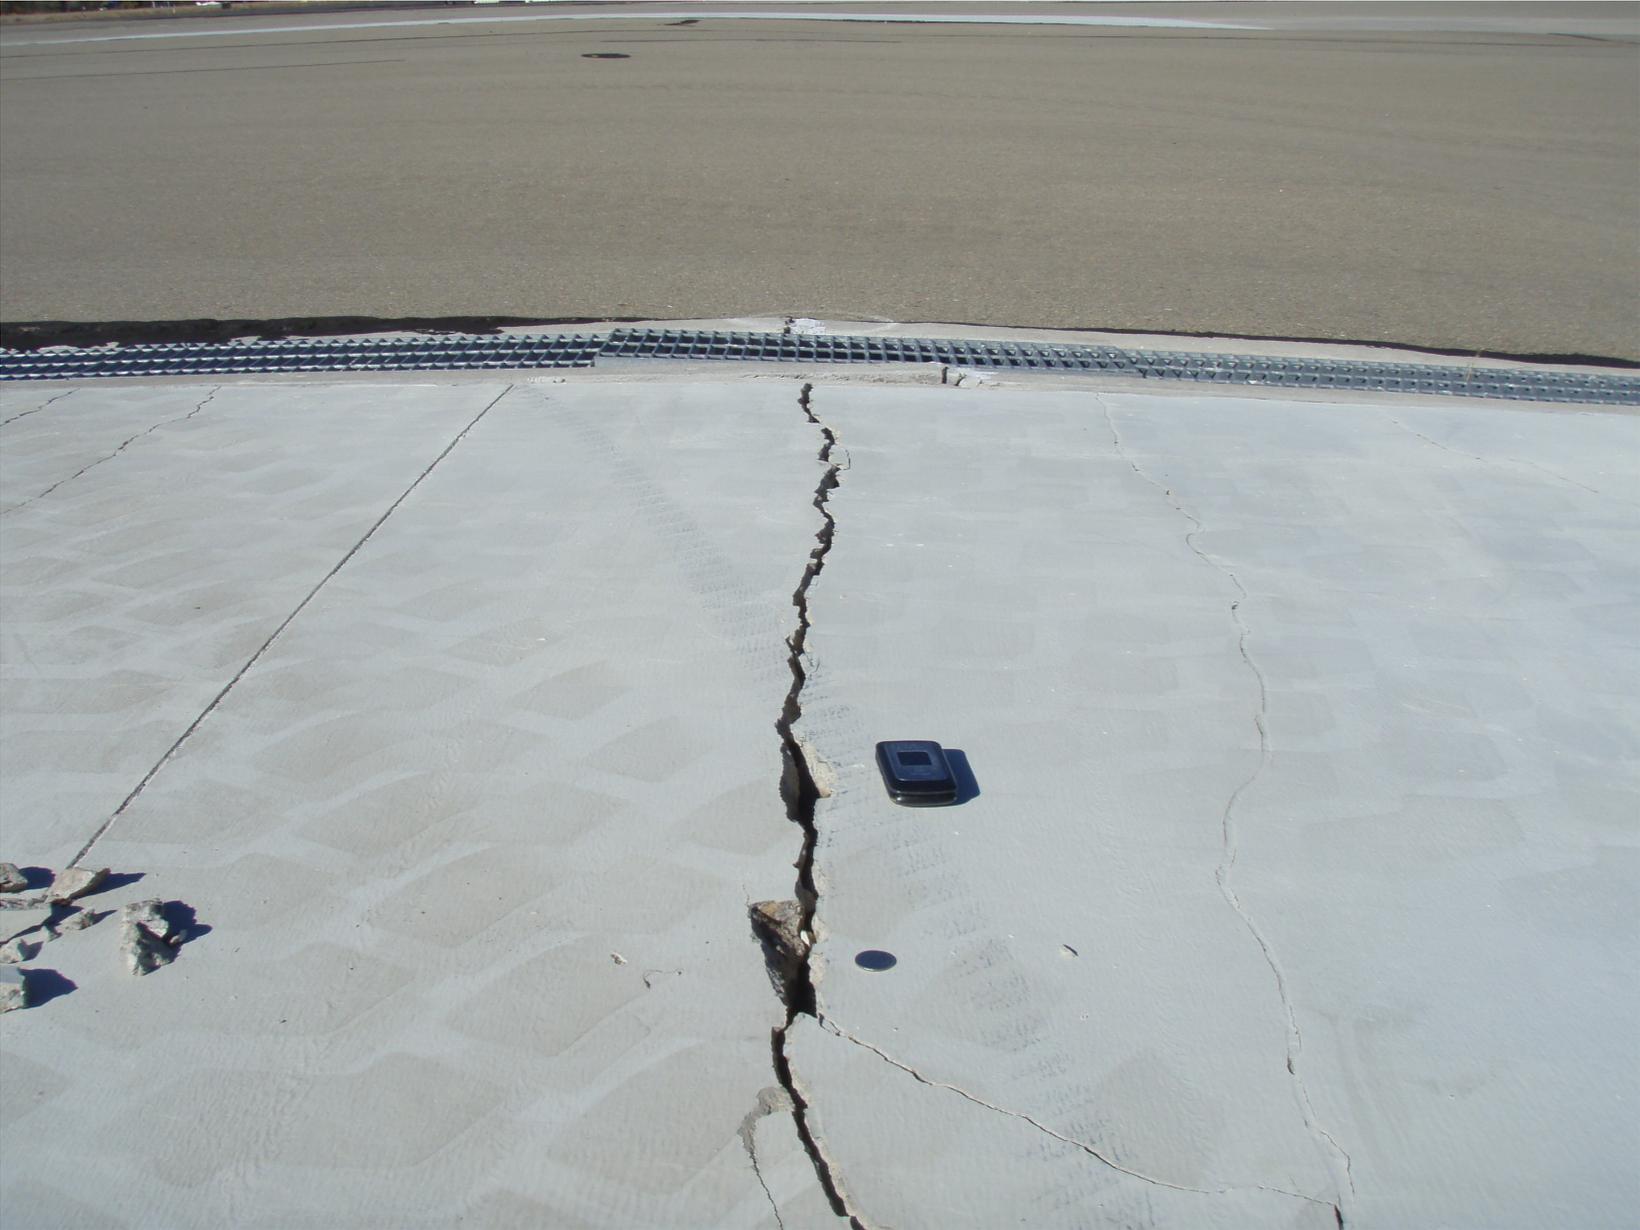
Photo 8: Crack in hangar pad 3

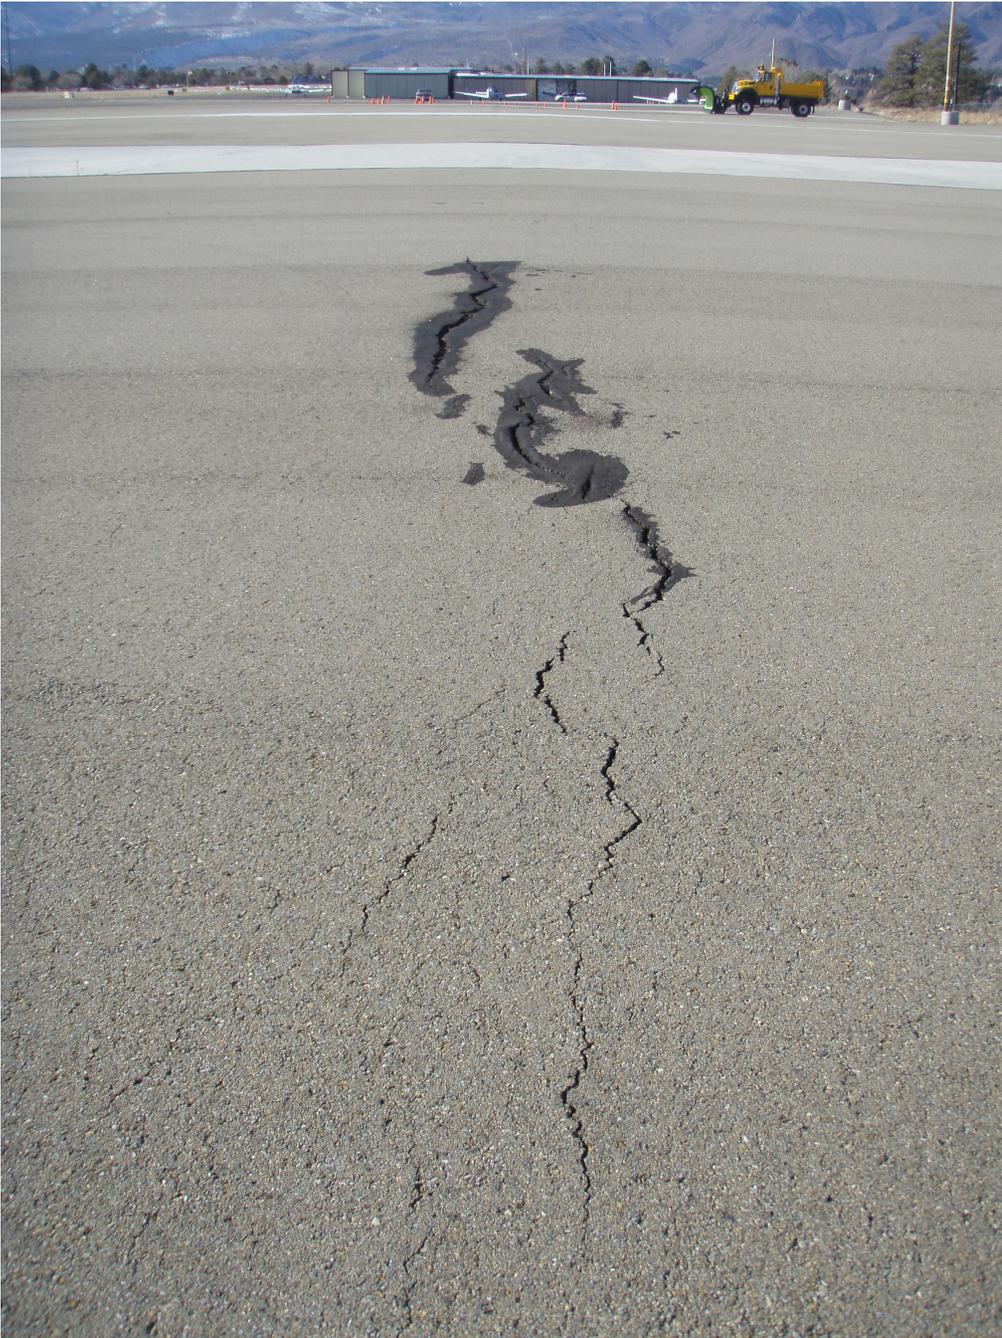
Photo 2 Cracks in the MatCon pavement along the hinge line between Pads 4 & 5.

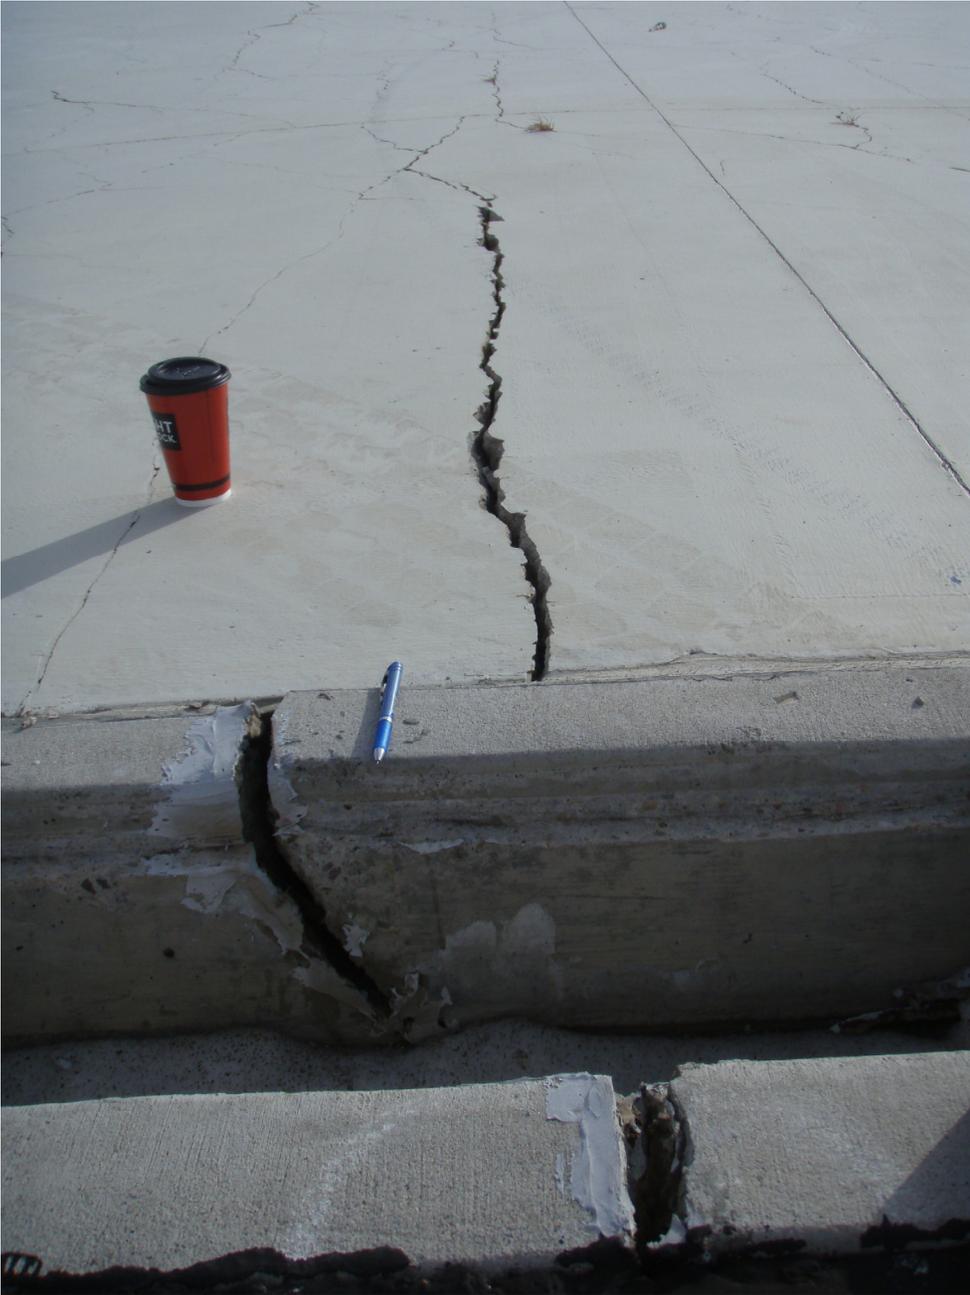
Photo 7: Crack across trench drain and into Pad 3

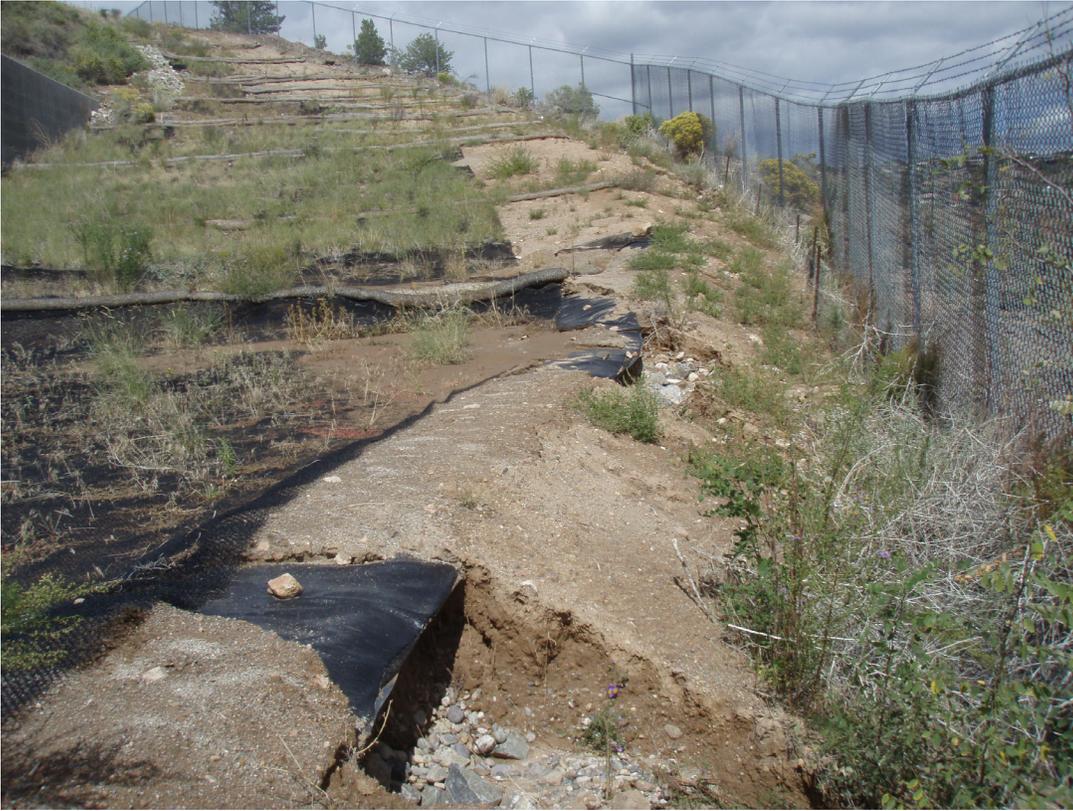
Photo 9. Wattle slope and retention area. Note failure of berm.

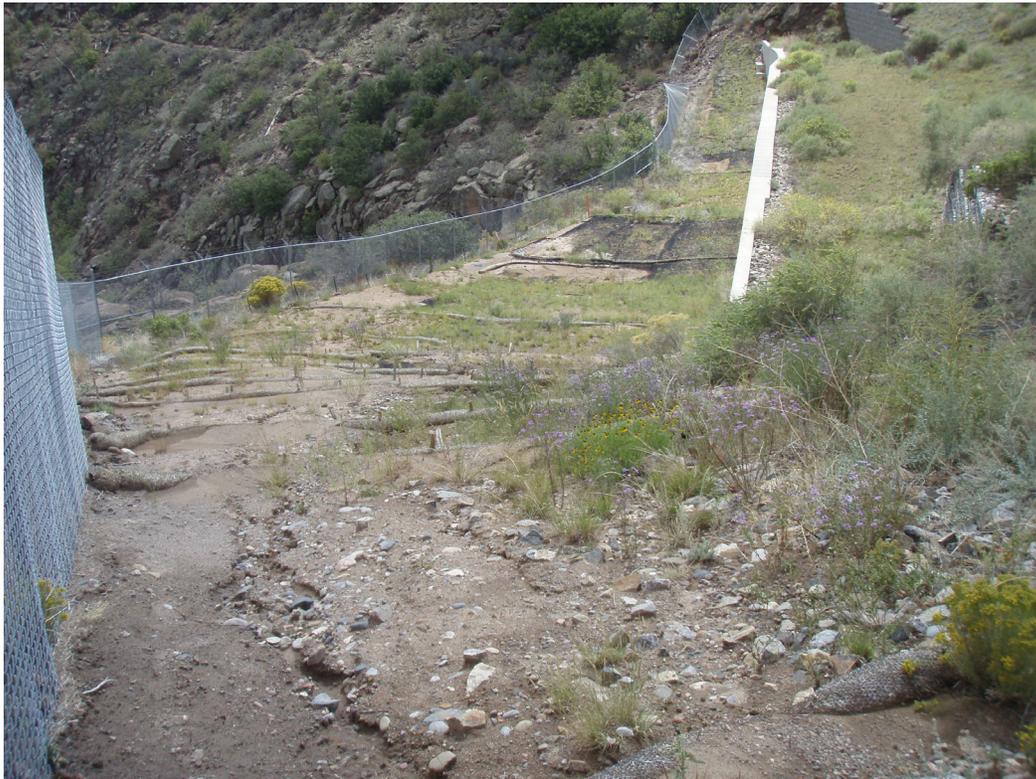
Photo 11. Wattle slope. Note rilling of slope, sediment accumulation behind wattles, failure of retention feature and downed perimeter fence.
