Subject: Detailed Ultrasonic Inspection Report - Solvent Waste Storage Tank

MIXED SOLVENT WASTE TANK INSPECTION

Produced for:
PHILIPS SEMICONDUCTORS
Albuquerque, New Mexico

File No. 701210

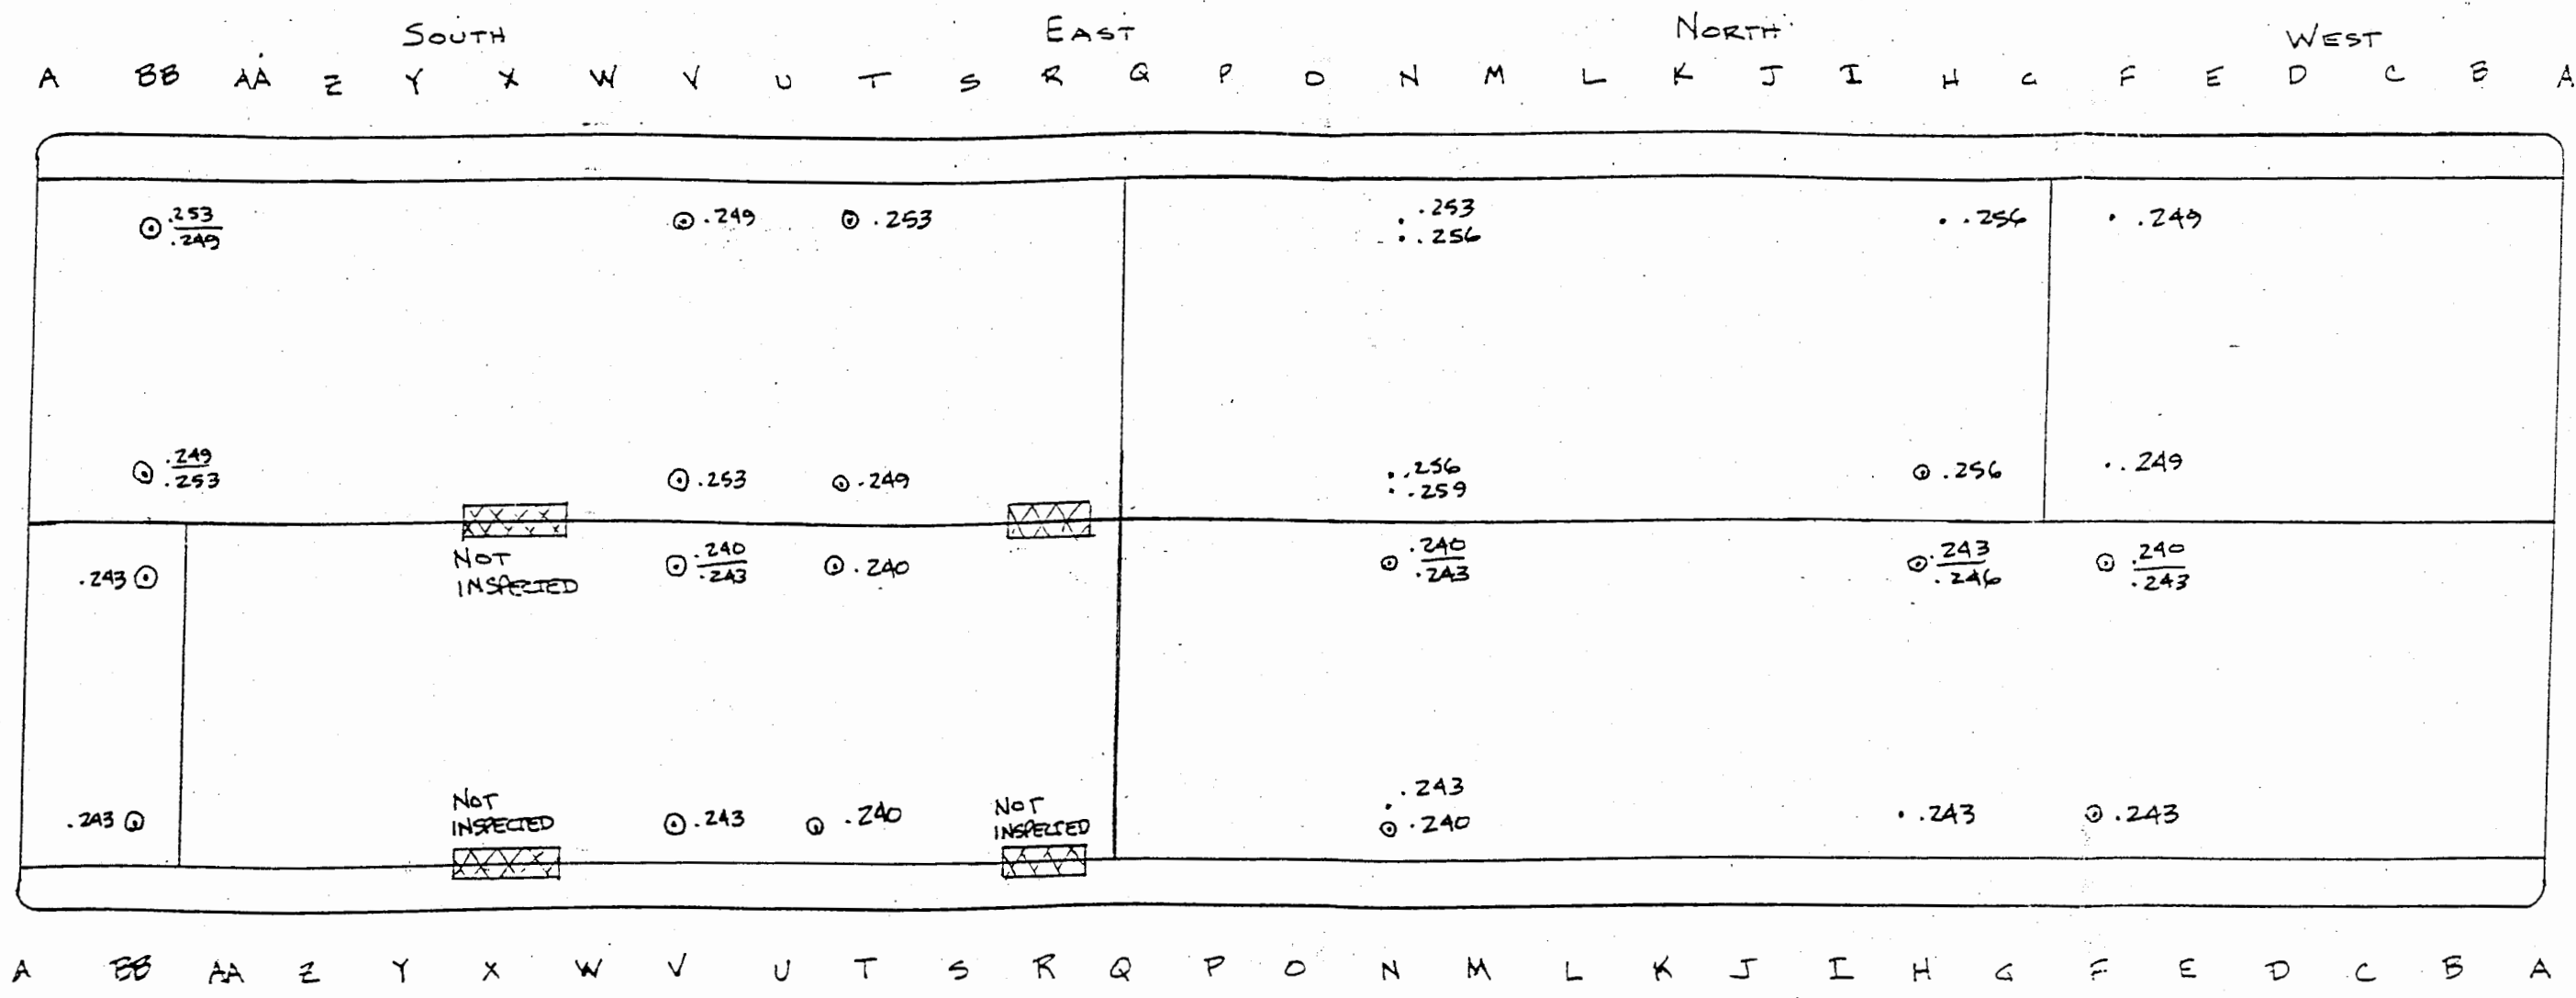
Figure 1 Map of Ultrasonic Thickness Measurements on Tank Shell

The tank wall thickness was spot checked at selected locations to compare with previous measurements. A map of the locations and measured wall thickness is presented in Figure 1. The thickness measurements agree with those reported during the previous inspection within accepted limits.

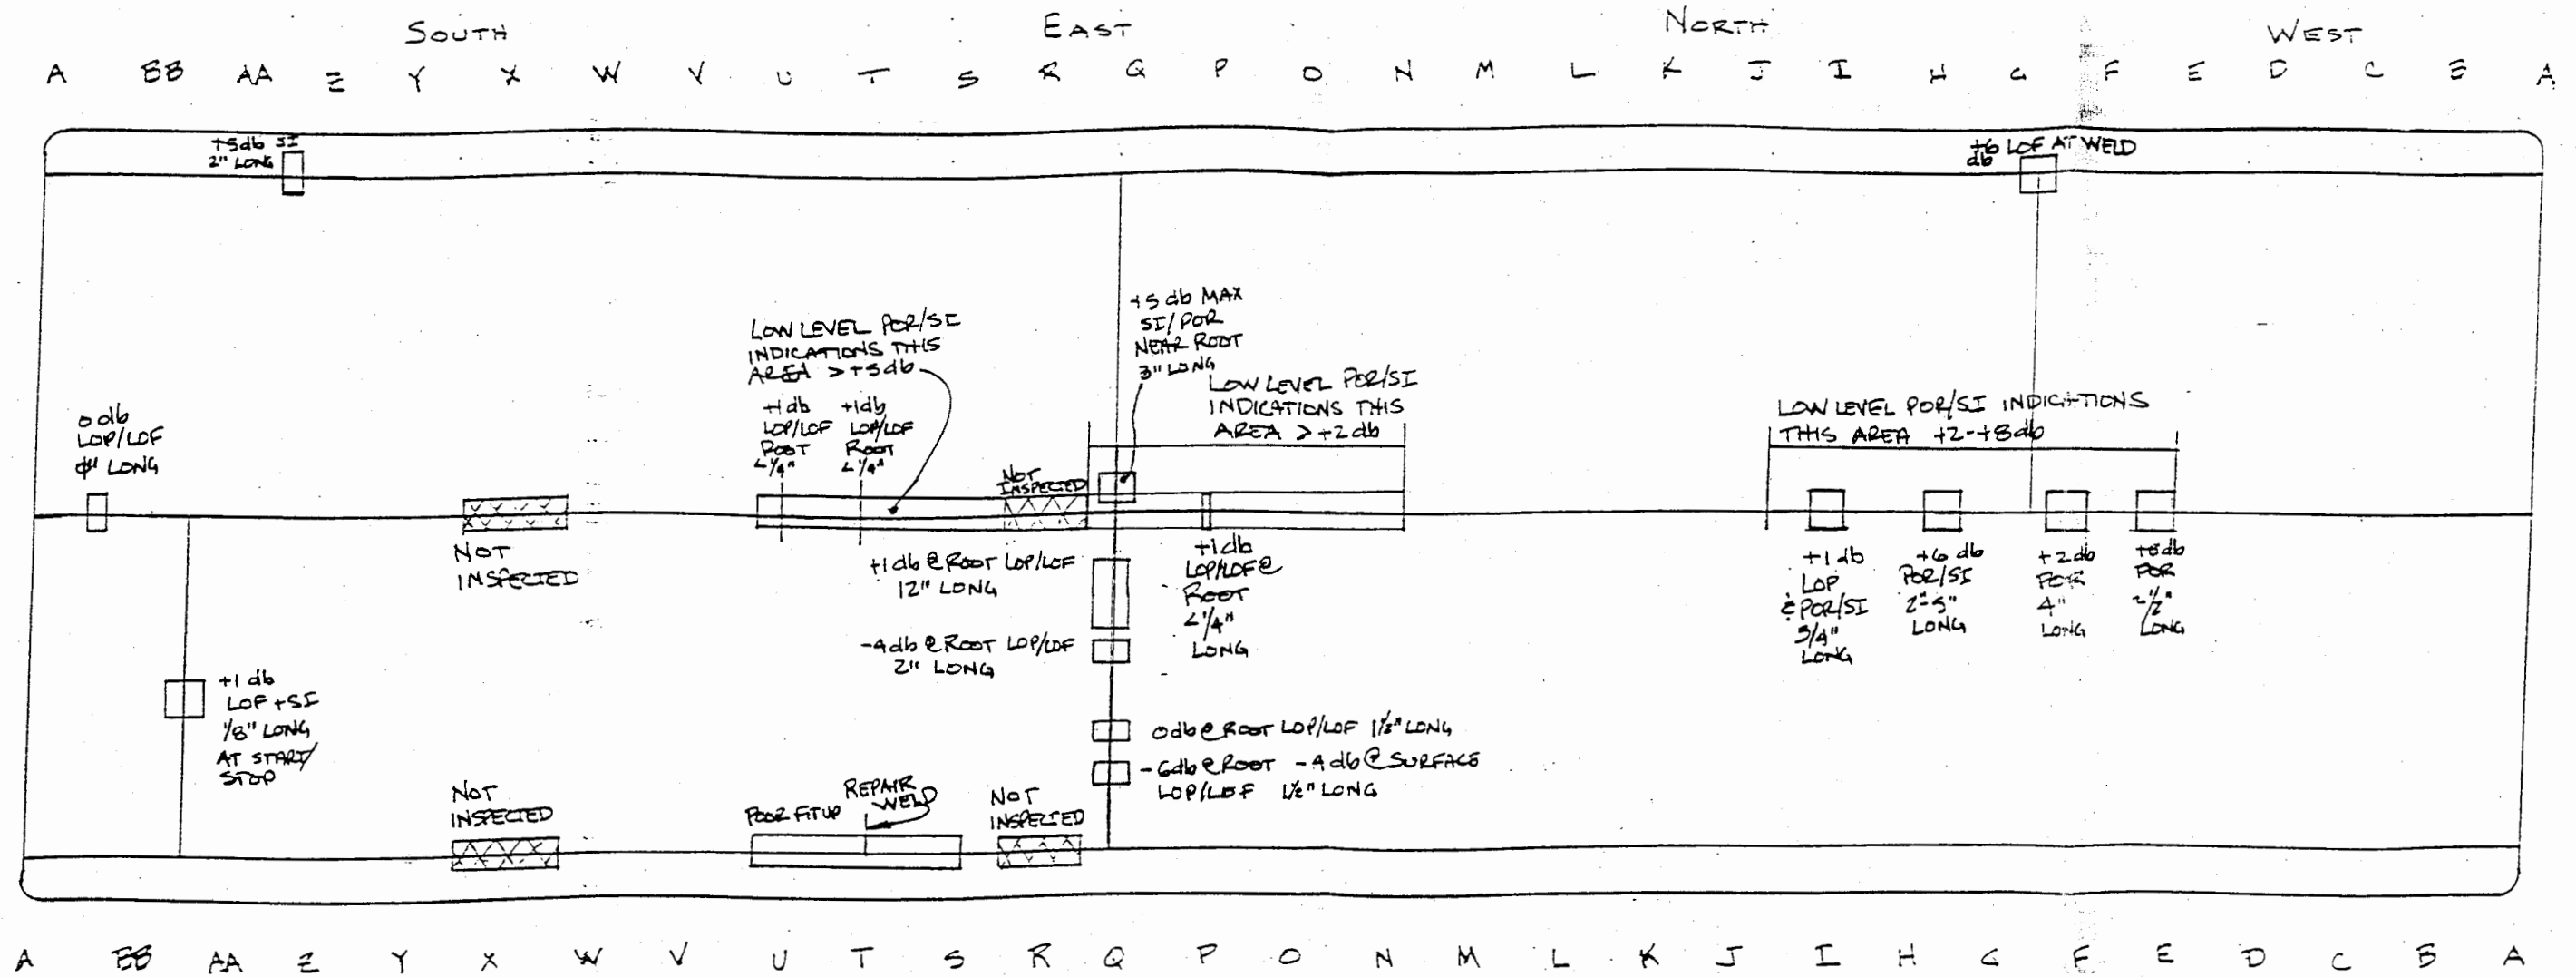
Figure 2 Map of Weld Defect Indications on Tank Shell

The defects which were detected and reported during the previous inspection were carefully checked during this inspection. The results of this inspection show no detectable propagation of prior defects and no detectable additional corrosion. Several additional defects were detected during this inspection. These are very minor in nature, and were likely present at the time of the previous inspection, but not detected at that time because of their small size.

As reported previously, many of the defects detected in the tank would be considered rejectable based on this standard, since they all meet or exceed the +5 db rating. The db ratings are indicated on the defect map presented in Figure 2.

More significantly, though, is the observation that the defects detected during the previous inspection have not propagated or corroded to a detectable degree since the prior inspection. The tank does not appear to be in any worse condition than when inspected in December of 1995.

We maintain our recommendation that the tank be replaced as soon as possible. Continued safe operation of the tank is possible for a finite period of time under certain conditions.

Rocky Mountain EMTEC, Inc. continues its recommendation that the tank be inspected visually every month. We also recommend that the tank be inspected ultrasonically, as it was in December of 1995 and in February of 1997, every 6 to 9 months while in service.

The tank must be removed from service immediately should a leak be detected or corrosive failure thought to be imminent.
