Safety Kleen ABC 4/4/94

# INSPECTION REPORT

Site Name/Address SAFteyKleen 2720 Girard Albuquerque N.M.

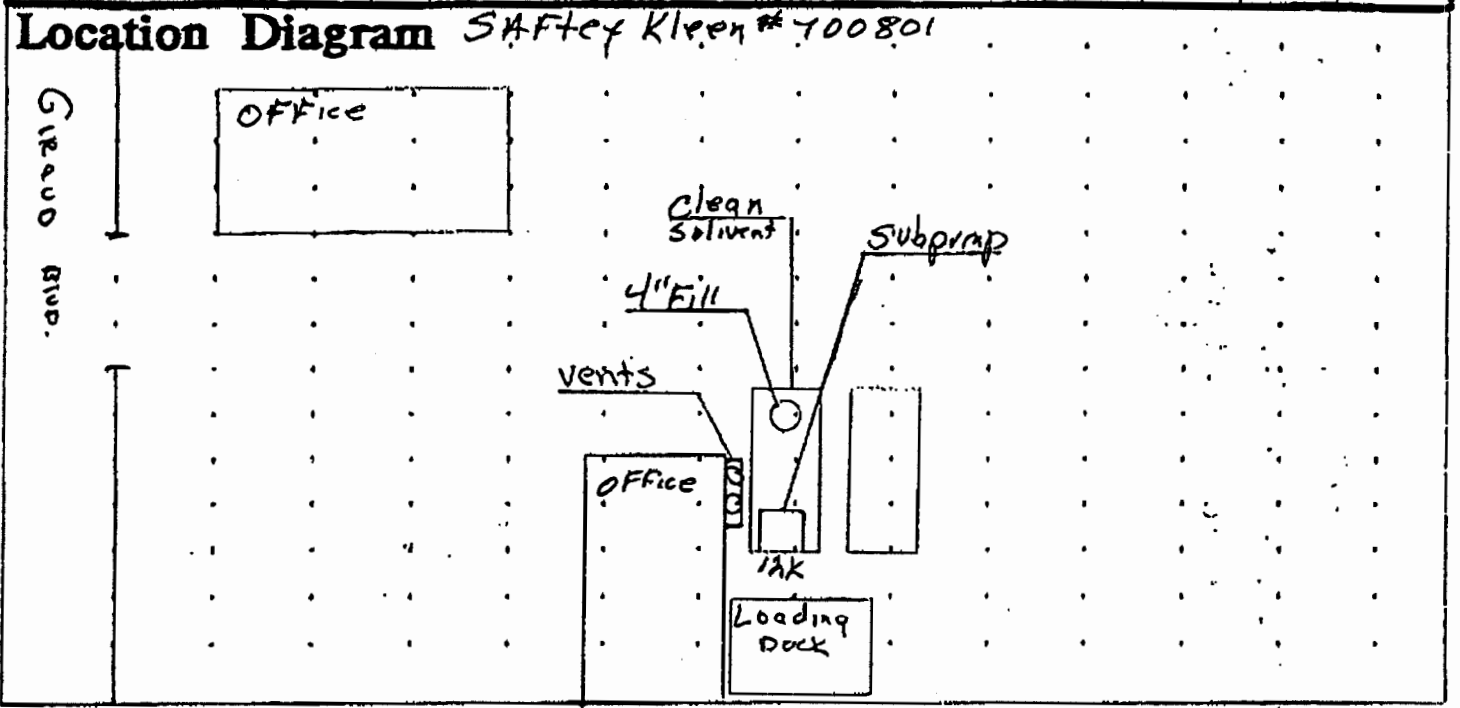
*Line would not hold pressure at all Failed Pvdgie E.*

**General Comments** *Bleeds off in 2 sec. changed Functional Element ✓ Valve and o-rings tested again Bleeding off. pulled pump changed packer o-ring tested 1st 2<sup>nd</sup> time no change checked to see if bleeding by silver bullet was not. Manager of location Ralph said they dipped tank it had 1 prod. height and the turned on the stop for 1 hr. and then redipped After dip. no prod. was showed prod. lost. Fuel Drop prior to lost*

**Parts and Labor used** *1 set of O-rings for Functional Element AND 1 packer o-ring.*
