**SAFETY-KLEEN CORPORATION
NMD980698849
FARMINGTON, NEW MEXICO**

RCRA FACILITY ASSESSMENT REPORT

April 18, 1990

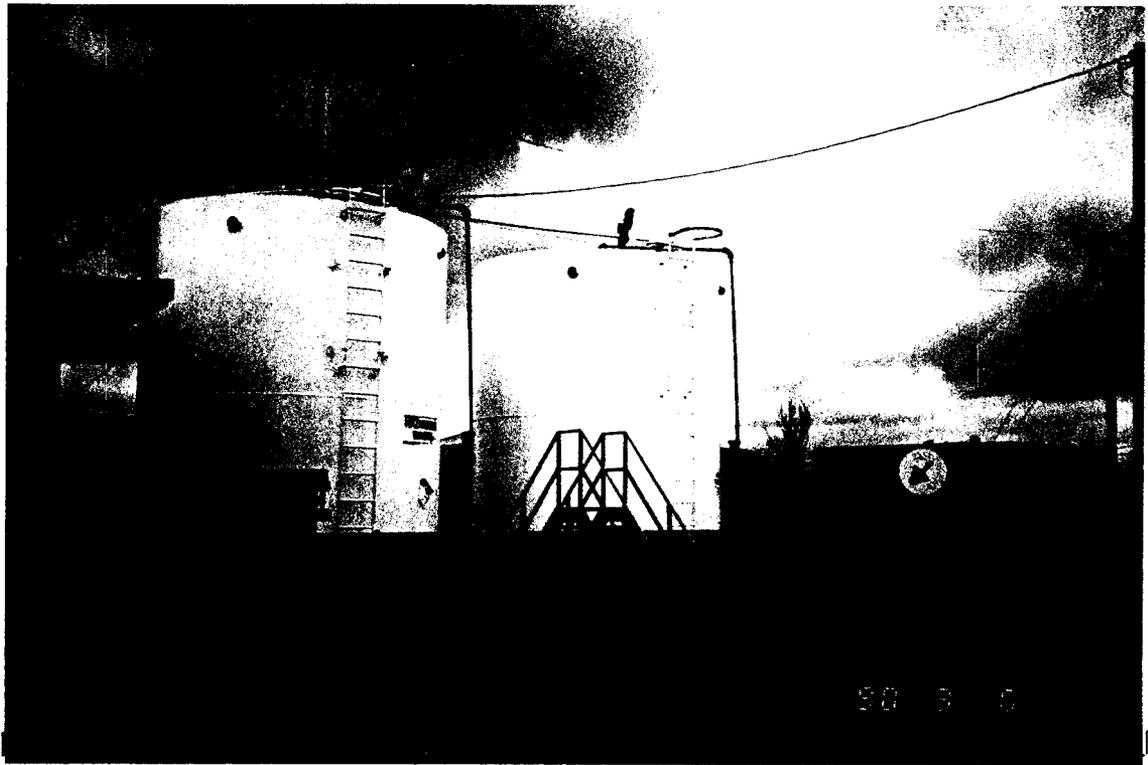
PHOTOGRAPH NO. 1 (SWMU NO. 1)

At SWMU No.1, the Spent Solvent Storage Tank drain valve is located directly above the Tank Farm secondary containment wall (Photo 1). The tank is drained by gravity through this valve into a tanker truck. The proximity of the drain valve to the secondary containment wall would allow leaks or spills to contaminate the underlying soil. A potential for release exists when the tank is emptied. If proper waste handling procedures are followed, the potential for soil contamination during waste transfer is low.

Date: 3-6-90 **Picture Taken By:** Lisa Z. Hooper **Direction Facing:** Northeast
Photo Description: Spent Solvent Storage Tank (SWMU No. 1) and Product Storage Tank (left to right). Note drain valve located at the southeast corner of the containment area (arrow at right hand side of picture).

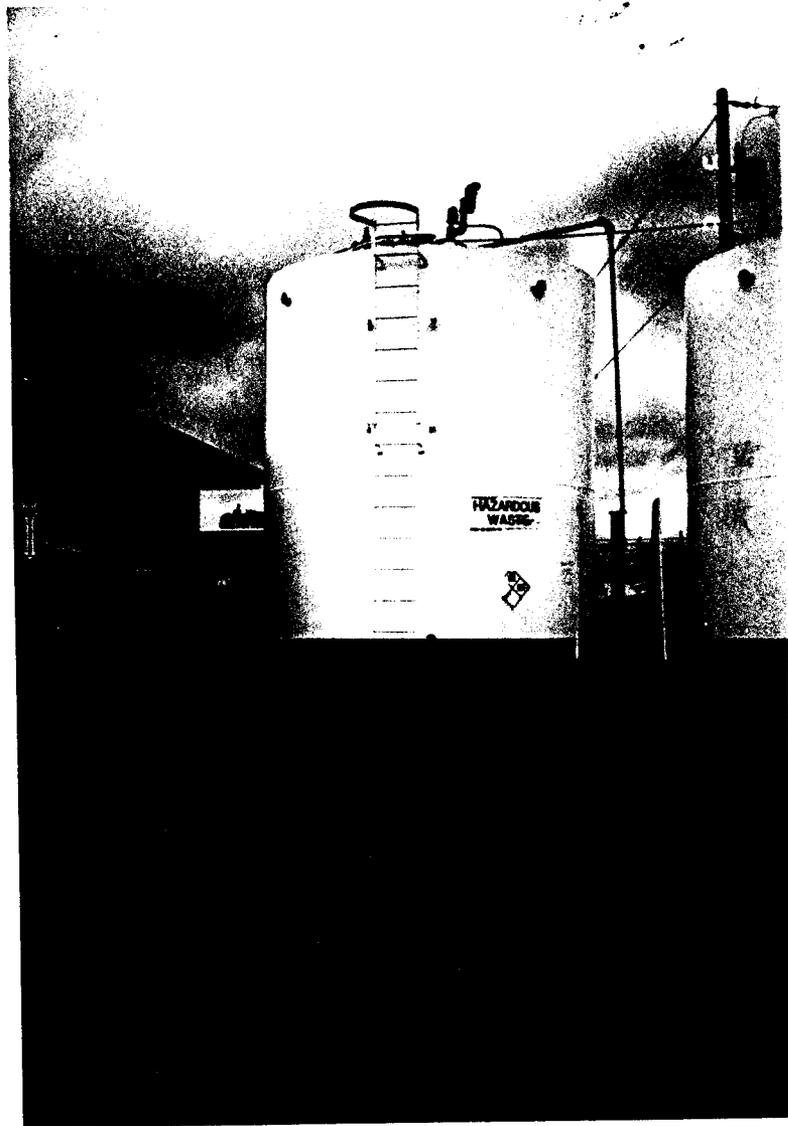
PHOTOGRAPH NO. 2 (SWMU NO. 1)

Date: 3-6-90 **Picture Taken By:** Lisa Z. Hooper **Direction Facing:** North
Photo Description: Spent Solvent Storage Tank

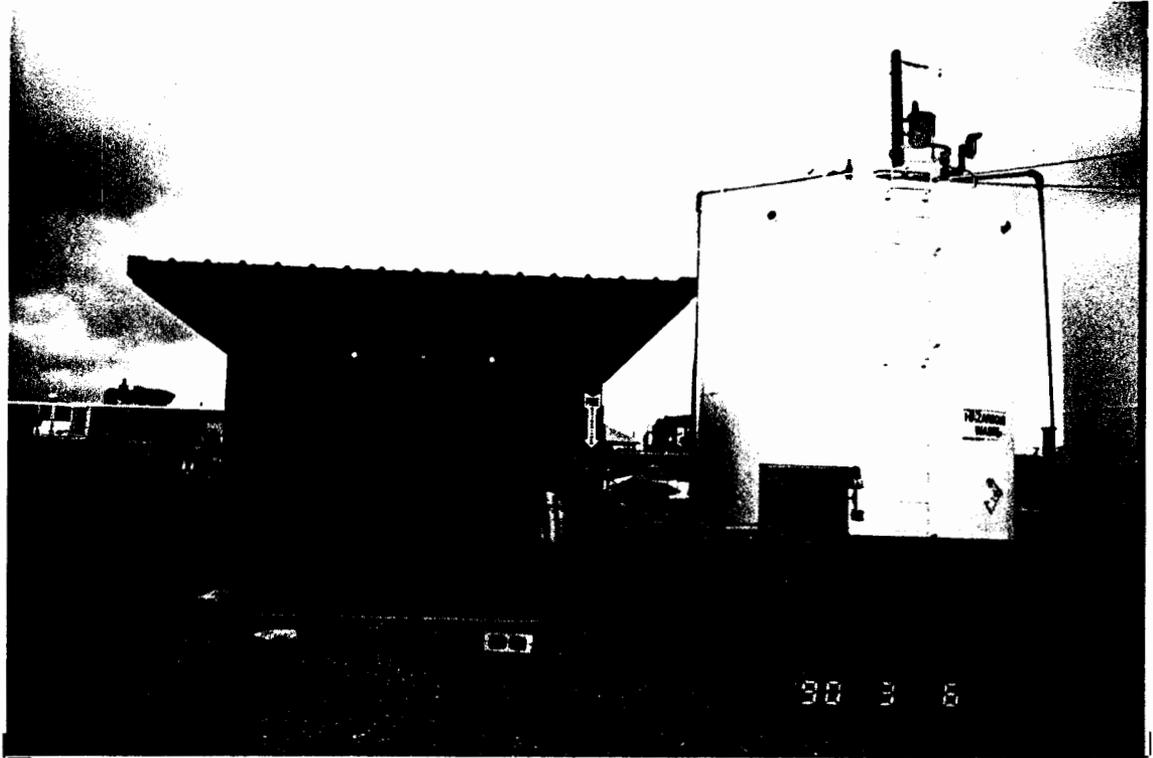
PHOTOGRAPH NO. 3 (SWMUs NOs.1 and 2)

Photo Description: Solvent-Return-and-Fill Station and Spent Solvent Storage Tank

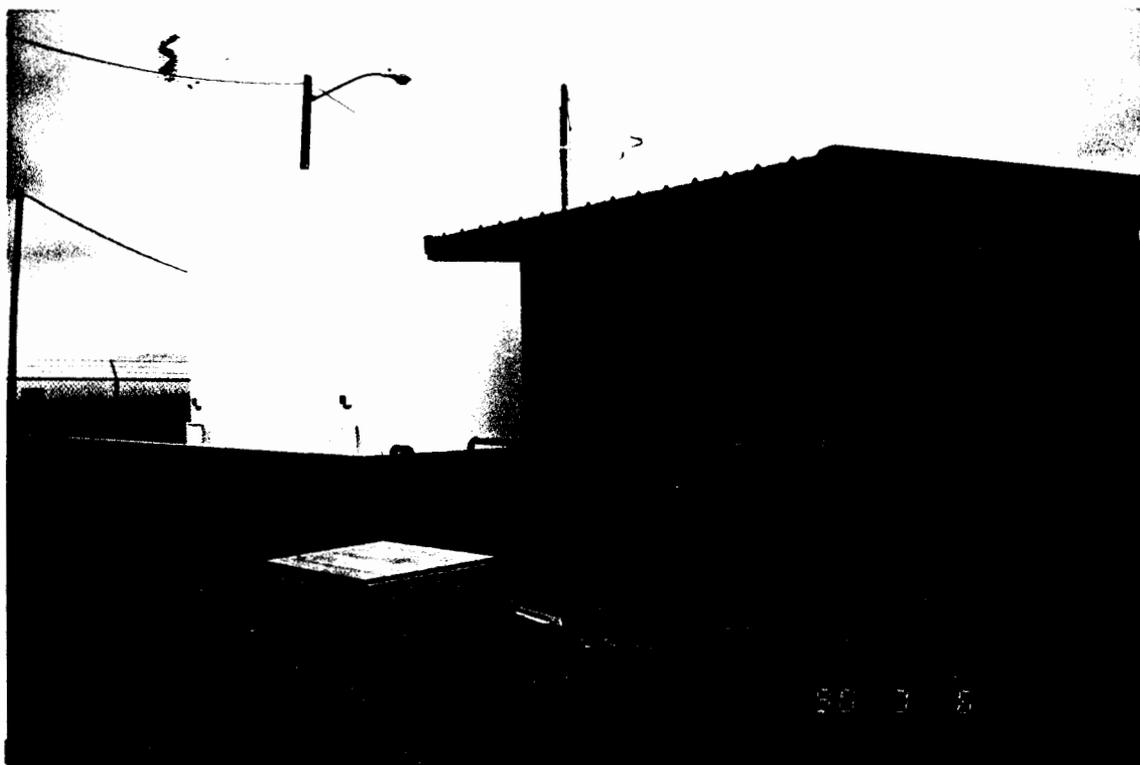
PHOTOGRAPH NO. 4 (SWMUs NOs. 1 and 2)

Date: 3-6-90 **Picture Taken By:** Lisa Z. Hooper **Direction Facing:** Southeast
Photo Description: Rear view of Solvent-Return-and-Fill Station and Tank Farm

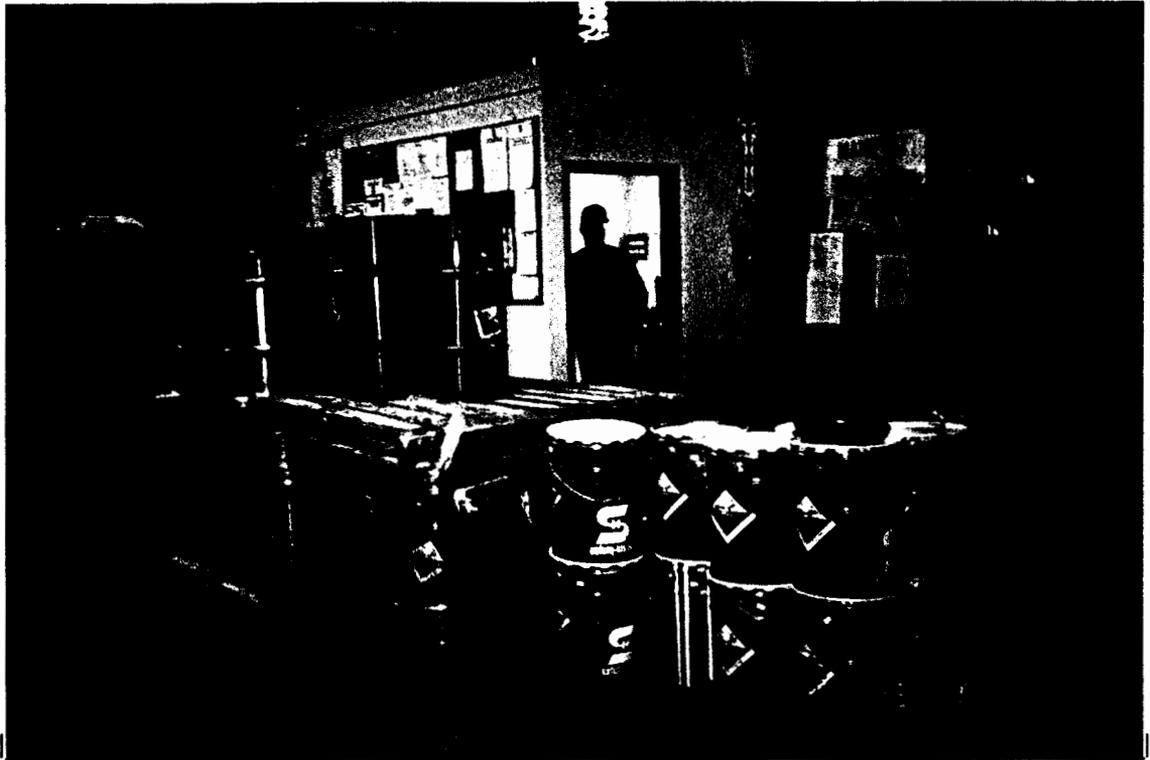
PHOTOGRAPH NO. 10 (SWMU NO. 3)

Date: 3-6-90 **Picture Taken By:** Lisa Z. Hooper **Direction Facing:** Southeast
Photo Description: South interior wall of Container Storage Area, adjacent office and product storage area (brown boxes behind wire); containers on pallets hold product

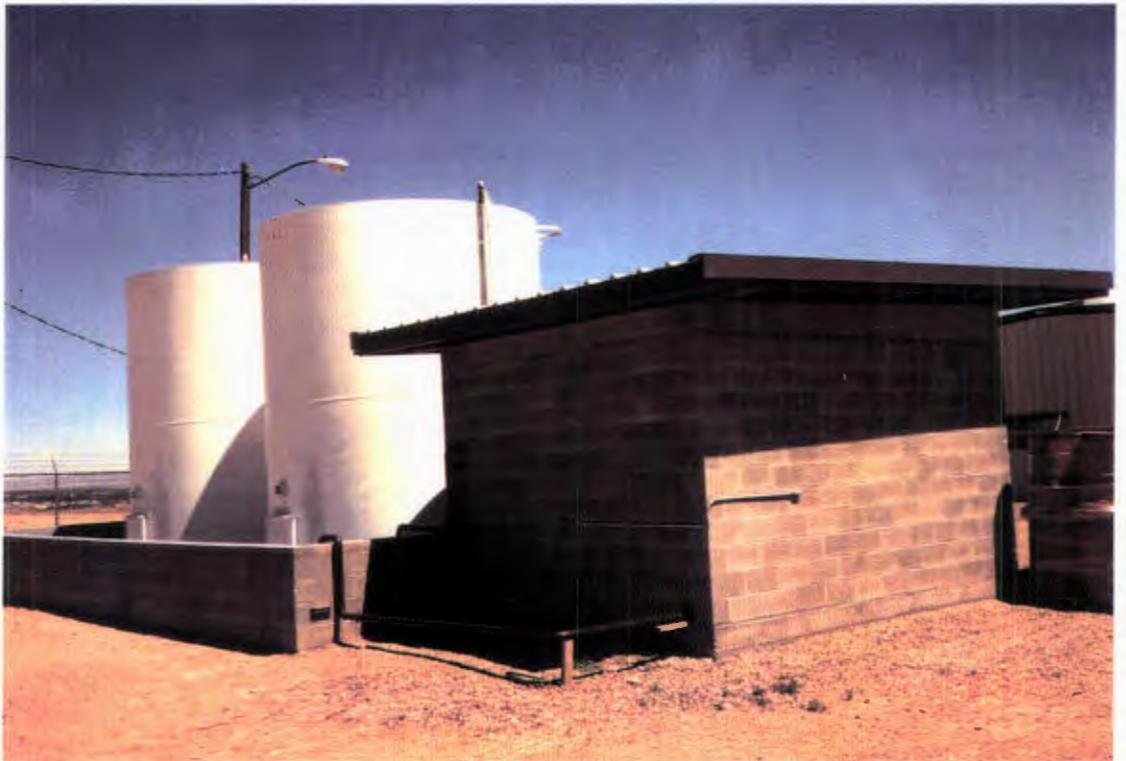
ALL PIPE JOINTS OUTSIDE CONTAINMENT ARE WELDED

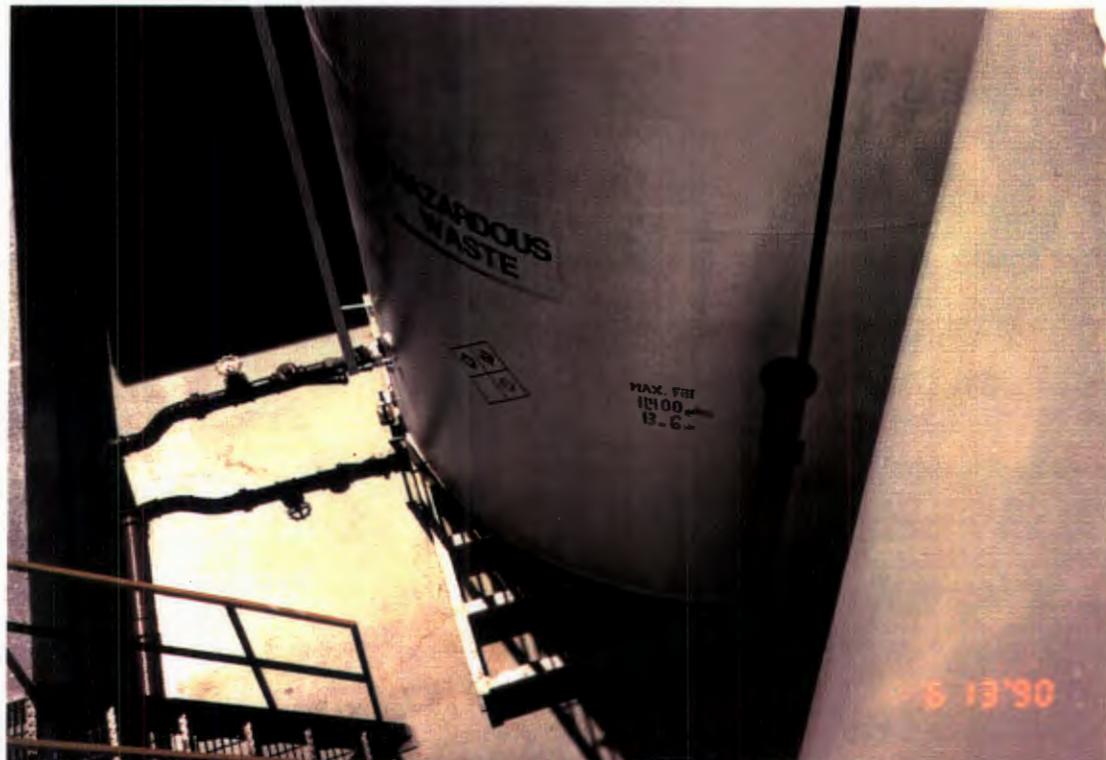
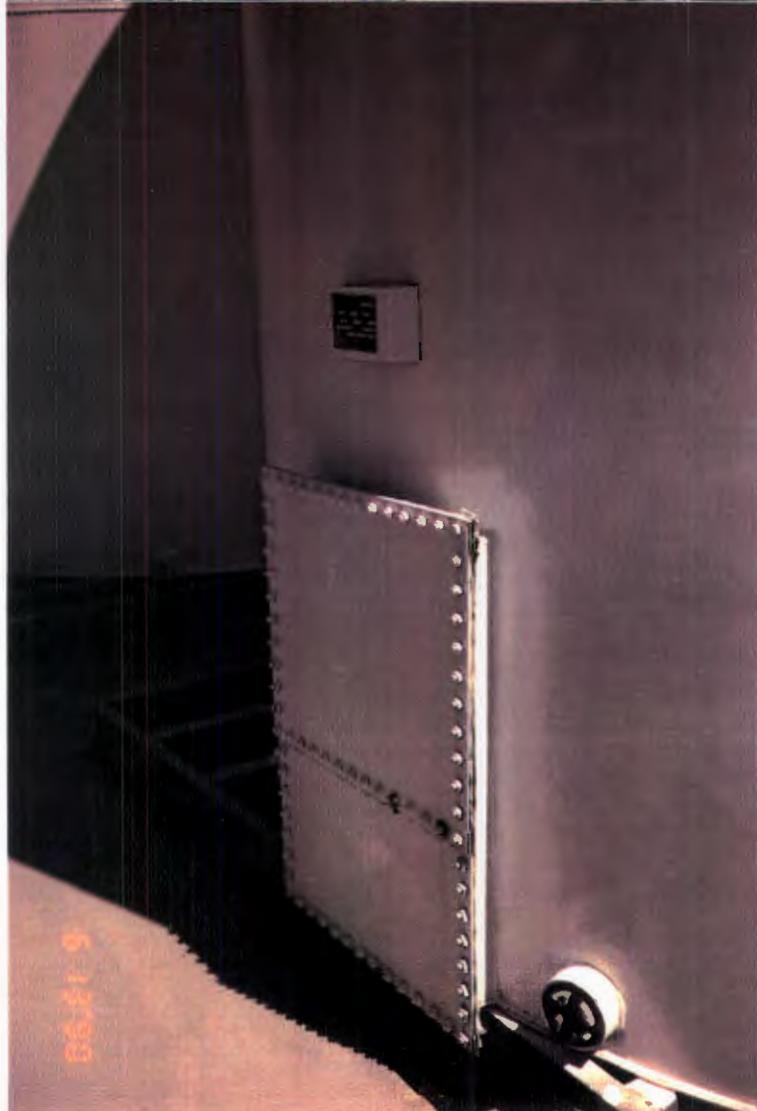
TYPICAL CONDITION OF TANK SHELL. NAME PLATE CARRIES API LOGO AND VERIFIES 12F CONSTRUCTION. CRACK IN FLOOR IS TIGHT AND SEALED WITH COATING
