**SAFETY-KLEEN CORPORATION
NMD980698849
FARMINGTON, NEW MEXICO**

RCRA FACILITY ASSESSMENT REPORT

April 18, 1990

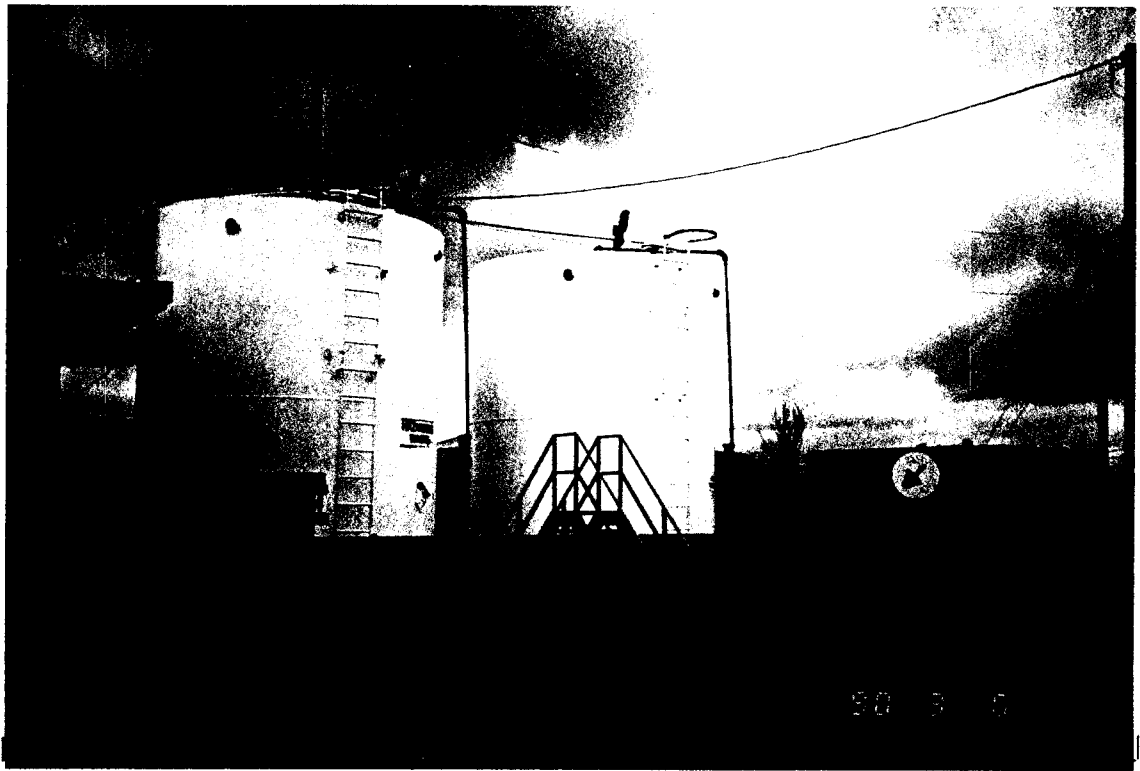
PHOTOGRAPH NO. 1 (SWMU NO. 1)

At SWMU No.1, the Spent Solvent Storage Tank drain valve is located directly above the Tank Farm secondary containment wall (Photo 1). The tank is drained by gravity through this valve into a tanker truck. The proximity of the drain valve to the secondary containment wall would allow leaks or spills to contaminate the underlying soil. A potential for release exists when the tank is emptied. If proper waste handling procedures are followed, the potential for soil contamination during waste transfer is low.

Date: 3-6-90 **Picture Taken By:** Lisa Z. Hooper **Direction Facing:** Northeast
Photo Description: Spent Solvent Storage Tank (SWMU No. 1) and Product Storage Tank (left to right). Note drain valve located at the southeast corner of the containment area (arrow at right hand side of picture).

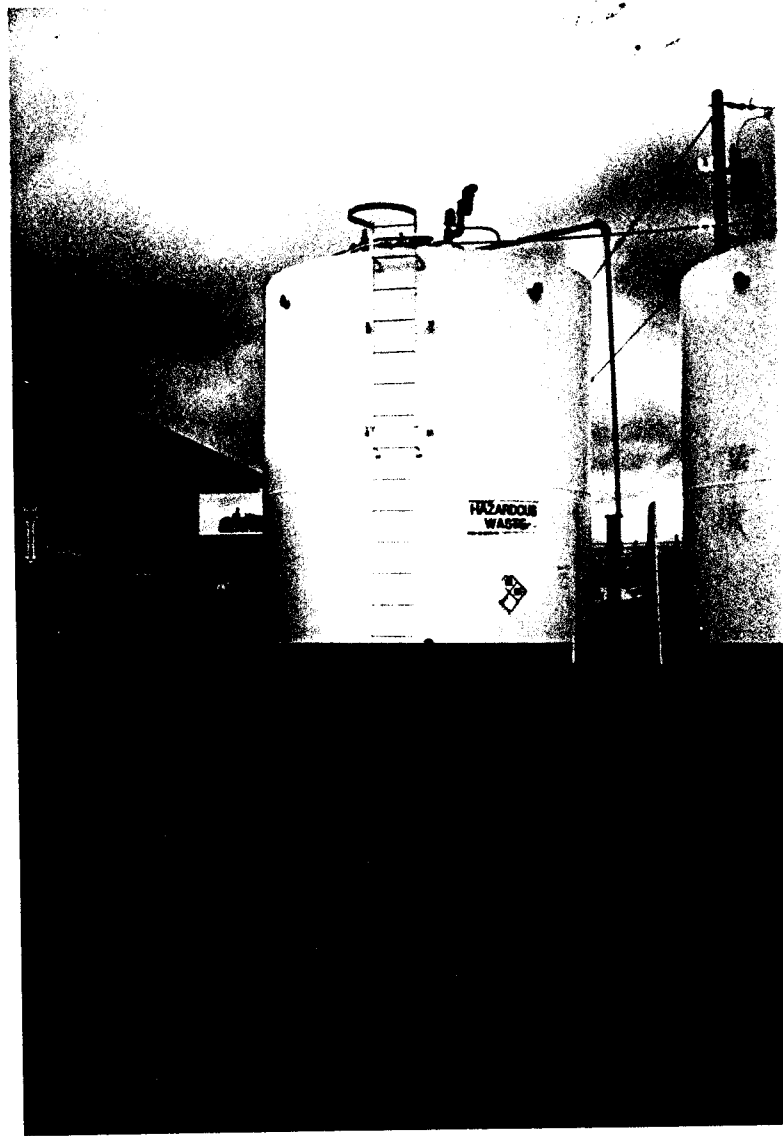
PHOTOGRAPH NO. 2 (SWMU NO. 1)

Date: 3-6-90 **Picture Taken By:** Lisa Z. Hooper **Direction Facing:** North
Photo Description: Spent Solvent Storage Tank

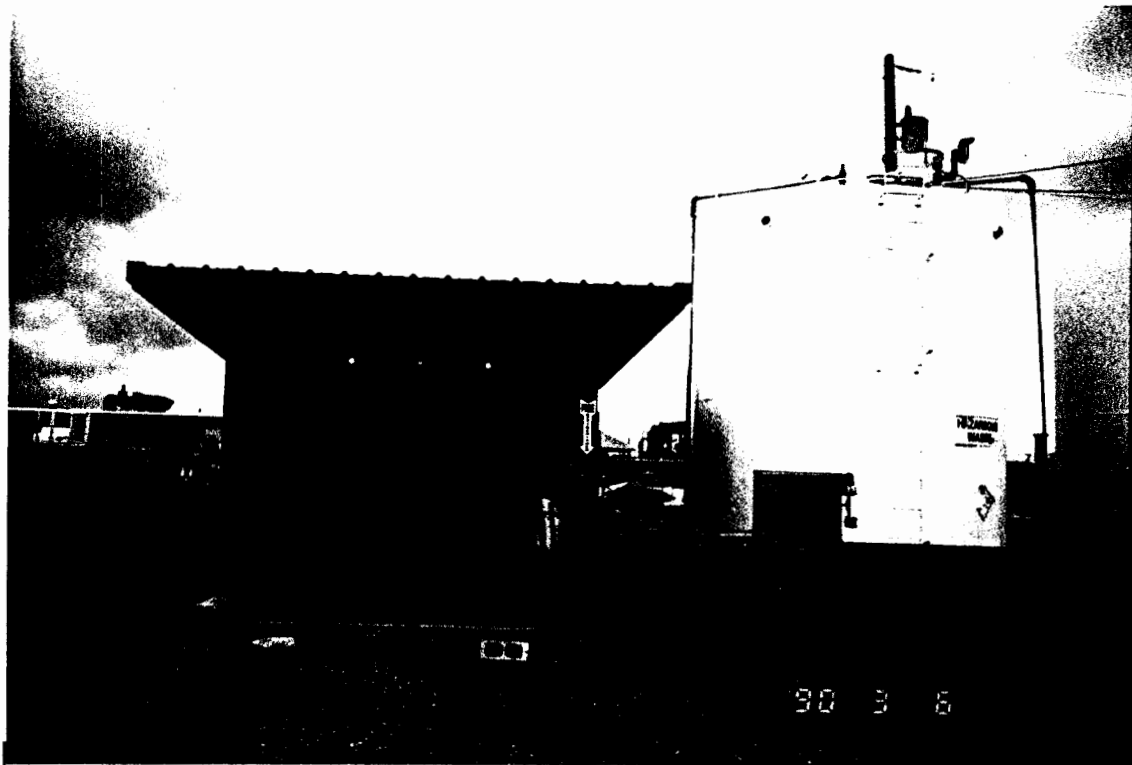
PHOTOGRAPH NO. 3 (SWMUs NOs.1 and 2)

Photo Description: Solvent-Return-and-Fill Station and Spent Solvent Storage Tank

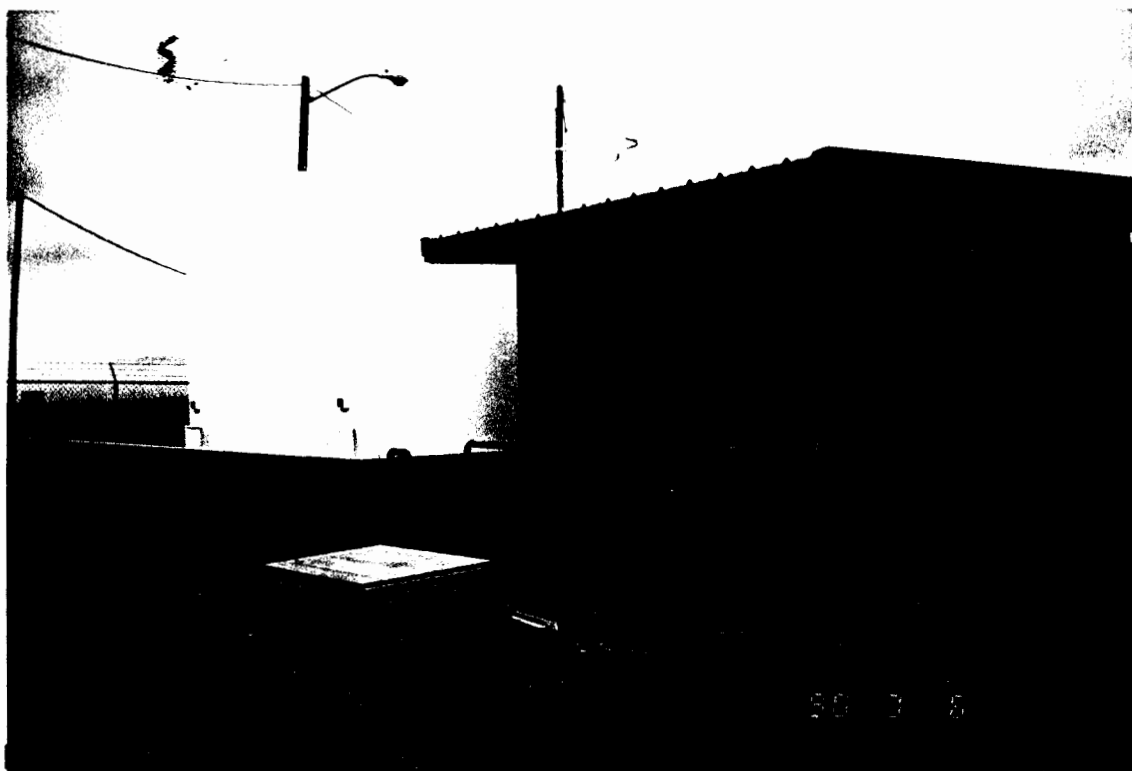
PHOTOGRAPH NO. 4 (SWMUs NOs. 1 and 2)

Date: 3-6-90 **Picture Taken By:** Lisa Z. Hooper **Direction Facing:** Southeast
Photo Description: Rear view of Solvent-Return-and-Fill Station and Tank Farm

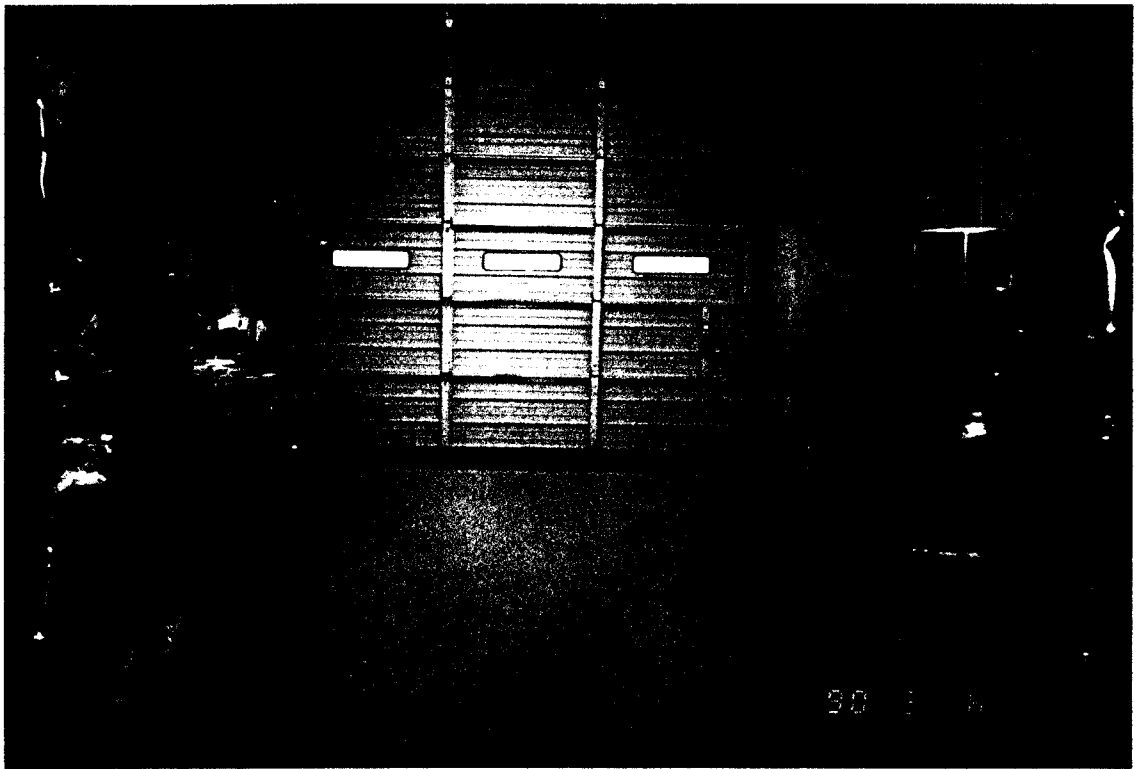
PHOTOGRAPH NO. 7 (SWMU NO. 3)

Date: 3-6-90 **Picture Taken By:** Lisa Z. Hooper **Direction Facing:** West
Photo Description: Interior of Container Storage Area

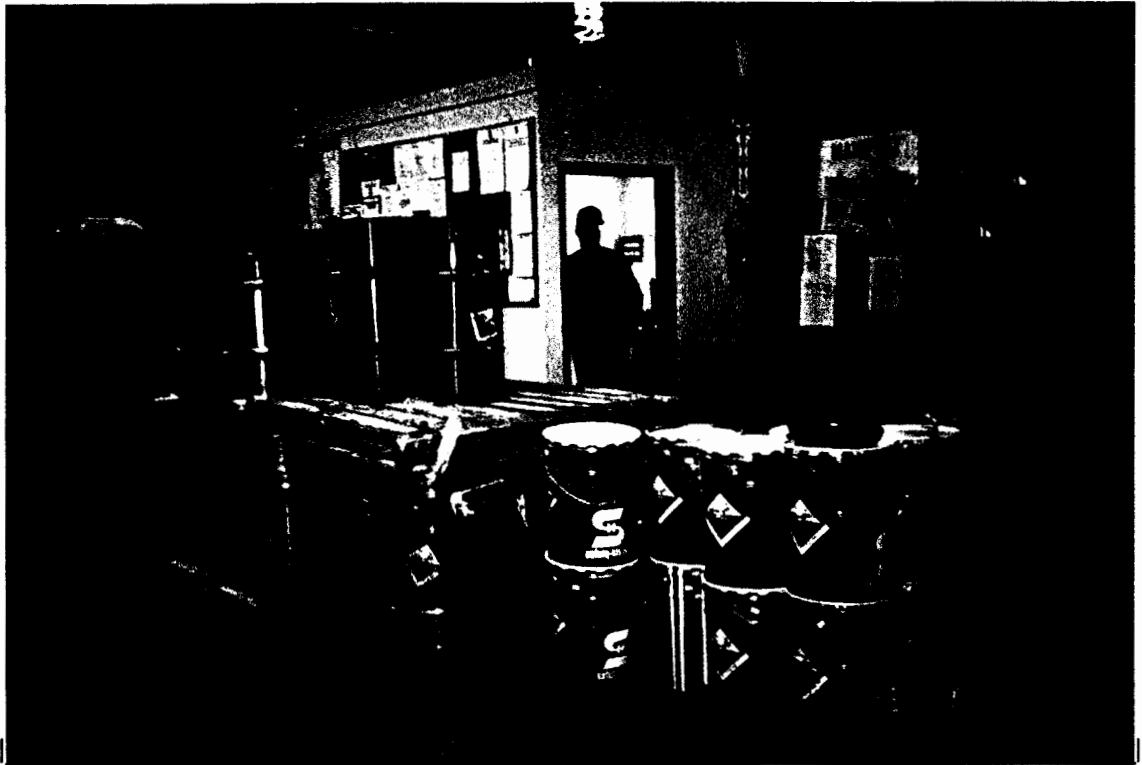
PHOTOGRAPH NO. 10 (SWMU NO. 3)

Date: 3-6-90 **Picture Taken By: Lisa Z. Hooper** **Direction Facing: Southeast**
Photo Description: South interior wall of Container Storage Area, adjacent office and product storage area (brown boxes behind wire); containers on pallets hold product

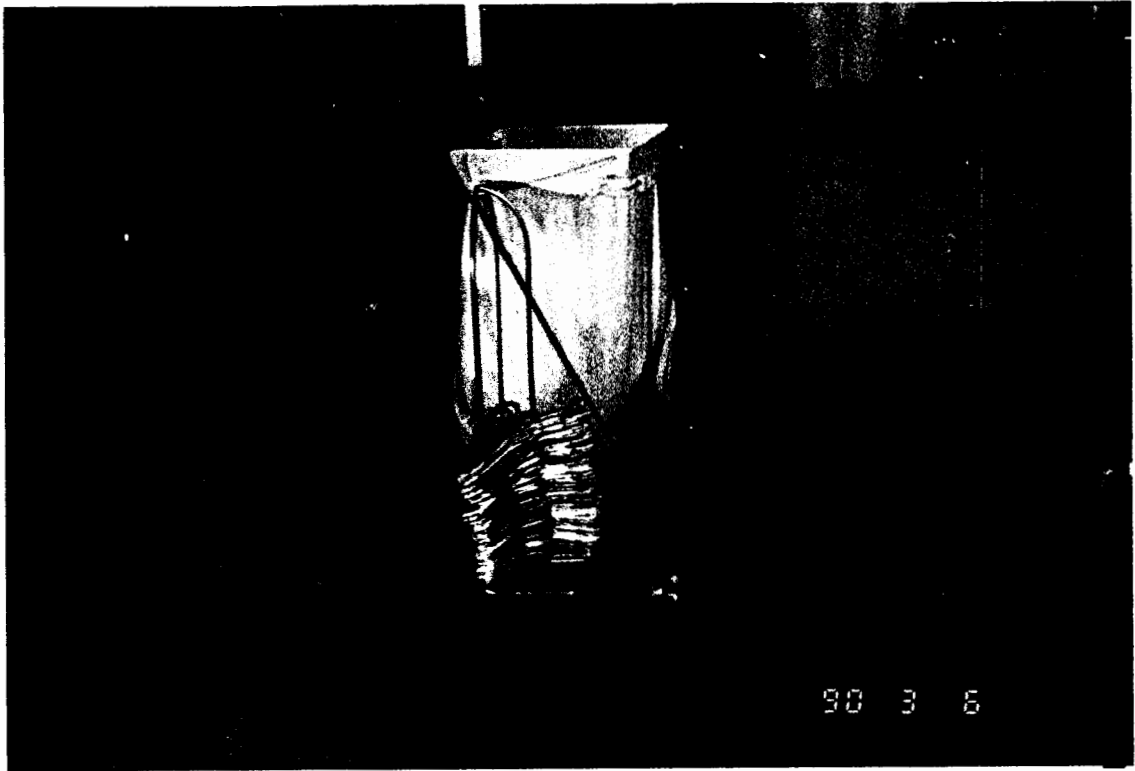
PHOTOGRAPH NO. 13 (SWMU NO. 3)

Date: 3-6-90 **Picture Taken By:** Lisa Z. Hooper **Direction Facing:** East
Photo Description: South wall of cement dike in the Container Storage Area. Note hole through cement slab floor in front of stacked white hangers.
