National Nuclear Security Administration

Appendix A of the MWL CMI Report is the MWL Alternative Cover Construction Quality Assurance (CQA) Report, which is a two volume report prepared by the independent third-party CQA Contractor. The MWL Alternative Cover CQA Report is certified by a New Mexico registered Professional Engineer and provides all construction quality control and CQA data and documentation. Volume 1 contains tables, figures, as-built drawings, etc. Volume 2 of this report provides supporting documentation in the form of attachments and is provided electronically on a compact disc at the end of the report. A separately bound hard copy of Volume 2 is provided for the NMED Hazardous Waste Bureau document library as previously discussed with Mr. William Moats of your staff. Additional hardcopies of the MWL Alternative Cover CQA Report Volume 2 will be maintained at the DOE/Sandia Document Repository (Public Reading Room, Zimmerman Library at the University of New Mexico) and the SNL/NM Customer Funded Records Center, formerly known as the SNL/NM Environment, Safety & Health and Security Records Center.

Document title: **Mixed Waste Landfill Corrective Measures Impleme

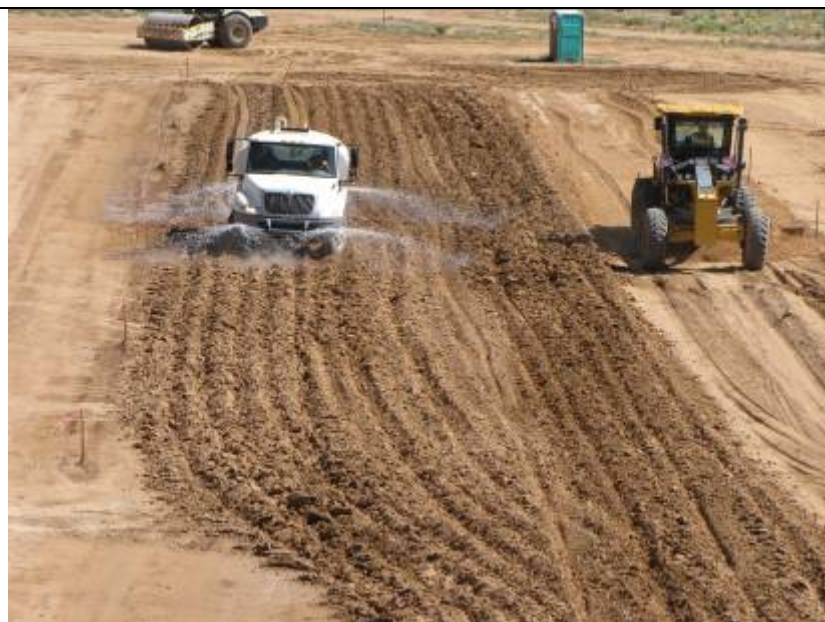
Date: 07/07/09 Time: 1604
Photo Taken by: J. Schermerhorn
Description: Adding water to increase the moisture to Lift 5 soil (grid blocks 1 and 2) after area ripped with grader scarifier shanks to a depth of ~6 inches after initial field compaction tests failed for moisture content
Facing: South

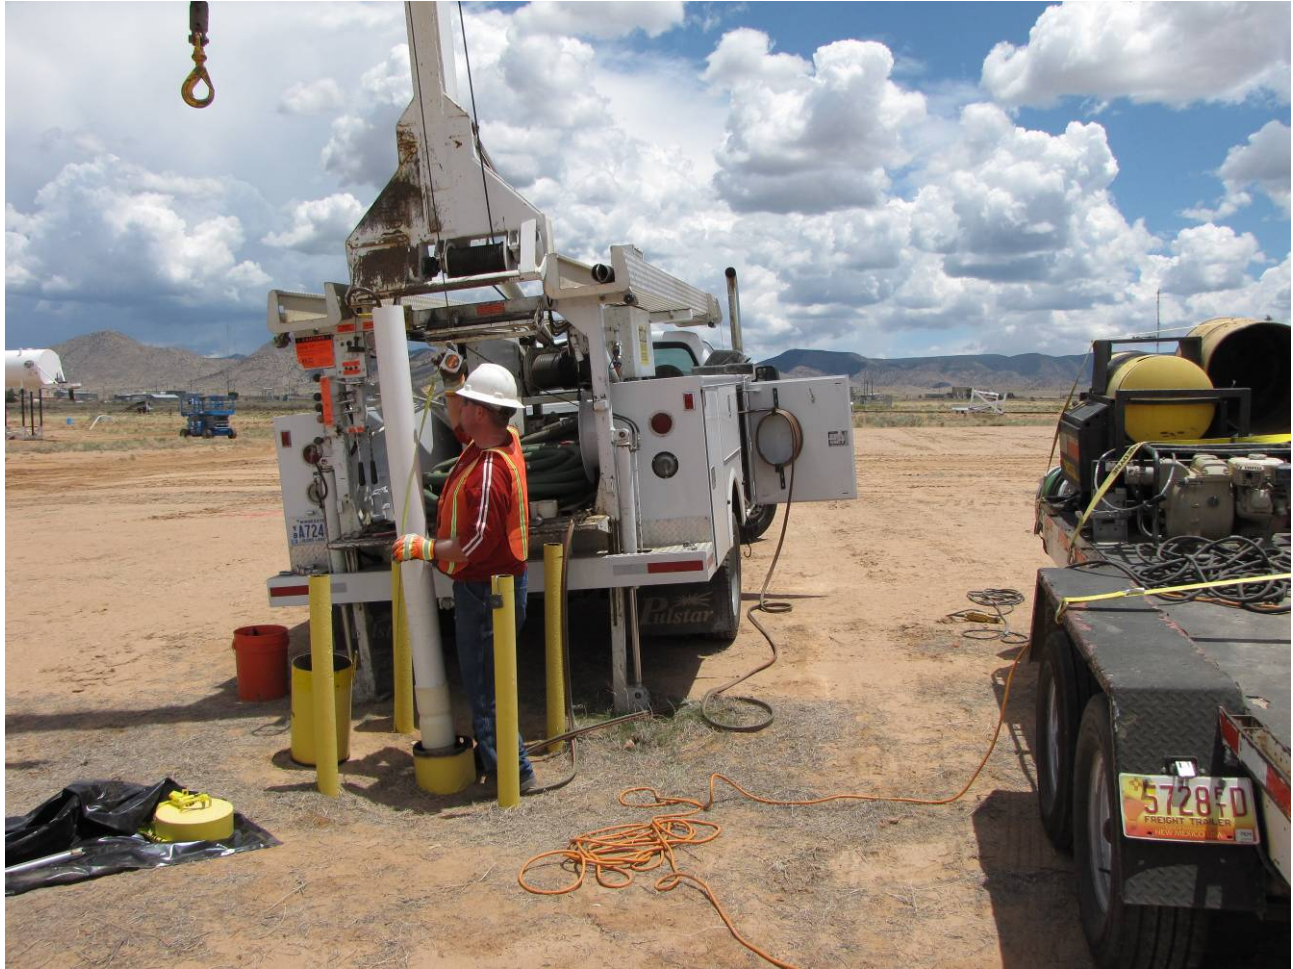
Figure 2-3
Extending the MWL-MW4 PVC well casing, attached to the existing PVC casing with a PVC slip coupling and stainless steel screws, May 27, 2009.
View to the east.
