SUBJECT: Responses to the New Mexico Environment Department *Notice of Disapproval: Mixed Waste Landfill Corrective Measures Implementation Report, January 2010 Sandia National Laboratories, EPA ID NM5890110518, HWB-SNL-10-005*

In this MWL Corrective Measures Implementation (CMI) Report, the DOE and Sandia demonstrate that the deployment of the MWL alternative Evapotranspirative (ET) Cover (hereafter referred to as the ET Cover) was performed in accordance with the requirements, specifications, and design drawings presented in the MWL Corrective Measure Implementation Plan (CMIP) (SNL/NM November 2005). The MWL CMIP was conditionally approved by the New Mexico Environment Department (NMED) in December 2008 (Bearzi December 2008), and all NMED conditions related to construction of the MWL ET Cover were addressed and incorporated into the CMIP through replacement pages (Davis February 2009).

Figure 1-4  
Schematic Diagram of the Mixed Waste Landfill Alternative Evapotranspirative Cover

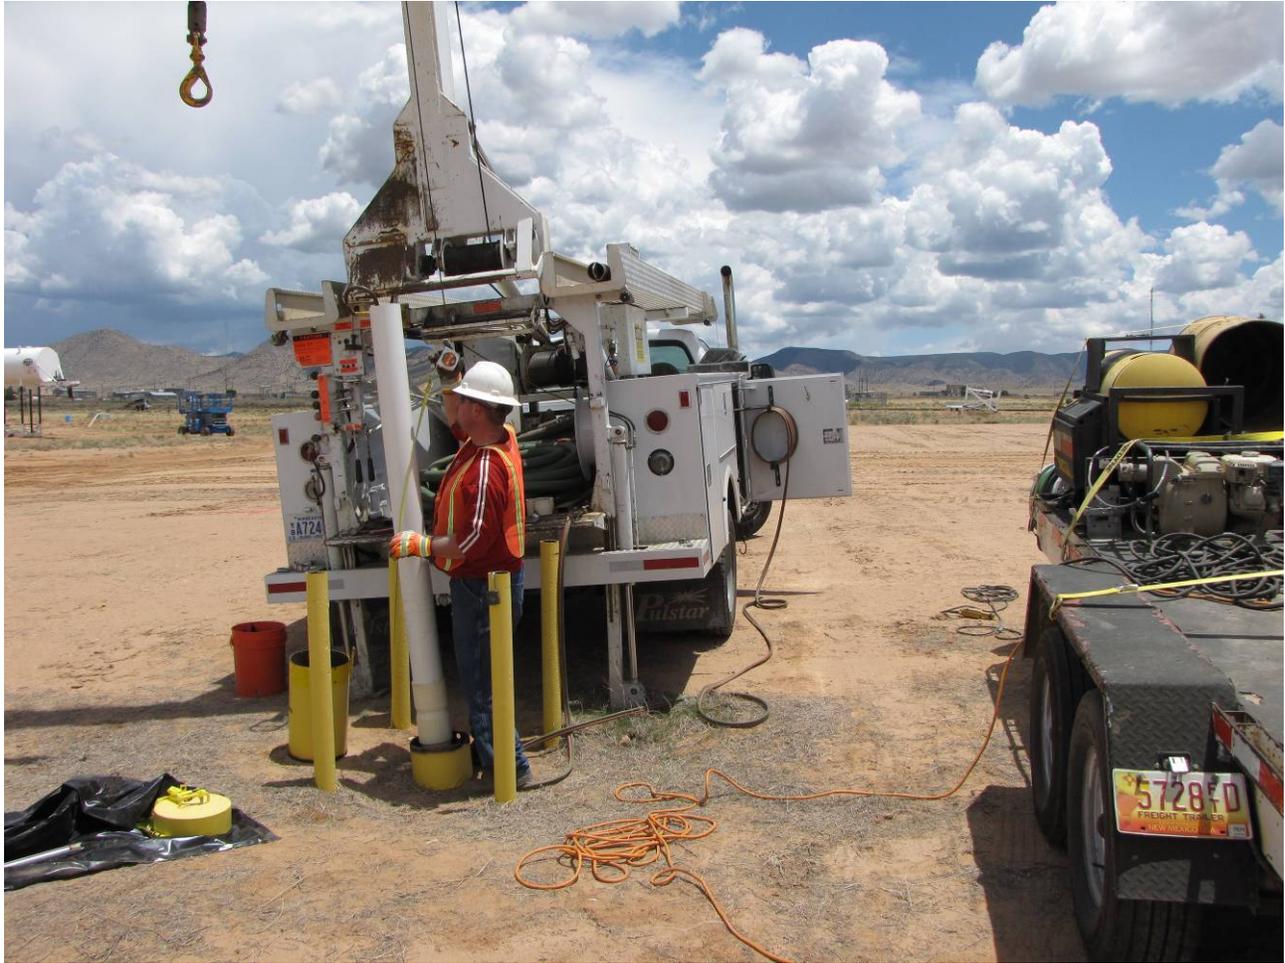
Figure 2-3  
Extending the MWL-MW4 PVC well casing, attached to the existing PVC casing with a PVC slip coupling and stainless steel screws, May 27, 2009.  
View to the east.
