Subject: Department of Energy/National Nuclear Security Administration, Sandia National Laboratories Environmental Restoration Operations, Reclamation of the Mixed Waste Landfill Borrow Pit

Document title: Department of Energy/National Nuclear Security Administration, Sandia National Laboratories Environmental Restoration Operations, Reclamation of the Mixed Waste Landfill Borrow Pit, November 2013

**Summary of Mixed Waste Landfill Borrow Pit Reclamation
May – August 2013**

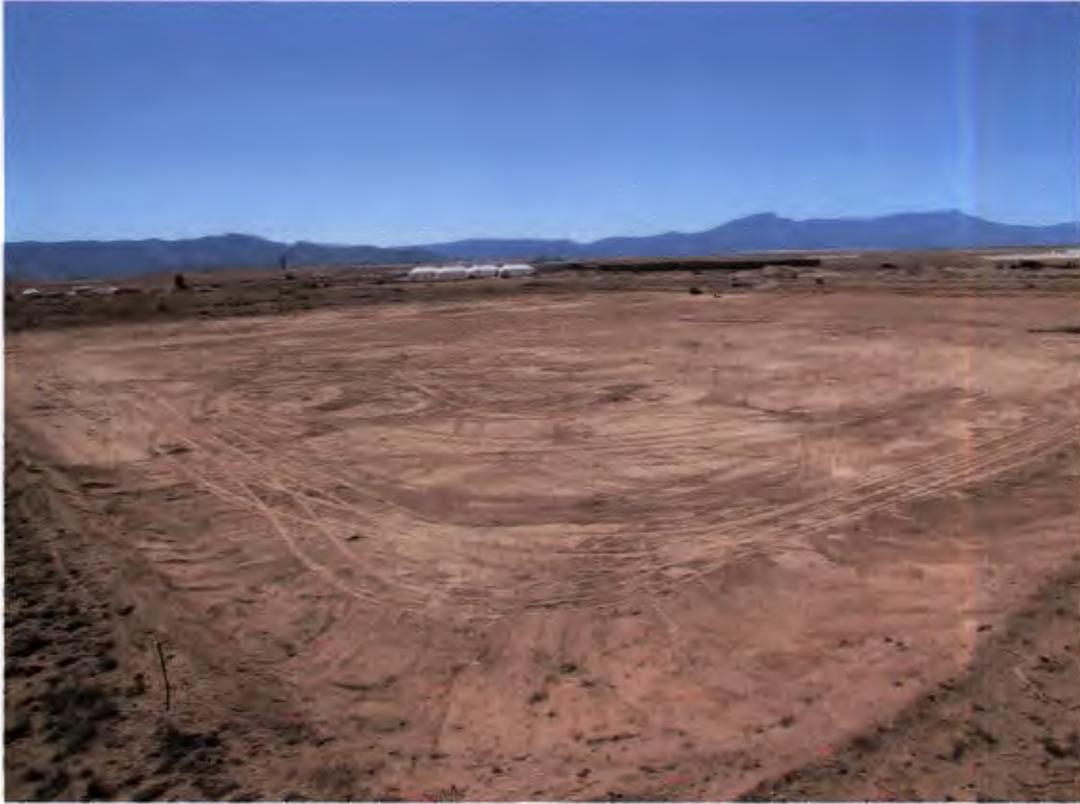
Borrow Pit in May 2013 at the start of the reclamation effort. View from northwest corner to southeast.

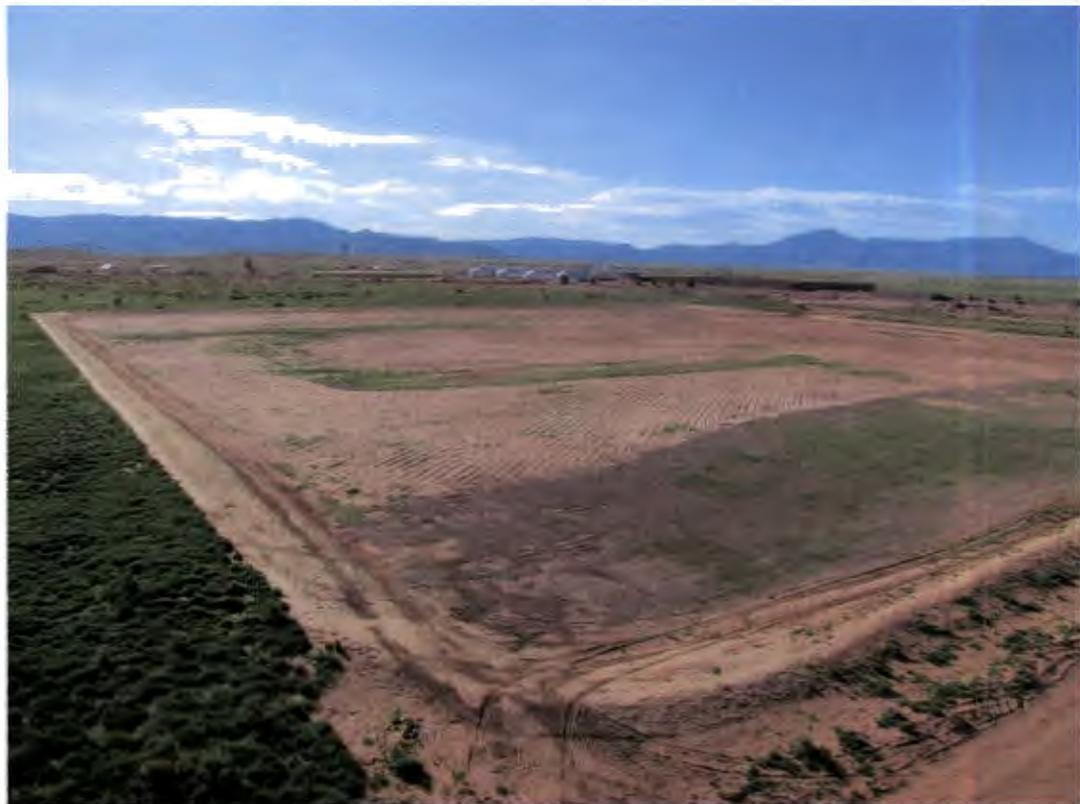
Borrow Pit in August after completion of the reclamation effort. View from northwest corner to southeast.
