Subject: Sandia National Laboratories Building 827, Fifteen Day Spill Report

**RELEASE/DISCHARGE NOTIFICATION
Fifteen-Day Report
U. S. Department of Energy
National Nuclear Security Administration
Sandia Field Office
Sandia National Laboratories**

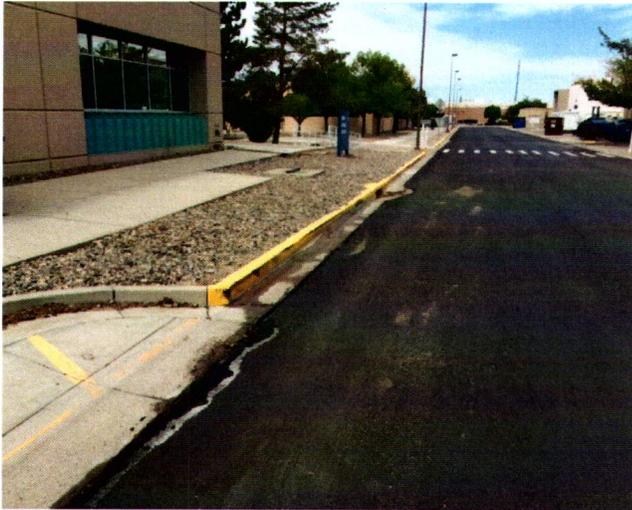
It is estimated that approximately 300 gallons of cooling tower water overflowed into Building 827. Of that cooling water, it was estimated that less than 10 gallons flowed out of the bay doors and into the storm drain system (Photo 1). The second and subsequent discharge of cooling tower water to the storm drain was due to a miscommunication by the EOC directing Custodial Services to pump water to the storm drain. Custodial Services personnel collected, logged, and pumped approximately 60 gallons of cooling tower water to the storm drain before stopping the pumping and cleanup operations. Remaining volume of water was directed to the sanitary sewer system, an authorized discharge with the Albuquerque Bernalillo County Water Utility Authority. The cooling water contained a scale inhibitor, at a concentration of approximately 114 ppb and bromine (used to control algae growth) at a concentration of 1.15 ppm with a pH of 7 (as tested on site by the EOC at the time of the event).

Photo 1 – Initial discharge to storm drain

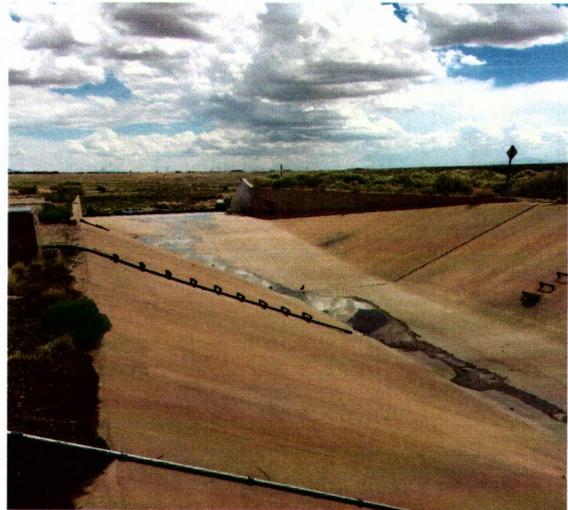
A grab sample was obtained downstream from the discharge location (see Photo 2 for approximate location) and was sent to the laboratory for analysis. In addition to the sample, a handheld pH meter was used providing a reading of 9.2. It is also noteworthy that earlier that day Sandia performed fire protection maintenance and testing throughout the site, and in the morning was also discharging water from the Hazardous Waste Handling Unit retention pond. These authorized discharges resulted in significant flow to the storm channel observed in Photo 2.

Photo 2 – Concrete line storm channel with water
