SPARTON TECHNOLOGY

July 16, 1992

This letter is written to inform you that Sparton Technology's Inc. Pond Closure Cap has two cracks in the wear surface. We propose to repair these cracks and seek your comments on this procedure.

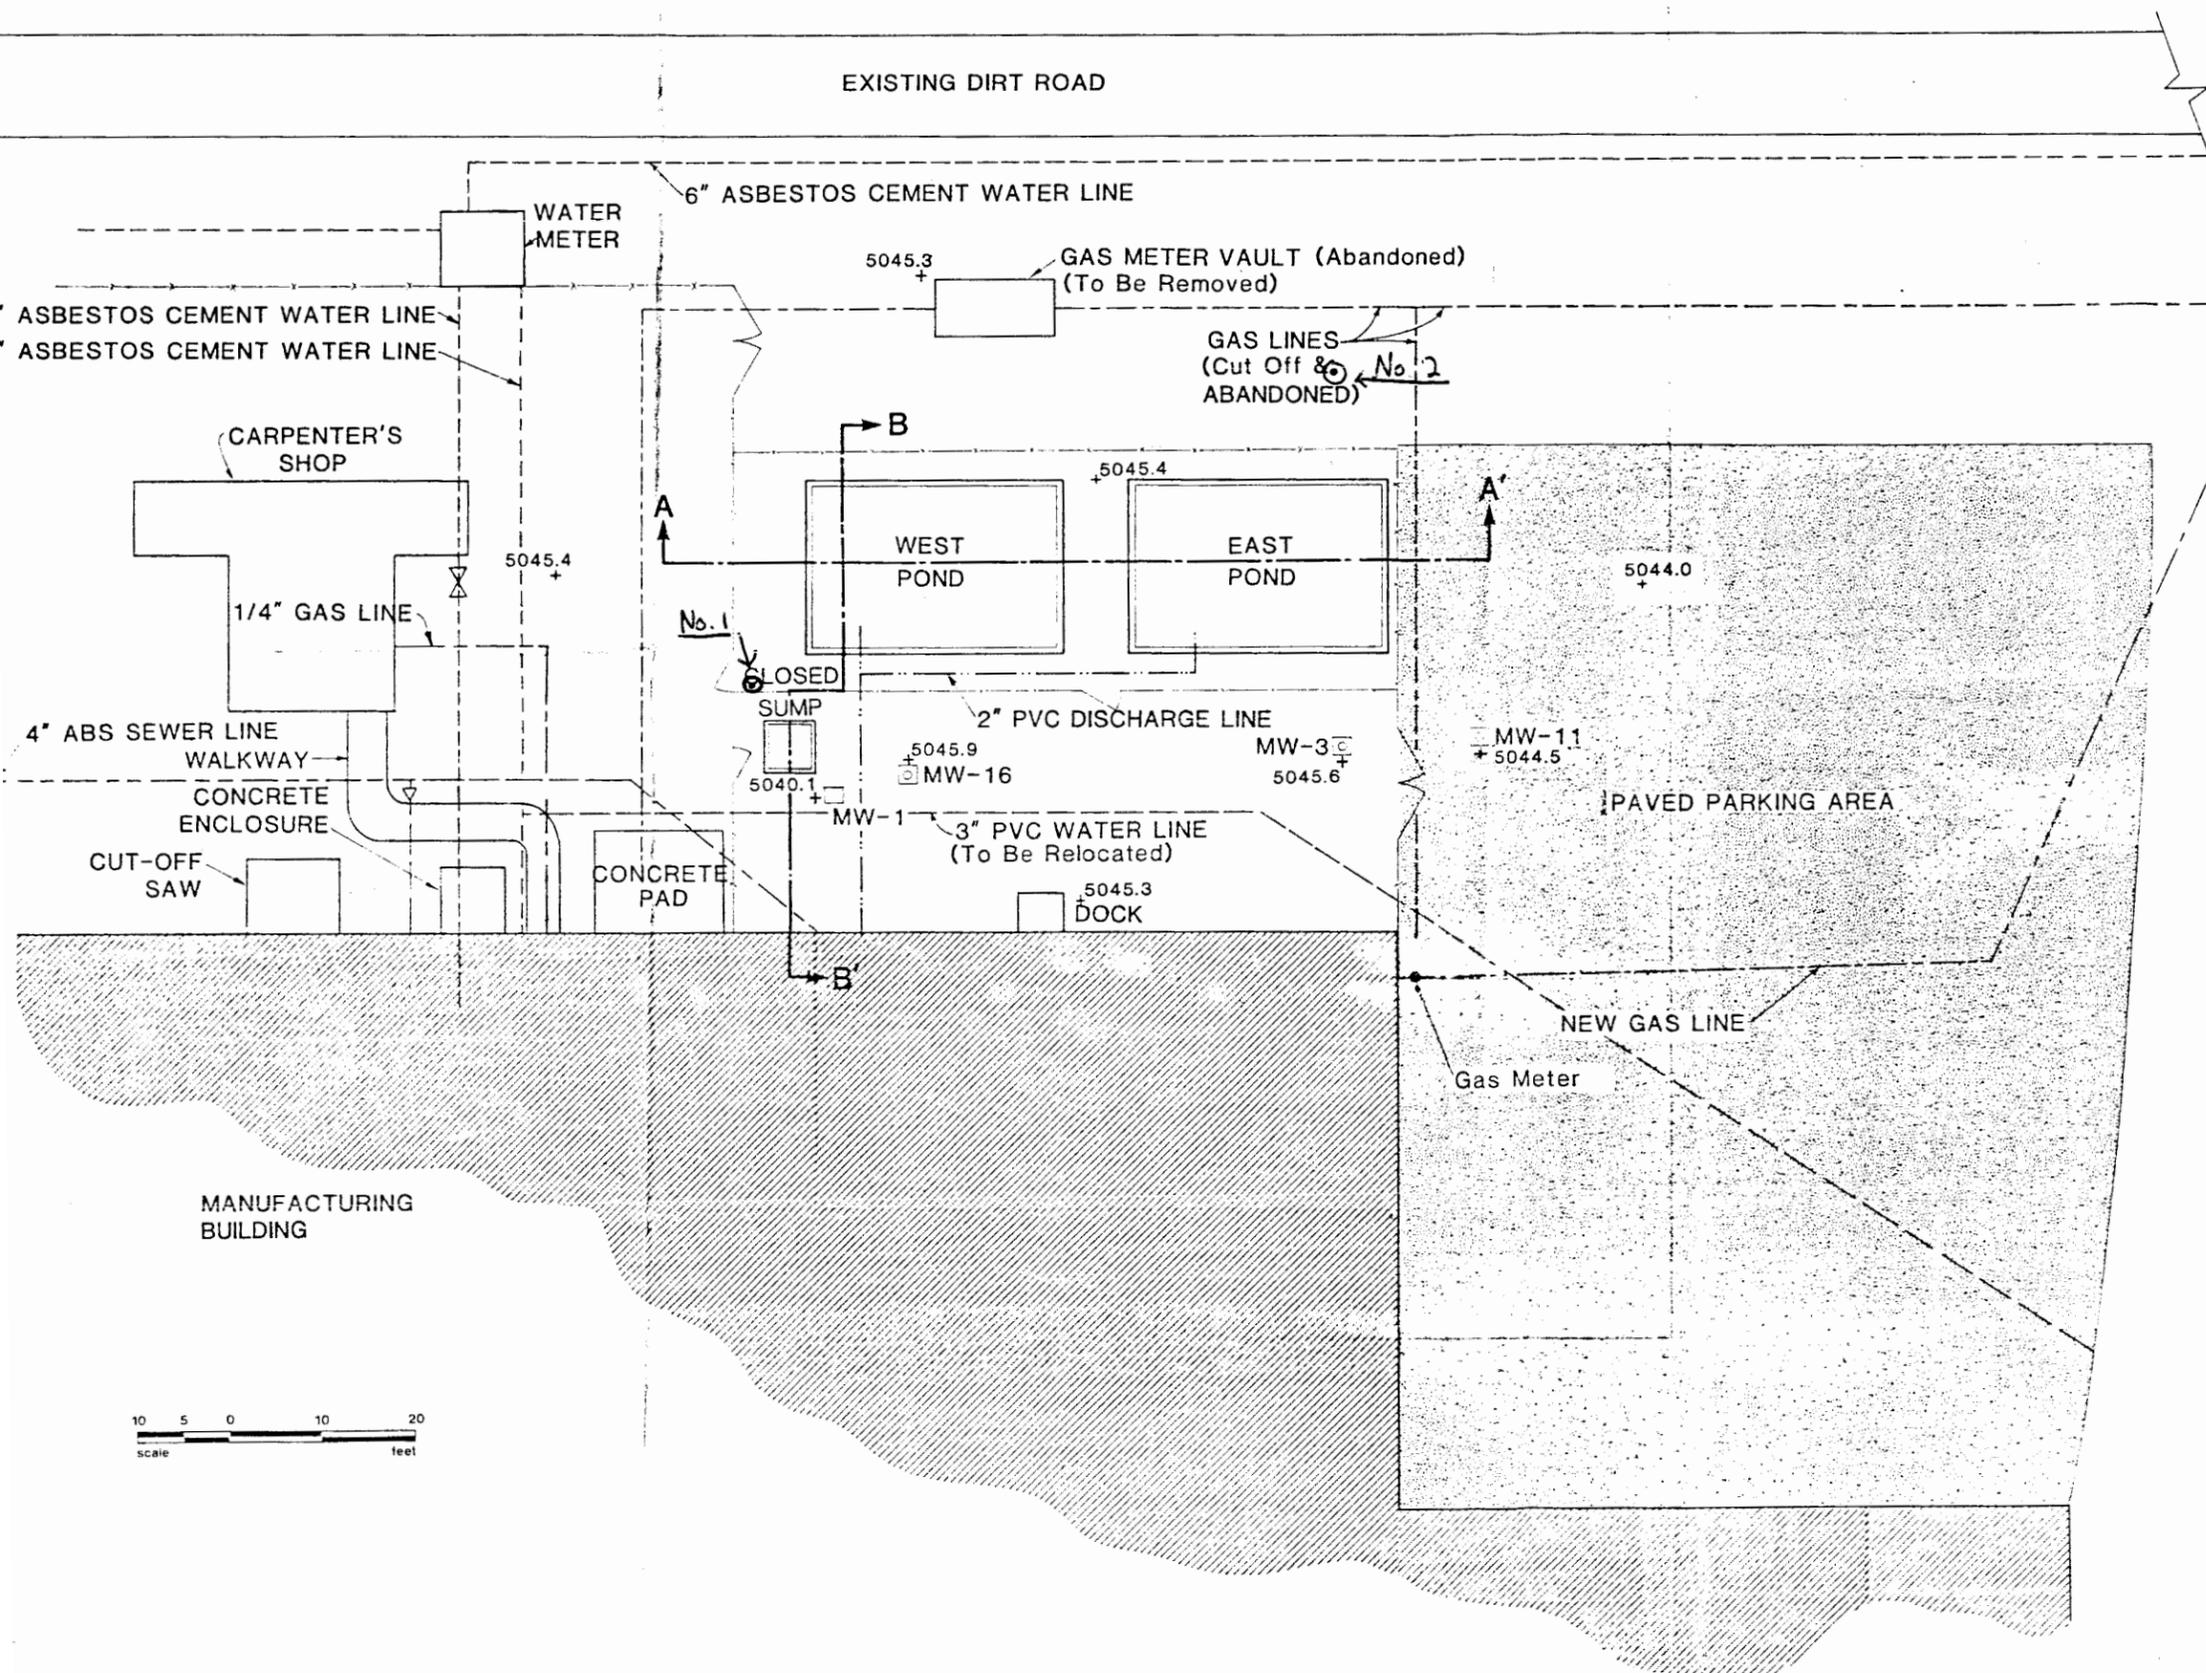
| <p>Harding Lawson Associates Engineers, Geologists & Geophysicists</p> | <p>POND AND SUMP AREA EXISTING FACILITIES BASE MAP</p> | | <p>A-1</p> |

The Pond Cap is composed of 2 layers of asphaltic concrete. The base course is 6 in. thick with a tack coat on the surface. The wear coat or surface course is 3 in. thick. The dimensions of the Pond Cap are approximately 65 ft. by 75 ft.. The larger crack is located on the west side of the cap from the edge and 27 ft. to the north of the facility. The crack radiates from a 1" elevated dome and is 12 inches in it's longest dimension. The second crack is located on the northeast corner approximately 7 ft. from the east boundary and 3 ft. from the north boundary. The longest dimension is 7 in. and the surface is domed $\frac{1}{2}$ inch. We do not believe these cracks penetrate the base course but represent a delamination of the surface course. Enclosed is a copy of the Pond Cap site plan with the location of the cracks sketched in.

Sparton proposes to contract with Rodgers Water Well Co. to repair these 2 cracks. A 14 inch hole saw will cut out the 3 inch surface coat at which point the integrity of the base coat will be determined. If the base course is intact Rodgers will apply a new tack coat and asphalt layer then tamp it level with the surrounding surface. If the base coat is cracked Rodgers will cut it out. The hole will be rebuilt with 3 successive 3 inch layers of tamped asphalt with intervening tack coats.
