SPARTON TECHNOLOGY

This letter is written to inform you of the actions Sparton Technology, Inc. has taken to repair two cracks in the Pond Closure Cap at the Coors Road Facility. This repair was initiated and completed on September 17, 1992 by Rodgers and Company, Inc. No unusual or unforeseen circumstances were encountered during the repair procedure. The repair work was completed as outlined in our proposal letter to your office dated July 16, 1992.

Summary of field notes taken during the repair of two cracks in Sparton Technology's, Inc. Pond Closure Cap on September 17, 1992.

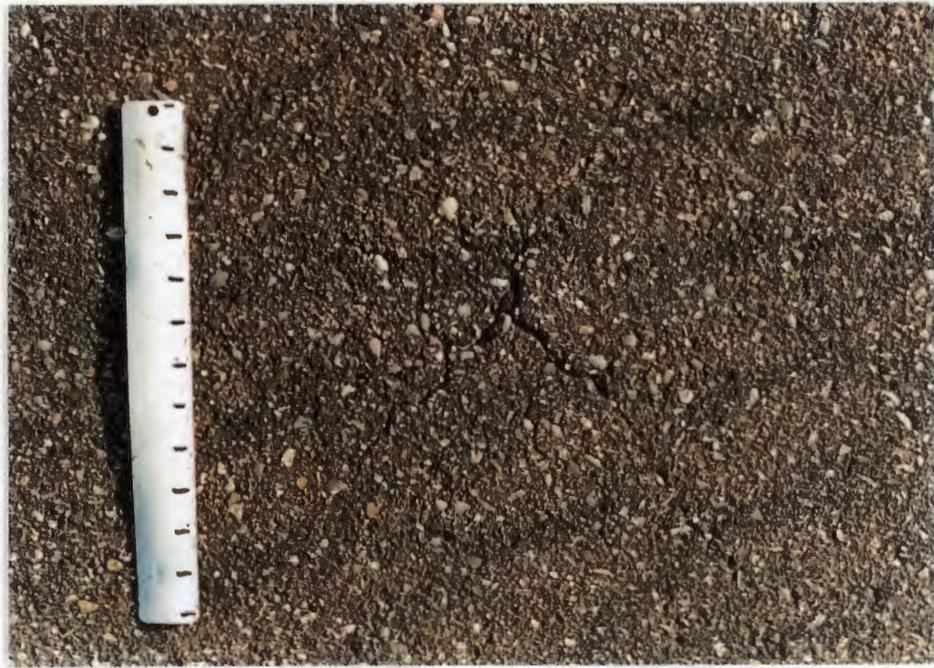
- 0940 Drilling commences on the northeast crack with a 14" carbide tipped hole saw, (No. 2 on the site plan, see photo. #1).
- 0950 Pond cap is cut to an average depth of 4", the surface or wear course detaches cleanly from the base course. No evidence of damage or cracks in the base course. A coating of water is present on both asphalt surfaces. No free standing water is present. Survey twine or string was found between the two asphalt layers, see photo. #2. Cracks in surface course apparently caused by delamination between the two layers.

Photograph 1, Northeast crack; No. 2 on site plan, prior to repair. .
Scale equals 1 ft. for all photos. .

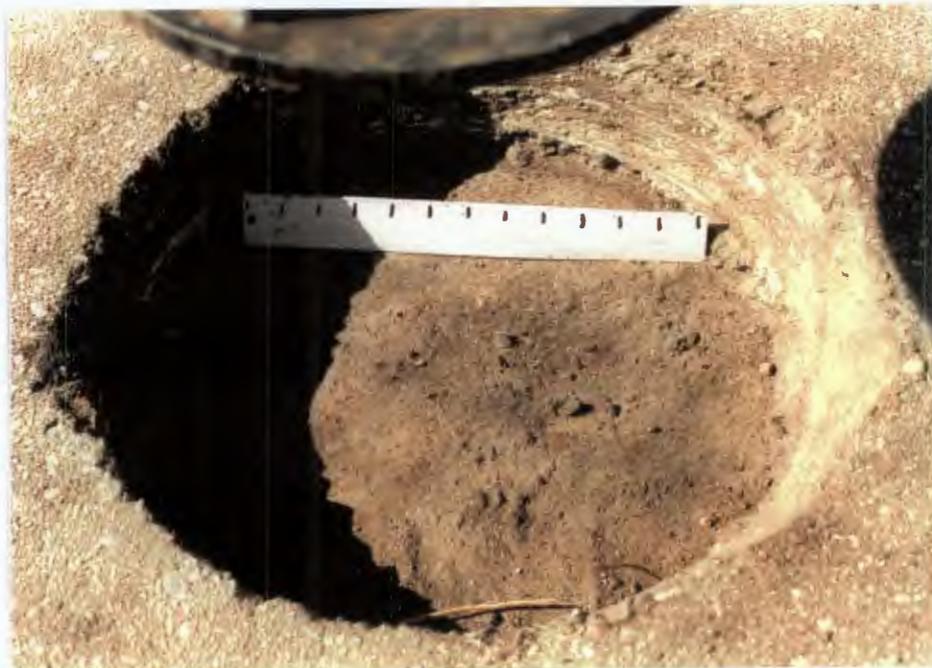
Photograph 2, Northeast crack; Surface layer removed and base
course intact.

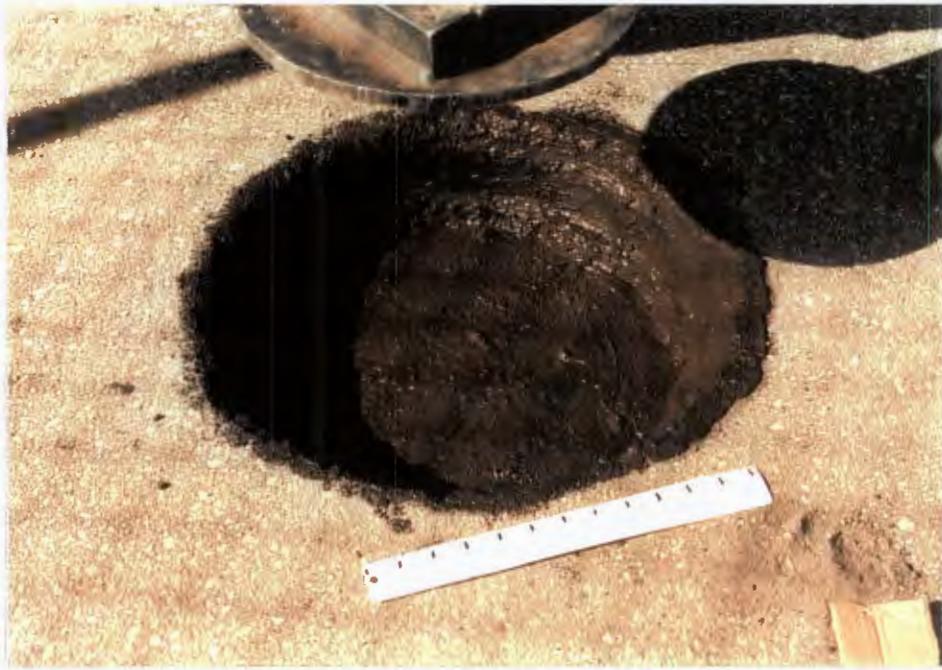
Photograph 3, Northeast crack; Initial tack coat application.

- 1010 A tack coat, (Environmental Coatings), was applied to the entire surface, see photo. #3. Two successive layers of asphalt with an intervening tack coat were applied and hydraulically tamped down. The asphalt was leveled with the surrounding surface course and a sealer coat was applied, see photos. #4 and 5.

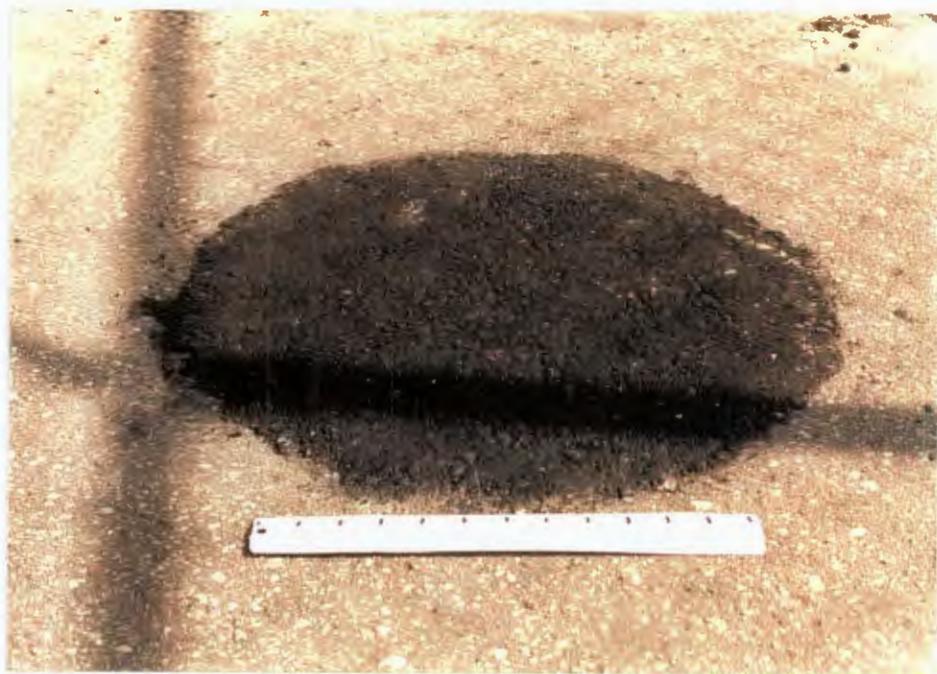
Photograph 4, Northeast crack; Filled with asphalt and tamped level with surrounding surface layer.

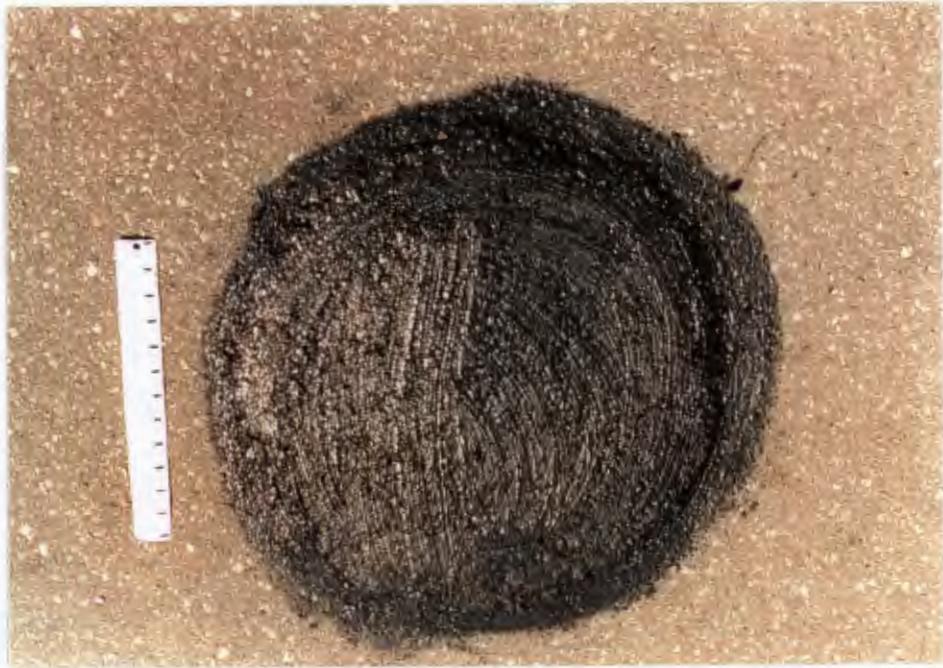
Photograph 5, Northeast crack; Sealer coat applied to repaired surface.

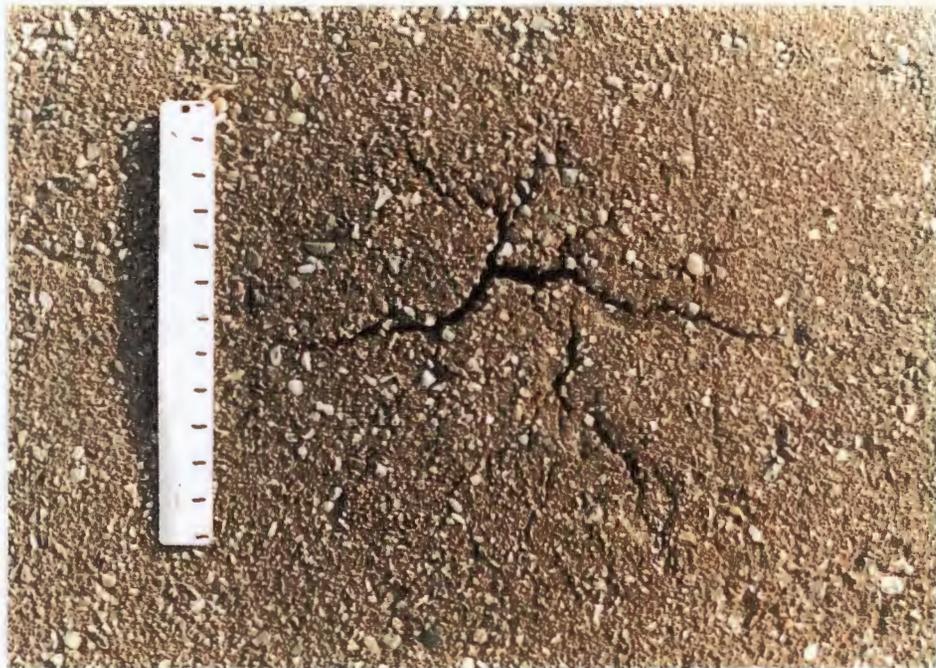
- 1030 Moved drilling rig to southwest crack, (No. 1 on the site plan) see photo. #6 for condition of crack prior to repair.
- 1040 Commenced drilling, no clear separation between surface and base course. Surface course is 2 to 2.5" thick at this location. Cracks appear to penetrate the base layer of the asphalt.

- 1100 Decided to remove base asphalt layer as there was no evidence of delamination and damaged extended into the base course. No evidence of moisture.

Photograph 6, Southwest crack; No. 1 on site plan, prior to repair.

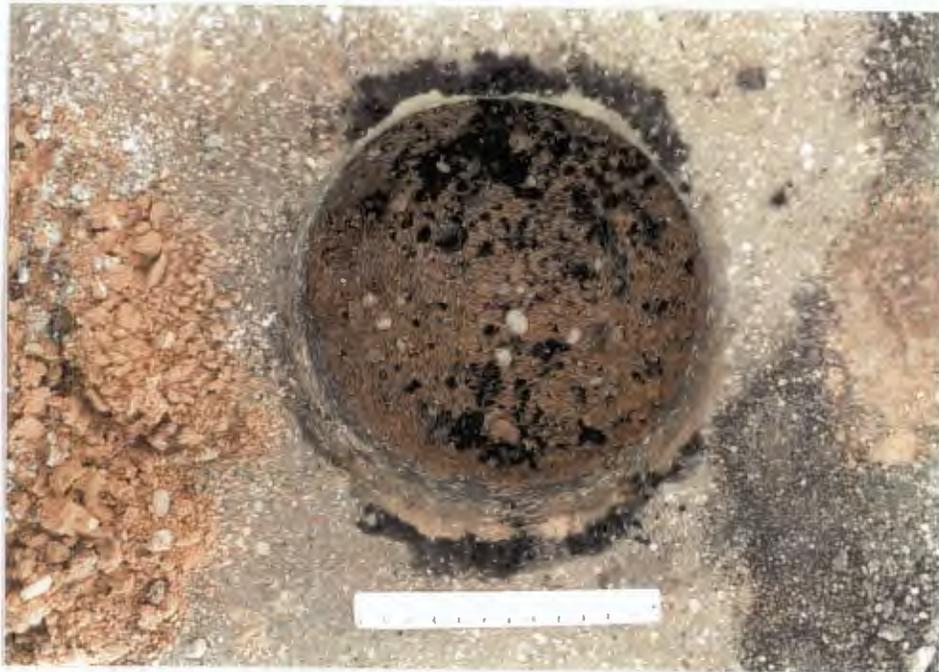
- 1120 The 8.5" thick base layer is drilled out, see photo. #7. Not able to determine maximum depth of crack penetration, but no evidence of cracking on the bottom of the asphalt base. The base of this layer is convex upward. No indication of causative agents for surface cracks. Proceeded to fill hole with 3 successive applications of asphalt and tack coat which was hydraulically tamped.

Photograph 7, Southwest crack; Surface and base layers removed exposing fill material.

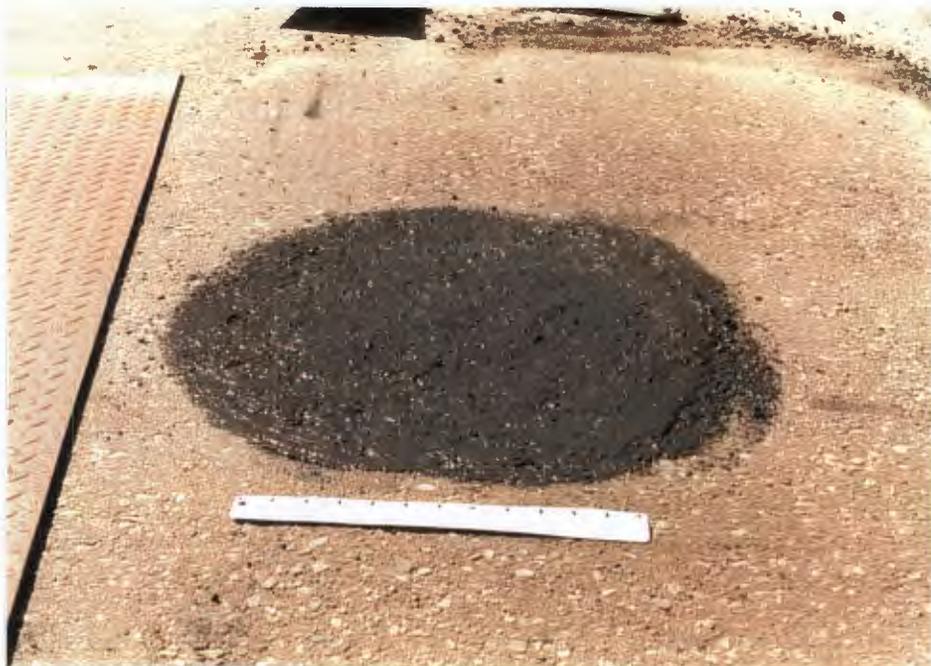
Photograph 8, Southwest crack; Filled with 3 successive layers of asphalt and tack material. Final sealer coat application.

- 1200 Finished filling hole and tamped level with surrounding Pond Cap Closure. Sealer coat applied, see photo. #8.
- 1245 Rodgers and Company, Inc. offsite.
