From: Kesterson, Thomas L, NMENV
Sent: Thursday, September 25, 2008 10:51 AM
To: Zappe, Steve, NMENV
Subject: Fire line inspection
Attachments: Steve-Inspection.doc; Fireline_1.JPG; Fireline_2.JPG; Fireline_3.JPG; Fireline_4.JPG

On Monday of this week, September 22, 2008, I was present during the inspection of the new fire suppression line at the Waste Isolation Pilot Plant. The Professional Engineer inspecting the line was Robert Frasier (Bridger and Paxton – Albuquerque). Those present during the inspection, besides Mr. Frasier and myself, were Dan Ferguson (DOE), John Ford (DOE), Stewart Jones (WRES), Sherman Butler (WTS), Jay Brazeal (Brazeal Plumbing), Bill Barnhart (WTS), and Hardy Bellows (WTS). The contractors for the installation were Constructors, which subcontracted the job to Brazeal Plumbing.

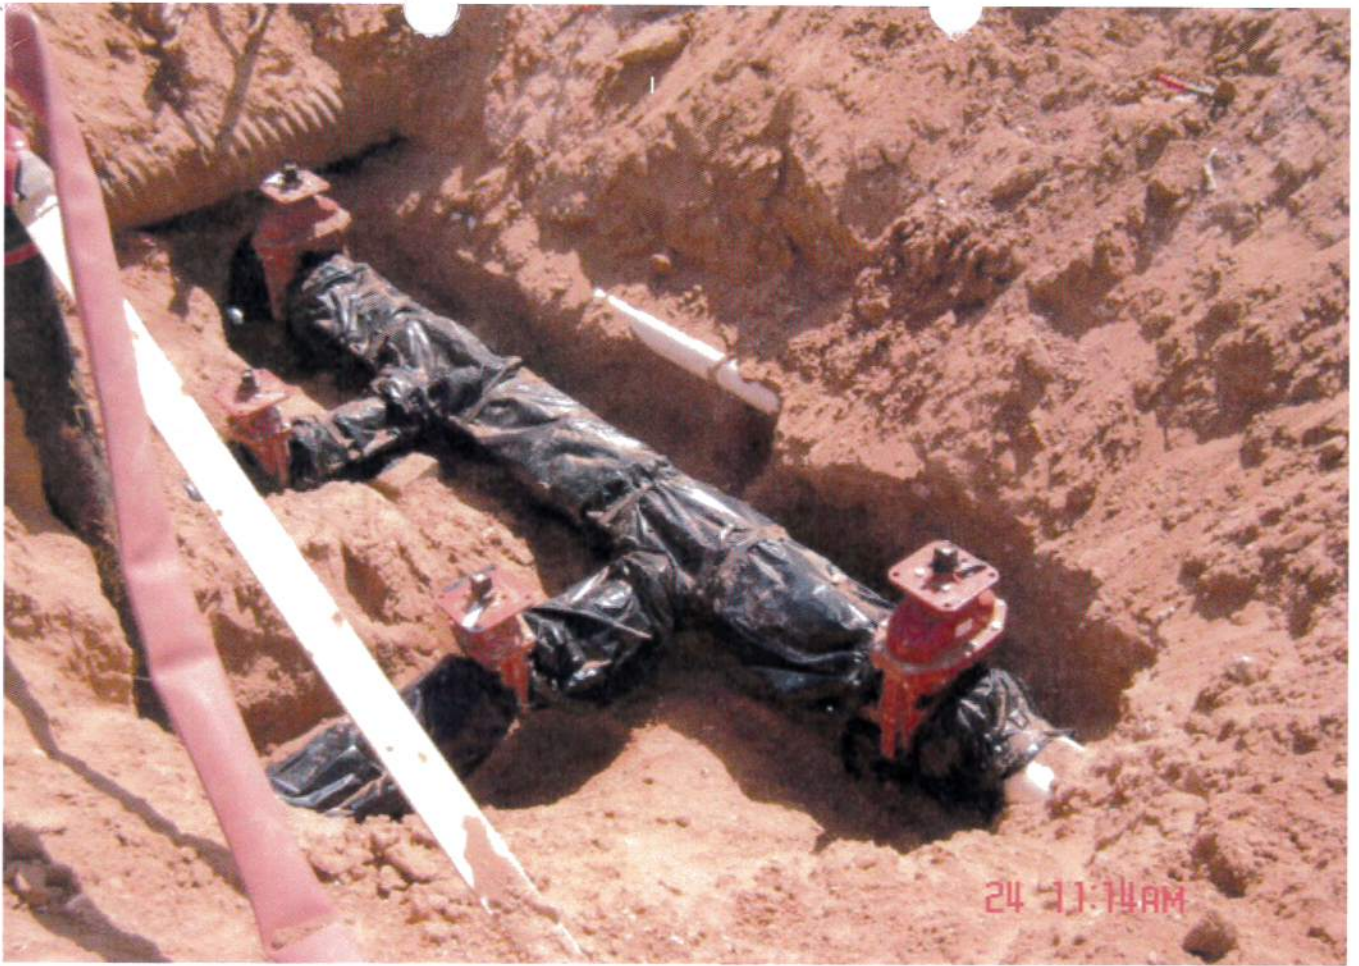
①

Fireline_1 shows the ten-inch pvc pipe emplaced with the old water main. This photo is towards the south. Fireline_2 is facing towards the north, and includes both the ten-inch line and the new fire hydrant. Fireline_3 is a joint in the six-inch line running towards the Waste Handling Building., again, covered with plastic. Fireline_4 shows the four-foot vertical rise outside the south wall of the Waste Handling Building. The blind was installed at the top of this rise, within the flange just below the red pipe.
