From: Maestas, Ricardo, NMENV
Sent: Wednesday, July 11, 2012 11:58 AM
To: Allen, Pam, NMENV
Subject: FW: drum picture
Attachments: Response to Inquiry - Punctured Drum June 19 2012_rev a.docx; Drum picture June 2012.JPG

Response to Inquiry
June 19, 2012
Drum damaged during underground emplacement

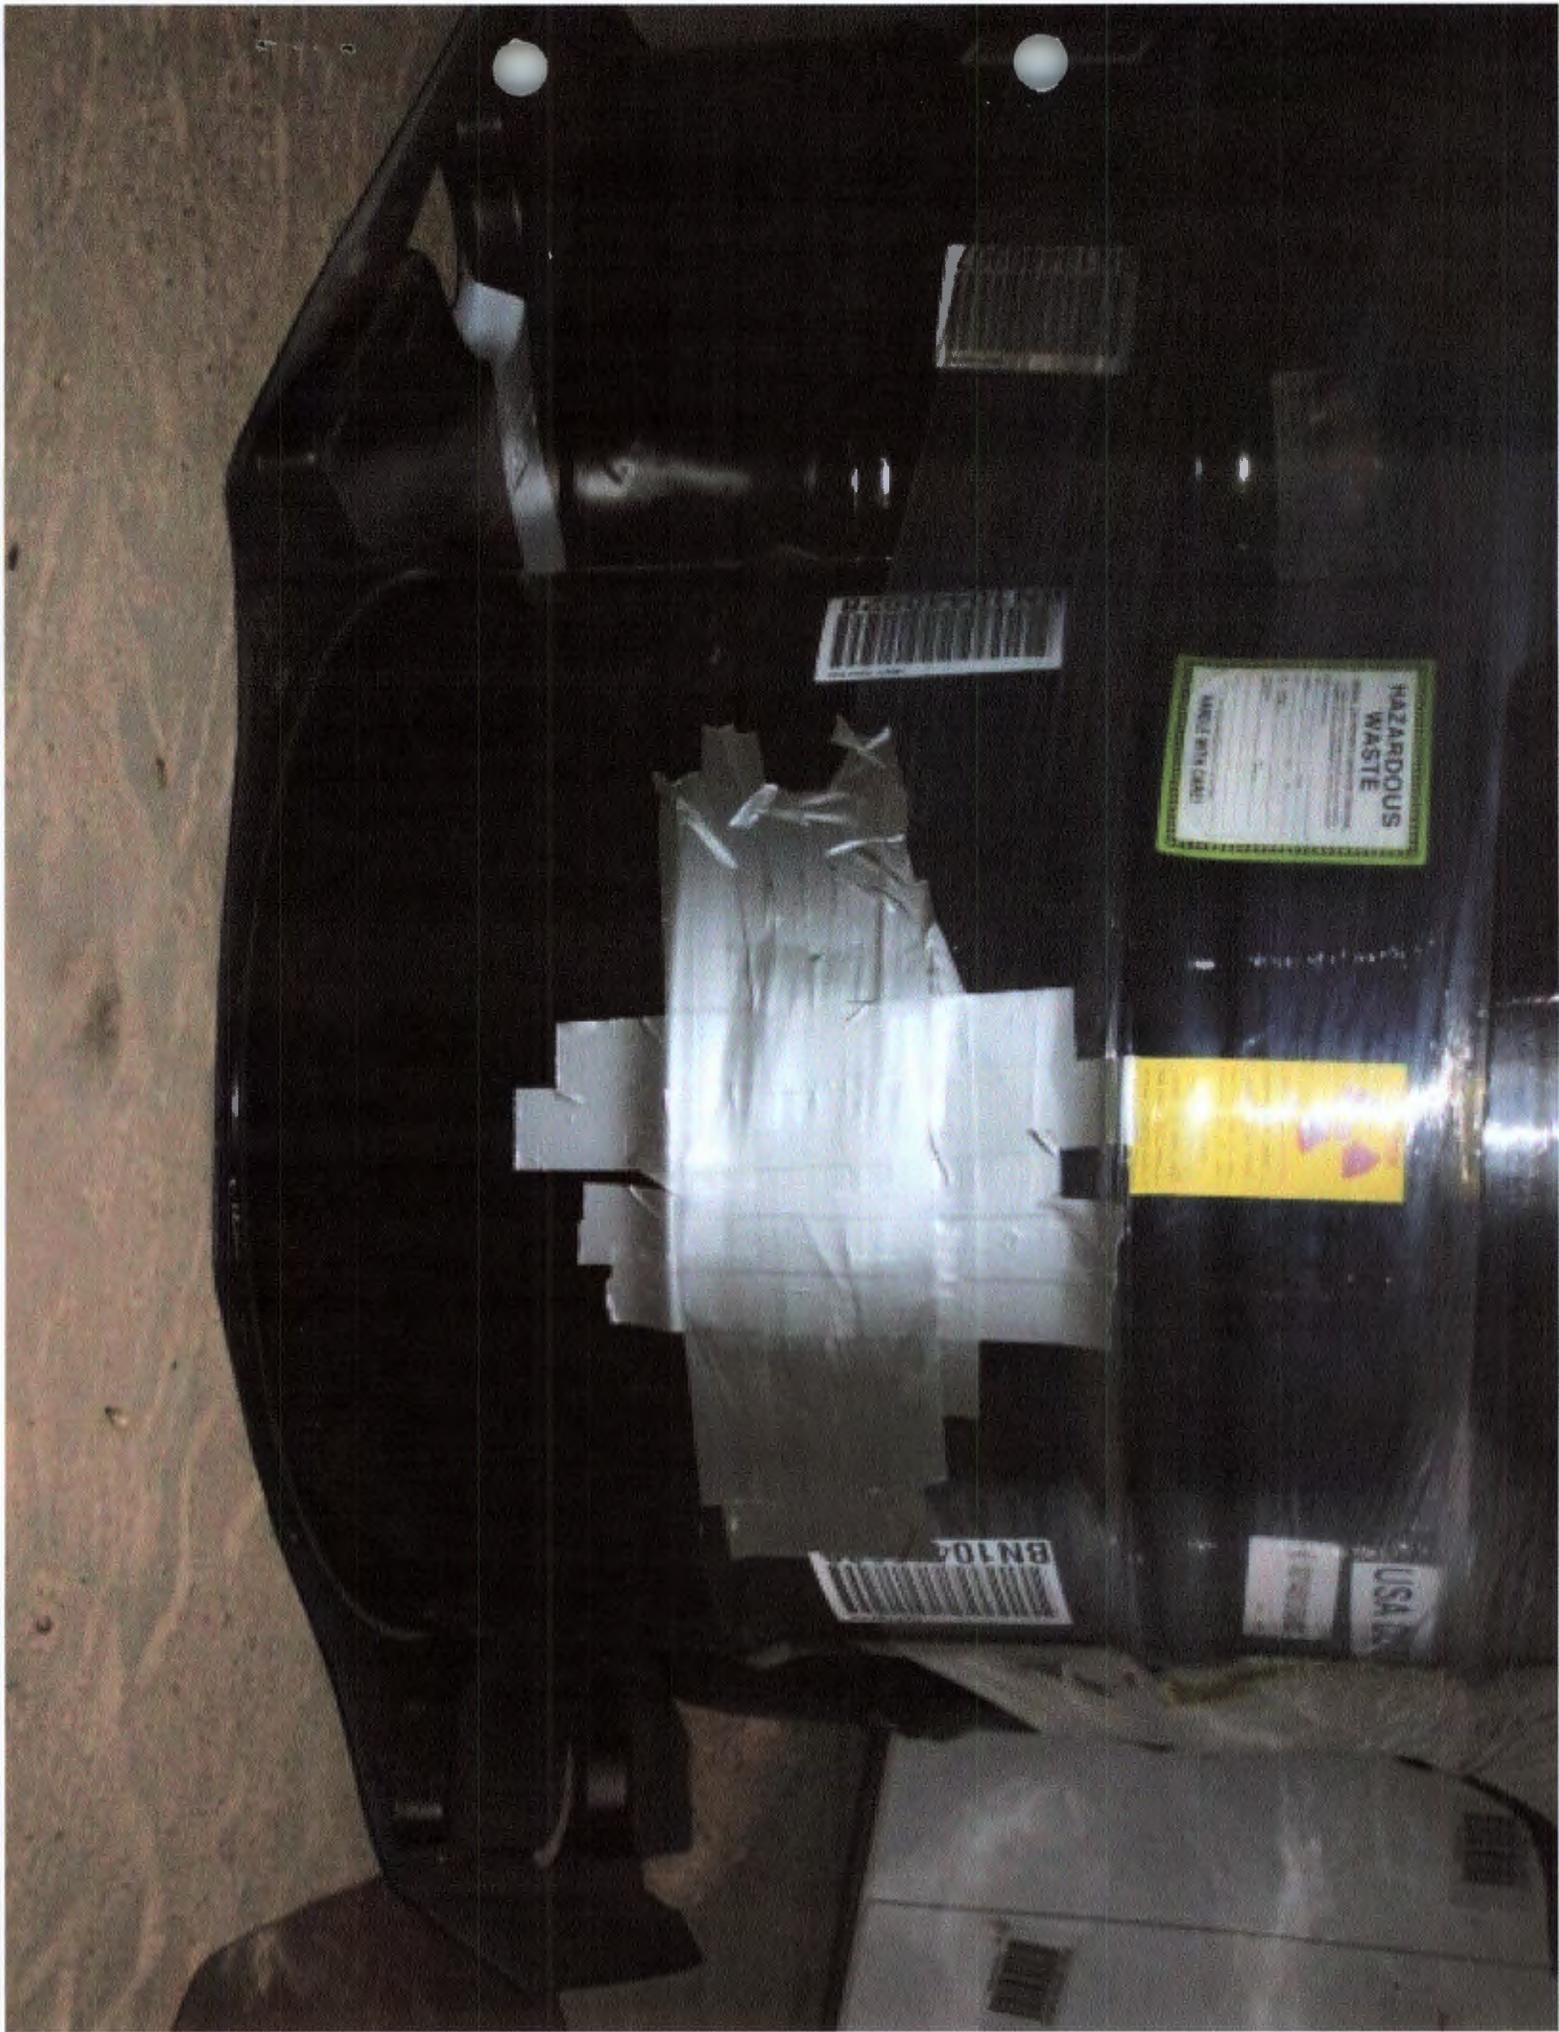
At approximately 1 p.m. on June 19, 2012, as waste handling crews were offloading and stacking waste drums in Room 5, Panel 6, for disposal, at the Waste Isolation Pilot Plant (WIPP), the forklift operator struck an emplaced container, creating an approximate three inch puncture in the emplaced waste drum.

The 100-gallon waste drum was from Idaho National Laboratory and consisted of compacted transuranic (TRU) waste debris. There were tubular spacers inside the drum, separating the compacted TRU waste from the drum wall.

Operations and radiological control personnel developed a work plan and within hours, had taken surveys (smears) of the drum and conducted radiological surveys of the area and equipment for contamination. No contamination was found and the drum puncture was sealed. As a precautionary measure, workers wore protective clothing while performing surveys.
