U.S. DEPARTMENT OF
ENERGY

WIPP Underground Fire Accident Investigation Summary February 5, 2014

Ted Wyka
Chairman, Accident Investigation Board
March 2014

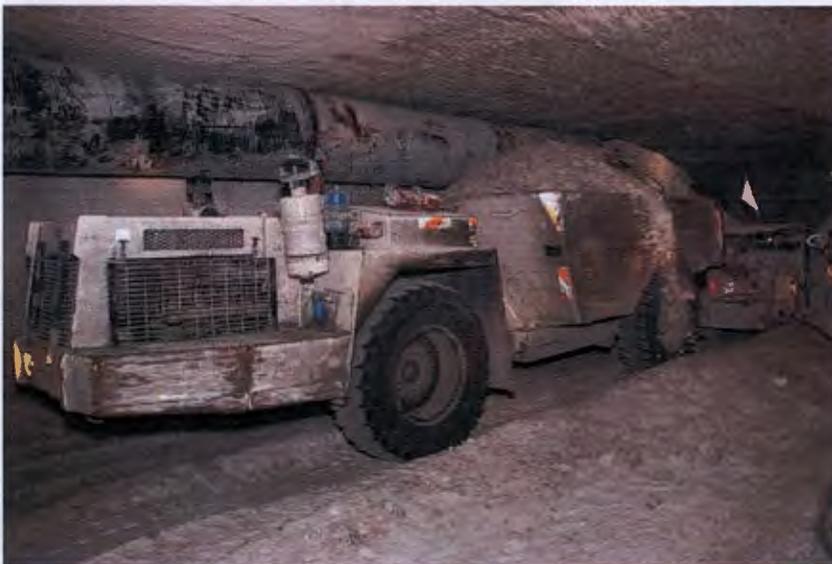
The EIMCO Model 985, 15 ton haul truck is a diesel powered vehicle used to haul salt from the mine. This is an aged piece of equipment, approximately 29 years old.

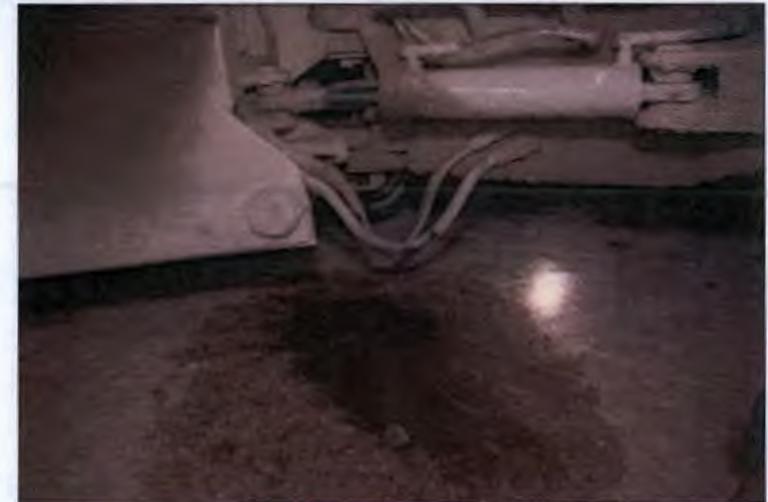
Hydraulic Leak under Sister Vehicle

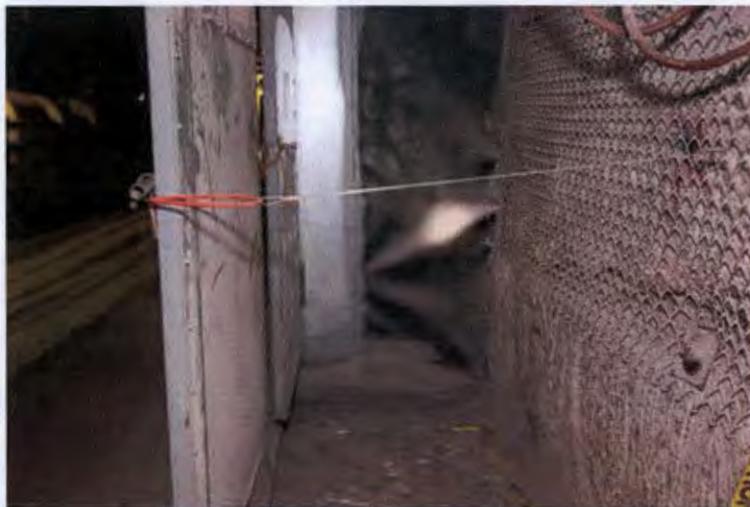
Air Lock Doors Wired Open

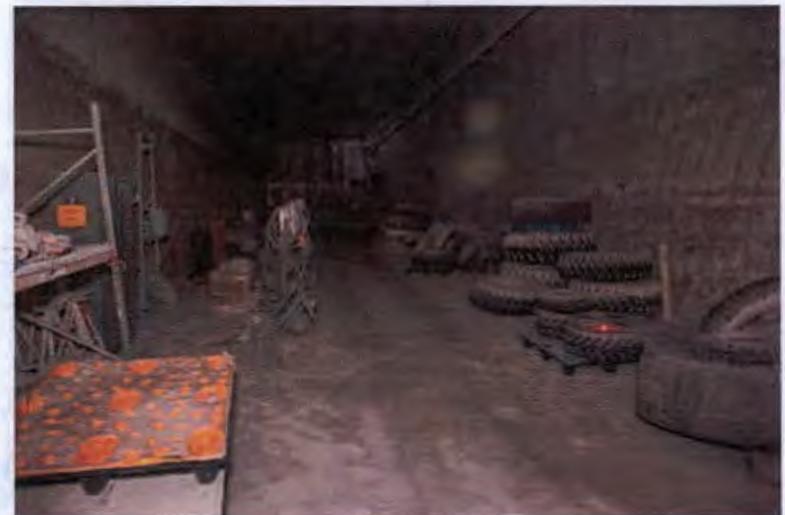
Combustible Loading in the Mine

- **Inadequate combustible loading program in the underground.**
- **Inadequate Fire hazard Analysis** (i.e. analysis of a fire near a shaft)
- **Maintenance, Emergency Management/Preparedness programs and NWP contractor assurance system (CAS) and CBFO oversight** were evaluated as **ineffective.**

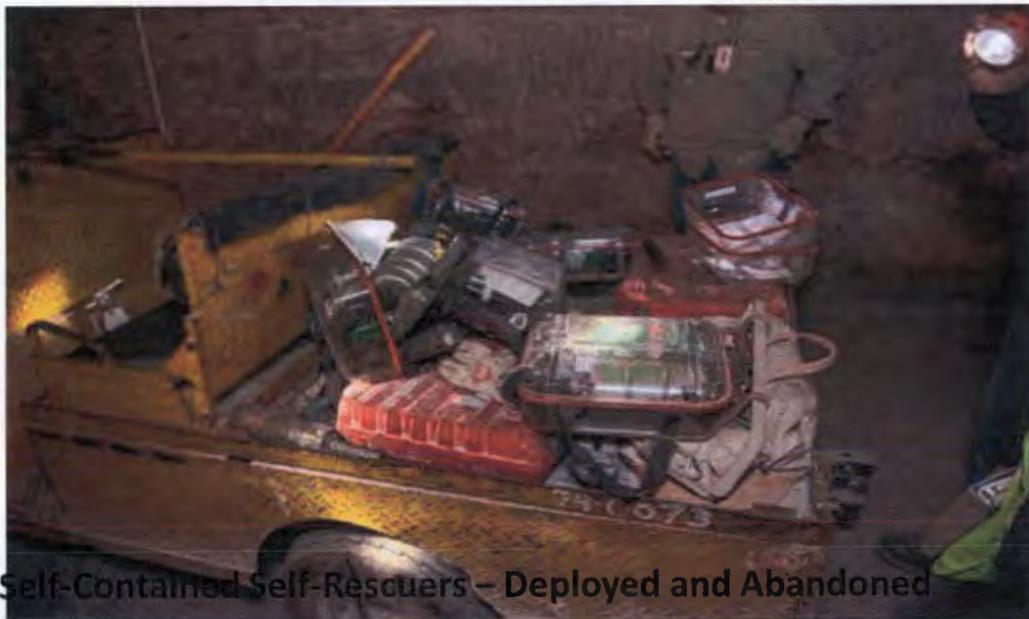
Self-Contained Self-Rescuers – Deployed and Abandoned

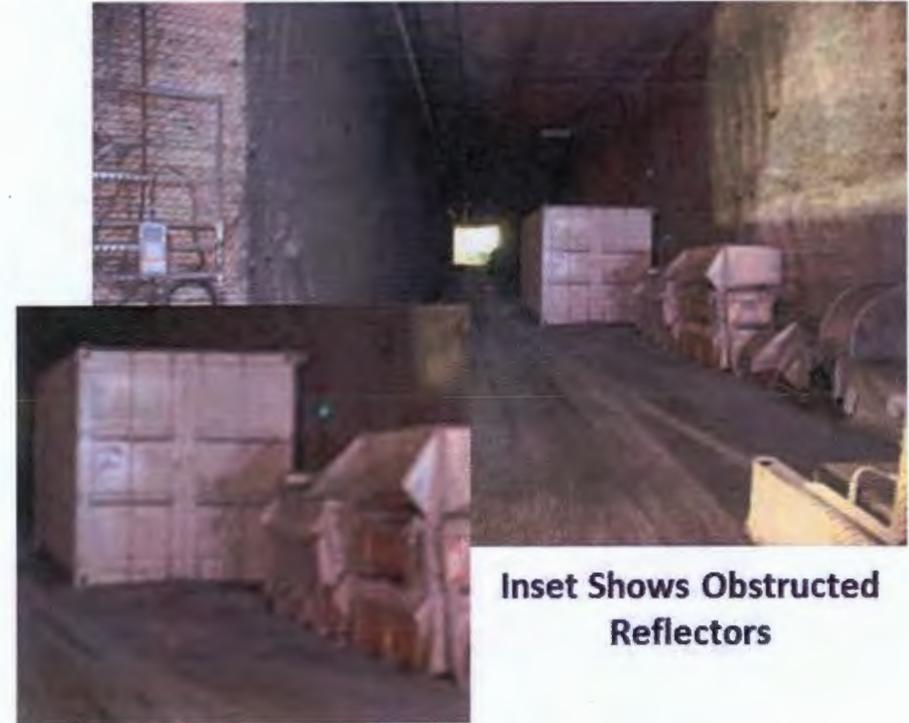
Inset Shows Obstructed Reflectors
