WIPP UPDATE: January 21, 2015

Roof Separation Highlights Bolting Priority

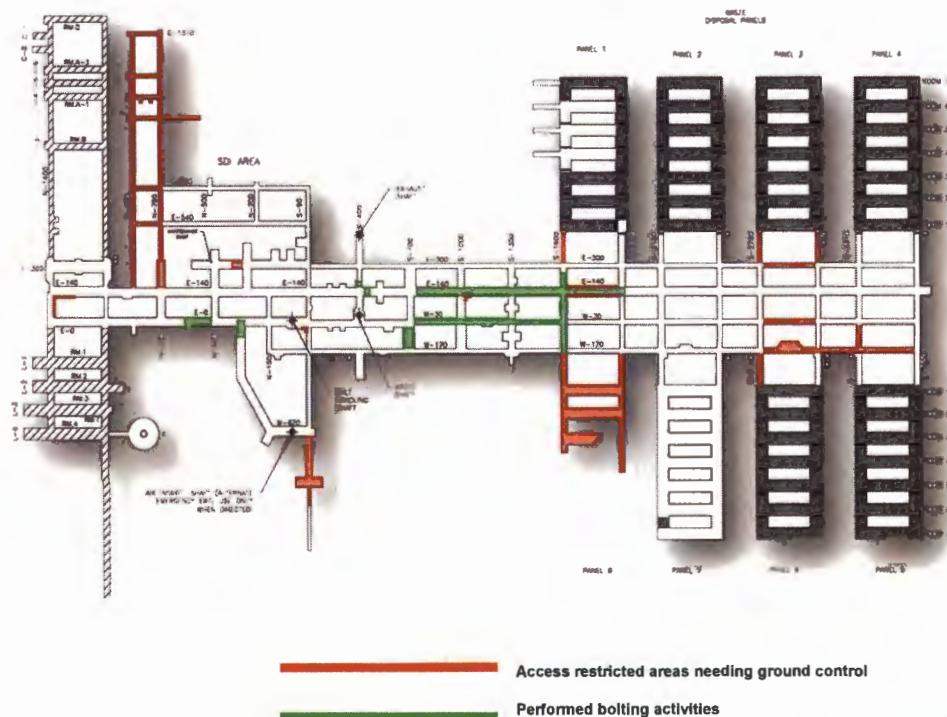
Roof bolting resumed in mid-November of 2014, and ground control engineers have indicated that the area where the roof fall occurred can be re-bolted and recovered. The map to the right identifies the areas where progress has been made to catch up on the backlog of ground control and maintenance activities, as well as areas where access is restricted until bolting activities can be completed.
