Subject: Transmittal of Notification of Adverse Conditions

**Evaluation of Ground Conditions  
in the  
S-2750 Entry to Panel 3  
Total Pages: 4**

## Evaluation of Ground Conditions in the S-2750 Entry to Panel 3

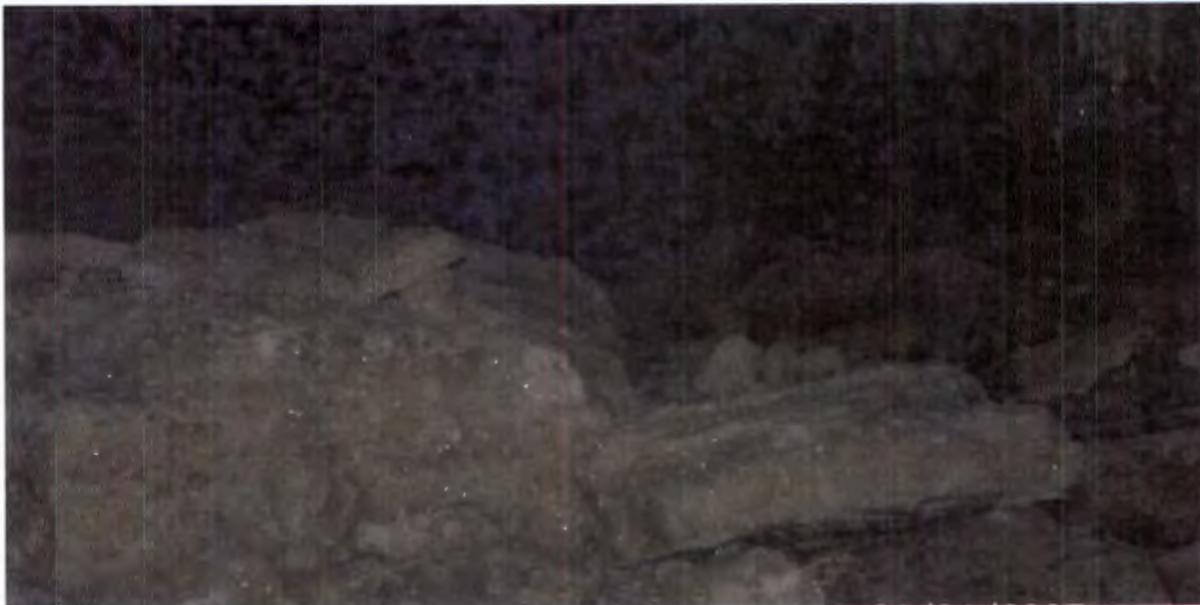
The installation of the ground support system consisted of several stages, of which only the first stage was partially completed prior to installation suspension. The first stage of the multilayer ground support system consisted of a chain-link mesh, 4-ft mechanical roof bolts and 12-ft resin anchored roof bolts. For temporary emplacement, the chain-link mesh was initially attached to the back using powder actuated spad nails. The intent was to install roof bolts soon after to provide adequate support to hold the roof beam in place. Roof bolt installation was initiated near the panel closure bulkhead and was progressing westward towards the E-300 Drift. This work was suspended in February 2014 before any roof bolts were installed to secure the chain-link mesh and provide the necessary support to the roof beam. As a result of continuing salt creep deformation, lateral compression forces on the roof beam resulted in the roof beam bowing downward creating separations along shallow anydrite stringers located approximately 18 to 24 inches into the roof. As the separations grew, the section of the roof beam, located below the stringers, could no longer support itself and fell. The chain-link mesh, which was only superficially attached to the back, separated at the overlap and provided little resistance to the fall (Figure 2).

Figure 1. A close up of the roof fall material.

Ground control engineers have indicated that the area where the roof fall occurred can be re-bolted and recovered. The systematic completion of the ground support system and ground monitoring can be used to regain and maintain safe access to this area.

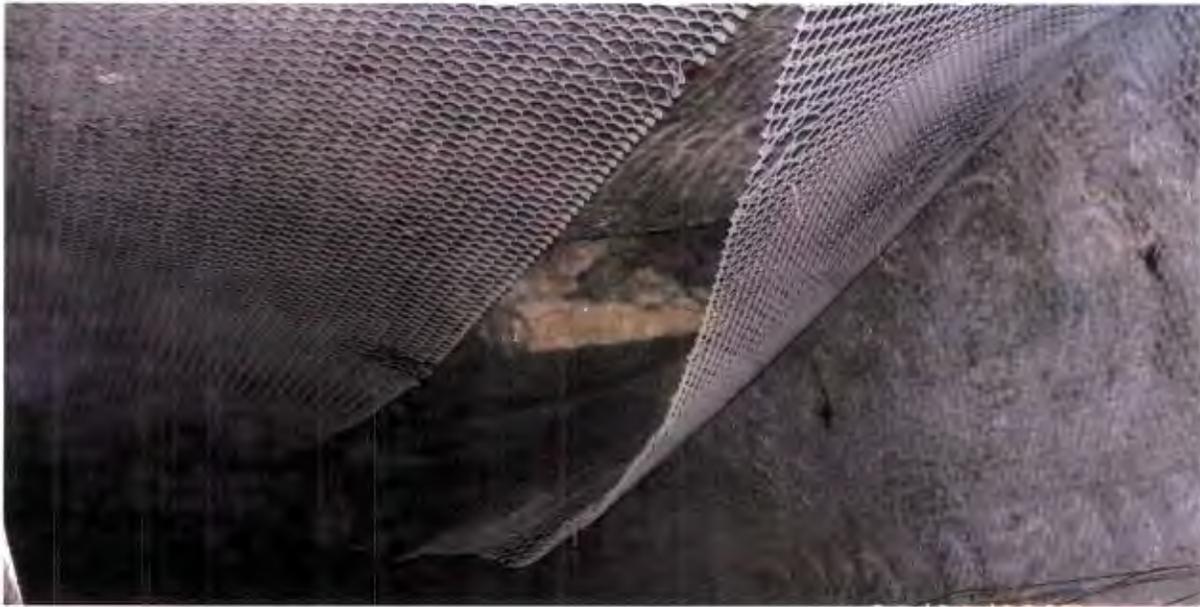
Figure 2. The separation in the chain-link mesh, along the overlap, caused by the roof fall.
