Subject: Notification of Trend Towards Adverse Conditions

## Notification of Trend Towards Adverse Ground Conditions

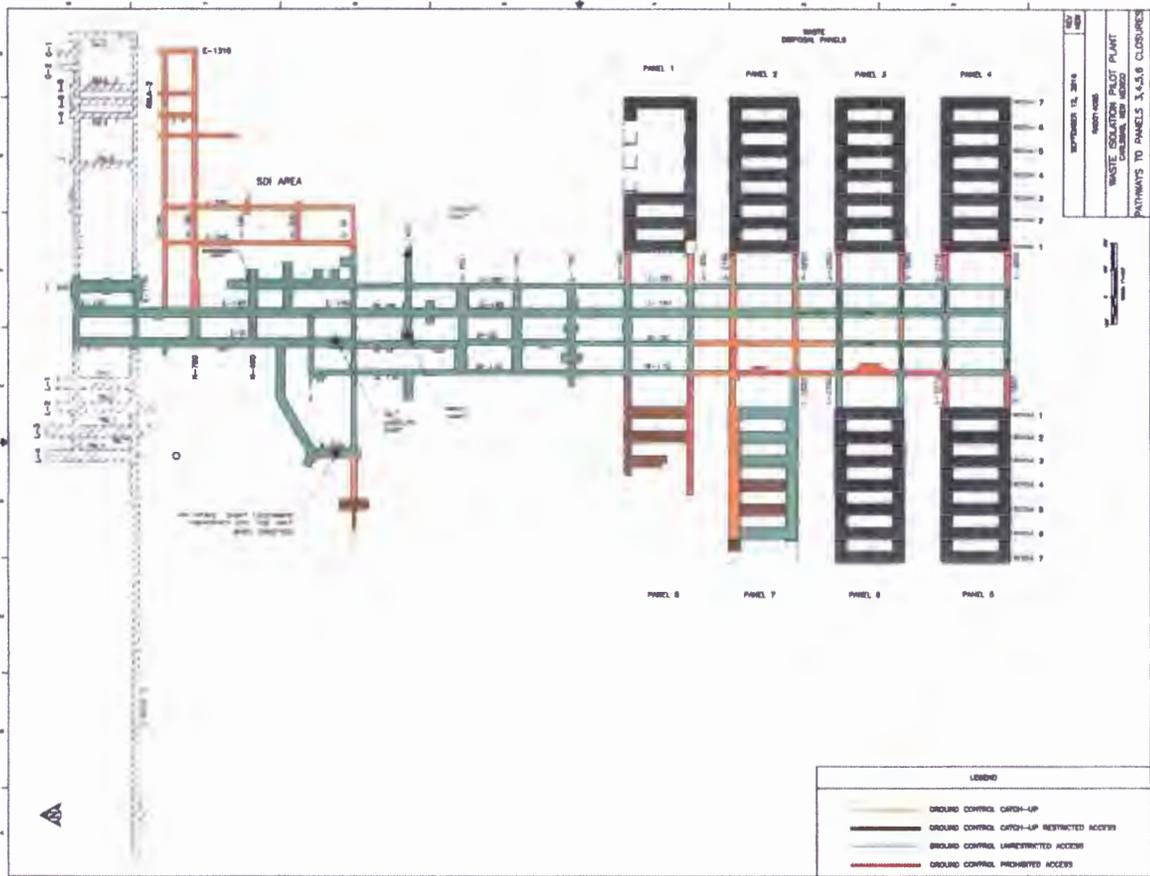
# Attachment 1

The purpose of this document is to provide notification of a trend towards adverse (unstable) ground conditions at various locations south of S-2180 drift. These locations include the following:

- Panel entries into Hazardous Waste Disposal Units (HWDUs) Panel 3, Panel 4, Panel 5, and Panel 7 Room 6.
- W-170 drift between S-2180 and S-2520
- W-170 drift between S-2750 and S-3310
- W-30 drift between S-2750 and S-3080
- S-2180 cross drift between W-170 and W-30
- S-3080 cross drift between W-170 and E-140.

These areas are shown on Attachment 1.

Due to the areas' history, its current condition, lack of ground support, limited ventilation to these areas and the inability to access these areas to complete the installation of the additional ground support or perform Geotechnical inspections and monitoring, it is recommended that access to these areas be prohibited and be controlled by Mine Operations management.
