From: Maestas, Ricardo, NMENV
Sent: Tuesday, October 31, 2017 10:18 AM
To: Allen, Pam, NMENV
Subject: FW: INFORMATION: WIPP Panel 8 Roof Fall - Update
Attachments: IMG_1970.JPG; Panel 8 roof fall 081817 Model (1).pdf

From: George Basabilvazo [mailto:george.basabilvazo@cbfo.doe.gov]
Sent: Monday, August 21, 2017 9:44 AM
To: Maestas, Ricardo, NMENV <Ricardo.Maestas@state.nm.us>; Anthony Stone <anthony.stone@cbfo.doe.gov>; Chavez, Rick - RES (Rick.Chavez@wipp.ws) <Rick.Chavez@wipp.ws>
Subject: INFORMATION: WIPP Panel 8 Roof Fall - Update
Importance: High

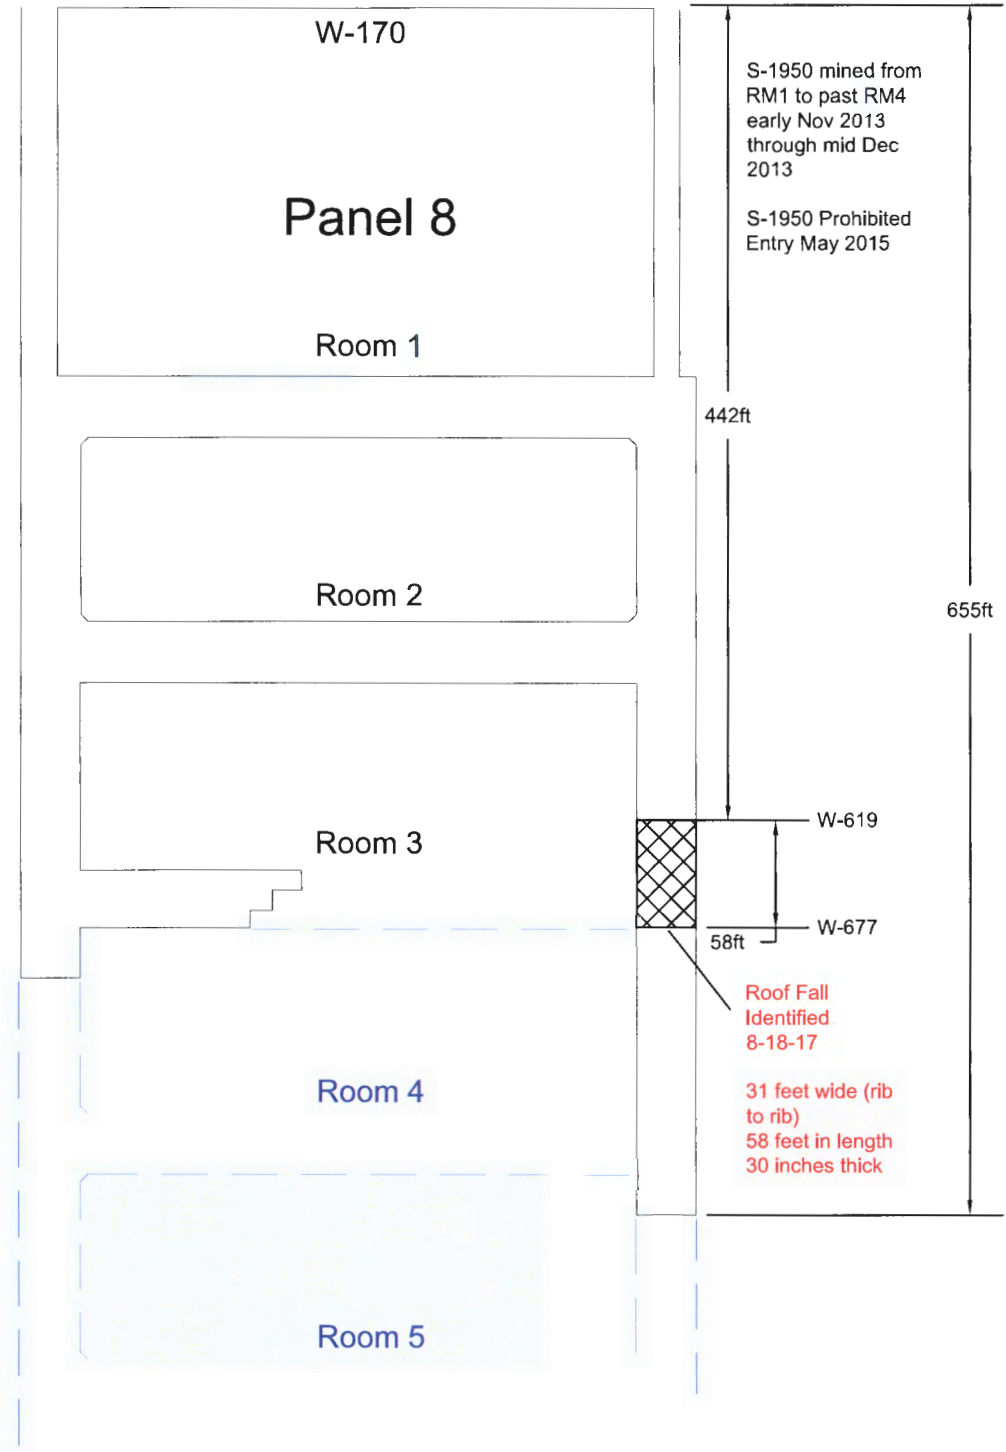
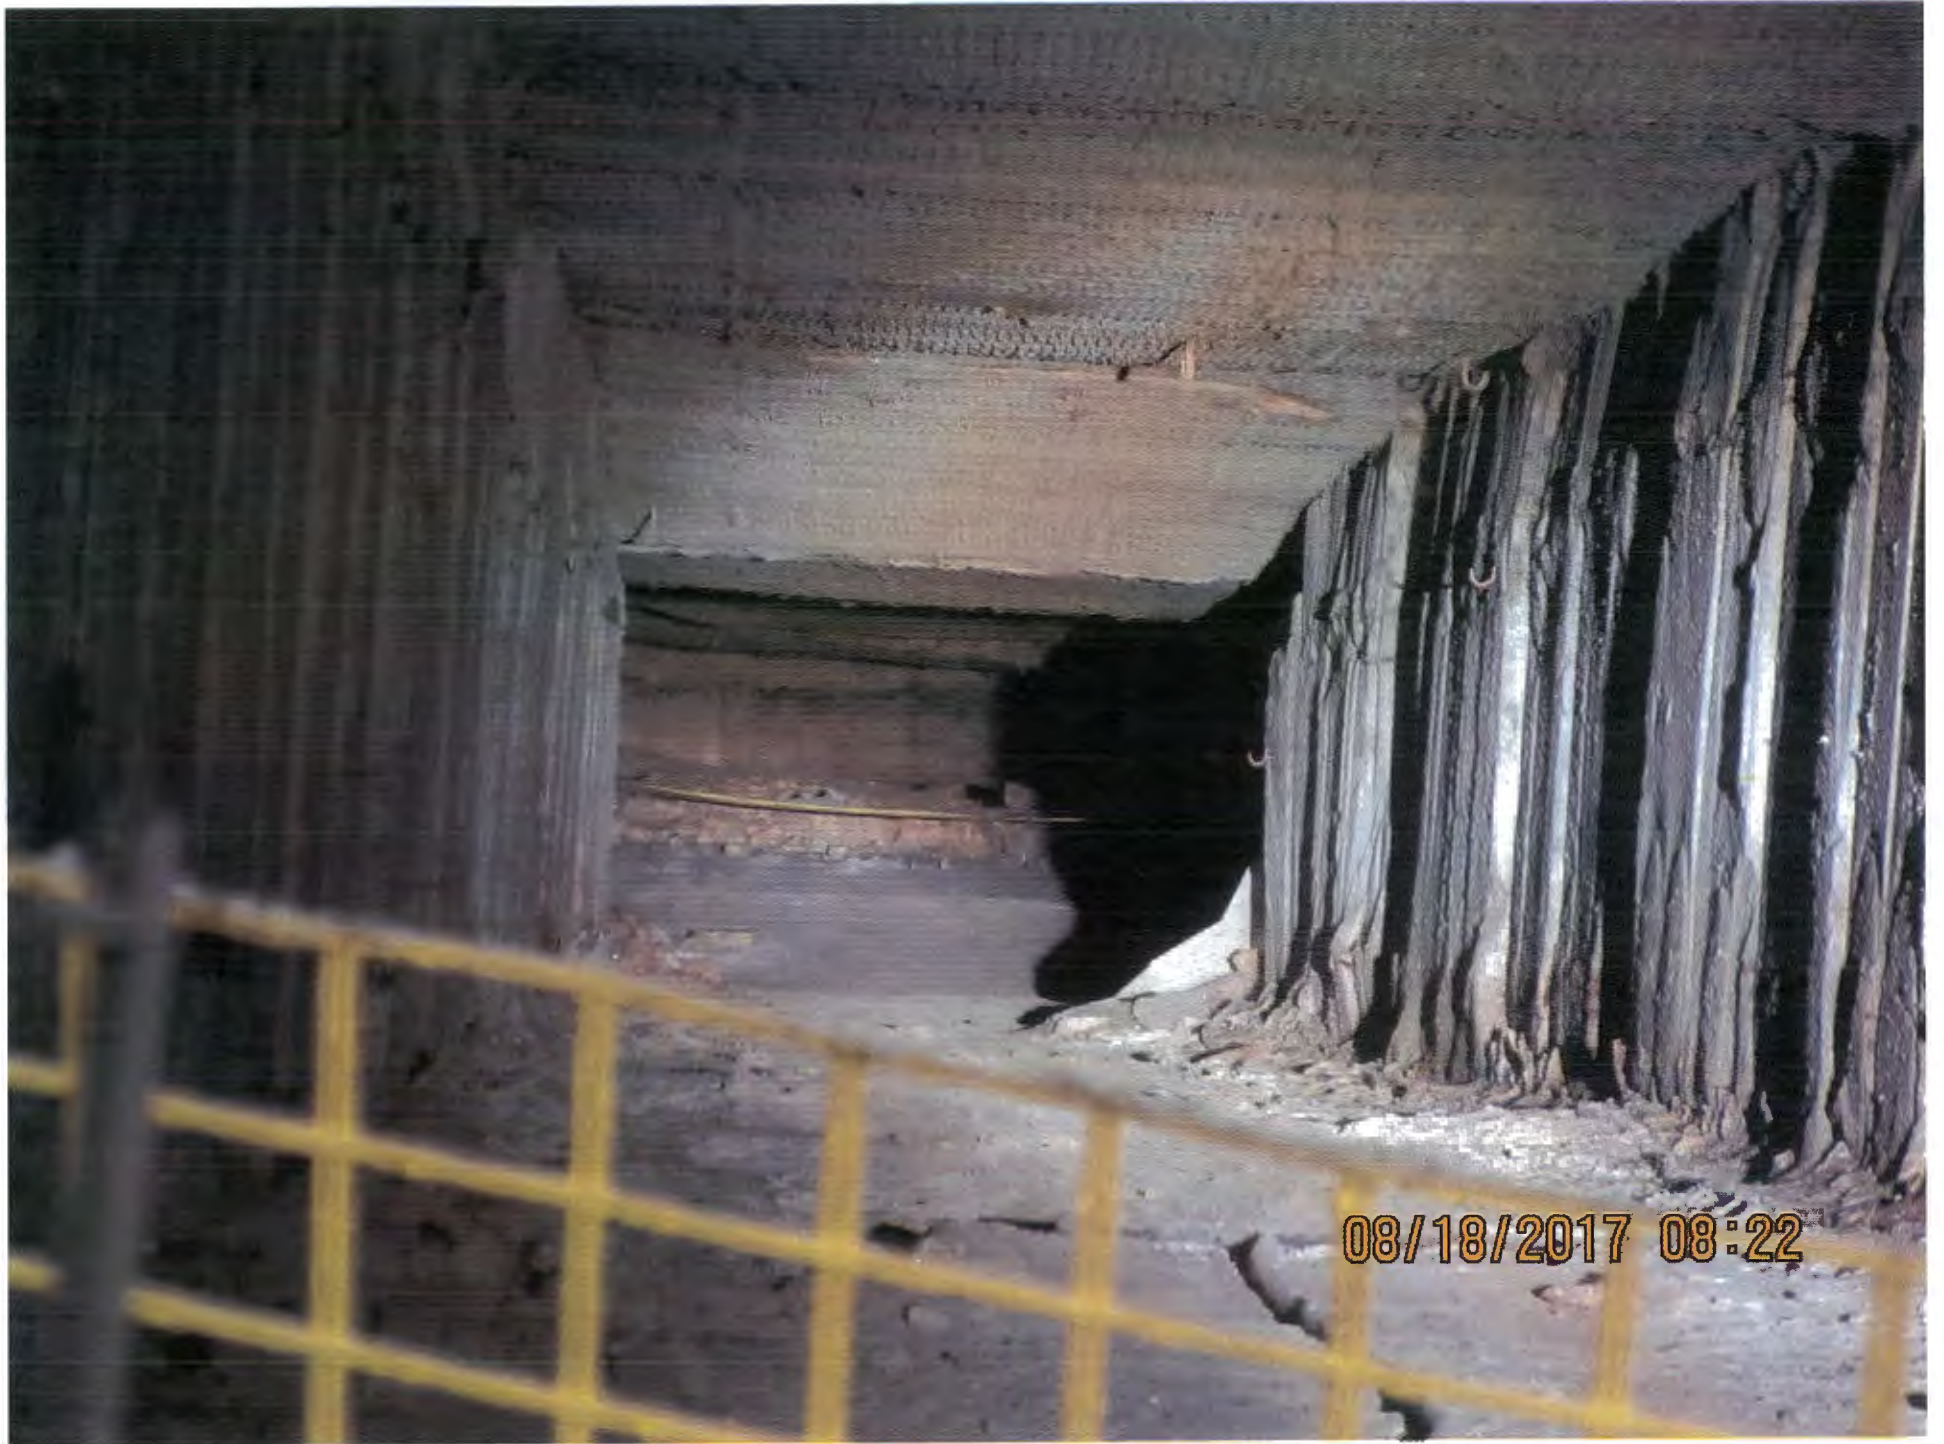
- Rock fall is near room 3 in Panel 8 in the S1950 exhaust drift. It was originally reported to be closer to room 2 but further investigation places it closer to unfinished room 3.
- The rock fall appears to be approximately 2 feet high and 60 feet long and covers the width of the drift. This area was mined approximately four years ago. As this area of the mine is prohibited and not routinely observed, the specific time of the rock fall is unknown but it is believed to have occurred within the last week. Because of the extended time the drift has been open without roof bolting, a roof fall was not unexpected.
