reference to RR Lagoon SWmu# 8

**From:** Jim Lieb [jlieb@giant.com]  
**Sent:** Wednesday, May 17, 2006 8:18 AM  
**To:** Monzeglio, Hope, NMENV  
**Cc:** Steve Morris  
**Subject:** Fan Area/Overflow Area Report

FIGURE 8  
 SITE PLAN  
 RAILROAD RACK LAGOON  
 CINIZA REFINERY  
 GIANT REFINING COMPANY  
 GALLUP, NEW MEXICO

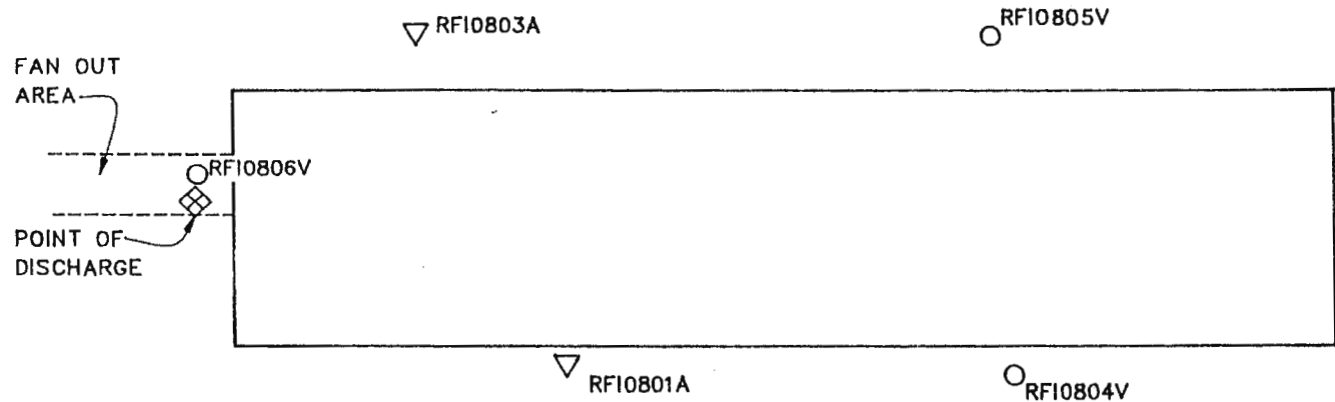
During the RCRA Facility Investigation (RFI), the periphery of the Railroad Rack Lagoon was sampled to determine the extent of soil contamination. Six borings were made at the locations shown on Figure 3, with borings No. 1, 2, and 3 advanced at an angle of 30 degrees from the vertical to sample soils beneath the pond. Samples were collected at the 5, 8, and 10.5 ft levels and analyzed for volatile organic compounds (VOCs) (U.S. Environmental Protection Agency, EPA, Method 8240), semi-volatile organic compounds (SVOCs) (EPA Method 8270), and total metals (EPA Method 6010). Additional seven vertical borings were made along the overflow channel and the fan area to the north of the lagoon to determine if VOCs/SVOCs or metals were carried north in overflow situations.

The first three columns in Table 3.1 characterize three detections in the 18 samples taken from the lagoon periphery. Borings No. 1 and 3 were angled under the lagoon berm and registered analyte concentrations above detection levels at the 5 ft depth. Boring No. 4 was

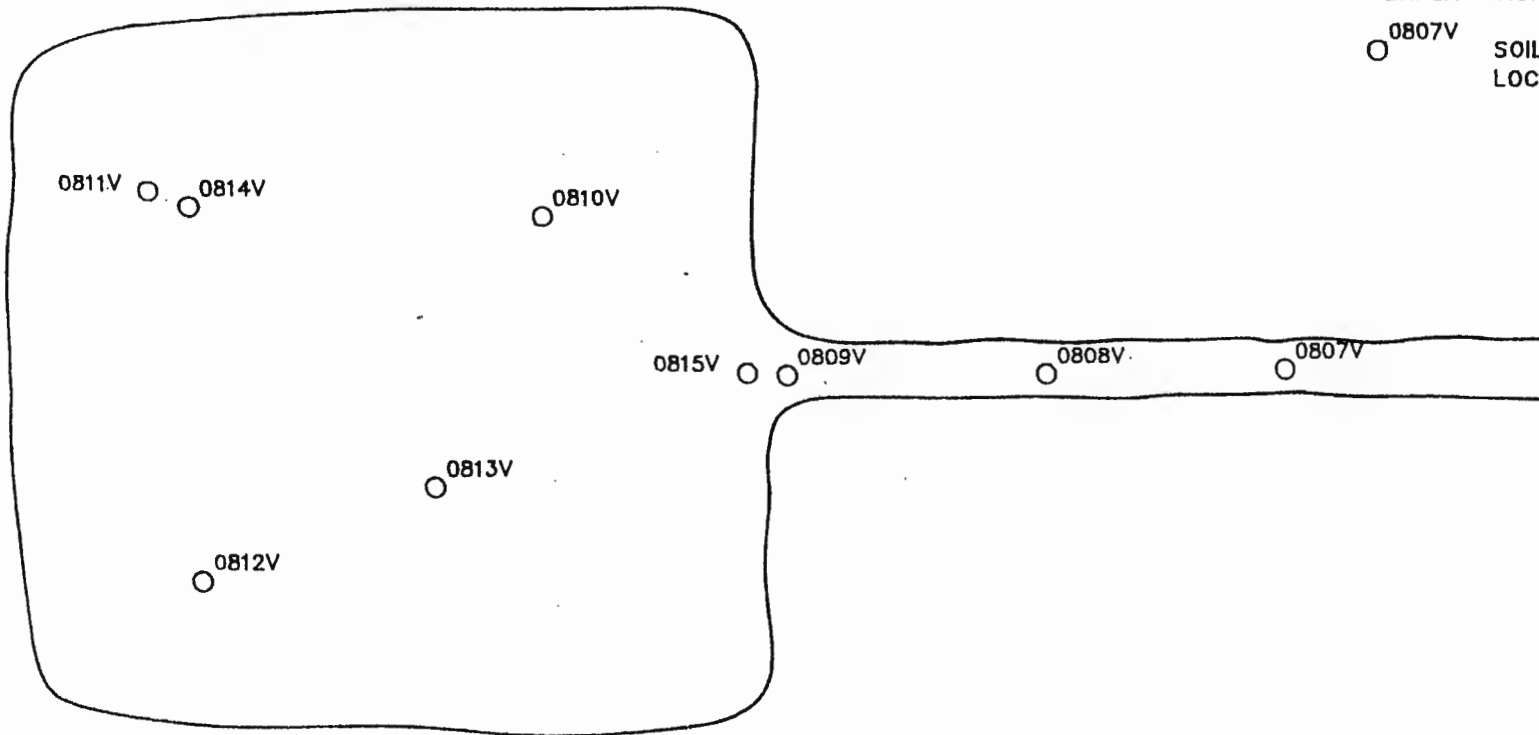
FIGURE 9  
SITE PLAN  
OVERFLOW CHANNEL & FAN OUT AREA  
CINIZA REFINERY  
GIANT REFINING COMPANY  
GALLUP, NEW MEXICO

Table 3.2 characterizes two detections out of the nine samples taken along the overflow channel. Boring No. 9 indicates an elevated chromium level consistent with those detected under the lagoon. The results from Boring No. 7 indicate elevated levels of all metals screened, and are inconsistent with the rest of the site sampling and background information.

Five of the 12 samples taken in the fan area indicate elevated levels of beryllium in the surface soils. Since subsurface soils exhibit these same levels in the background data, the detections appear to be due to loss of the surface soils in the fan area through wind erosion or borrow operations.
