From: Rajen, Gaurav [Gaurav.Rajen@wnr.com]
Sent: Tuesday, August 25, 2009 1:58 PM
To: Chavez, Carl J, EMNRD; Monzeglio, Hope, NMENV
Cc: Riege, Ed
Subject: Final report - Tank 116 spill

C-141 Final Report - Tank 116 Spill

1.0 Description of Site and Incident

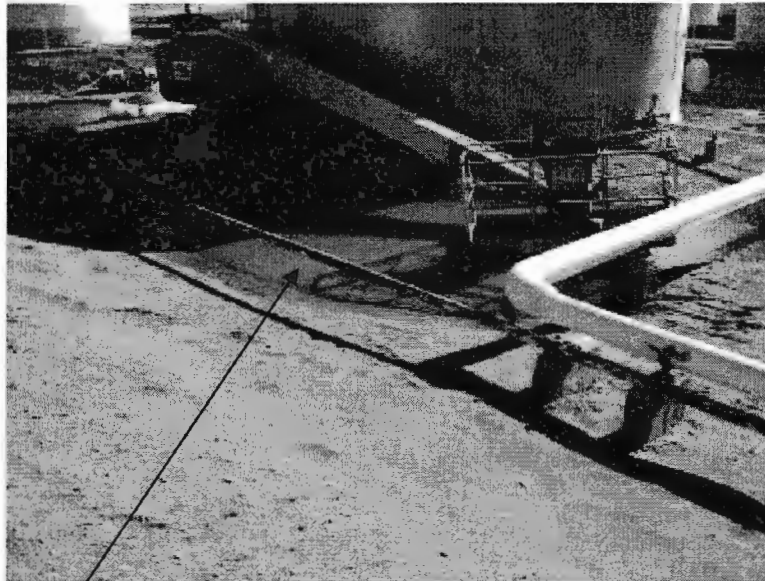
**Area around Tank 116, Tank 115,
and within the berm affected by
the ULSD spill**

Figure 2: Photograph depicting contaminated areas within the berm adjacent to Tank 116 – Tank 116 is off the picture; much of the product flowed and collected next to Tank 115 which can be seen. At this time, maintenance work was ongoing on Tank 115 which is why heavy equipment is seen in the area.

Almost immediately following the spill, a vacuum truck was used to pick up free product (as much as possible), and absorbent material was placed on affected areas to soak up product remaining on the surface. Later, contaminated soil was excavated and stored on plastic in a staging area for later disposal in a permitted landfill. Figures 4-7 depict photographs of various stages of the excavation and subsequent clean-up of the area.

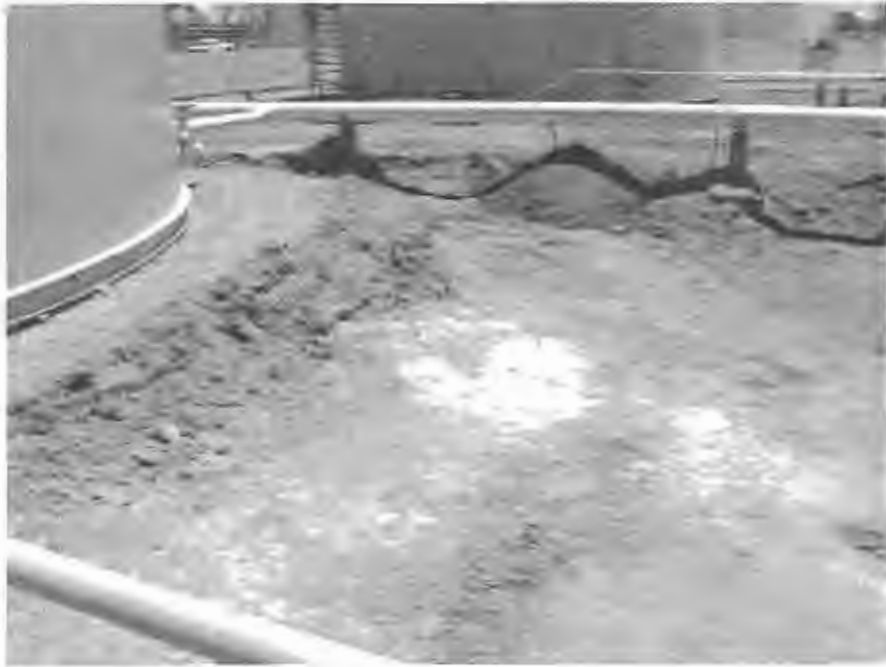
Figure 4: Excavation of contaminated soil in the area described in Figure 2. Note active pipeline towards the rear.

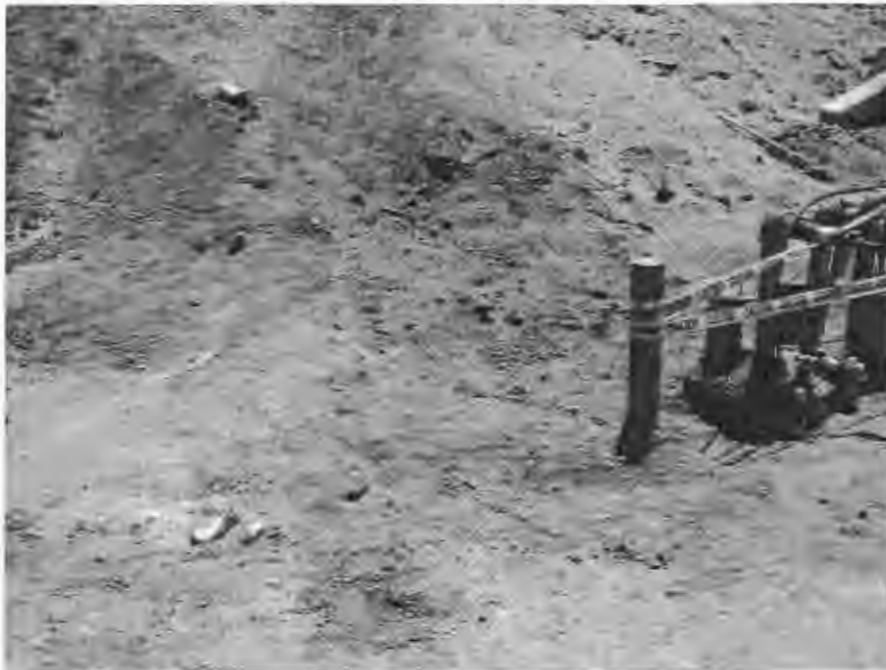
Figure 5: Preliminary excavation of contaminated soils near the drain pipes where product flowed out from the open foam line within the tank

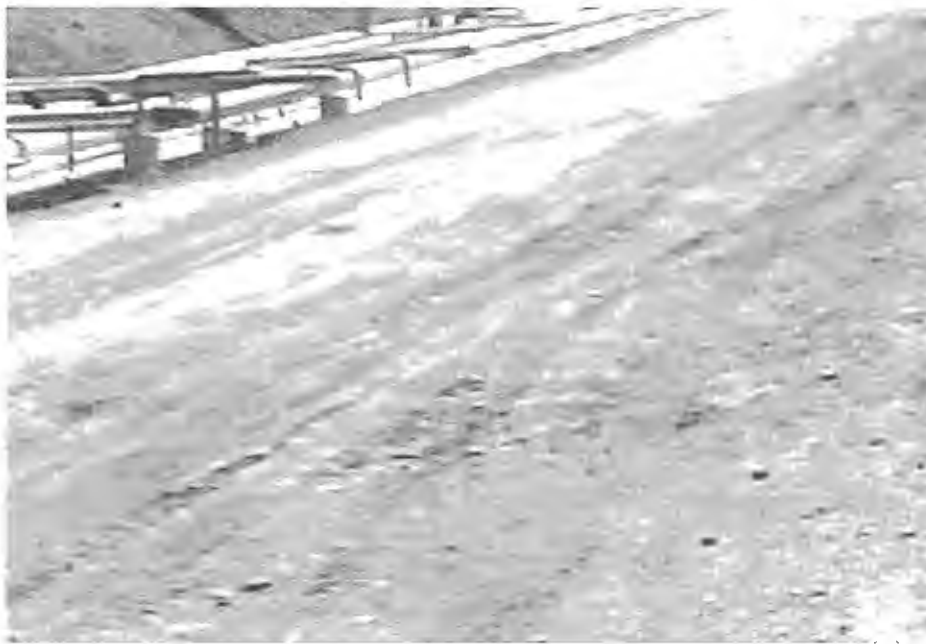
Figure 6: Preliminary clean-up of road which had experienced run-off of product.

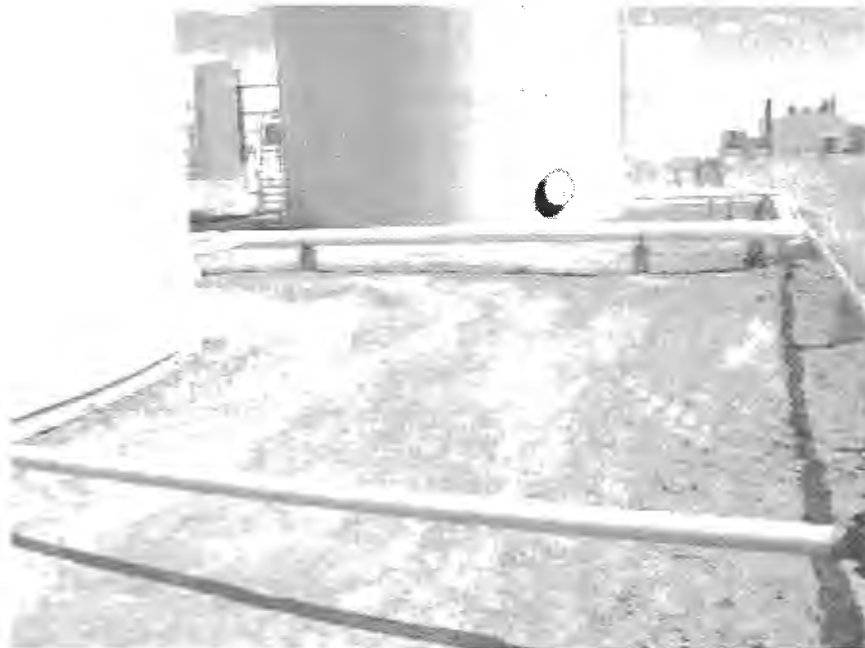
Figure 7: Final clean-up of affected area near Tank 116

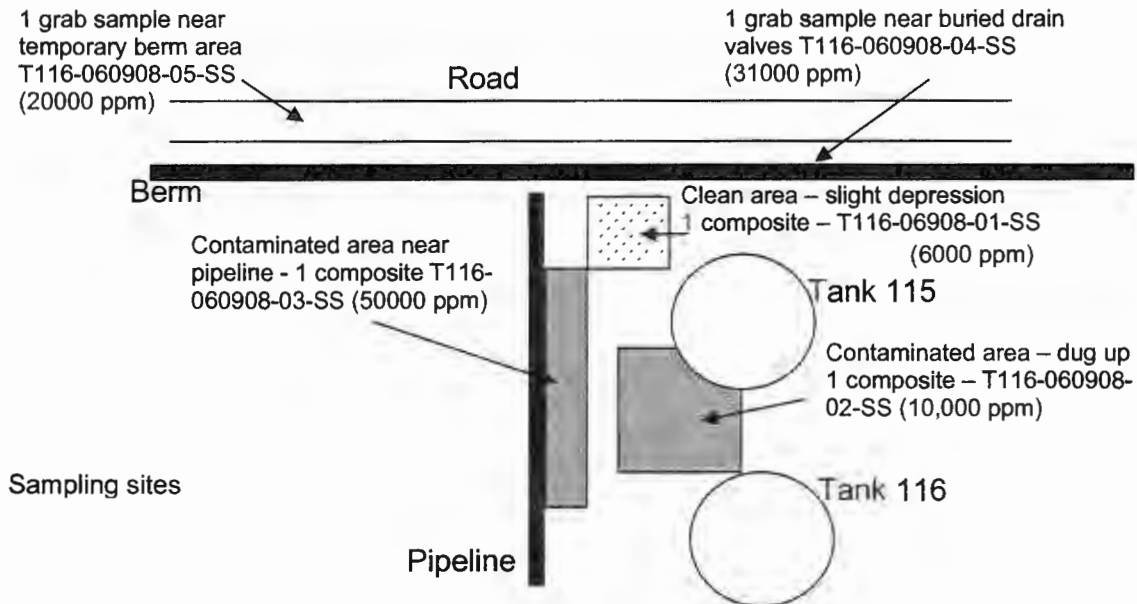
Figure 8: Preliminary sampling locations and results for DRO

These data showed levels of DRO from 6000 ppm to 50,000 ppm. The samples were also analyzed for Gasoline Range Organics (GRO) and Benzene, Toluene, Ethylbenzene, and Xylene (BTEX) using EPA-approved and OCD-recommended methods. GRO and BTEX were at non-detect levels. Based on these data, subsequent excavations were undertaken and the sites were sampled again. Figure 9 presents results from this second set of samples.

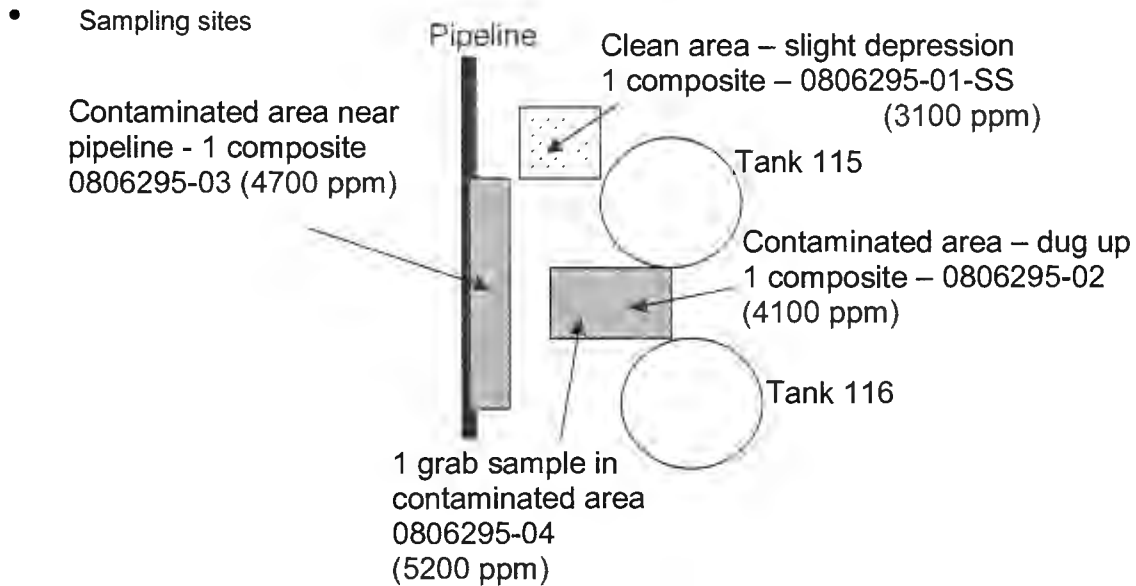
Figure 9: Second set of results after excavation had occurred.

Laboratory data for these samples are also presented in Appendix A. These results show levels of DRO of the order of 4000 - 5000 ppm that were found at the bottom of the excavated area even after 2 feet of contaminated dirt had been removed.

We have assessed the potential for contaminants from this current spill to migrate into the subsurface as being much less than 2 feet. We have excavated soils to this level and disposed off these soils at a permitted landfill. We believe that the levels of DRO being found below this level are probably from previous historical occurrences. Also, near the active pipelines located within the spill area that bring product in and out of the tanks it is not possible for us to excavate deeper without prejudice to the safety of these pipelines. We have reduced the levels of contamination by a factor greater than 10. However, there is some contamination at the level of approximately 4000 – 5000 ppm of DRO existing at the site.

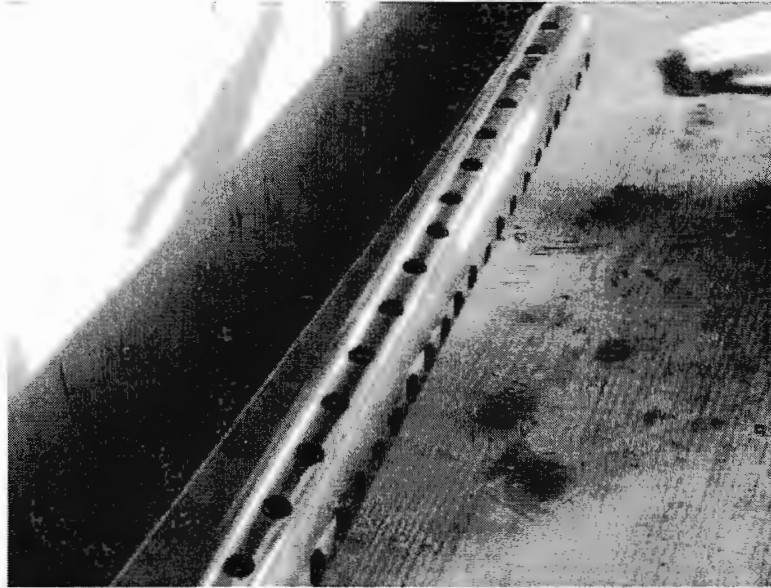
Figure 10: Perforated pipe that has been constructed

- We have carried out a test of passive venting at the site, using a perforated pipe emplaced in to the soil above an area of contamination and started collecting measurements of vapor concentrations within this pipe. Figure 10 depicts a photograph of the perforated pipe we constructed, and Figure 11 shows it in place near a pipeline where it is difficult to excavate.

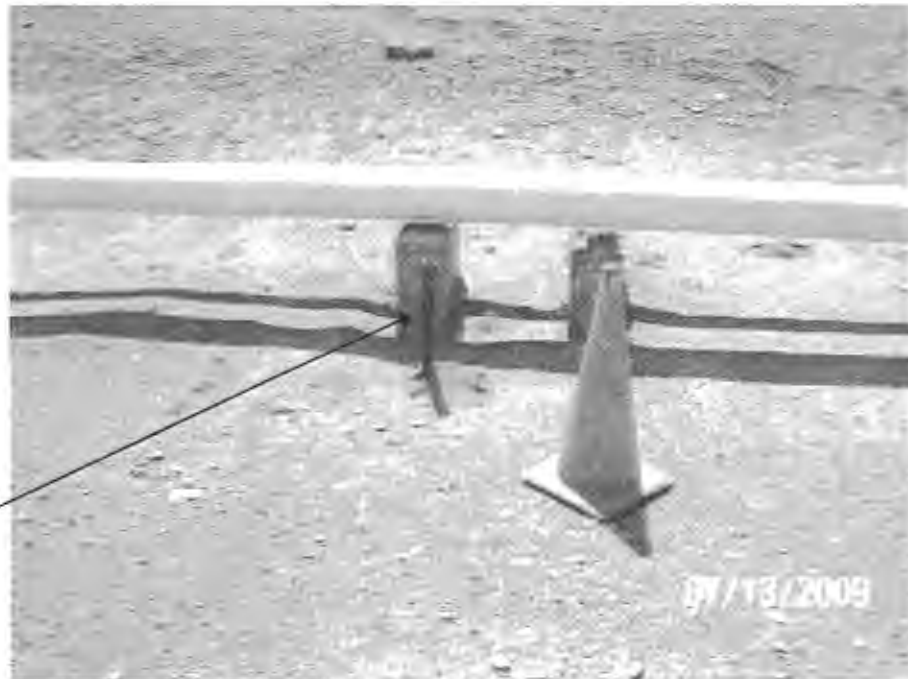
Figure 11: Photograph of emplaced pipe – the section with holes is inside the ground

Over time, vapor concentrations found within the pipe varied considerably. To monitor these concentrations we used a sensitive hydrocarbon vapor detection system based on a flame ionization detector. The concentrations could have been varying because microbial activity within the ground was being enhanced by virtue of the perforated pipe allowing increased air to breathe into the soil. These changing levels could also be from diurnal variations in the flow of soil gases as the ground heats and cools. We monitored these levels for a period of 12 months. Then, we collected a soil sample from this location which was previously known to be at 4700 ppm of DRO. **This level is now 190 ppm.** Details of this set of samples are provided in Figure 12. (We were confident that the entire road surface and buried valve area had been entirely cleaned up – however, as confirmatory samples had not been taken we have collected these and results are also provided.) We will now place more such pipes with OCD's concurrence to reduce contamination that is known to exist within the ground. We also seek OCD's concurrence to postpone further excavation until an opportune time arises in the future, and/or the area is taken out of service.

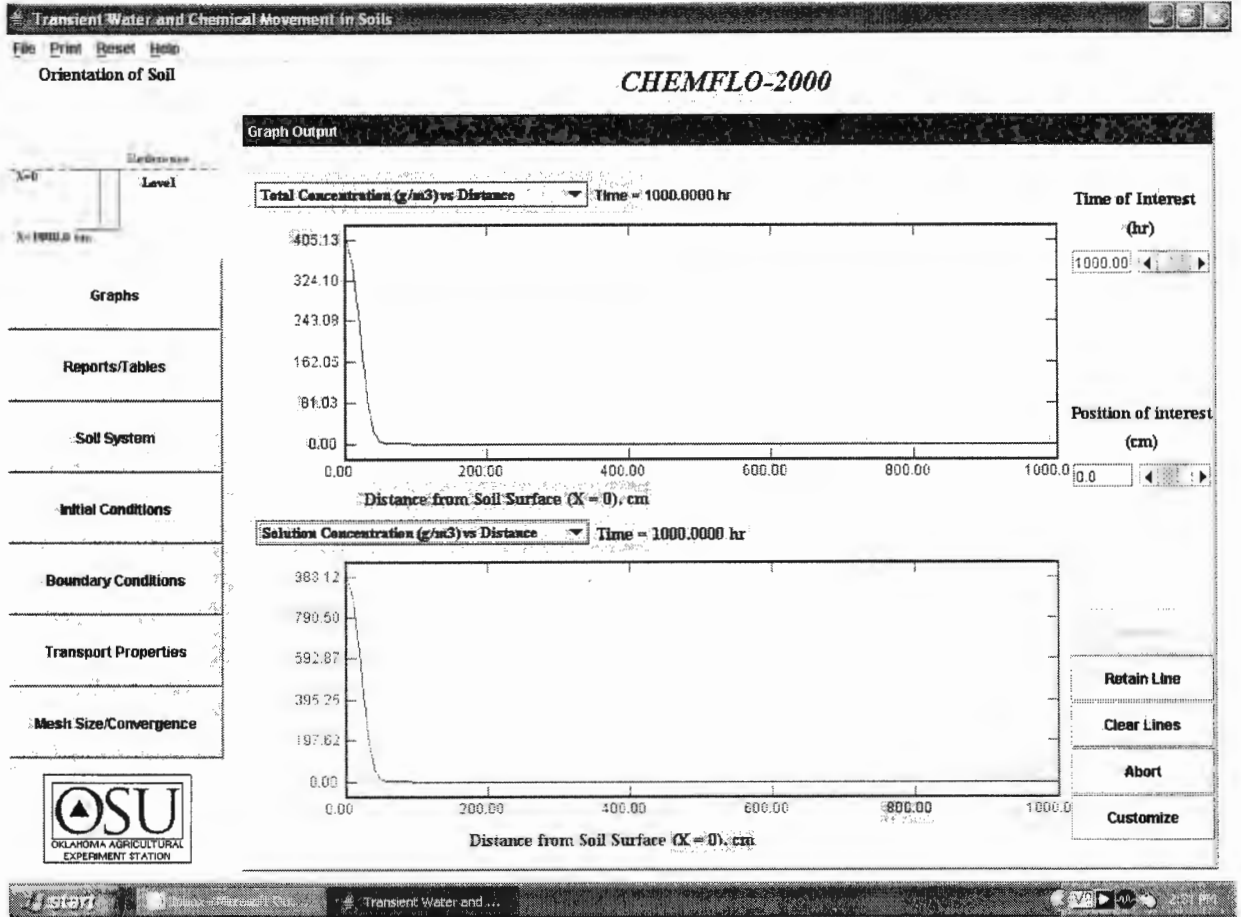
foot of ponded liquids on top. No contamination was predicted to travel deeper than about 1-2 feet even if the liquids stayed at a 1 foot depth on the surface for over 1000 hours – this was not the case in practice as product was picked up within a few hours after the spill. Details are provided in Appendix A. This lends support to the conclusion that contaminated soils below two feet is probably from previous activities.

Figure A.1: Likely migration of contaminants into the subsurface – as can be seen, even after 1000 hours, no contamination is expected deeper than about 50 cm (1.6 feet). Therefore, it is extremely likely that contamination found deeper than 2 feet was from previous spills.
