RE: Engineering Review of the Evaporation Pond Repair for Western Refining Southwest, Inc., Gallop, New Mexico.

**Engineering Review Comments on the Evaporation Pond Repairs for Western Refining
Southwest, Inc., Gallop, New Mexico**

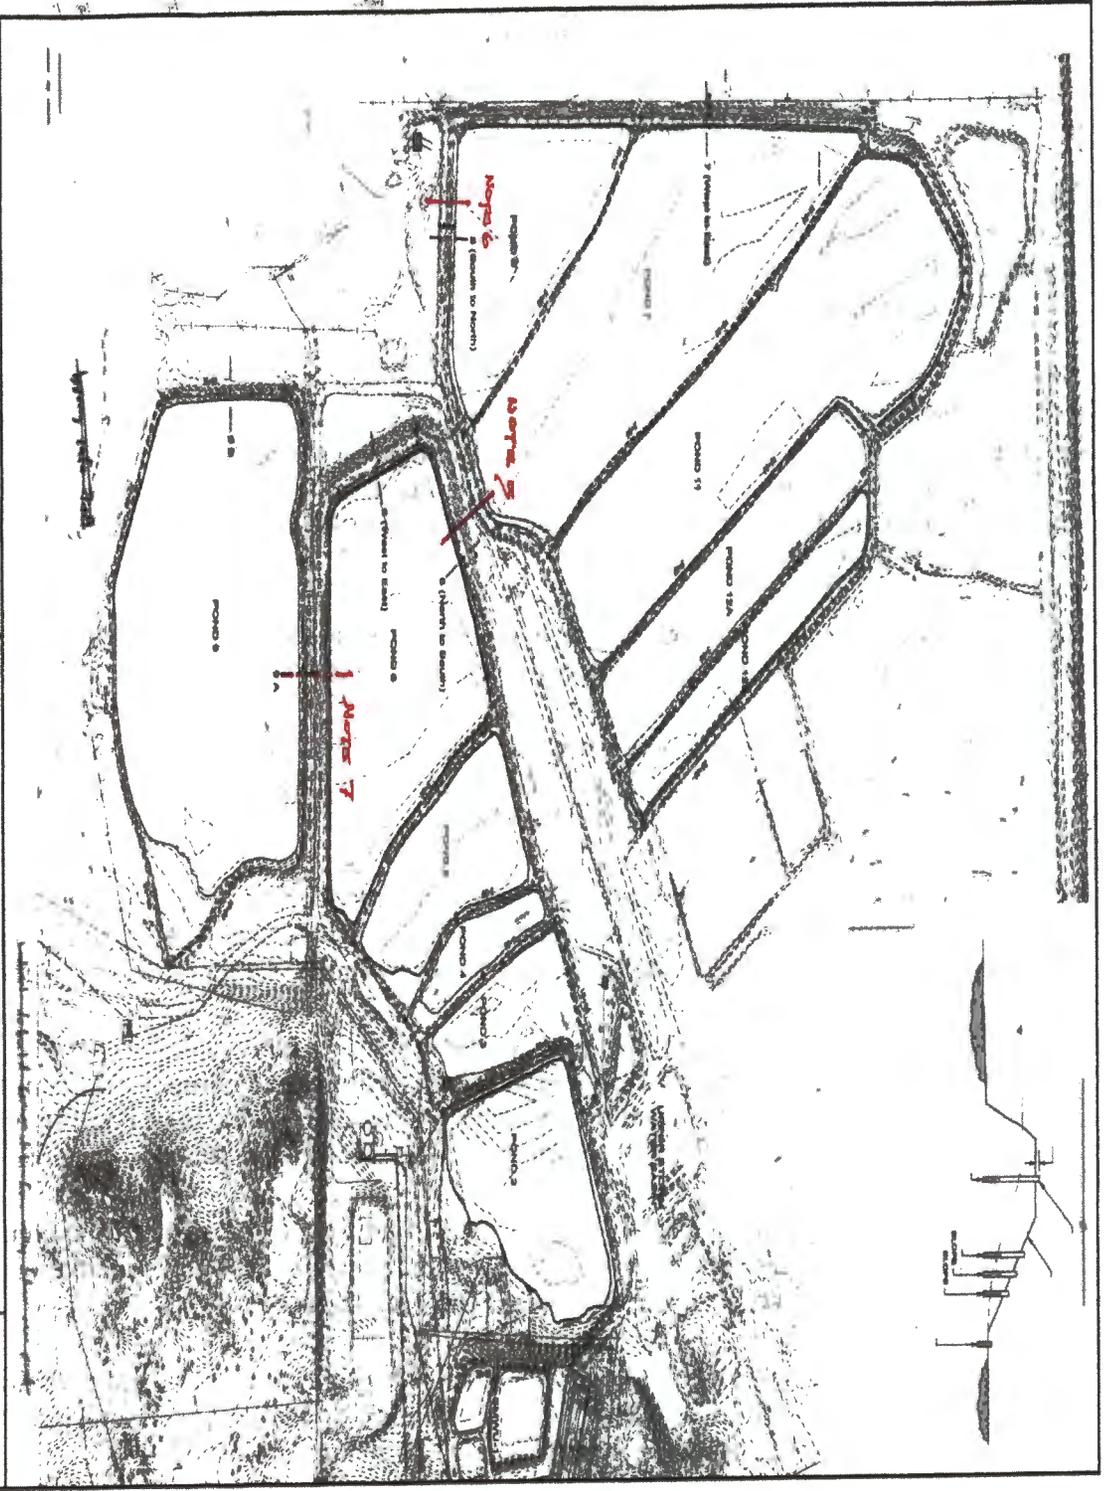
6a

- The report does not explicitly state why the sections were cut where they were. Therefore, suggest moving Section 6 to the southwest and extending Section 6 into the bottom of Pond 7 to enable a stability analysis of the interior slopes of Ponds 6 and 7, including a surcharge loading (as appropriate). [See Annotated Drawing 6a, note 5]

- Suggest moving Section 8 slightly to the west to capture the low point of the pond, corresponding to what appears to be the tallest and most appropriate embankment section for the analysis of stability. [See Annotated Drawing 6a, note 6]

- Suggest extending Section 9A directly north into the Pond 6 bottom, so the stability analysis is performed of the interior slopes of Ponds 6 and 9, with the inclusion of surcharge loads, as appropriate. [See Annotated Drawing 6a, note 7]
